SAGUACHE CREEK DIVERSION INFRASTRUCTURE INVENTORY

Structure Name: MIDDLE D-CURTIS

Date: April 4, 2019

Saguache Creek Stream
Management Plan

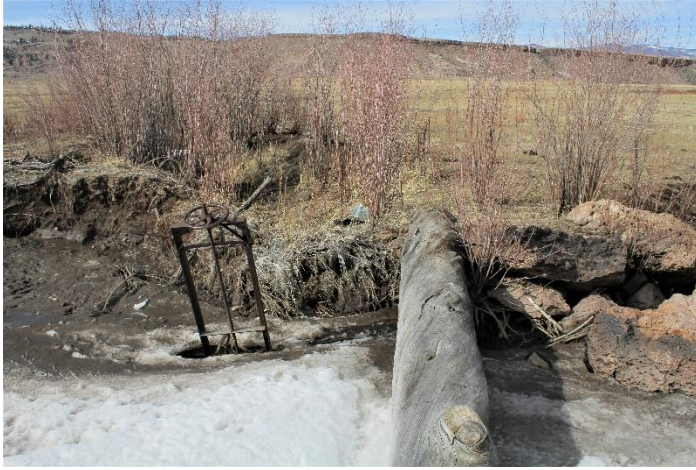
Old headgate looking downstream

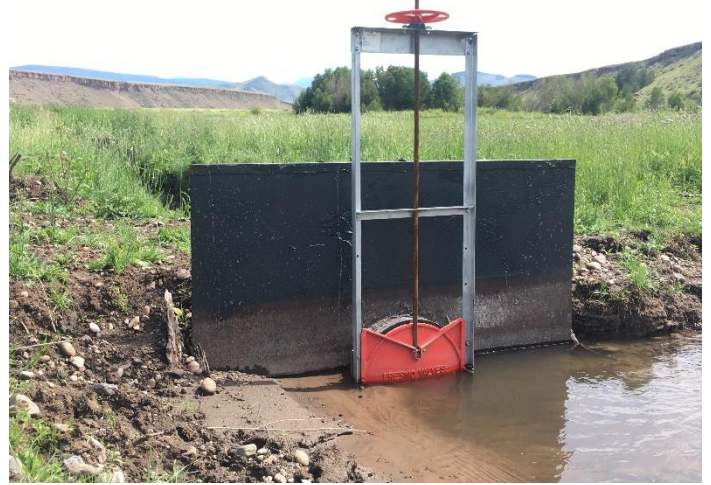
New headgate looking downstream

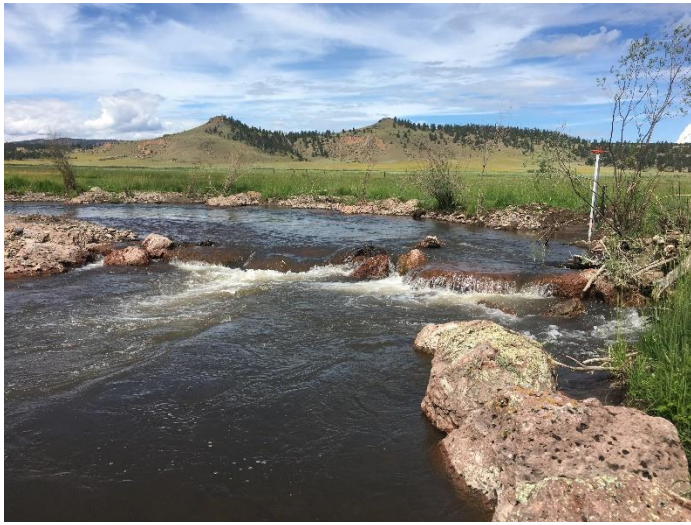
Diversion dam looking upstream

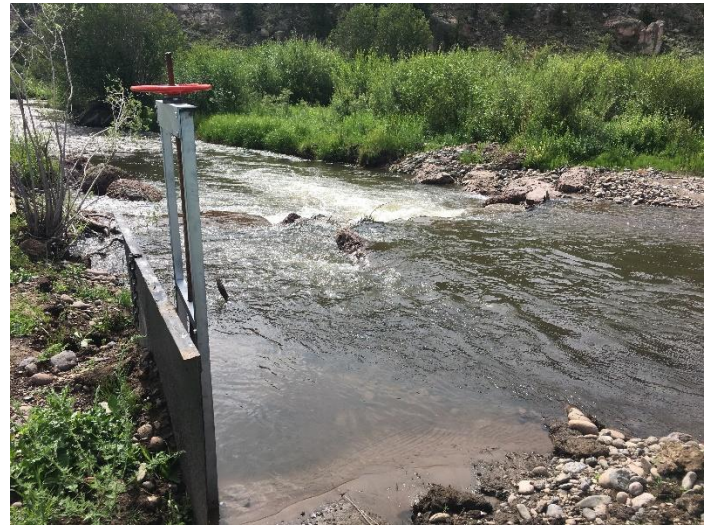
Diversion dam looking downstream

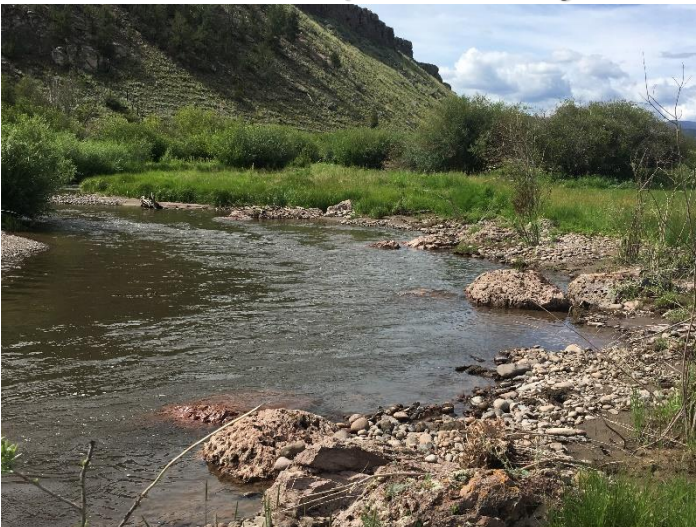
Bank stabilization upstream of headgate

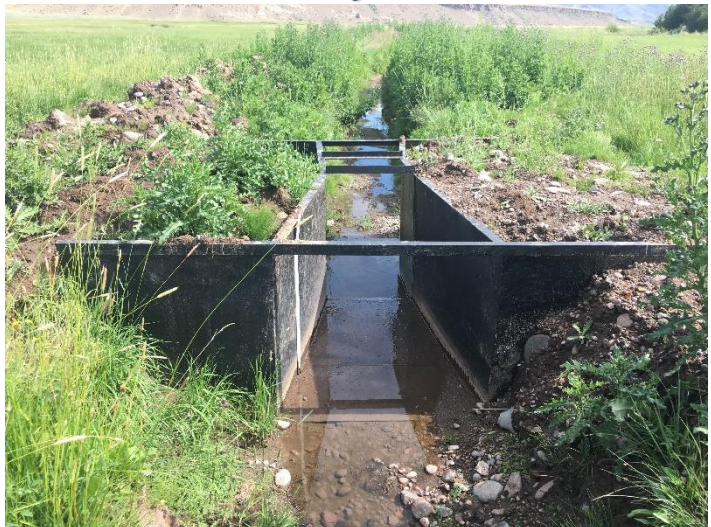
Flume looking downstream

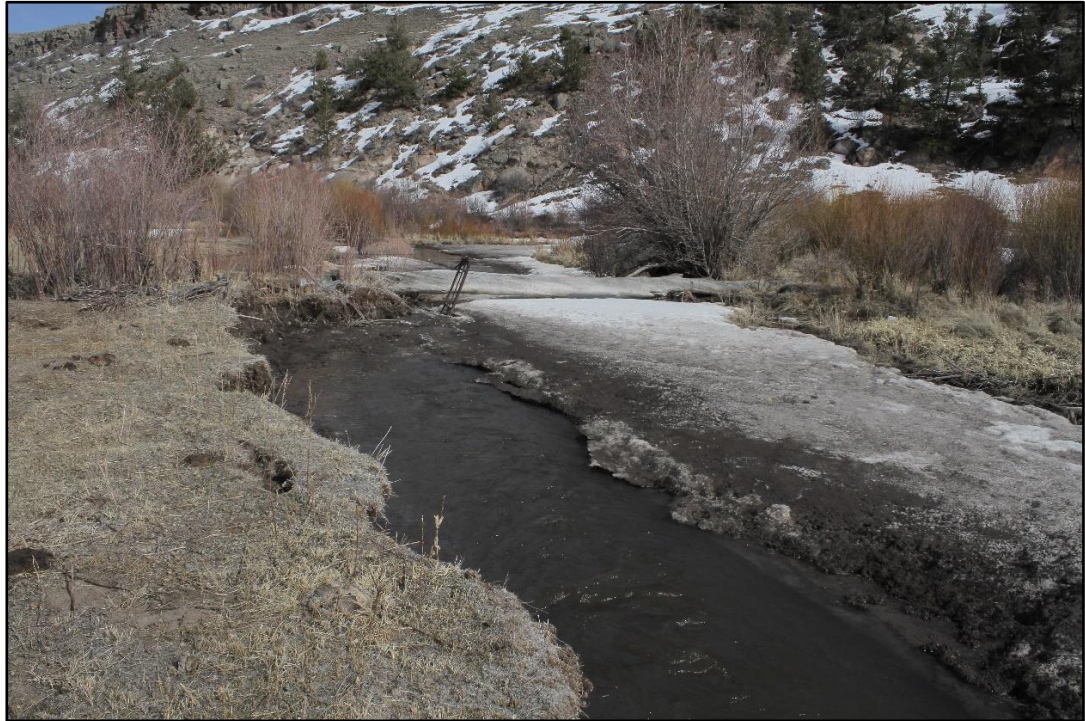
Old headgate looking downstream

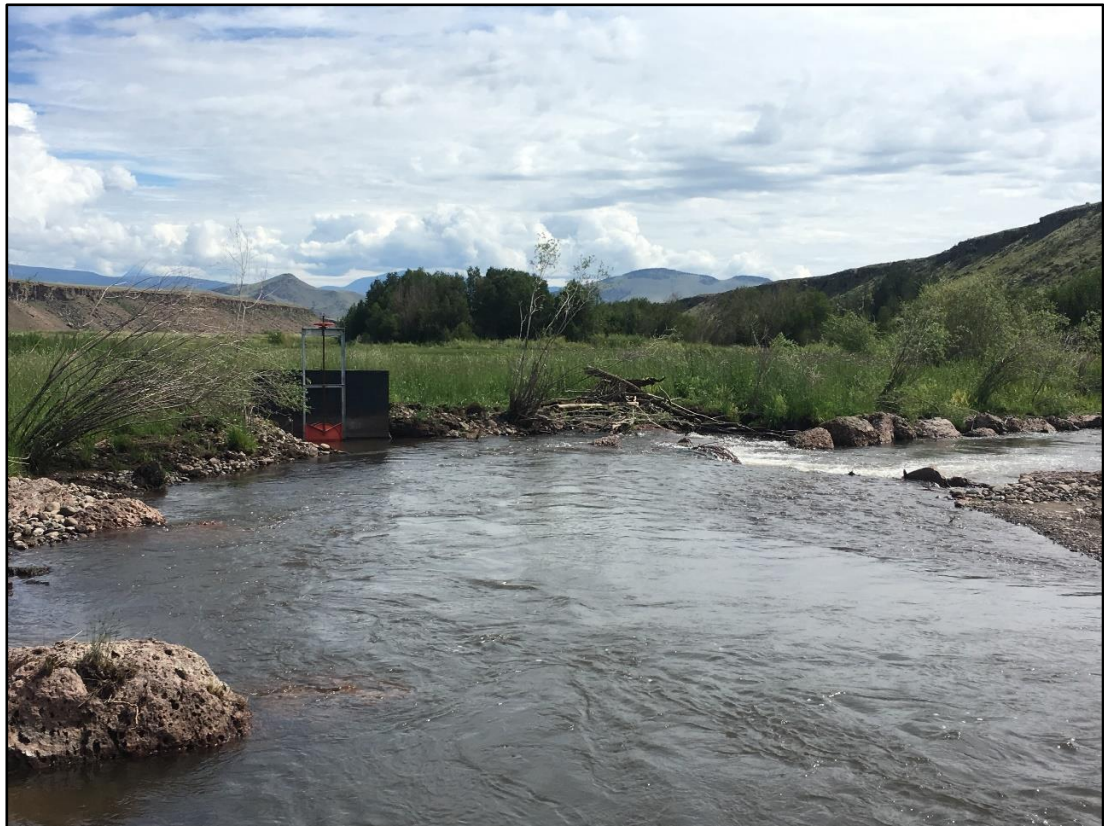
New headgate looking downstream
