# SAGUACHE CREEK DIVERSION INFRASTRUCTURE INVENTORY

**Structure Name:** MONK D 2

**Date:** August 8, 2019

MONK DITCH 2

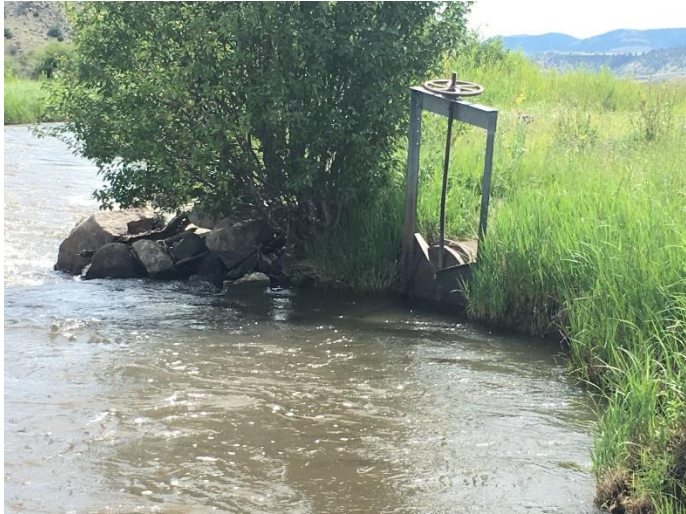
**Structure Description:** A stacked rock diversion dam directs water to the headgate, located on the south bank of the stream. Upstream of the diversion, the south stream bank is experiencing erosion. The meander upstream of the diversion is also at risk of being cut off. The headgate is tilted and functions poorly.

Headgate looking downstream

**Repair(s) or Improvement(s) Currently Needed:** The TAT recommends bank stabilization upstream of the diversion and leveling the headgate. Stabilization would protect the headgate and help prevent the upstream meander from being cut off.

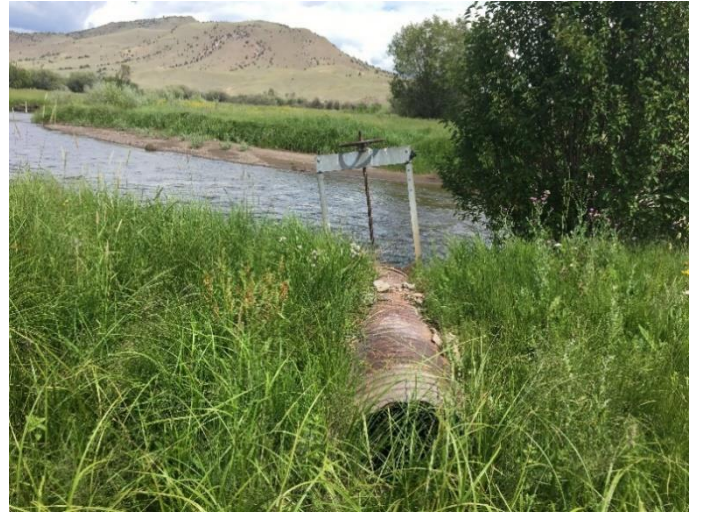
Headgate outlet

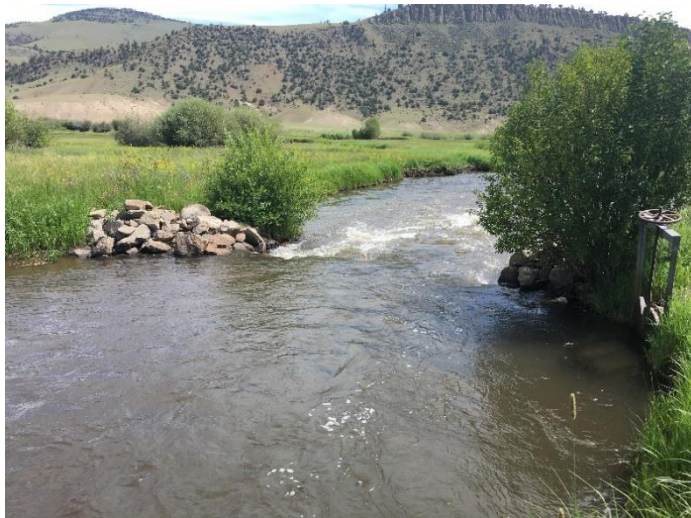
Headgate and diversion dam

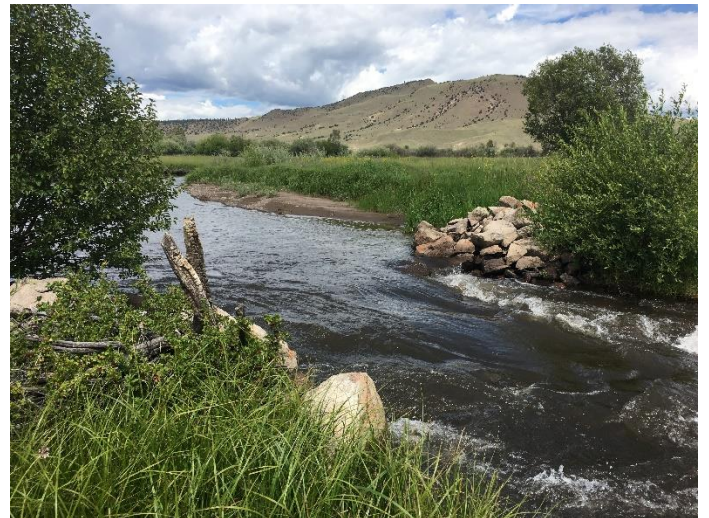
Diversion dam

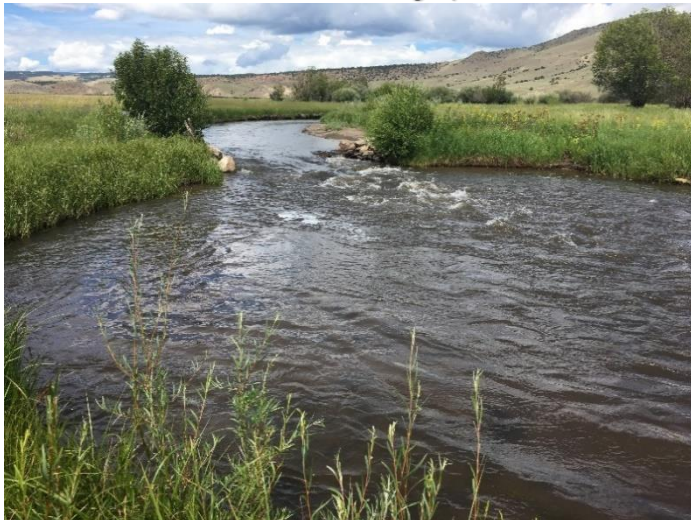
Diversion dam looking upstream

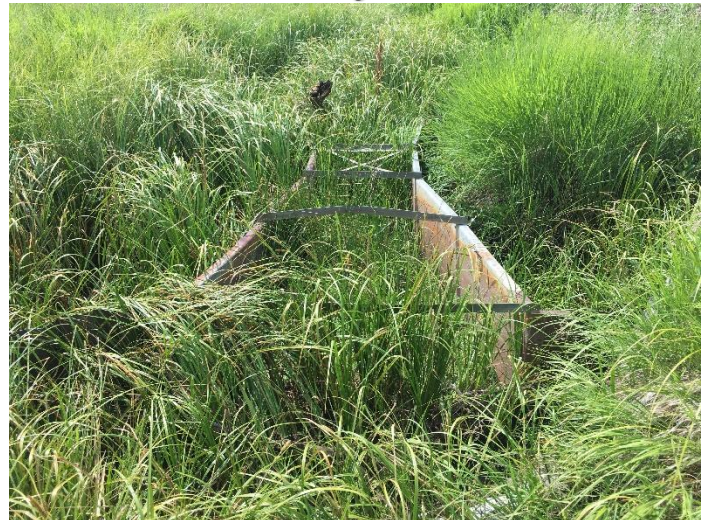
Flume looking downstream
