# SAGUACHE CREEK DIVERSION INFRASTRUCTURE INVENTORY

**Structure Name:** MORRISON D

**Date:** August 8, 2019

MORRISON DITCH

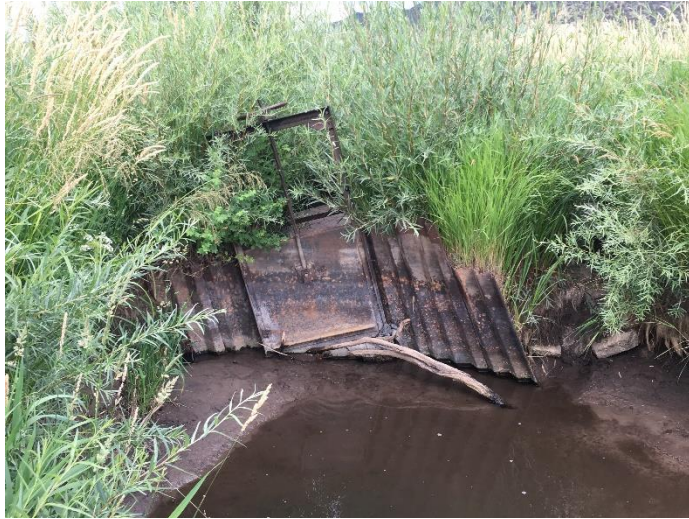
**Structure Description:** This structure is located at the downstream end of a meander. A stacked rock diversion dam with two large tree trunks and other woody debris directs water to the headgate, located on the south bank of the stream. The headgate is titled and is difficult to operate. The diversion can form a barrier to fish passage at low flows. During 2019 spring runoff, the recently installed diversion dam was partially washed out. Many of the boulders making up the diversion were washed downstream (see photos below). Below the headgate, the ditch is relatively flat, leading to sediment and debris accumulation issues, including at the flume. Beaver activity in and nearby the ditch contribute large quantities of woody debris, presenting a significant maintenance challenge for the landowner and water users.

Headgate looking downstream

**Repair(s) or Improvement(s) Currently Needed:** The SMP Technical Advisory Team (TAT) recommends repairing or replacing the diversion, resetting the headgate, and resetting or replacing the flume to improve measurement accuracy. Resetting the headgate would improve function and ease of use. The TAT also recommends incorporating fish passage if the diversion is modified or replaced. Note: between this diversion and Fullerton Ditch 1 APD, the stream bifurcates, with Werner Arroyo flowing south of the mainstem.

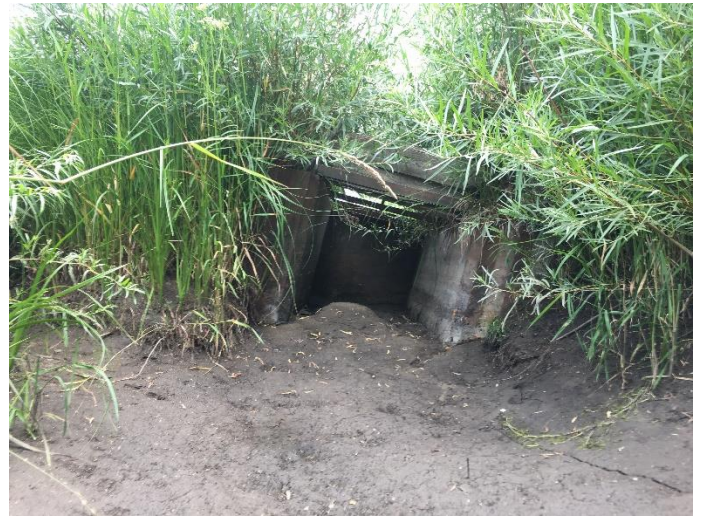
Headgate outlet

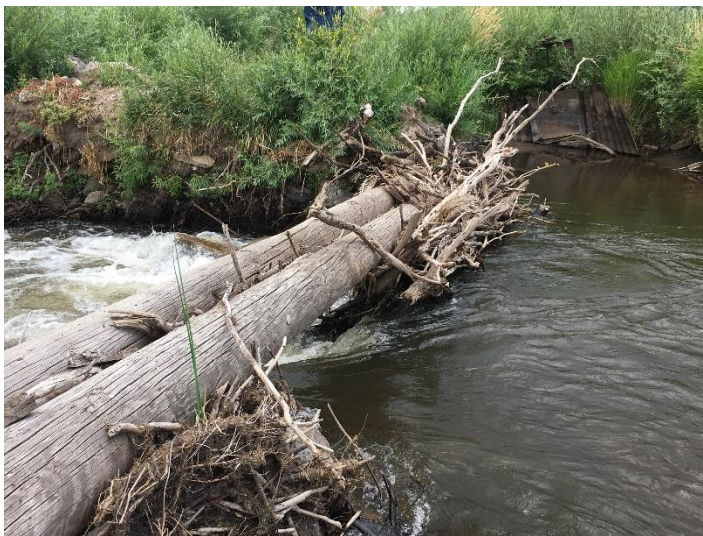
Headgate and diversion dam

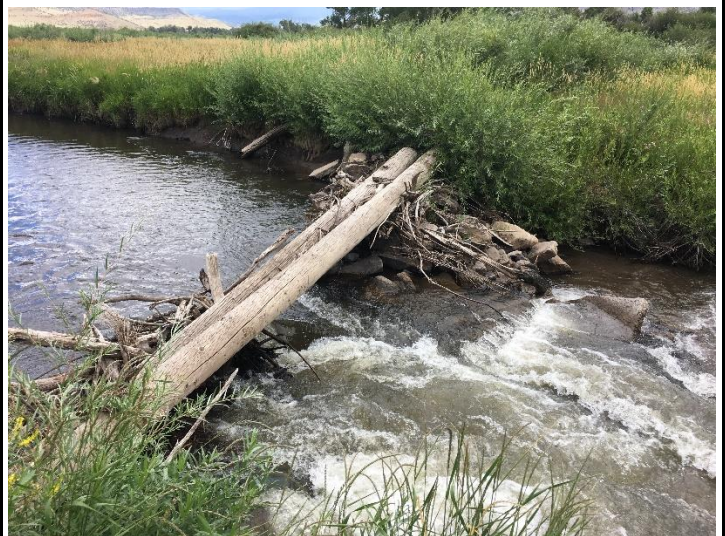
Diversion dam

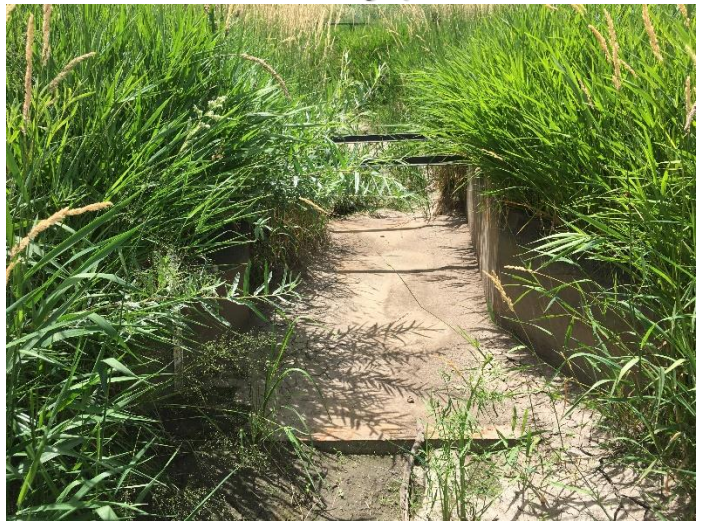
Flume looking upstream

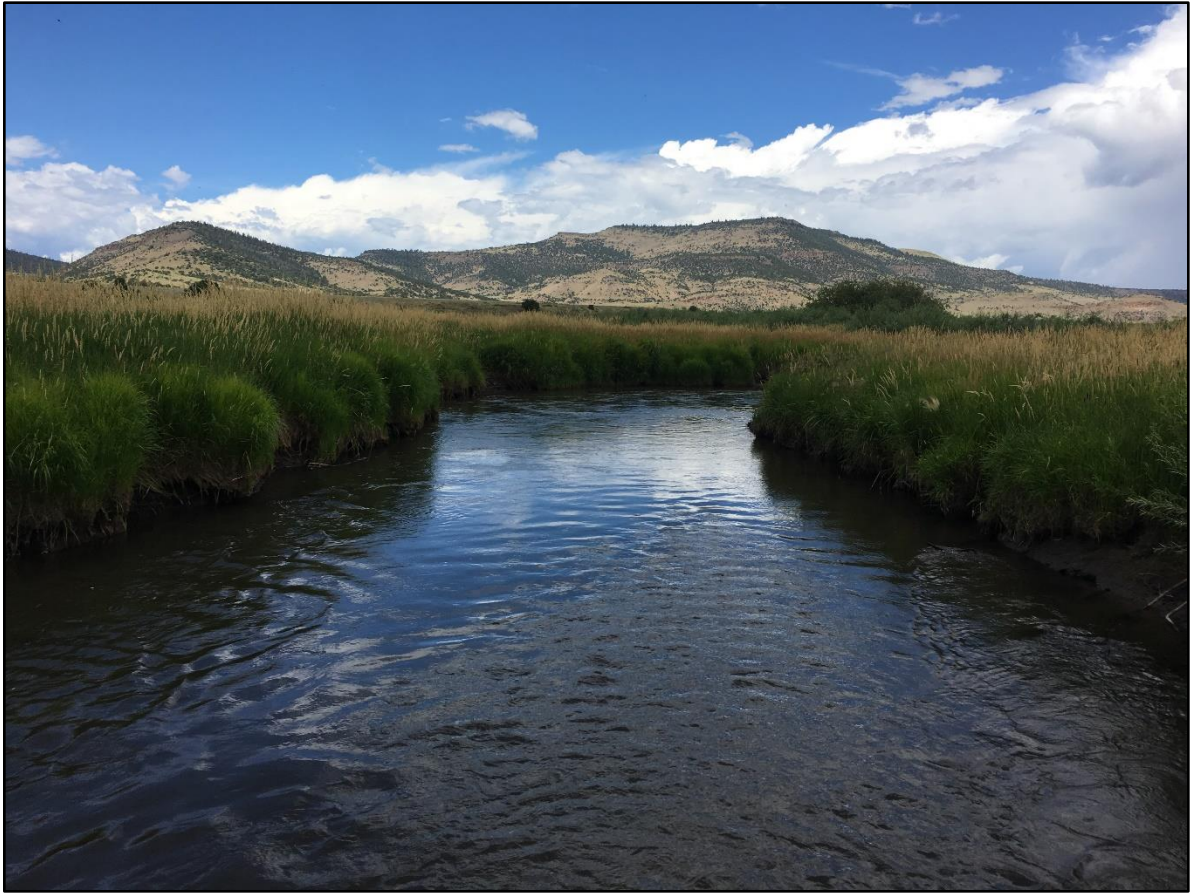
**Saguache Creek channel looking upstream of diversion**

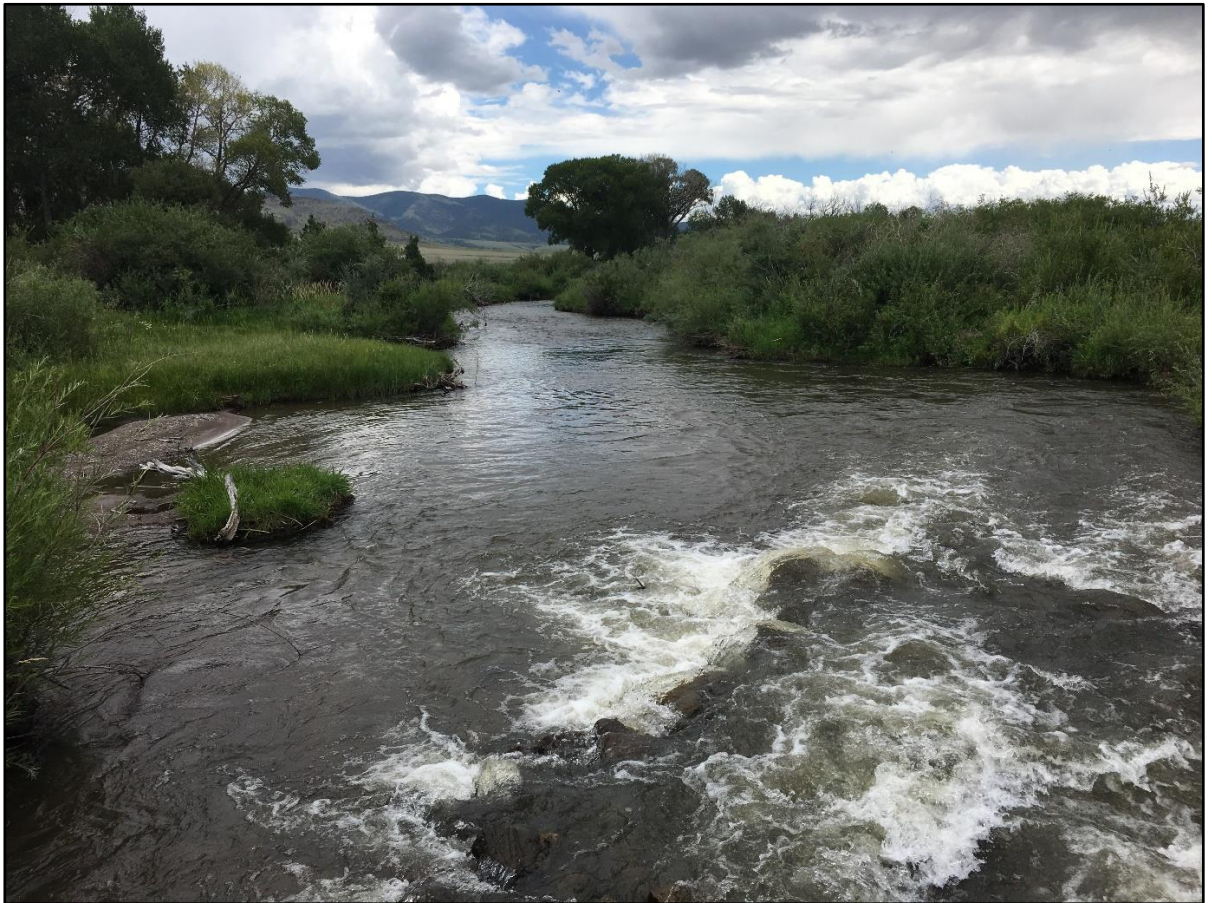
**Saguache Creek channel looking downstream of diversion**
