SAGUACHE CREEK DIVERSION INFRASTRUCTURE INVENTORY

Structure Name: PIQUET D 21

Date: August 8, 2019

Saguache Creek Stream Management Plan

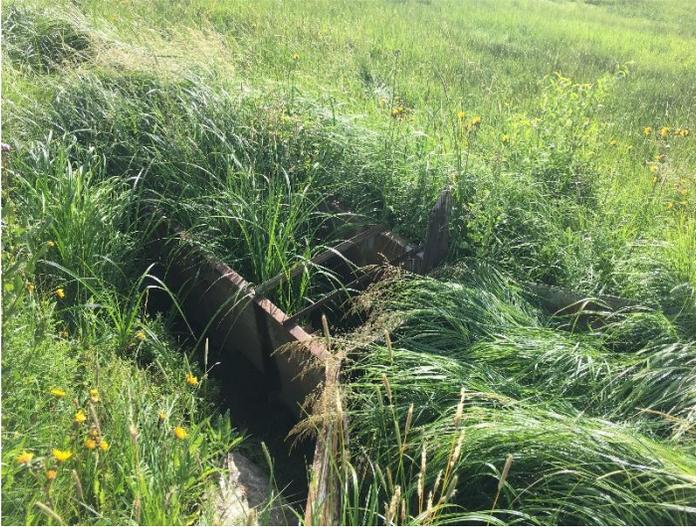
Headgate looking downstream

Structure Description: A stacked rock diversion dam directs water to the headgate, located on the south bank. The diversion dam is in poor condition, with few boulders remaining, and is unable to divert water at low flows. The headgate also functions very poorly, failing to seal. Accelerated bank erosion is occurring near this structure. The measurement device could not be located at the time of inspection.

Repair(s) or Improvement(s) Currently Needed: The SMP Technical Advisory Team (TAT) recommends replacing the diversion with an improved stacked rock structure, implementing riparian revegetation, and repairing the headgate. An improved diversion would divert water at all flows and headgate repair would eliminate leakage and increase efficiency. Riparian revegetation would reduce bank erosion and mitigate sediment impacts at this structure.
