SAGUACHE CREEK DIVERSION INFRASTRUCTURE INVENTORY

Structure Name: PROFFIT MCDONOUGH D

Date: April 3, 2019

Saguache Creek Stream
Management Plan

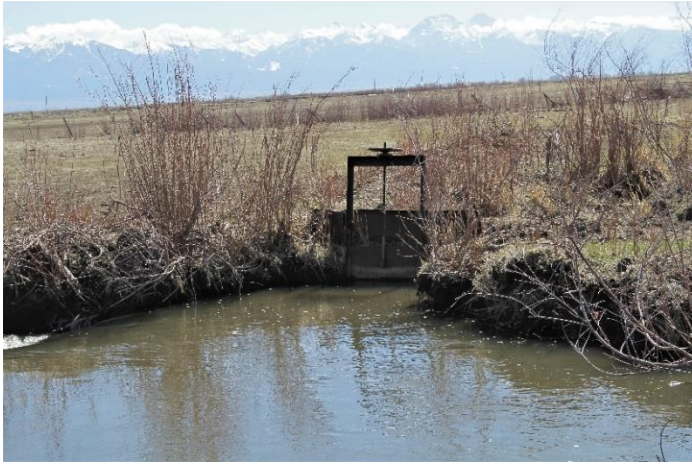
Headgate looking downstream

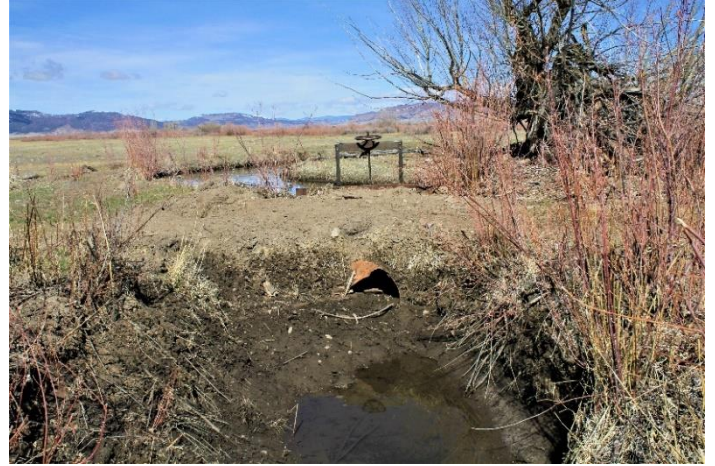
Headgate outlet

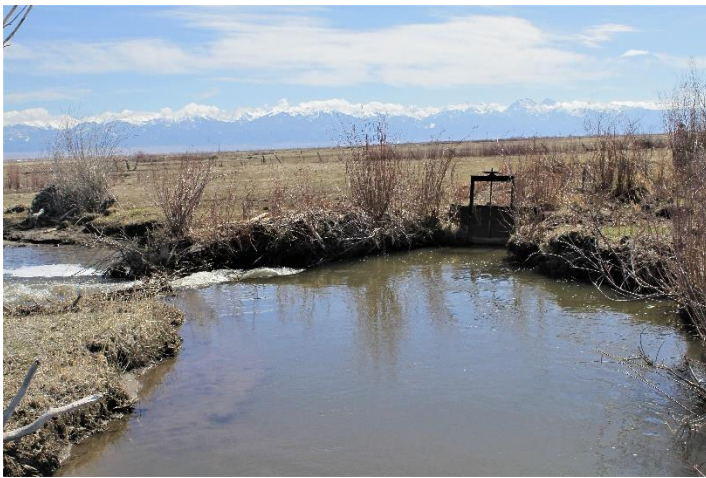
Headgate and diversion dam

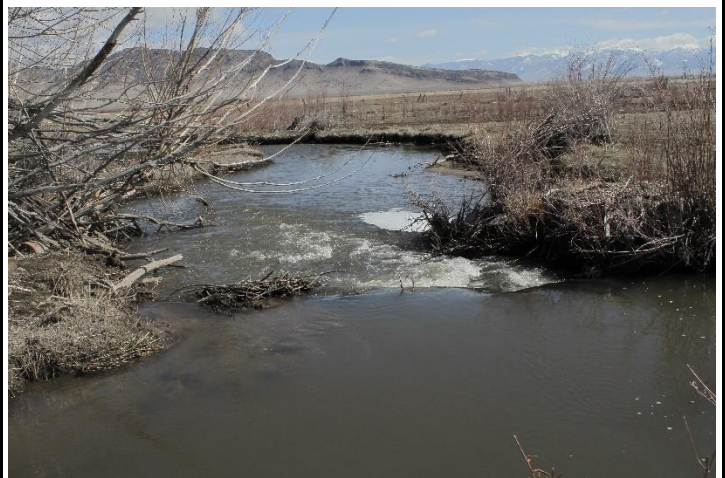
Diversion dam looking downstream

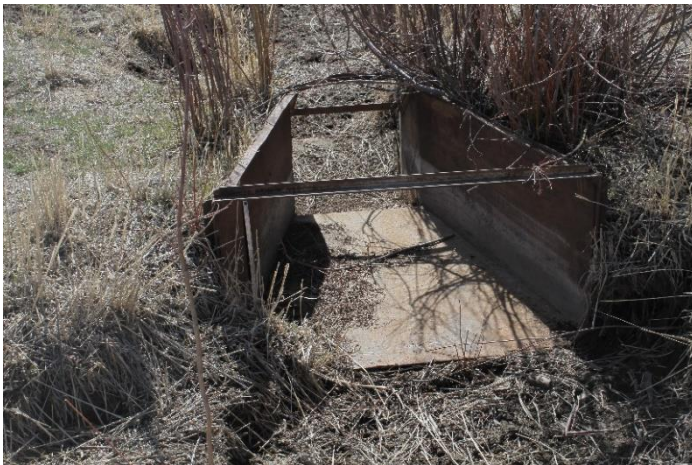
Structure Description: The stream's gradient in this reach is very low and the stream is sinuous, with the potential for meanders to be cut off during high flow events. This structure's headgate is located on the south bank of the stream on the downstream end of a meander. The stream bank around the headgate was recently stabilized to prevent flows from bypassing it. The diversion dam is a stacked rock structure and functions moderately well. Occasionally, sand prevents the headgate from closing completely. The flume is tilted.

Flume looking downstream

Repair(s) or Improvement(s) Currently Needed: The SMP Technical Advisory Team (TAT) recommends bank stabilization and riparian revegetation near this structure and resetting the flume. Stabilization and revegetation upstream of the diversion would help prevent the meander from being cut off and would mitigate erosion. Resetting the flume would improve long-term measurement accuracy.

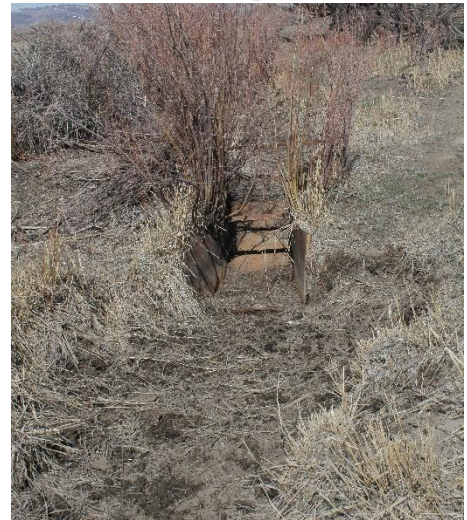
Flume looking upstream
