SAGUACHE CREEK DIVERSION INFRASTRUCTURE INVENTORY

Structure Name: QUARTET D

QUARTET DITCH

Saguache Creek Stream Management Plan

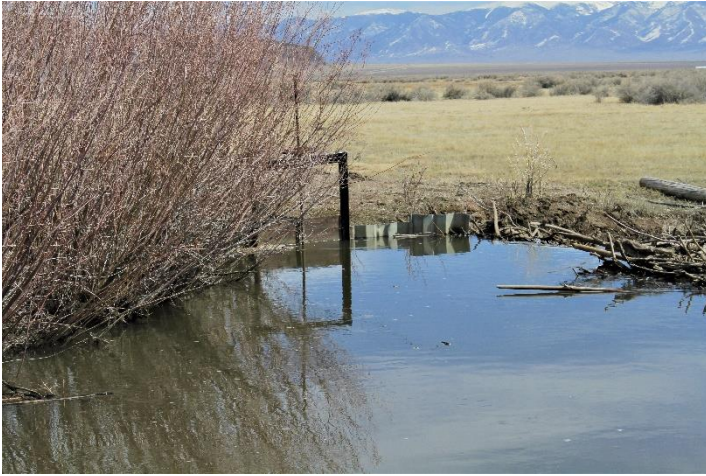
Headgate looking downstream

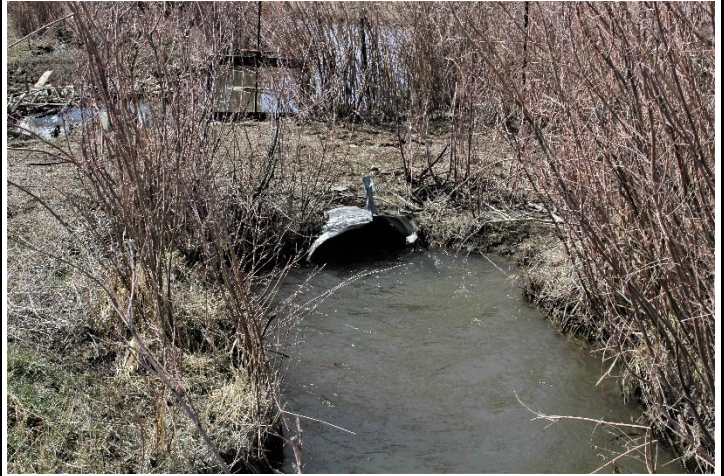
Headgate outlet

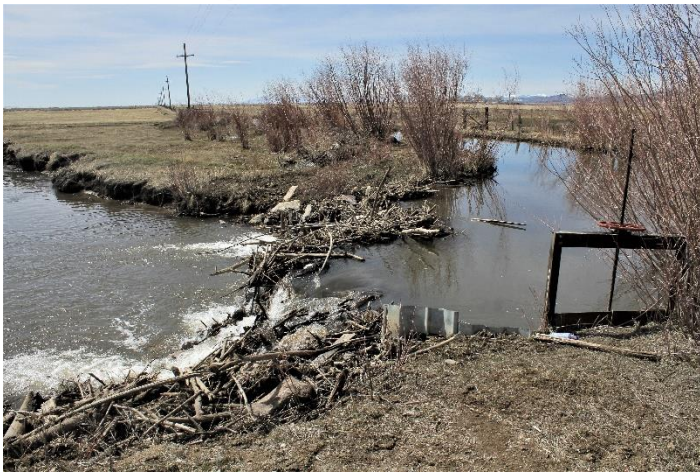
Headgate and diversion dam

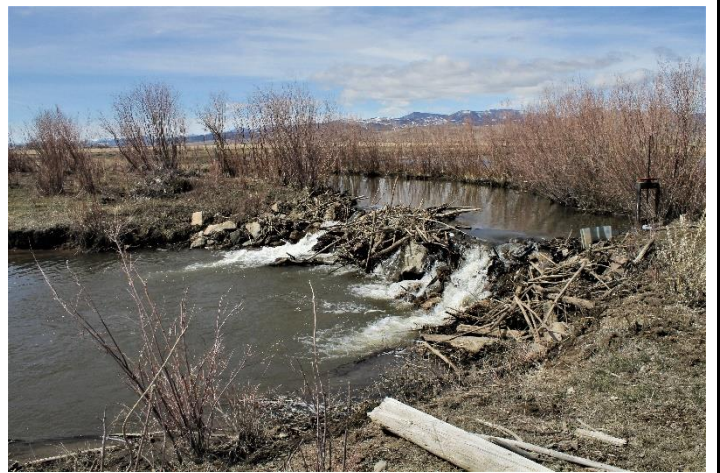
Structure Description: This structure is located at the apex of a meander. A boulder diversion dam directs water to the headgate, located on the north bank of the stream. The diversion dam effectively diverts the ditch's water users, but debris accumulates on the dam and the structure has led to altered sediment transport, bank erosion, and channel widening downstream of the dam. The dam creates a significant drop in the stream's elevation, forming a fish barrier and leading to a scour pool downstream of the dam. During high flows, it is possible that the stream could intercept a historic channel, causing the stream to bypass the George Ball Ditch headgate. The flume functions but is aging and may fail in the near future.

Diversion dam

Repair(s) or Improvement(s) Currently Needed: Given these issues, the SMP Technical Advisory Team (TAT) recommends installing a new diversion, implementing bank stabilization and riparian revegetation, and replacing the flume. A new diversion would reduce maintenance needs, create fish passage, and restore the sediment transport regime. Stabilization and revegetation would help prevent the meander from being cut off and would mitigate erosion. Replacing the flume would improve long-term functionality.

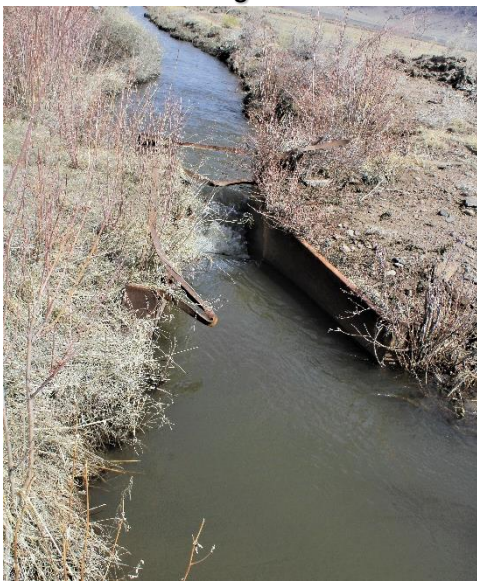
Flume looking downstream

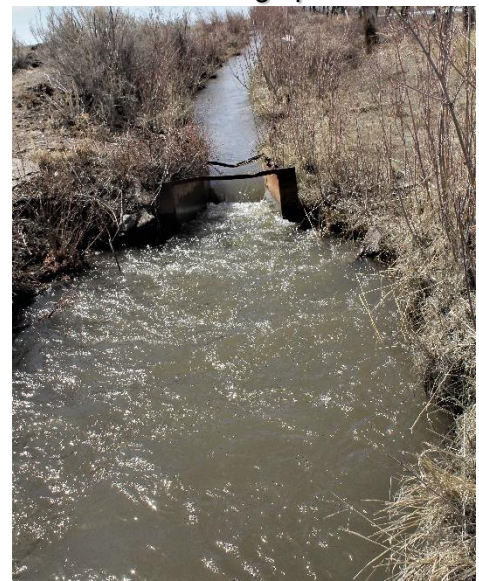
Flume looking upstream

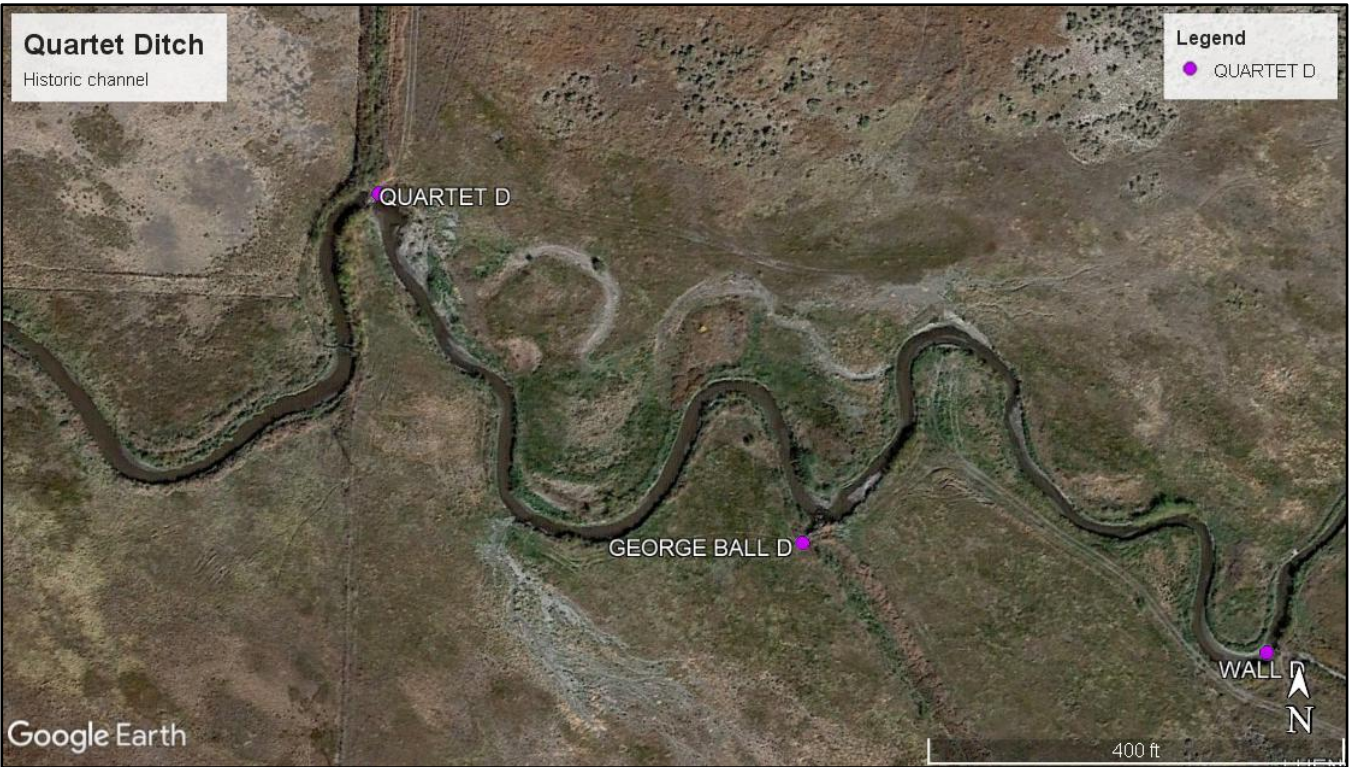
Image illustrating historic channel downstream of Quartet Ditch
