SAGUACHE CREEK DIVERSION INFRASTRUCTURE INVENTORY

Structure Name: RESERVOIR ENLARGEMENT D

Date: April 11, 2019

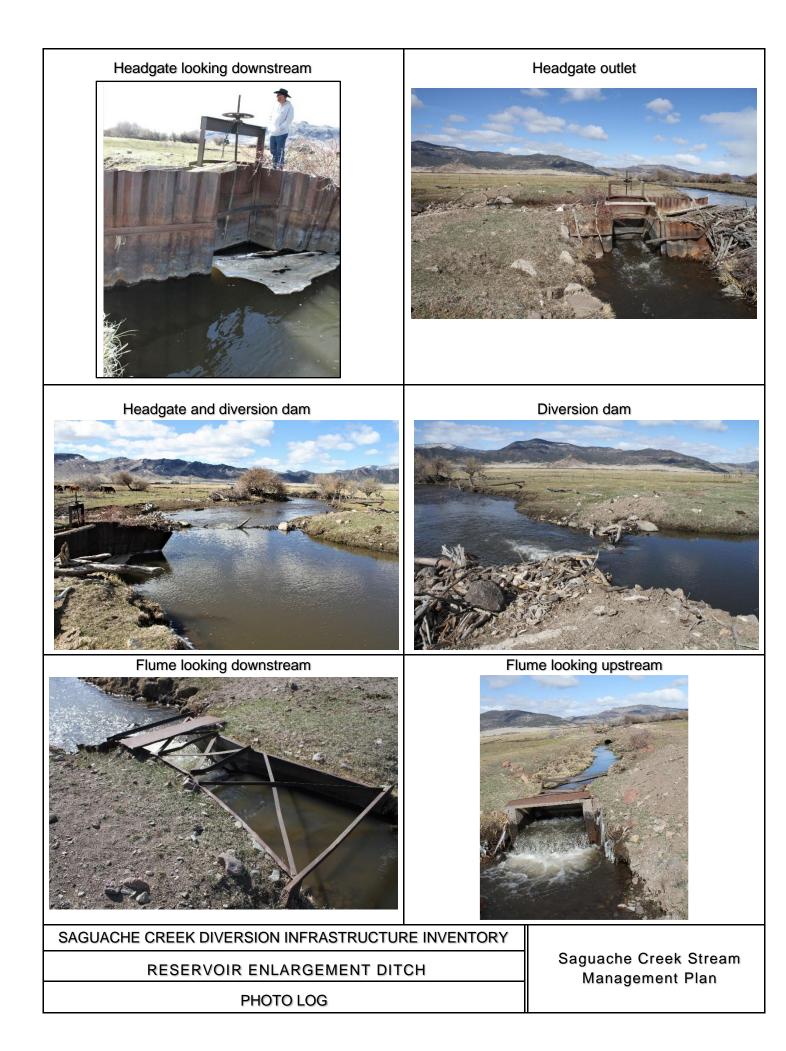
Structure Description: A diversion dam made of rocks and debris diverts water to the headgate on the north bank of the stream. This ditch has trouble accessing its full decree in low flow conditions. The stream is relatively stable here, however accelerated bank erosion is occurring near this structure. The headgate is in poor condition. The headwall is bulging and the screw gate is bent.

Repair(s) or Improvement(s) Currently Needed: Given these issues, the SMP Technical Advisory Team (TAT) recommends improving the diversion dam, riparian revegetation, and headgate/headwall repair or replacement. An improved diversion and headgate would allow this ditch to access its full decree during low flows and would increase ditch efficiency. Riparian revegetation would reduce bank erosion and mitigate sediment impacts at this structure
