SAGUACHE CREEK DIVERSION INFRASTRUCTURE INVENTORY

Structure Name: RUSSELL D 4

Date: April 4, 2019

Saguache Creek Stream
Management Plan

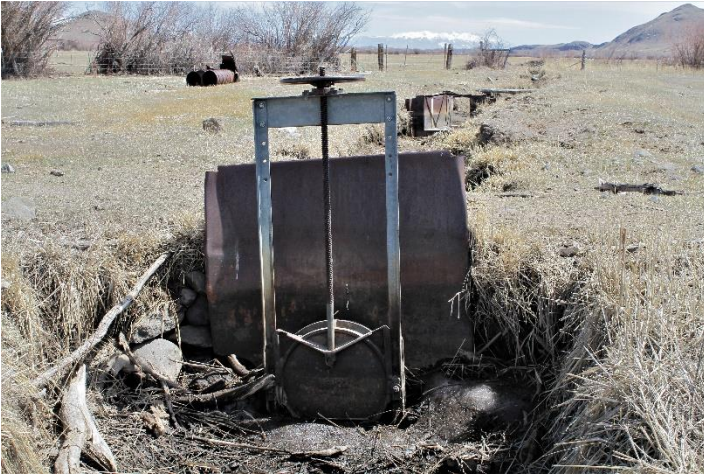
Headgate looking downstream

Repair(s) or Improvement(s) Currently Needed: Given these issues, the SMP Technical Advisory Team (TAT) recommends bank stabilizing and riparian revegetation upstream of the diversion structure, improving the diversion, and stabilizing and leveling of both the headgate and flume. Bank stabilization would reduce erosion and sedimentation at the structure and diversion, while headgate and flume improvements would increase efficiency and reduce maintenance needs.

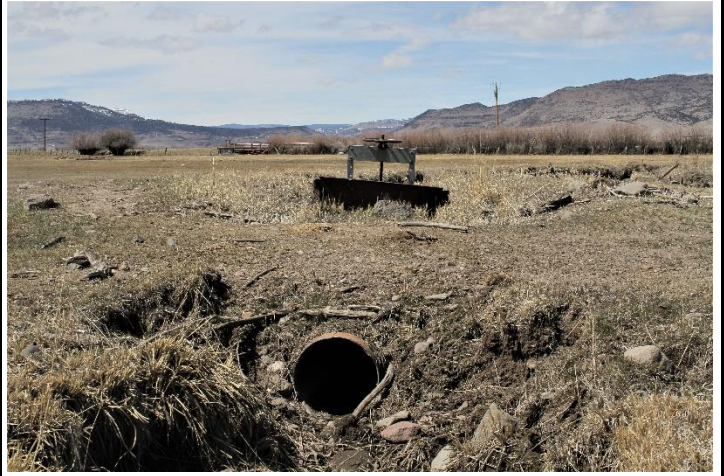
Headgate outlet

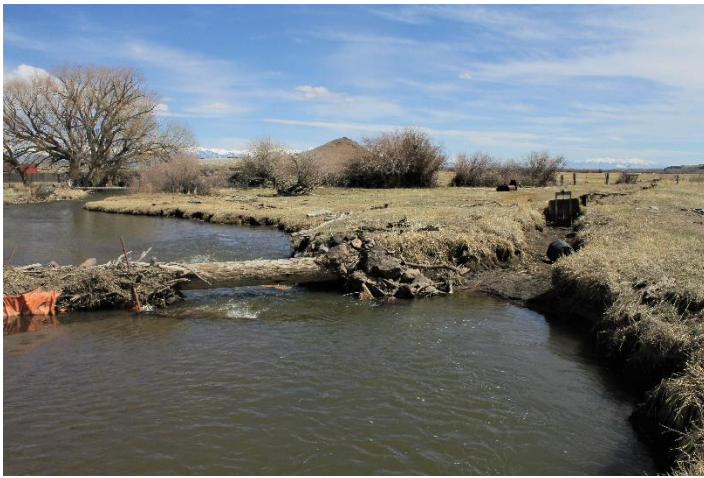
Headgate and diversion dam

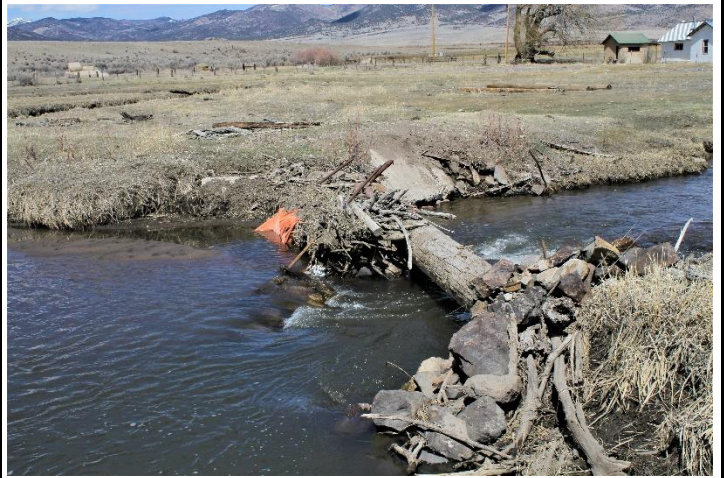
Diversion dam

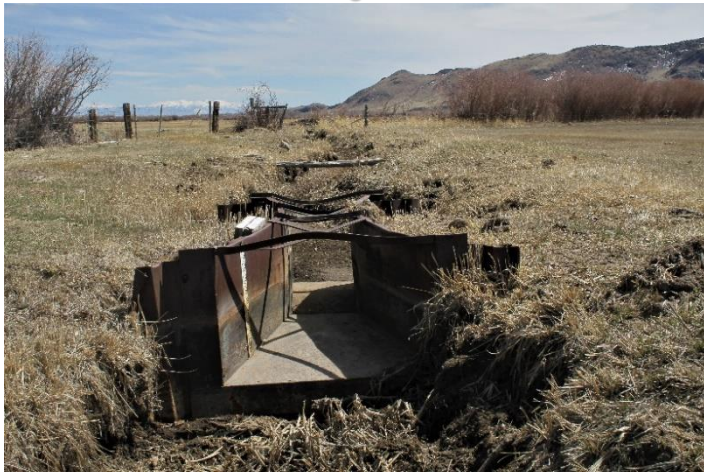
Flume looking downstream

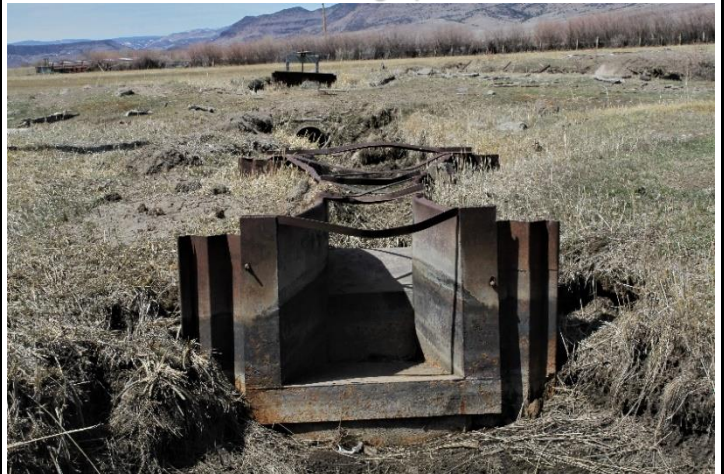
Flume looking upstream
