SAGUACHE CREEK DIVERSION INFRASTRUCTURE INVENTORY

Structure Name: SEITZ MCCLURE ASHLEY D

Date: April 3, 2019

Saguache Creek Stream Management Plan

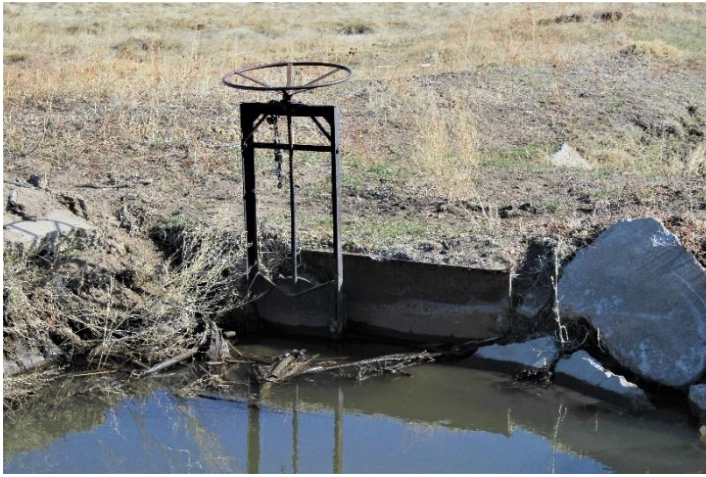
Headgate looking downstream

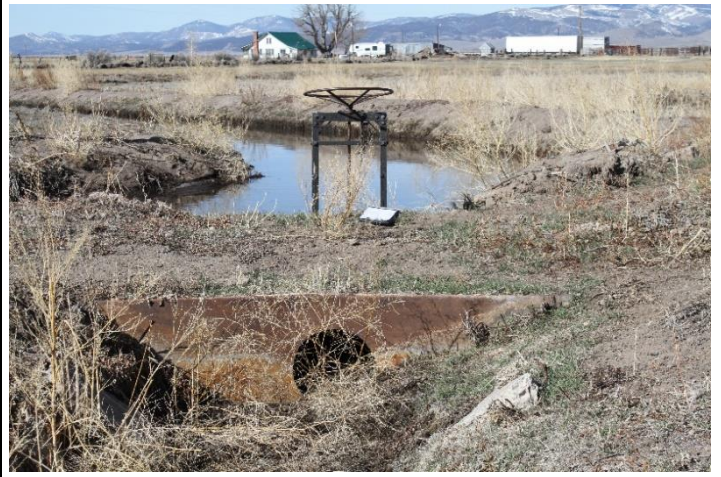
Headgate outlet

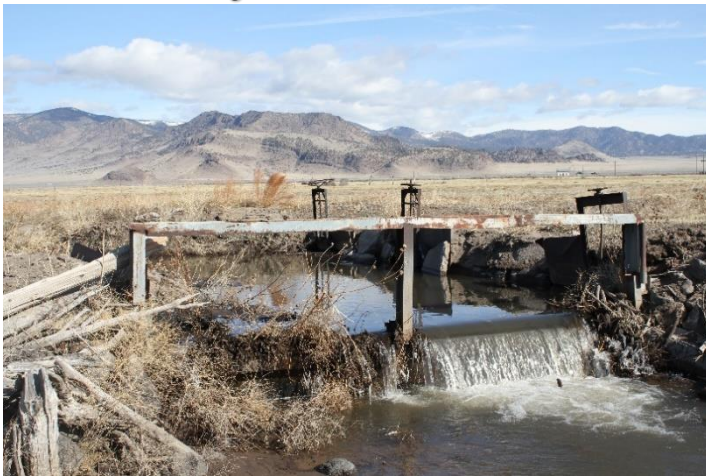
Headgate and diversion dam

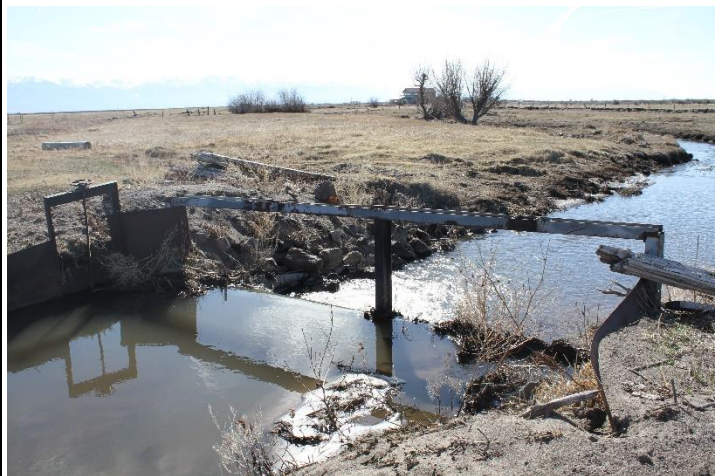
Repair(s) or Improvement(s) Currently Needed: Sediment accumulation is an issue for this structure. The SMP Technical Advisory Team (TAT) recommends installing a sluice gate on the stream's north bank. A sluice gate would improve the sediment transport and reduce ditch maintenance at this location.

Diversion dam

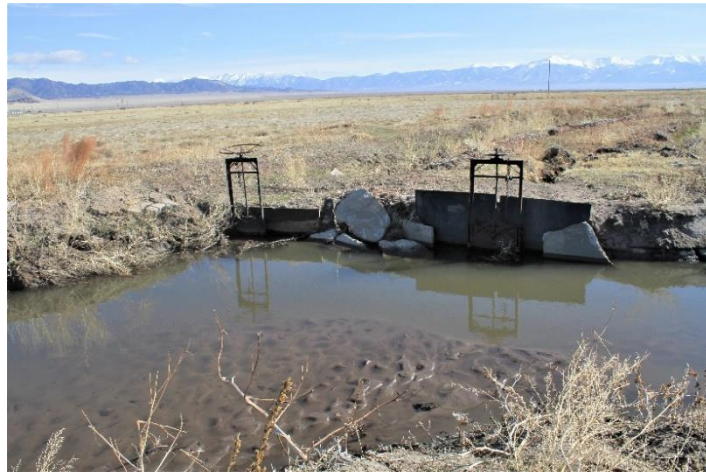
Headgate next to Taylor A Ashley Ditch

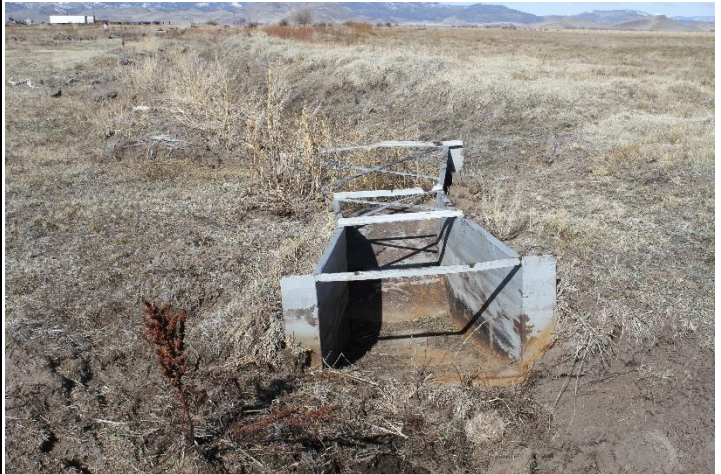
Flume looking upstream
