SAGUACHE CREEK DIVERSION INFRASTRUCTURE INVENTORY

Structure Name: SLANE SCANDRETT D

Date: July 3, 2019

Saguache Creek Stream Management Plan

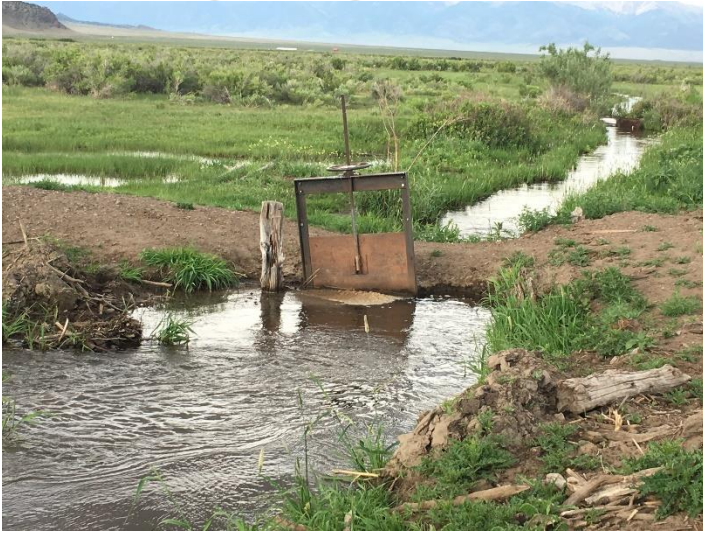
Headgate looking downstream

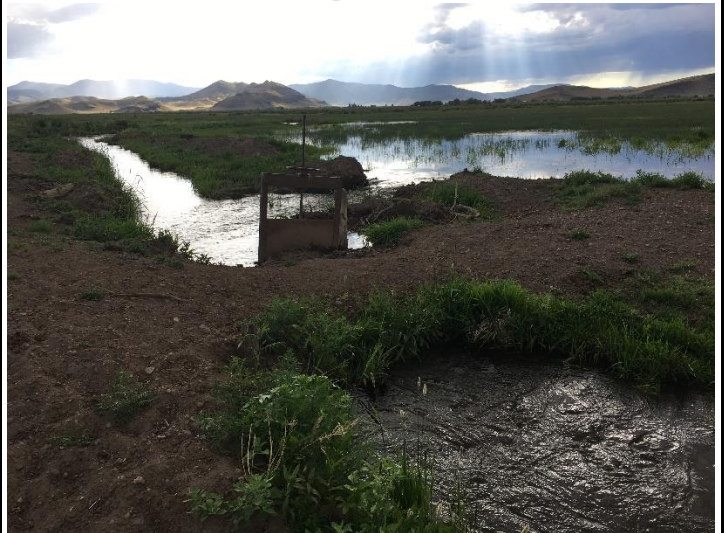
Headgate outlet

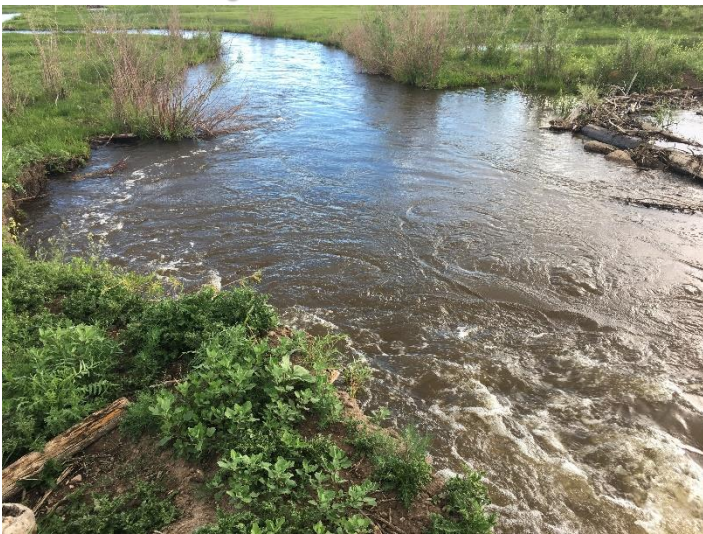
Headgate and diversion dam

Repair(s) or Improvement(s) Currently Needed: Despite recently installed concrete road barriers, significant erosion was occurring downstream of the diversion dam at the time of inspection. The SMP Technical Advisory Team (TAT) recommends improving the diversion dam and implementing bank stabilization and riparian revegetation. A new diversion could be designed to direct flow away from the bank and reduce erosion and maintenance needs. Alternatively, combining the diversion dam with that of the Jeep Scandrett may improve this ditch's function and reduce maintenance. Stabilization and revegetation would also reduce erosion.

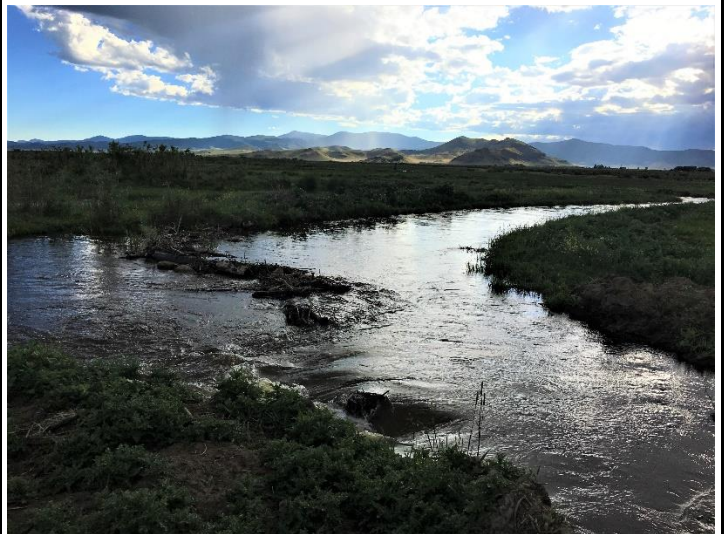
Diversion dam

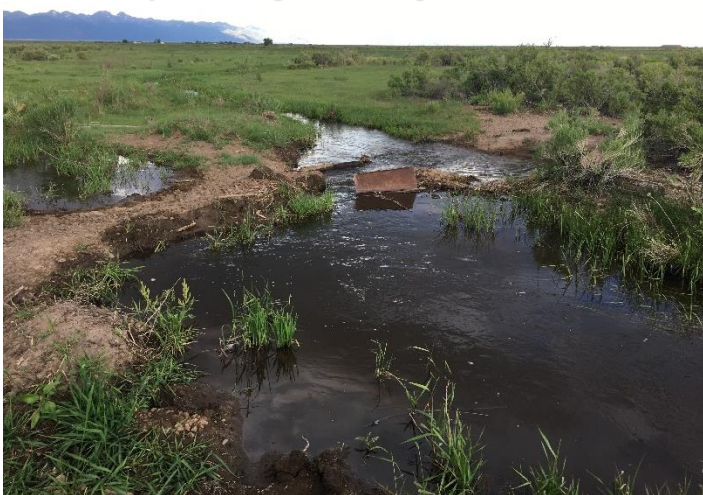
Adjustment gate looking downstream

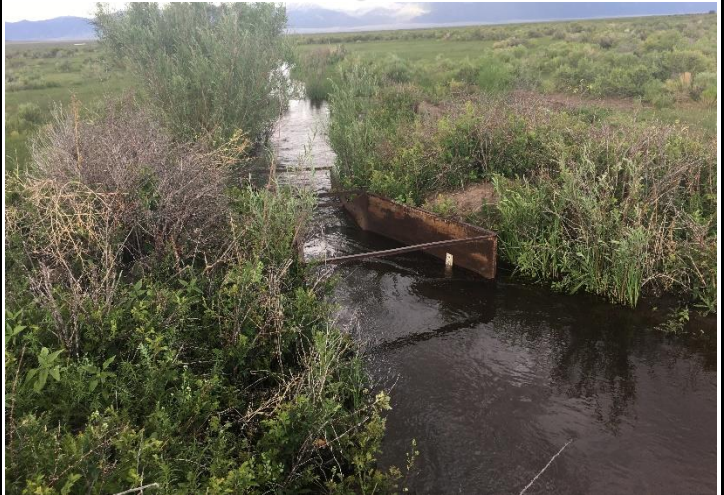
Flume looking downstream
