SAGUACHE CREEK DIVERSION INFRASTRUCTURE INVENTORY

Structure Name: STAR D

Date: August 8, 2019

Saguache Creek Stream Management Plan

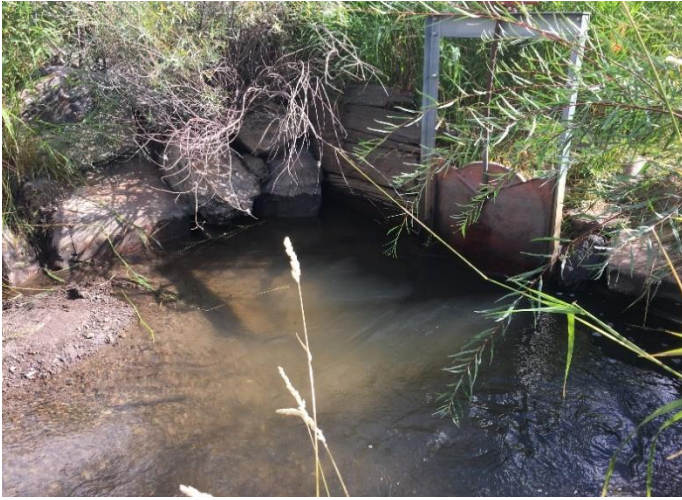
Headgate Condition:	A <input type="checkbox"/>	Diversion and Other Condition:	A <input type="checkbox"/>	Stream Miles from Saguache Creek Terminus (Point of Diversion):	Structure Submerged: Yes <input type="checkbox"/>
	B <input checked="" type="checkbox"/>		B <input checked="" type="checkbox"/>	36.0 mi	No <input checked="" type="checkbox"/>
	C <input type="checkbox"/>		C <input type="checkbox"/>		
	D <input type="checkbox"/>		D <input type="checkbox"/>		
	F <input type="checkbox"/>		F <input type="checkbox"/>

Headgate looking downstream

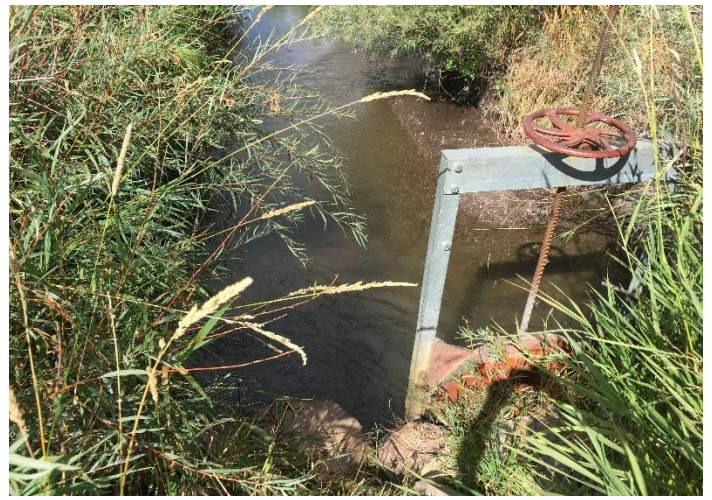
Headgate looking upstream

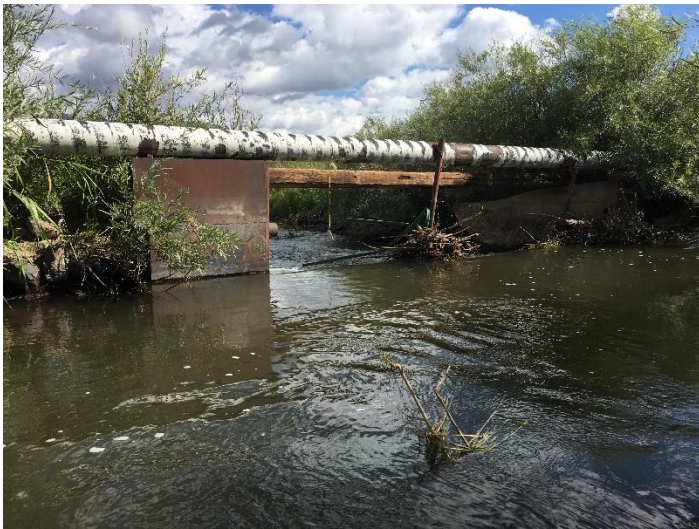
Structure Description: This structure is located on the outside of a meander. The diversion dam is a welded steel check board structure with boulders and a metal fence as additional reinforcement. The diversion dam directs water to the headgate, located on the south bank of the stream. The dam functions well, although woody debris accumulation is an issue and the structure has difficulty diverting water during low flows. The headgate is stabilized with large boulders and functions effectively.

Diversion dam looking downstream

Repair(s) or Improvement(s) Currently Needed: The SMP Technical Advisory Team (TAT) recommends modifying the diversion to improve its adjustment capabilities. Modifications would reduce debris accumulation and would allow the ditch to effectively divert water at a range of flows. This ditch also services the priority 25 Gotthelf Ditch No. 5.

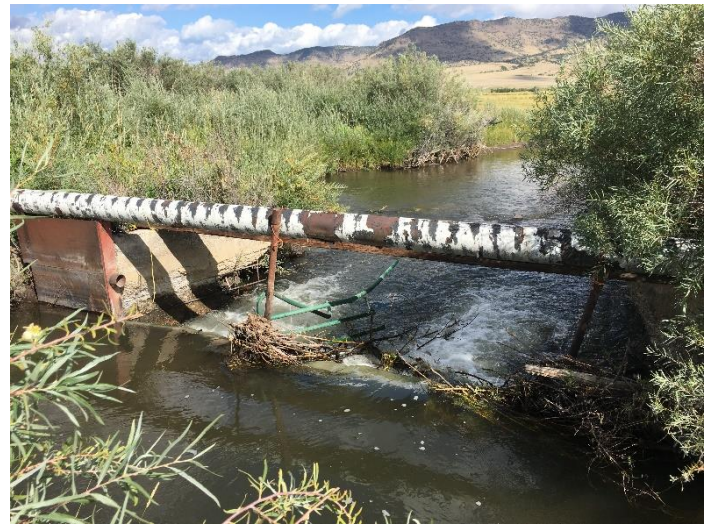
Diversion dam looking downstream

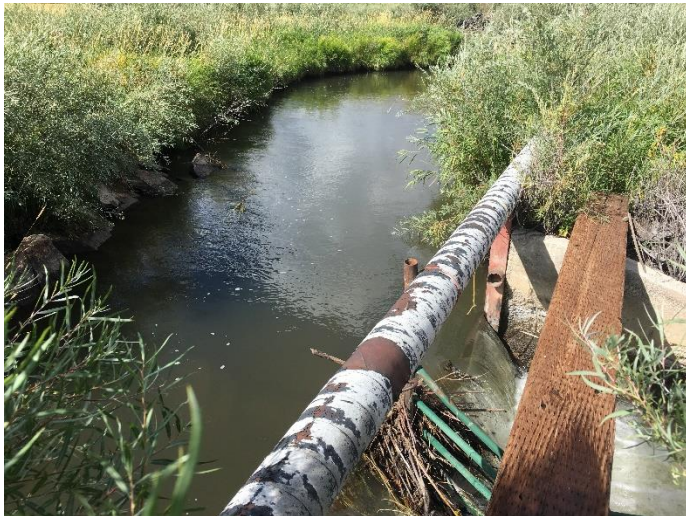
Diversion dam looking upstream

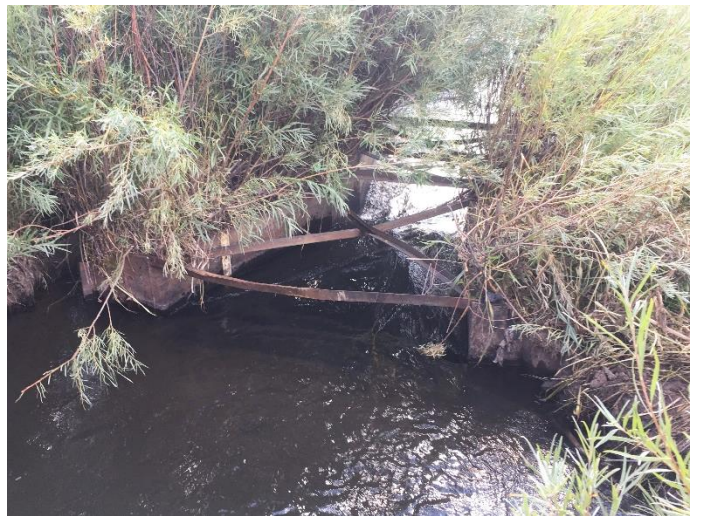
Flume looking downstream

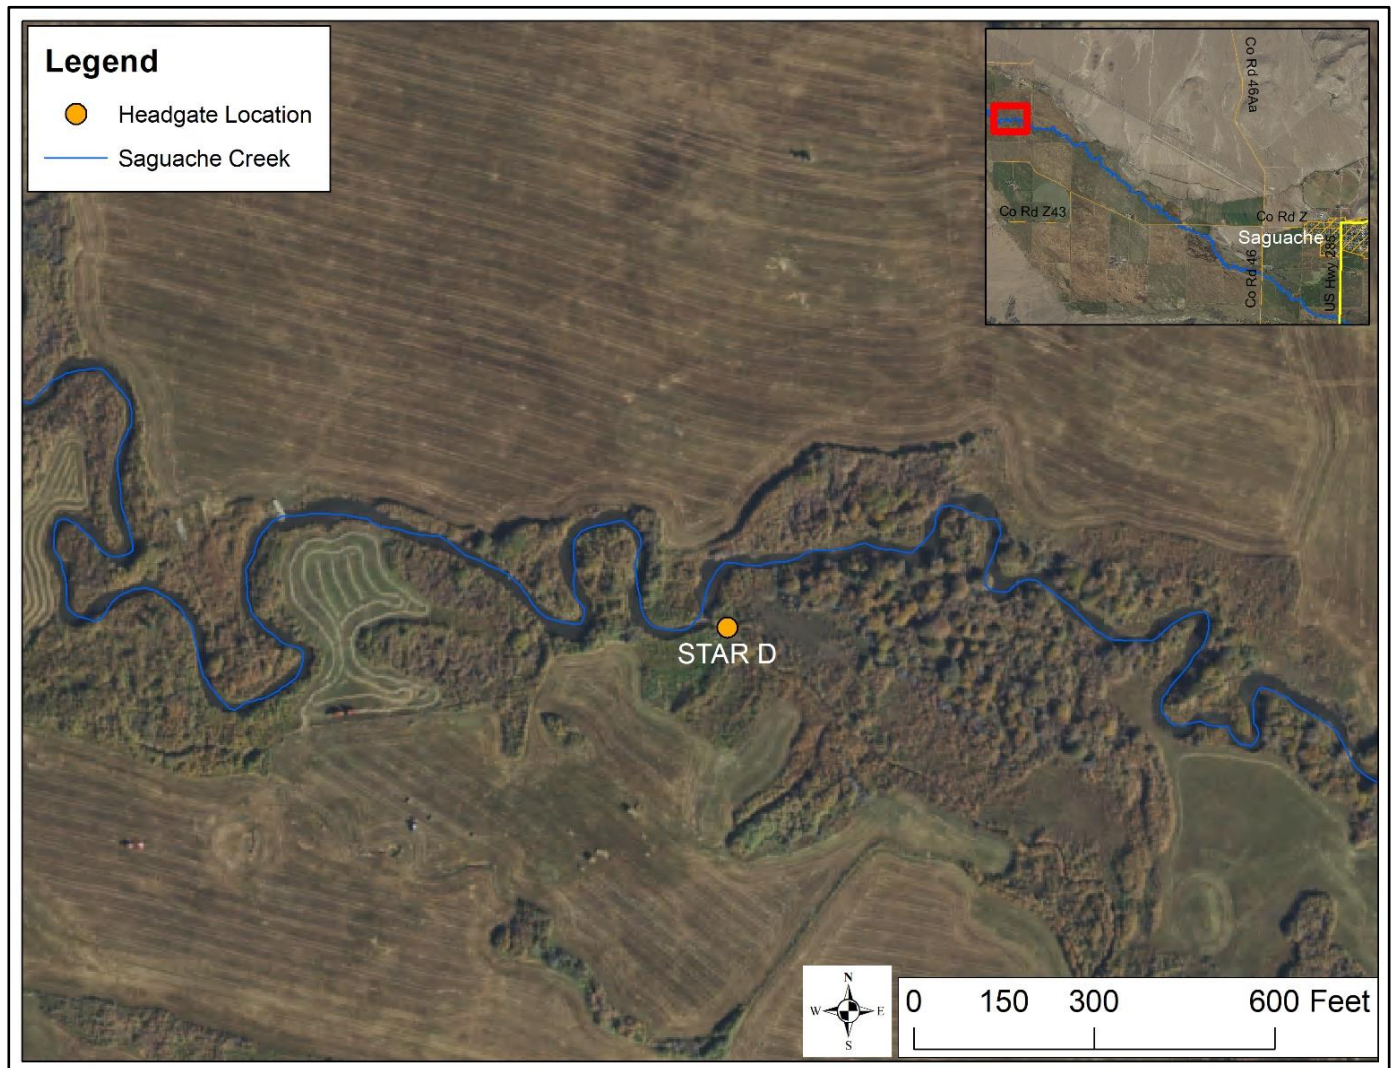
Stream channel downstream of structure
