SAGUACHE CREEK DIVERSION INFRASTRUCTURE INVENTORY

Structure Name: TAYLOR A ASHLEY D

Date: April 3, 2019

Saguache Creek Stream
Management Plan

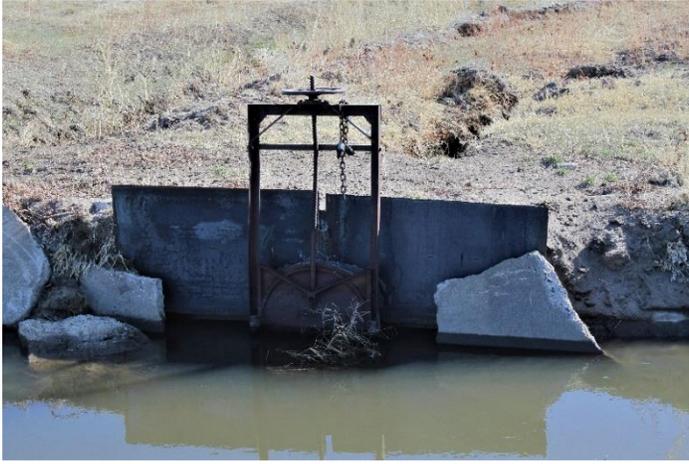
Headgate looking downstream

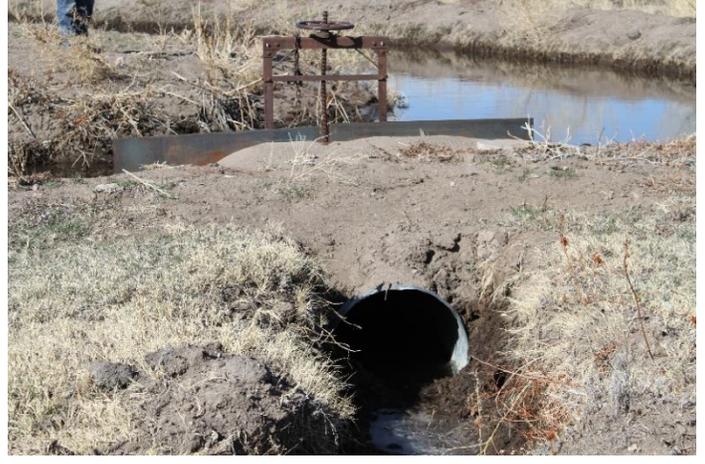
Headgate outlet

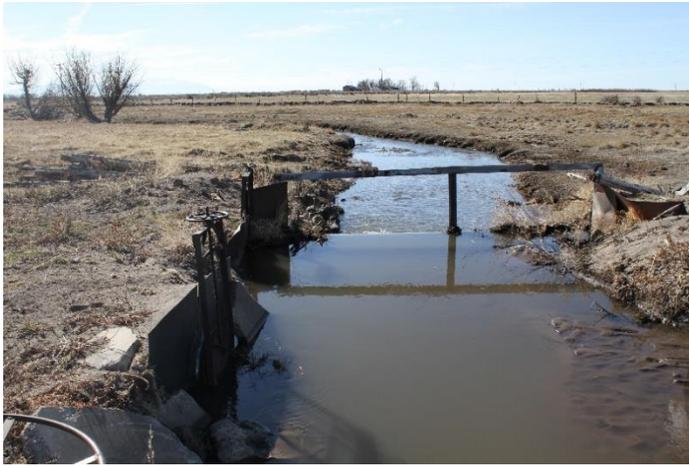
Headgate and diversion dam

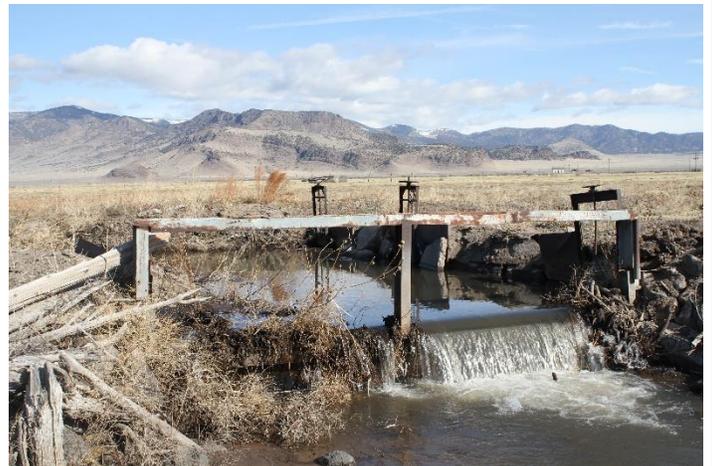
Diversion dam looking upstream

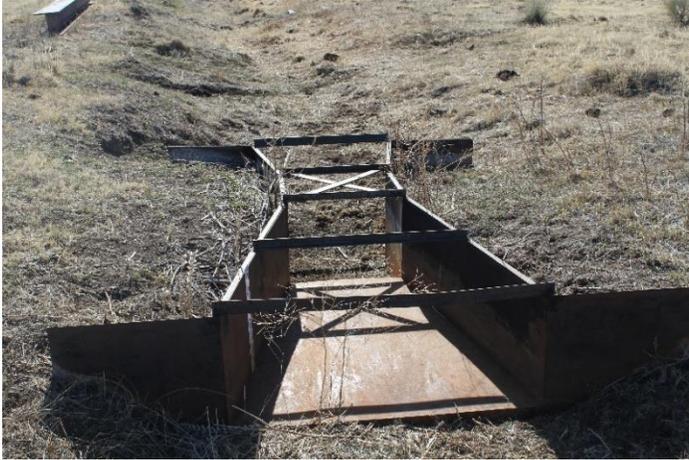
Flume looking downstream

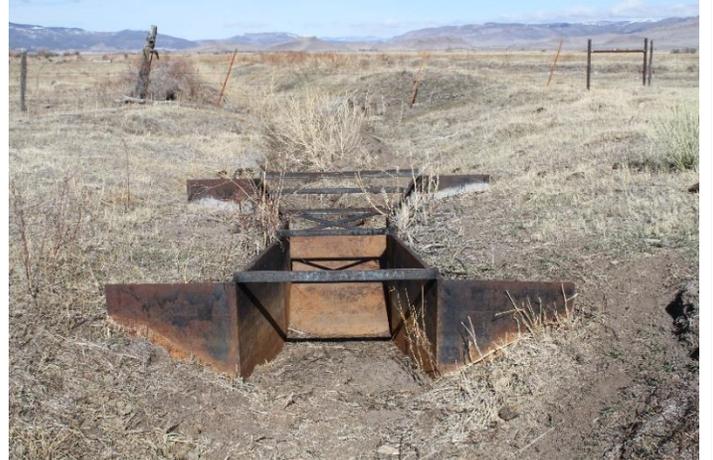
Flume looking upstream
