SAGUACHE CREEK DIVERSION INFRASTRUCTURE INVENTORY

Structure Name: WALL D

WALL DITCH

**Saguache Creek Stream
Management Plan**

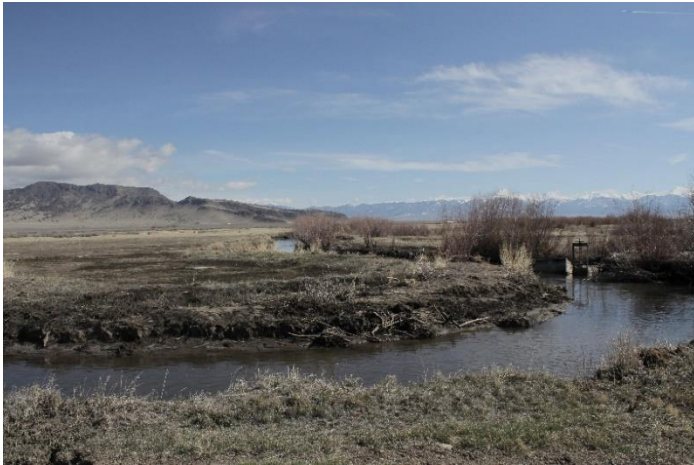
Channel looking downstream

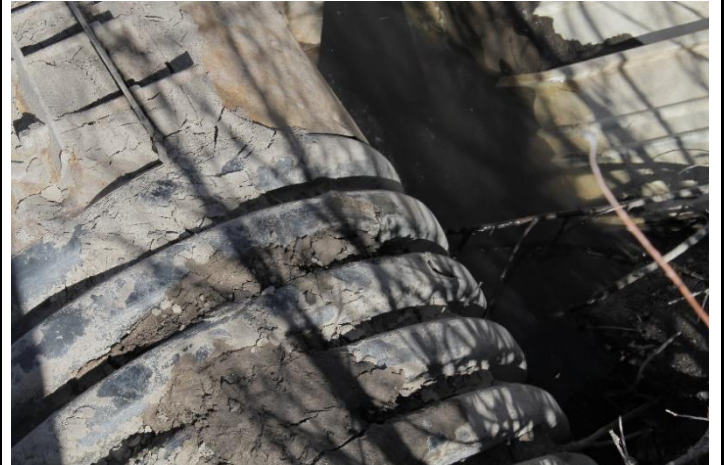
Structure Description: This diversion is located on the downstream end of a meander in the stream. The diversion dam is made up of t-posts, roofing metal, and other debris. It is typically removed during the winter. The headgate is located on the south bank and suffers from erosion, with the only remaining wing wall collapsing. The exposed headgate culvert has holes which leak at high flows. The flume measures accurately when a shift is applied, however it is eroding.

Damage to headgate culvert

Repair(s) or Improvement(s) Currently Needed: Given these issues, the SMP Technical Advisory Team (TAT) recommends replacing the diversion and headgate and repairing or replacing the flume. A new and integrated diversion and headworks would reduce maintenance and improve ditch function. Reinforcing the flume to prevent erosion would improve long-term functionality. Alternatively, this structure could be combined with the George Ball and/or Hearn diversions. Consolidation would reduce maintenance and substantially reduce sediment transport impacts.
