# SAGUACHE CREEK DIVERSION INFRASTRUCTURE INVENTORY

**Structure Name:** WOODARD BROS D

WOODARD BROS DITCH

Saguache Creek Stream  
Management Plan

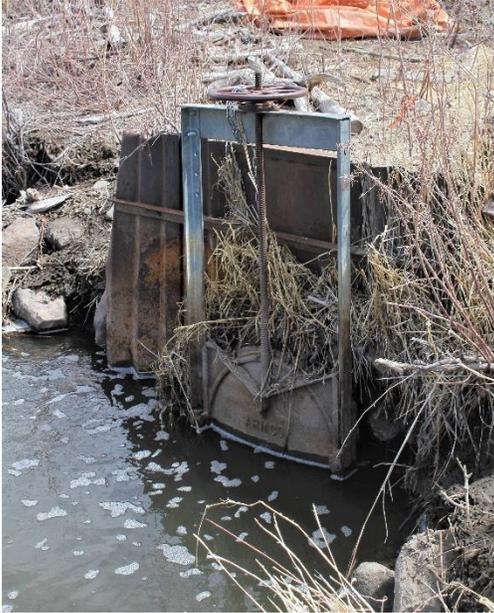
**Structure Description:** The diversion dam is a stacked rock structure with a utility pole that directs water to the headgate, located on the south bank. The diversion functions but requires regular maintenance. The headgate leaks and sediment accumulation is an issue at this structure.

Headgate looking downstream

**Repair(s) or Improvement(s) Currently Needed:** The SMP Technical Advisory Team (TAT) recommends repairing the headgate leak, installing a sluice gate, and improving the diversion dam. A new headgate and adjacent sluice gate would increase efficiency and sediment transport capacity. An improved diversion would reduce maintenance needs and help ensure long-term function.

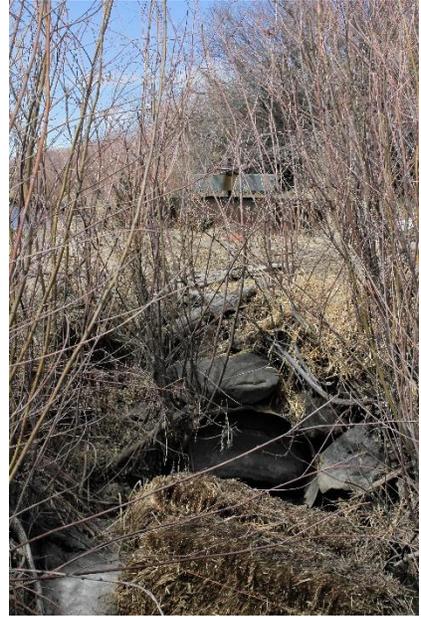
Headgate outlet

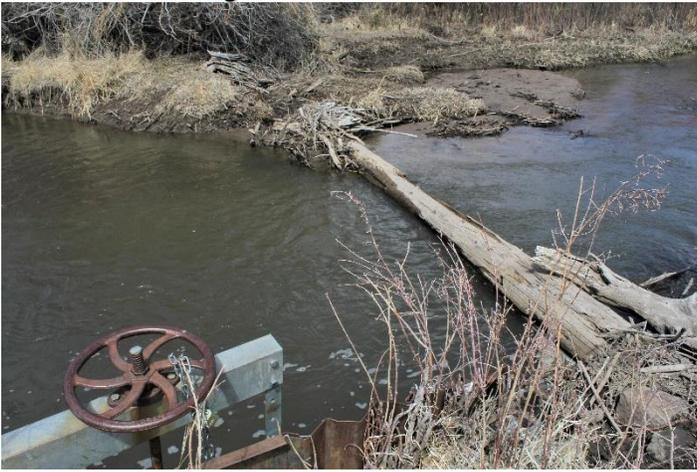
Headgate and diversion dam

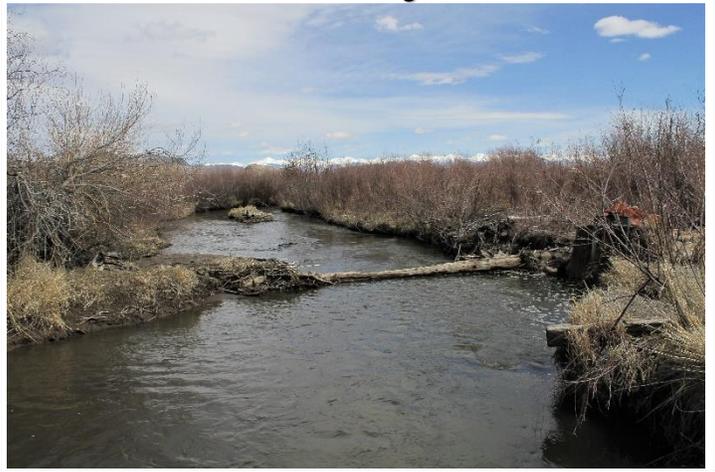
Diversion dam looking downstream

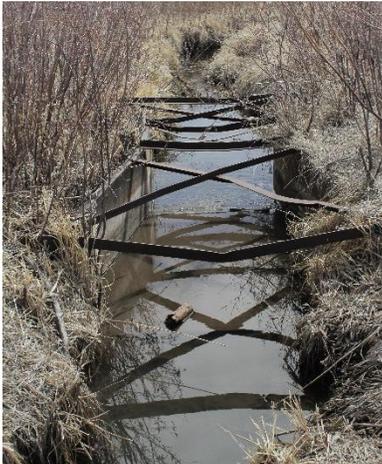
Flume looking downstream

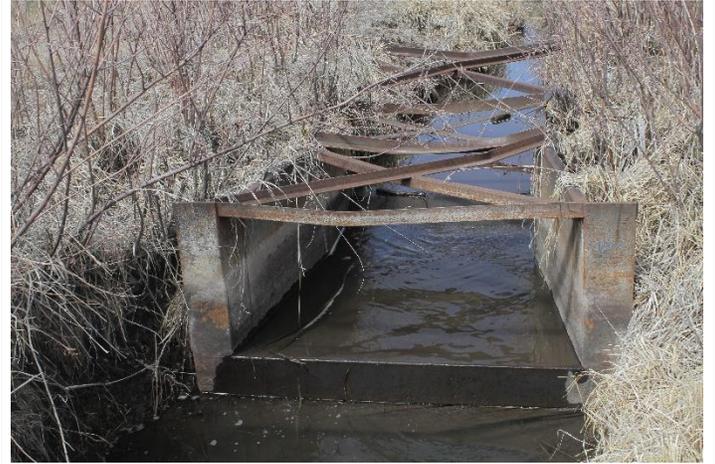
Flume looking upstream
