## SAGUACHE CREEK DIVERSION INFRASTRUCTURE INVENTORY

## Structure Name: FRIESE D 2

Date: April 11, 2019

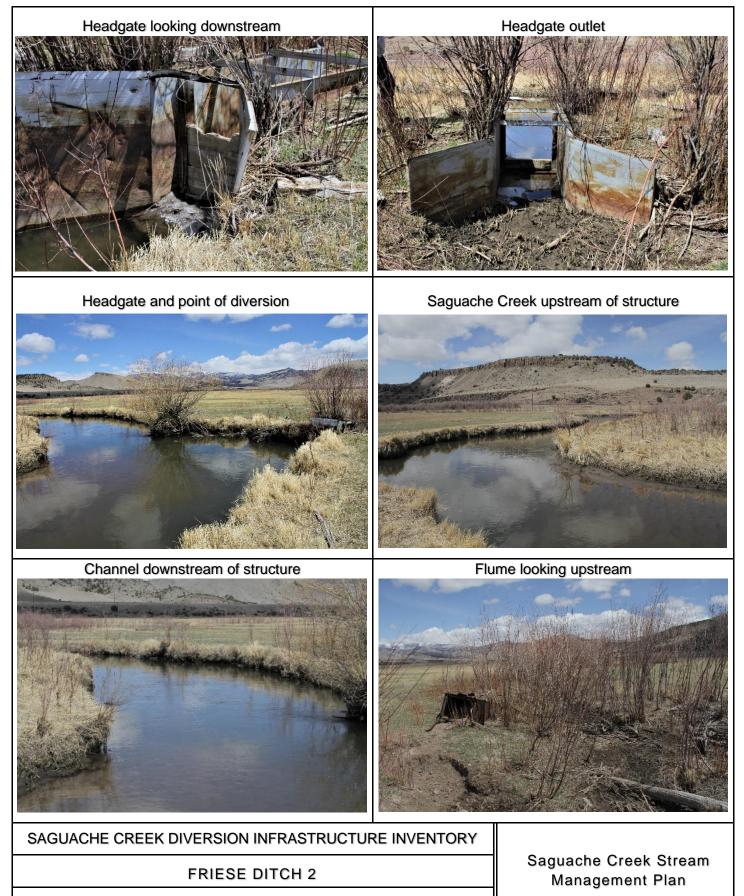
**Structure Description:** This structure is located just upstream of Friese Ditch 1 at the apex of a meander. There is no diversion as this ditch is a junior priority and the stream is typically flowing sufficiently when it is in priority. The headgate functions very poorly and the flume was removed from the ditch at the time of inspection.

**Repair(s) or Improvement(s) Currently Needed:** Given these issues, the SMP Technical Advisory Team (TAT) recommends installing a new headgate, measurement structure, and implementing bank stabilization. A new diversion with adjustment and locking capabilities along with a new measurement device would increase efficiency and reduce maintenance. Bank stabilization and riparian revegetation, especially between this structure and Friese Ditch 1, would reduce erosion and prevent future bank failure.
