# SAGUACHE CREEK DIVERSION INFRASTRUCTURE INVENTORY

**Structure Name:** FULLERTON D 1

PHOTO LOG

Saguache Creek Stream Management Plan

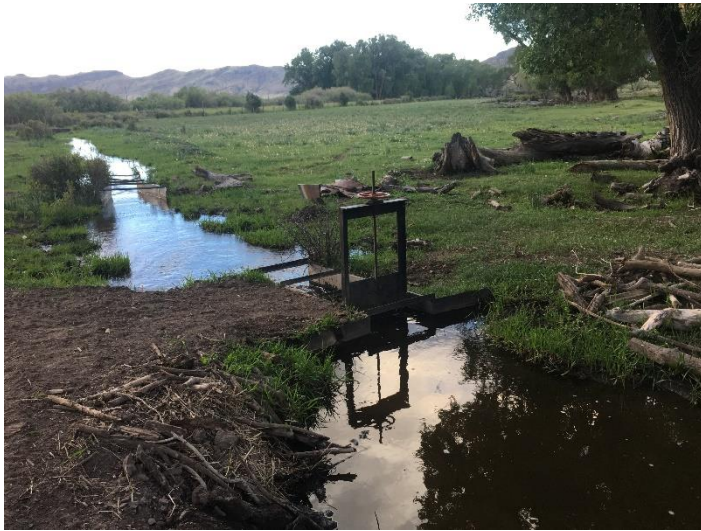
Headgate looking downstream

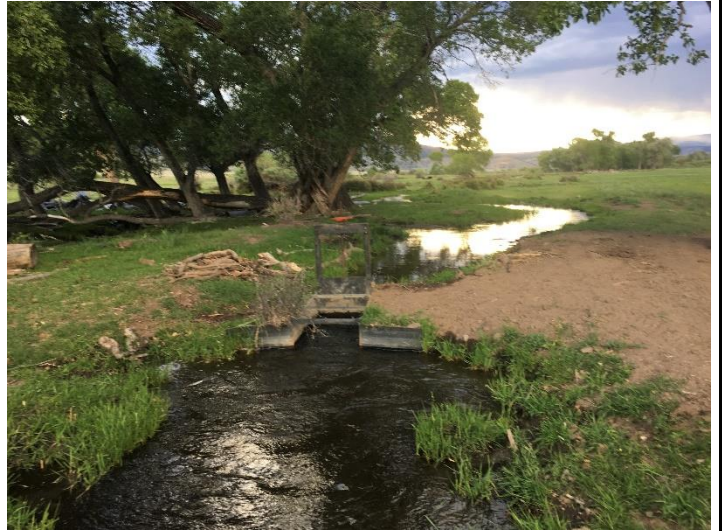
Headgate outlet

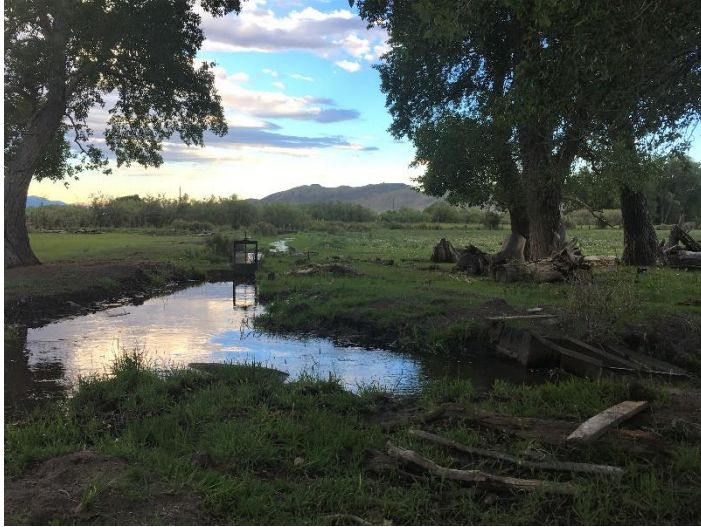
Headgate and diversion dam

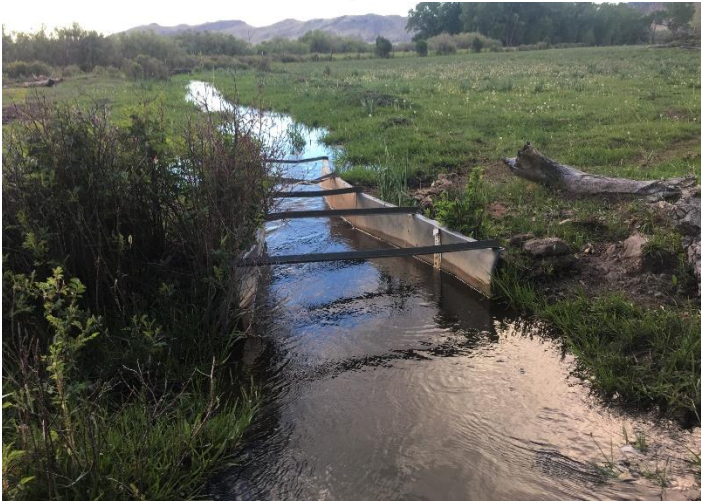
Flume looking downstream

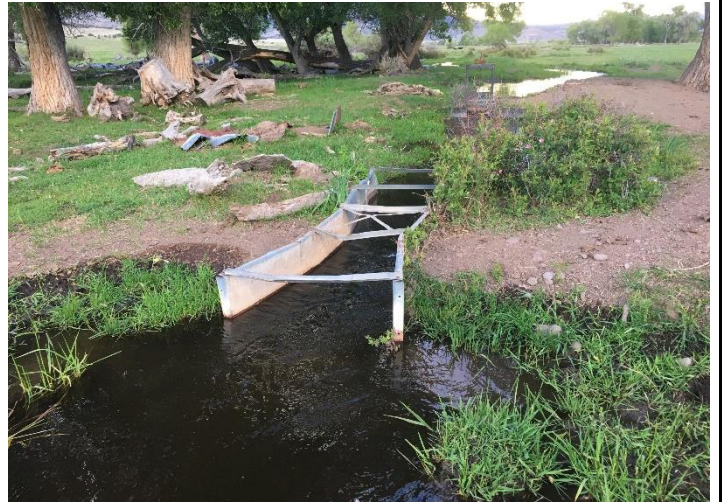
Flume looking upstream
