# SAGUACHE CREEK DIVERSION INFRASTRUCTURE INVENTORY

**Structure Name:** FULLERTON D1 APD

FULLERTON DITCH 1 APD

Saguache Creek Stream  
Management Plan

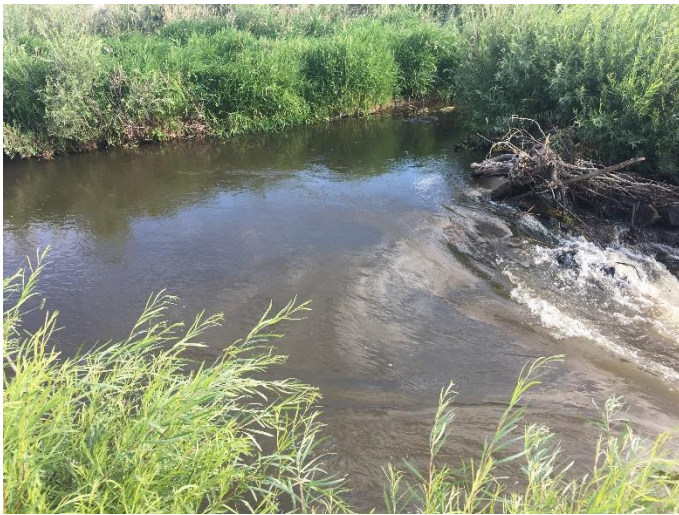
Diversion dam and ditch entrance

**Structure Description:** This structure is located on the outside of a meander. A stacked rock diversion dam directs water to the headgate, located on the north bank of the stream. The diversion is in an ideal location, but during 2019 spring runoff, it was damaged, with many of the boulders being washed out.

**Repair(s) or Improvement(s) Currently Needed:** The SMP Technical Advisory Team (TAT) recommends repairing and improving the diversion and installing a trash rack at the headgate. An improved diversion would prevent future failure during high flows and a trash rack would reduce debris accumulation at the headgate.
