SAGUACHE CREEK DIVERSION INFRASTRUCTURE INVENTORY

Structure Name: HODDING D 3

Date: April 12, 2019

Saguache Creek Stream
Management Plan

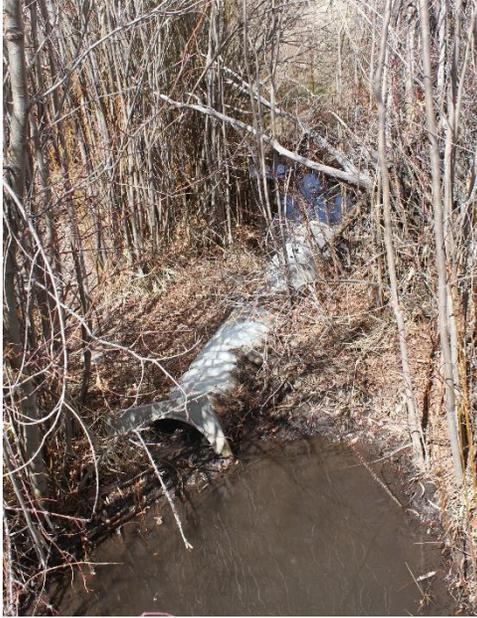
Structure Description: This structure receives water from Hodding Creek but affects the administration of Saguache Creek water rights. It does not have a headgate. Instead, a culvert directs flow to the ditch. The measurement device could not be located at the time of inspection.

Culvert looking downstream

Repair(s) or Improvement(s) Currently Needed: The SMP Technical Advisory Team (TAT) recommends installing a new headgate and measurement device as well as improved access to the structure.

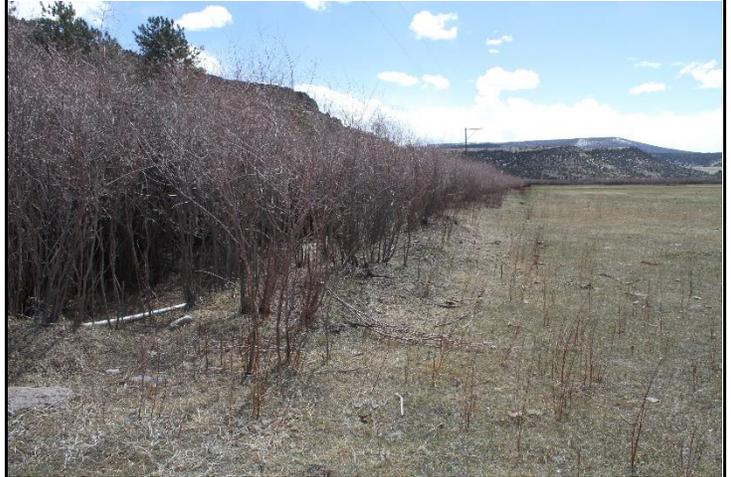
Ditch looking upstream

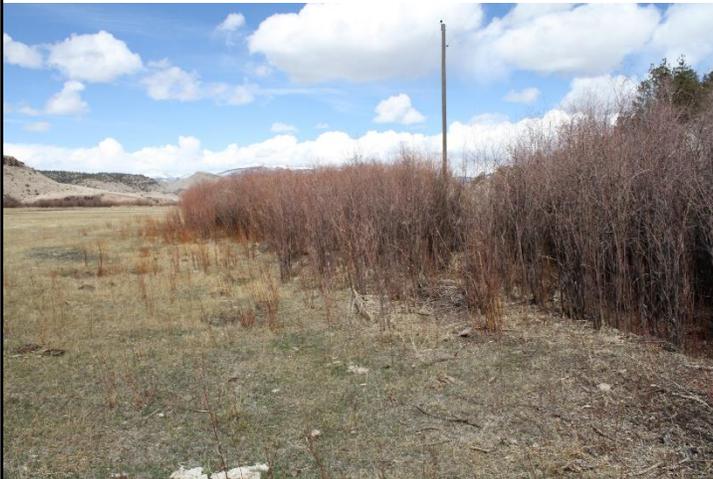
Ditch looking downstream
