SAGUACHE CREEK DIVERSION INFRASTRUCTURE INVENTORY

Structure Name: HOUGLAND CREEK D

Date: April 11, 2019

Saguache Creek Stream
Management Plan

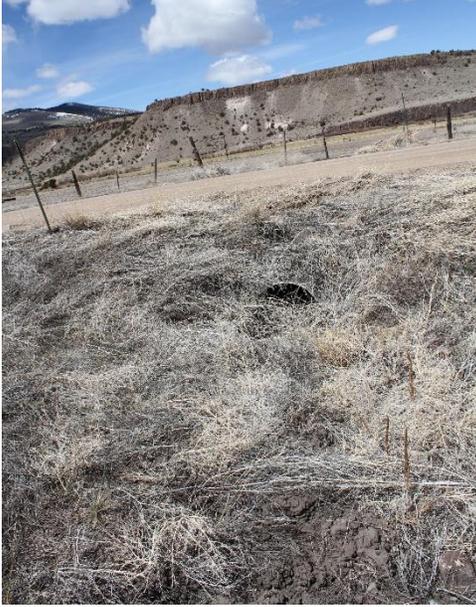
Ditch entrance looking downstream

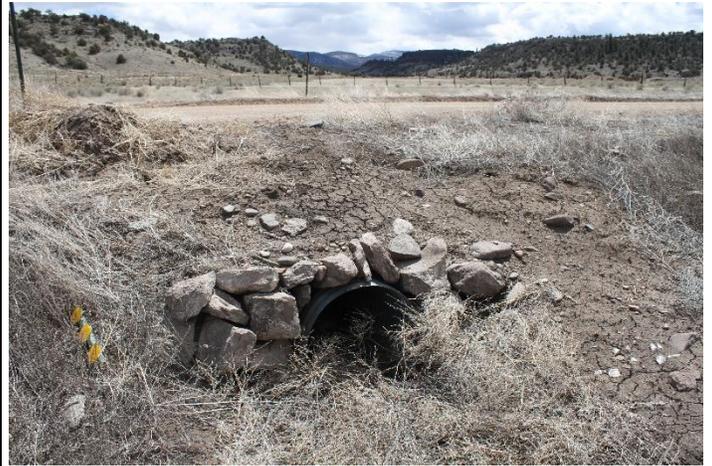
Ditch culvert outlet

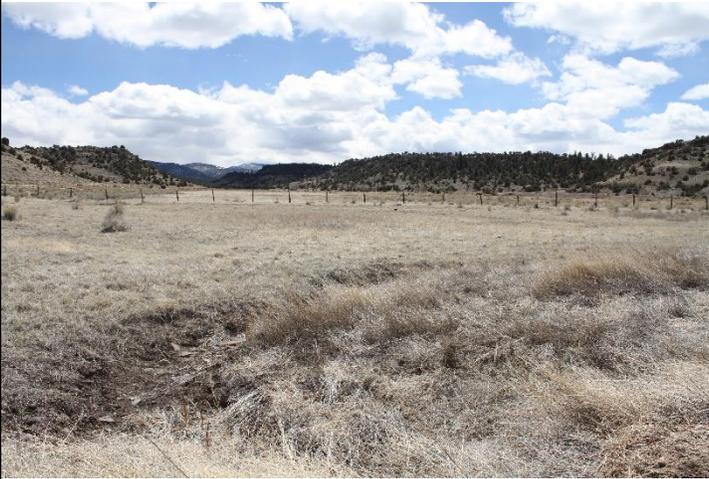
Channel looking upstream of ditch
