# SAGUACHE CREEK DIVERSION INFRASTRUCTURE INVENTORY

**Structure Name:** MALONE SULLIVAN COMMUNITY D

**Date:** April 3, 2019

Saguache Creek Stream Management Plan

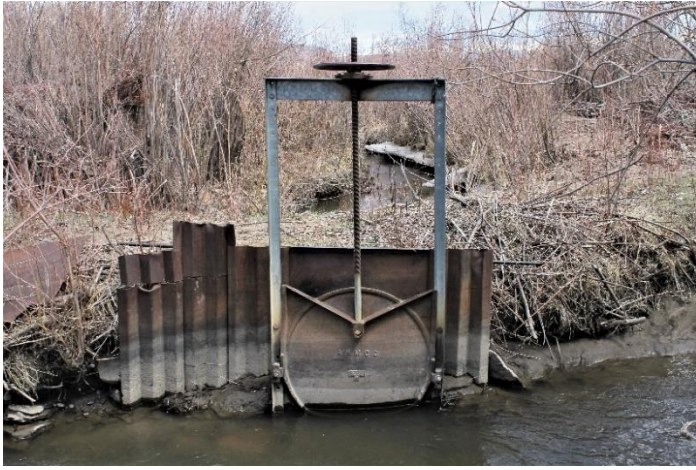
Headgate looking downstream

**Structure Description:** This diversion is located just downstream of County Rd 46. A stacked rock diversion dam directs water to an approximately 450 ft feeder channel that delivers water to a second diversion dam and to the headgate. The headgate currently functions but is at risk of washing out at high flows. The diversion dam on the feeder channel is a check board structure with steel wing walls that directs water to the headgate on the north bank of the stream. Any unused water returns to the stream just downstream of the diversion dam. The diversion's wing walls are bulging and it is difficult to adjust for low flow conditions. The ditch between the headgate and flume was recently cleared and improved.

**Repair(s) or Improvement(s) Currently Needed:** Given the issues identified, the SMP Technical Advisory Team (TAT) recommends repairing or replacing the diversion and improving the headgate. Diversion improvement would reduce maintenance and improve the ditch's ability access to its full decree at all flows. Headgate reinforcement would prevent it from being washed out.
