SAGUACHE CREEK DIVERSION INFRASTRUCTURE INVENTORY

Structure Name: MUNRO D 1

Date: April 11, 2019

Saguache Creek Stream Management Plan

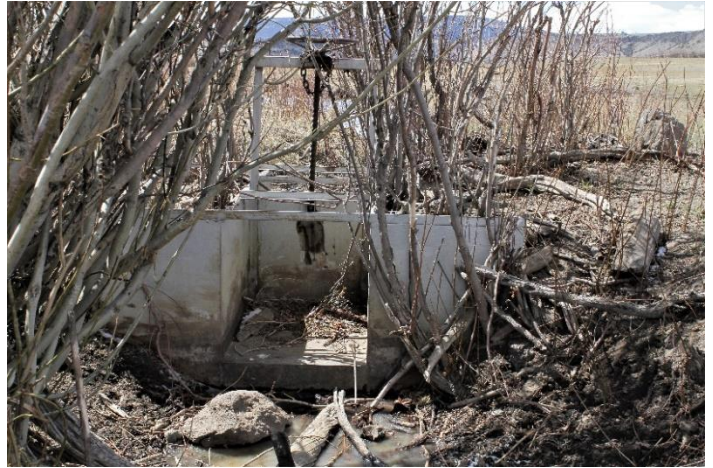
Headgate outlet

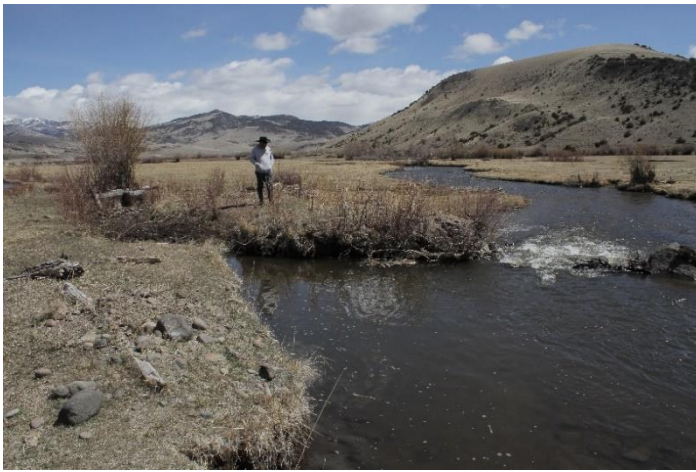
Structure Description: This diversion is located at the apex of a meander in the stream. Accelerated bank erosion is occurring near this structure and contributing to sedimentation at the diversion. A stacked boulder diversion dam directs water to the headgate, which is located on the north bank of the stream. The diversion has led to channel constriction and a disruption to natural sediment transport processes. It also forms a partial barrier to fish passage, depending on flow levels and the configuration of the diversion. The headgate is tilted and the flume is sunken and partially collapsed due to woody vegetation.

Headgate and diversion dam

Repair(s) or Improvement(s) Currently Needed: The SMP Technical Advisory Team (TAT) recommends replacing the diversion and resetting the headgate and flume to reduce maintenance and improve long-term measurement accuracy. The TAT also recommends creating fish passage and improving sediment transport at this location. A new diversion would reduce maintenance, create fish passage, and improve sediment transport processes. Headgate and flume repairs would improve efficiency and reduce maintenance. Riparian revegetation would reduce bank erosion and mitigate sediment impacts at this structure.

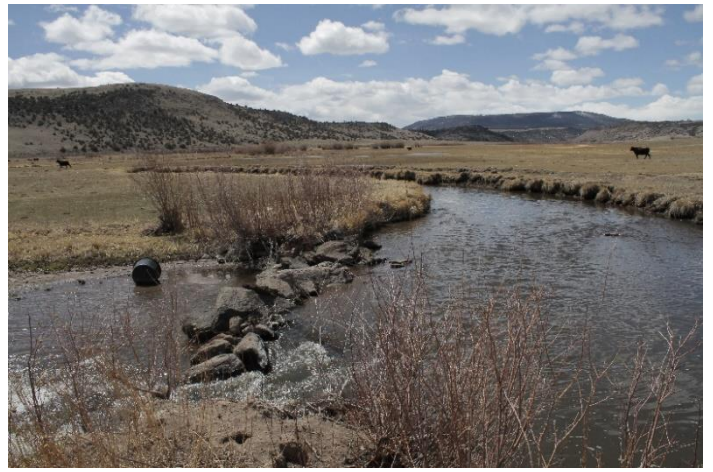
Diversion dam

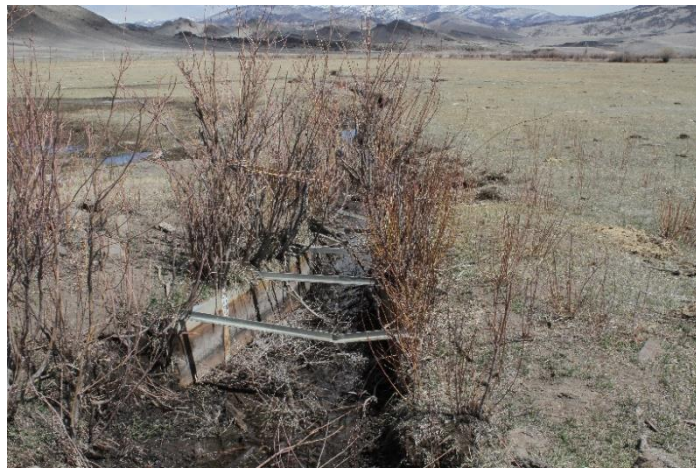
Flume looking downstream
