SAGUACHE CREEK DIVERSION INFRASTRUCTURE INVENTORY

Structure Name: PROFFIT COMPANY D

PROFFIT COMPANY DITCH

Saguache Creek Stream Management Plan

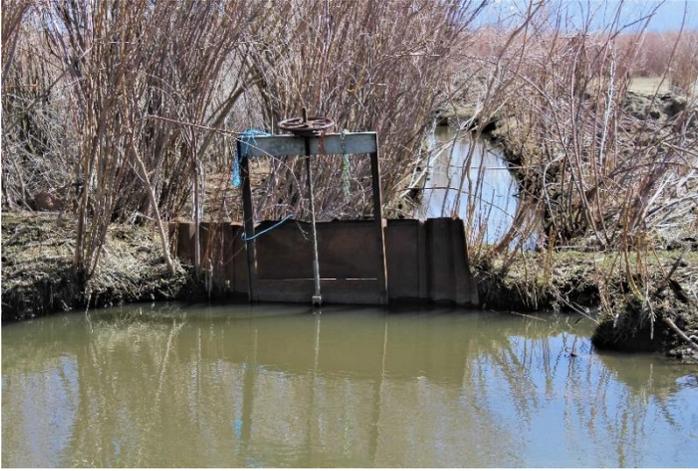
Headgate looking downstream

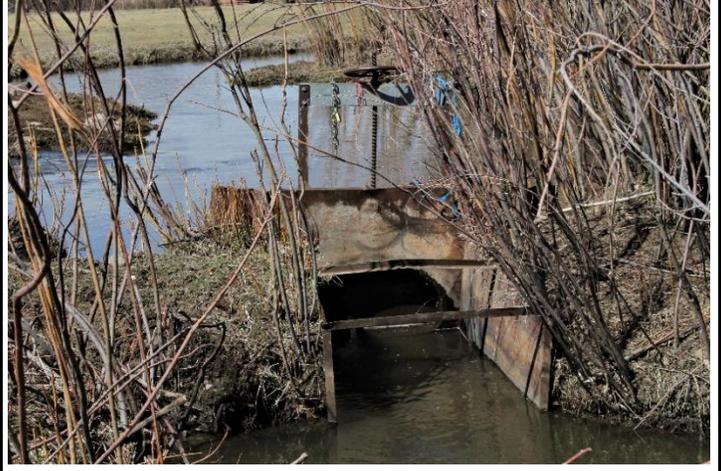
Headgate outlet

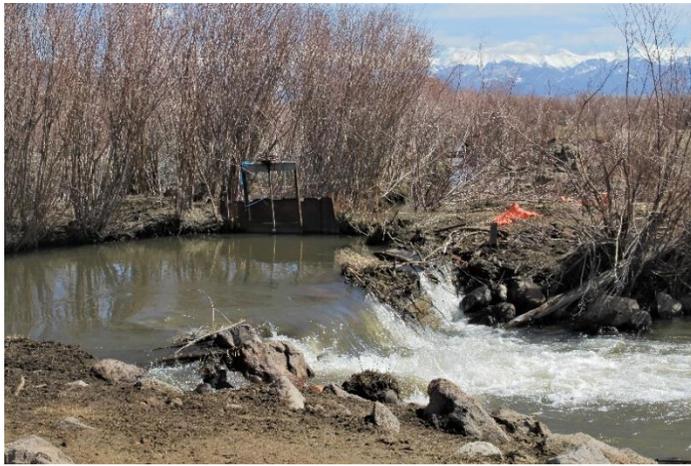
Headgate and diversion dam

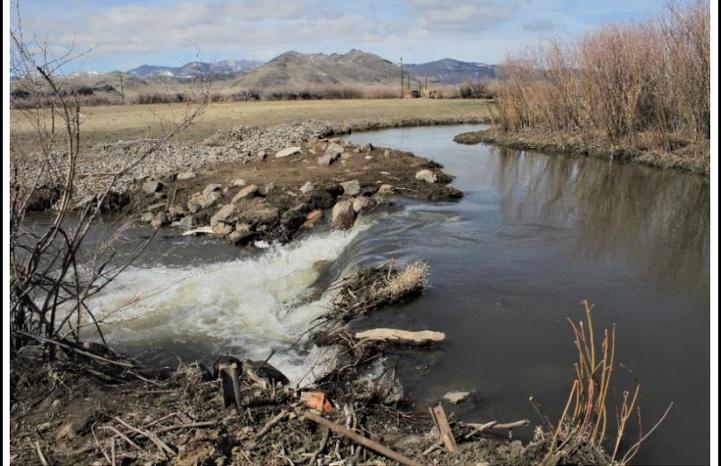
Diversion dam

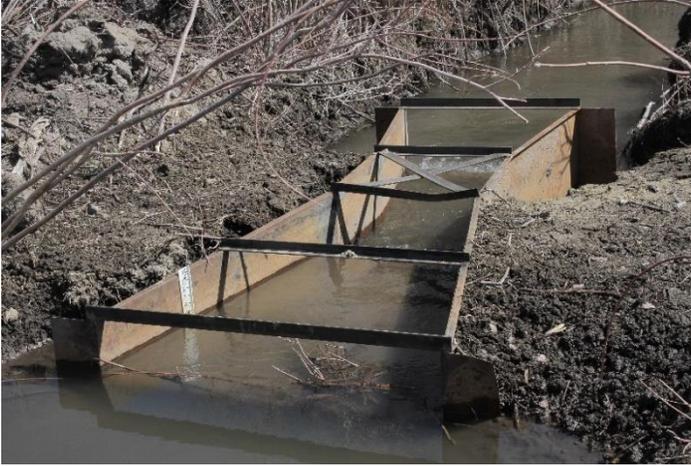
Flume looking downstream

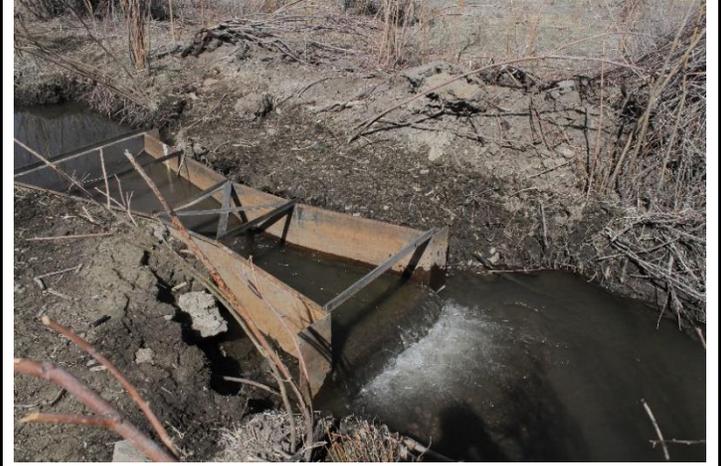
Flume looking upstream
