SAGUACHE CREEK DIVERSION INFRASTRUCTURE INVENTORY

Structure Name: WARD HIGHLINE D

Date: April 12, 2019

Saguache Creek Stream Management Plan

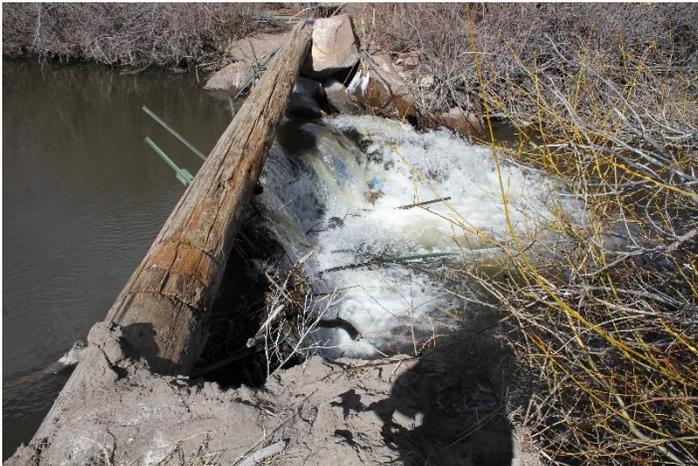
Structure Description: This diversion is located in the transition zone between two meanders. Bank erosion is occurring, particularly upstream of the structure. The diversion dam is made up of boulders, t-posts, and a large utility pole spanning the stream. The diversion dam directs water to a short, approximately 50-foot feeder channel and to the headgate. The utility pole provides bracing for the t-posts as well as bridge access across the stream. The diversion causes a significant drop in the stream's elevation, which creates a barrier to fish passage. At high flow, the drop by can be as high as 6 ft. It also causes sediment accumulation upstream of the diversion dam.

Diversion dam

Repair(s) or Improvement(s) Currently Needed: Although this diversion functions for water users, the SMP Technical Advisory Team (TAT) recommends replacement to create fish passage at this location. Alternatively, the Farrington Ditch 2 point of diversion could be utilized for this ditch. Consolidating the two structures would reduce maintenance and stream impacts. Riparian revegetation would reduce bank erosion and mitigate sediment impacts at this structure.

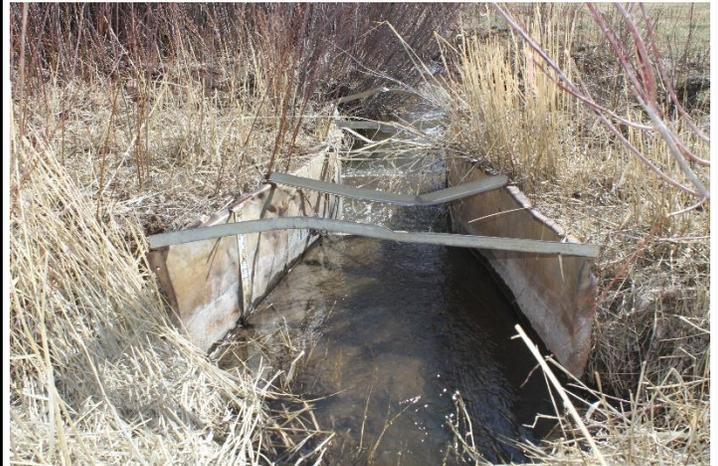
Flume looking upstream
