RIO GRANDE DIVERSION INFRASTRUCTURE INVENTORY

Structure Name: RIO GRANDE D 4

Date: April 9, 2019

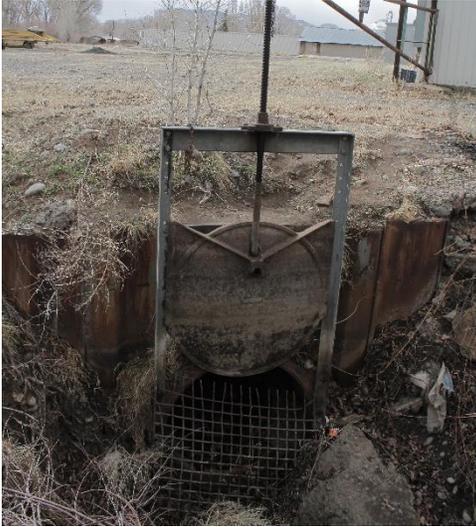
Headgate Type: Manually operated 2' wide cast iron slide gate

Headgate Condition:	A <input type="checkbox"/>	Diversion and Other Condition:	A <input type="checkbox"/>	River Miles from New Mexico State Line (Point of Diversion):	Structure Submerged: Yes <input type="checkbox"/>
	B <input type="checkbox"/>		B <input checked="" type="checkbox"/>		No <input checked="" type="checkbox"/>
	C <input checked="" type="checkbox"/>		C <input type="checkbox"/>	101.02 mi	
	D <input type="checkbox"/>		D <input type="checkbox"/>		
	F <input type="checkbox"/>		F <input type="checkbox"/>

Headgate looking downstream

Repair(s) or Improvement(s) Currently Needed: Given the issues facing this structure, the SMP Technical Advisory Team (TAT) recommends headgate repair, minor improvements to the diversion for effective low flow diversion, and the installation of a trash rack to prevent woody debris from entering the feeder channel. Continual maintenance and feeder ditch clearing will be necessary if a trash rack or other debris mitigation system is not employed.

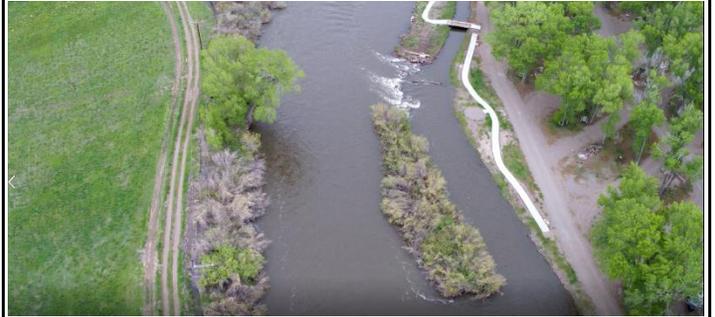
Aerial view of diversion dam looking downstream

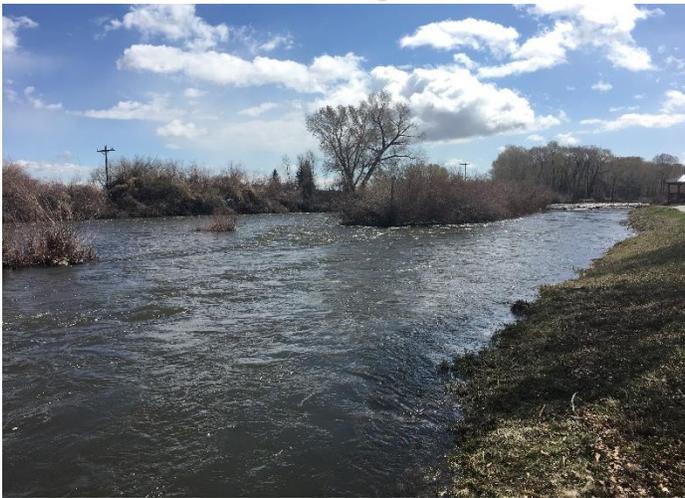
Diversion dam looking downstream

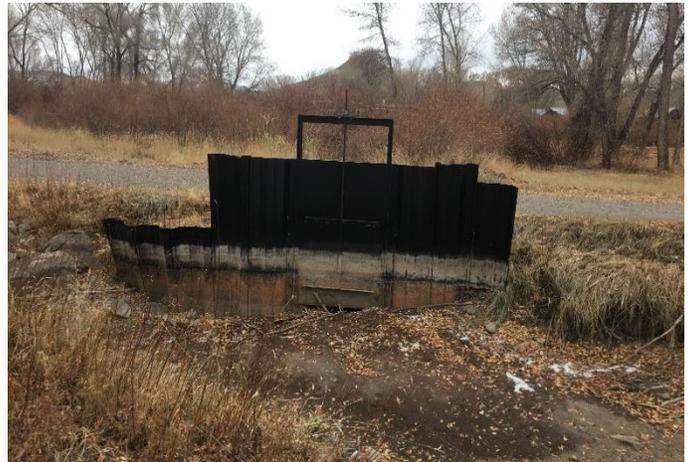
Structure Description: There is a long feeder channel, with the point of diversion located on the south bank of the Rio Grande. The feeder channel travels past the Woods & River RV Park, past the Del Norte Town Park, and under State Hwy 112, before it reaches the headgate. A small vertical corrugated metal pipe with check boards and a concrete headwall, located just upstream of the headgate, directs unused water into the return flow channel back to the river. The headgate leaks slightly. Water entering the headgate is carried in a corrugated metal pipe underneath the adjacent property to the east, where it becomes a 12 ft plastic corrugated pipe. The plastic pipe travels under the Rio Grande and irrigates the island formed by the North and South Channels of the Rio Grande. Just downstream of the flume, the ditch goes into a siphon and is carried under the Rio Grande. The diversion dam, which is upstream of the Hwy 112 bridge, functions well except at low flows, when the ditch has difficulty accessing water. During 2019 spring runoff, significant sediment and woody debris became lodged at the diversion dam entrance, including a large cottonwood.

Diversion dam (post-2019 runoff)

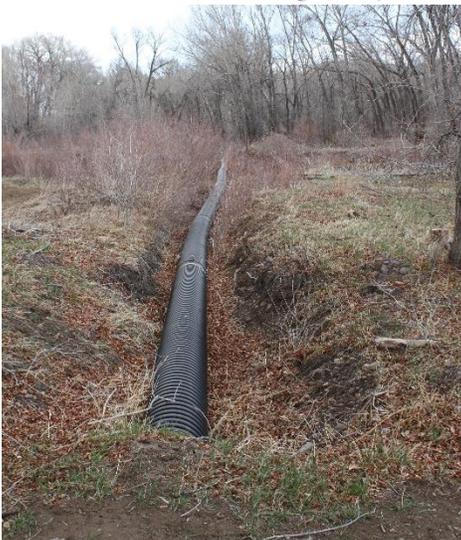
Ditch carrier made of corrugated plastic pipe

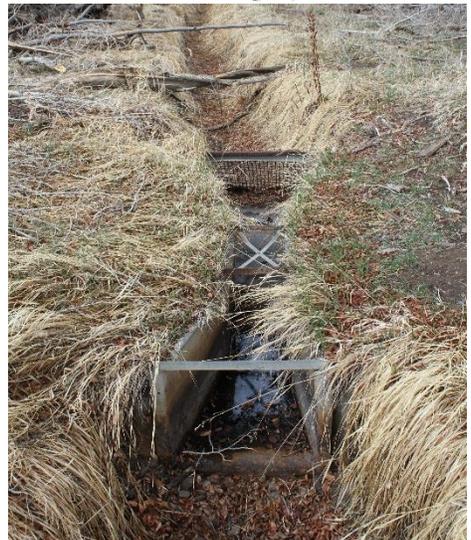
Flume looking upstream

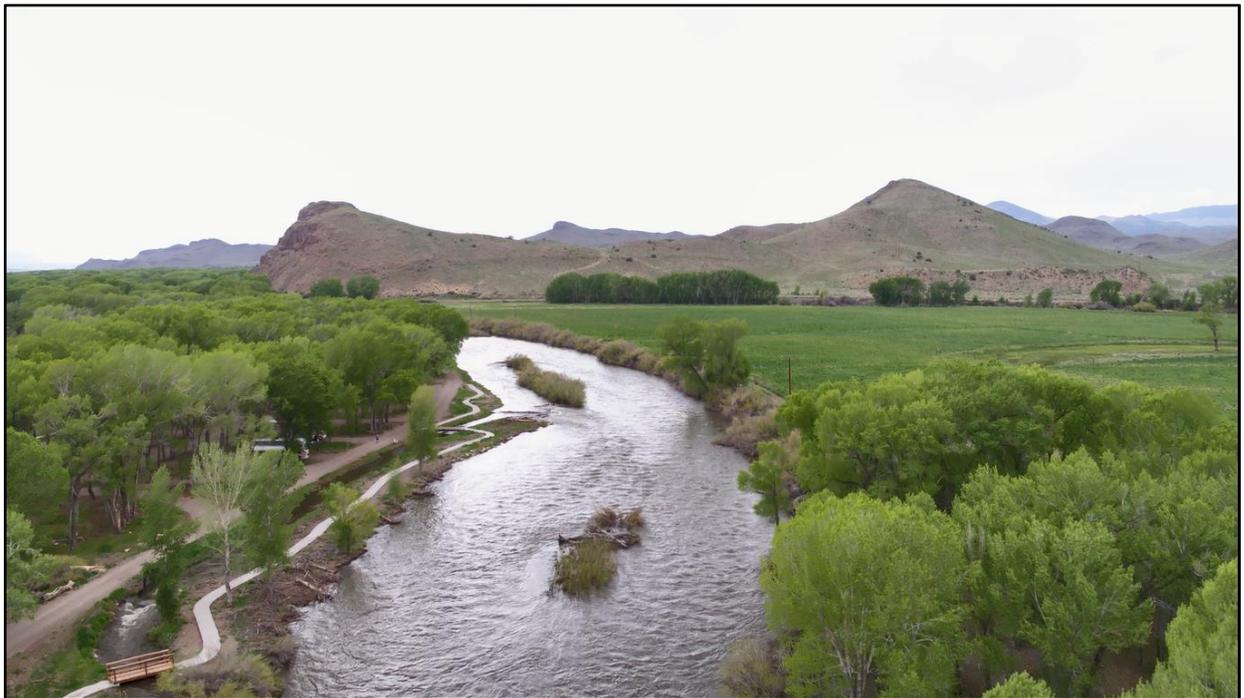
Rio Grande D 4 diversion dam looking upstream.

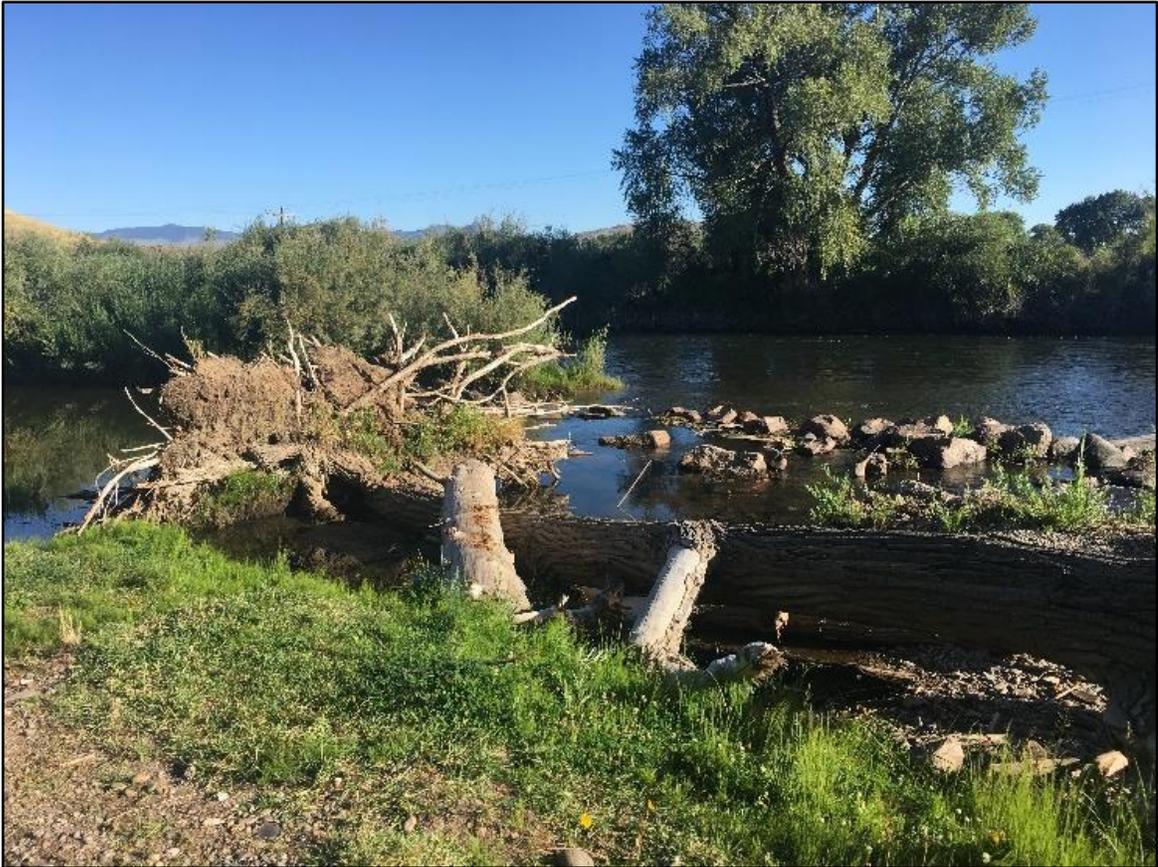
Point of diversion, post-2019 runoff. This cottonwood is currently blocking the feeder channel.
