Issue Report

Hotel Contruction Mapping

Report created on August 25, 2020

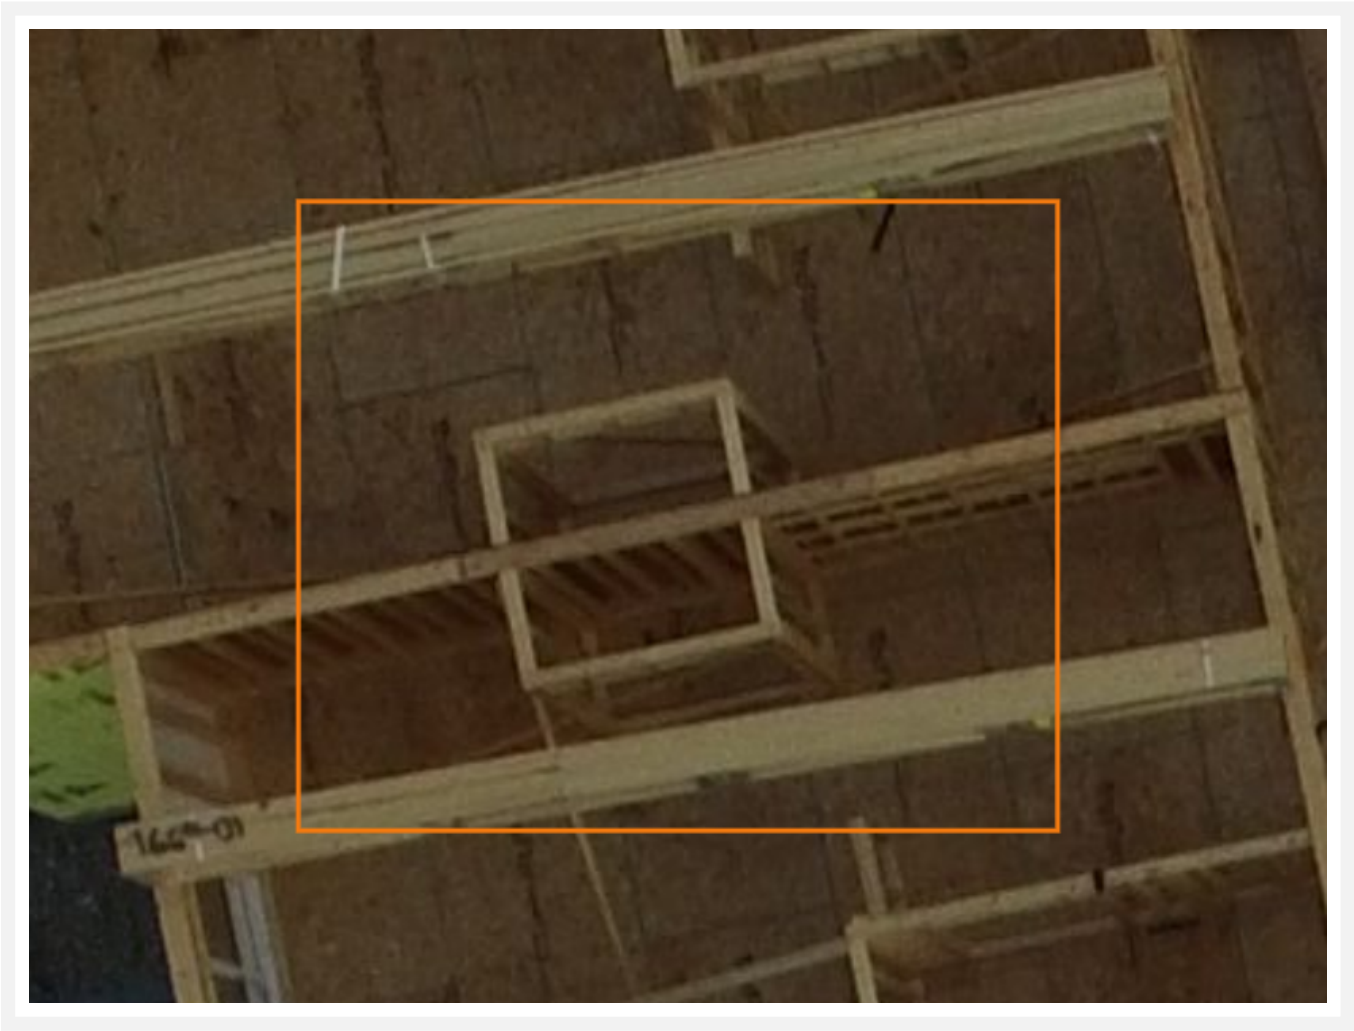
No. 1 OPEN

Broken Part

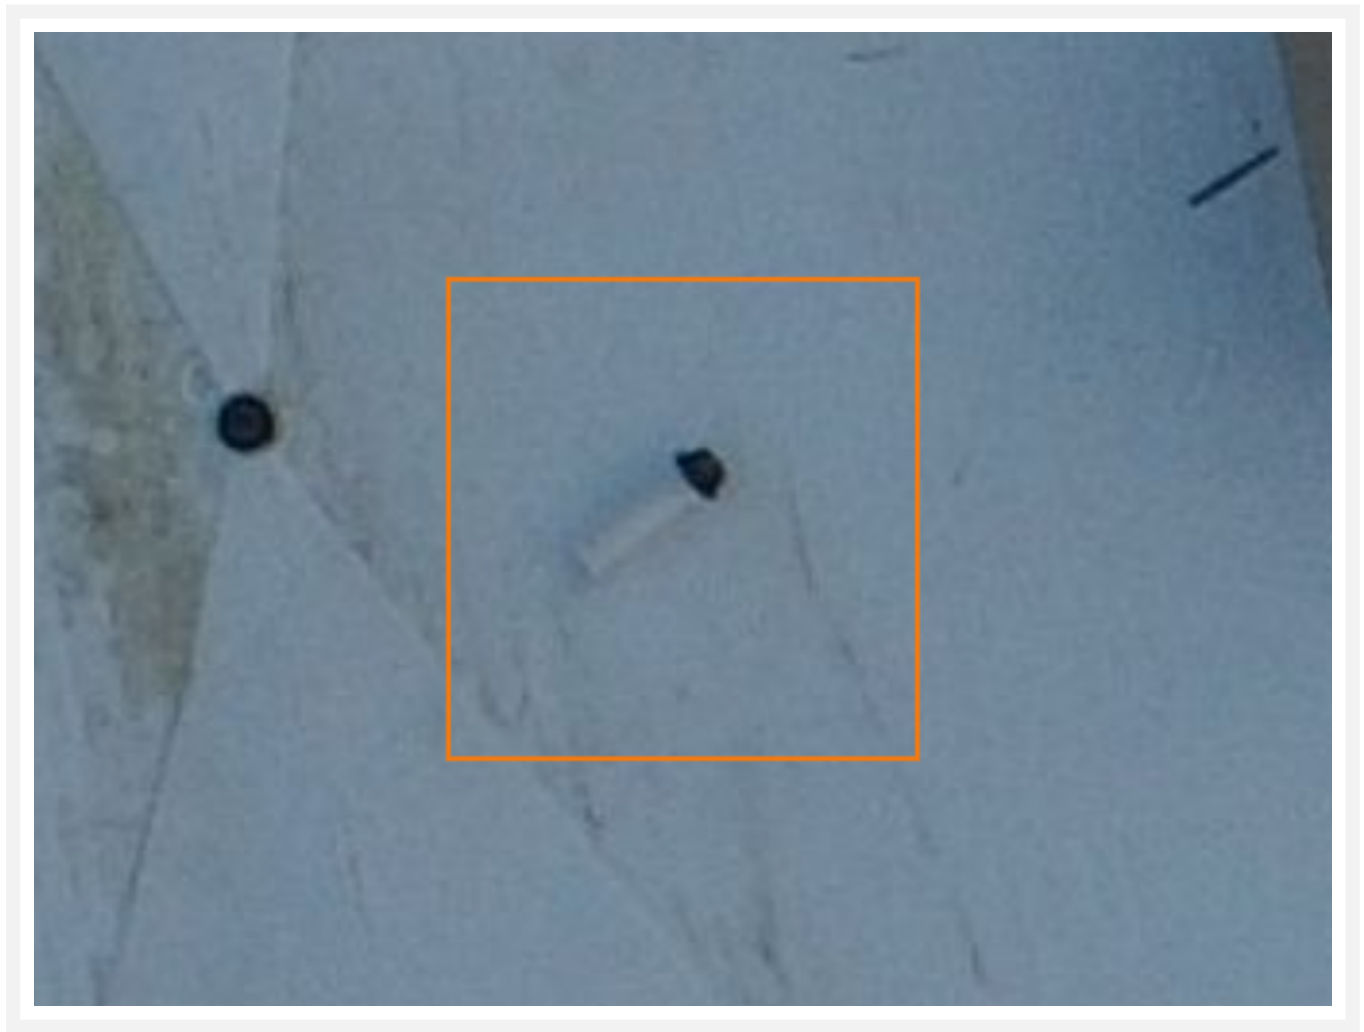
No. 3 OPEN***Captured:*** Aug 23, 2020 at 7:05am

Broken Part

Flashing Repair

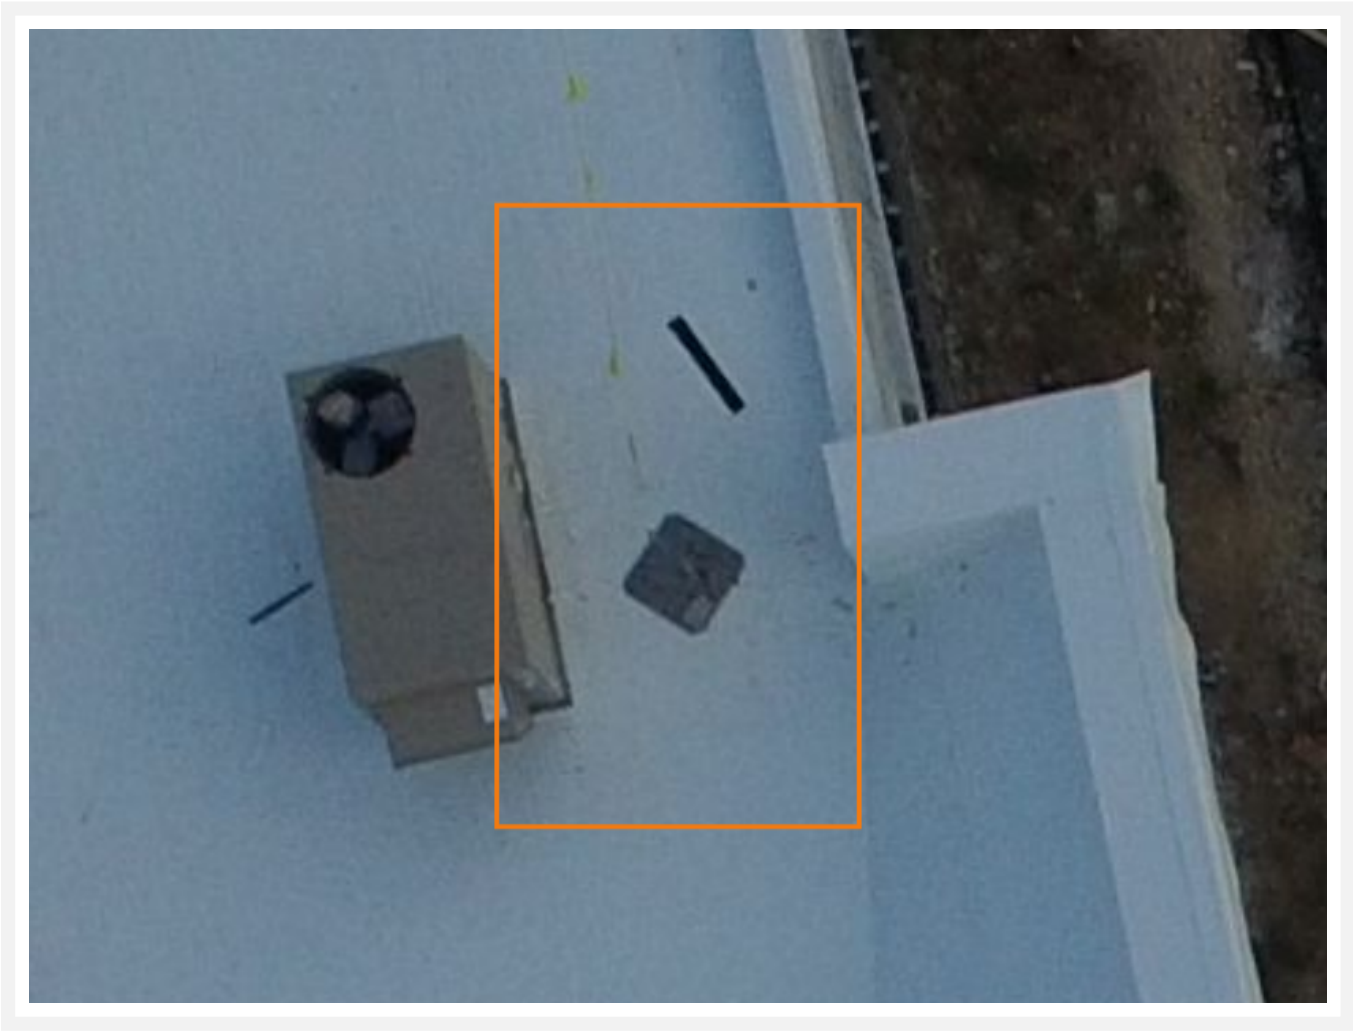
No. 2 OPEN

Type
Debris

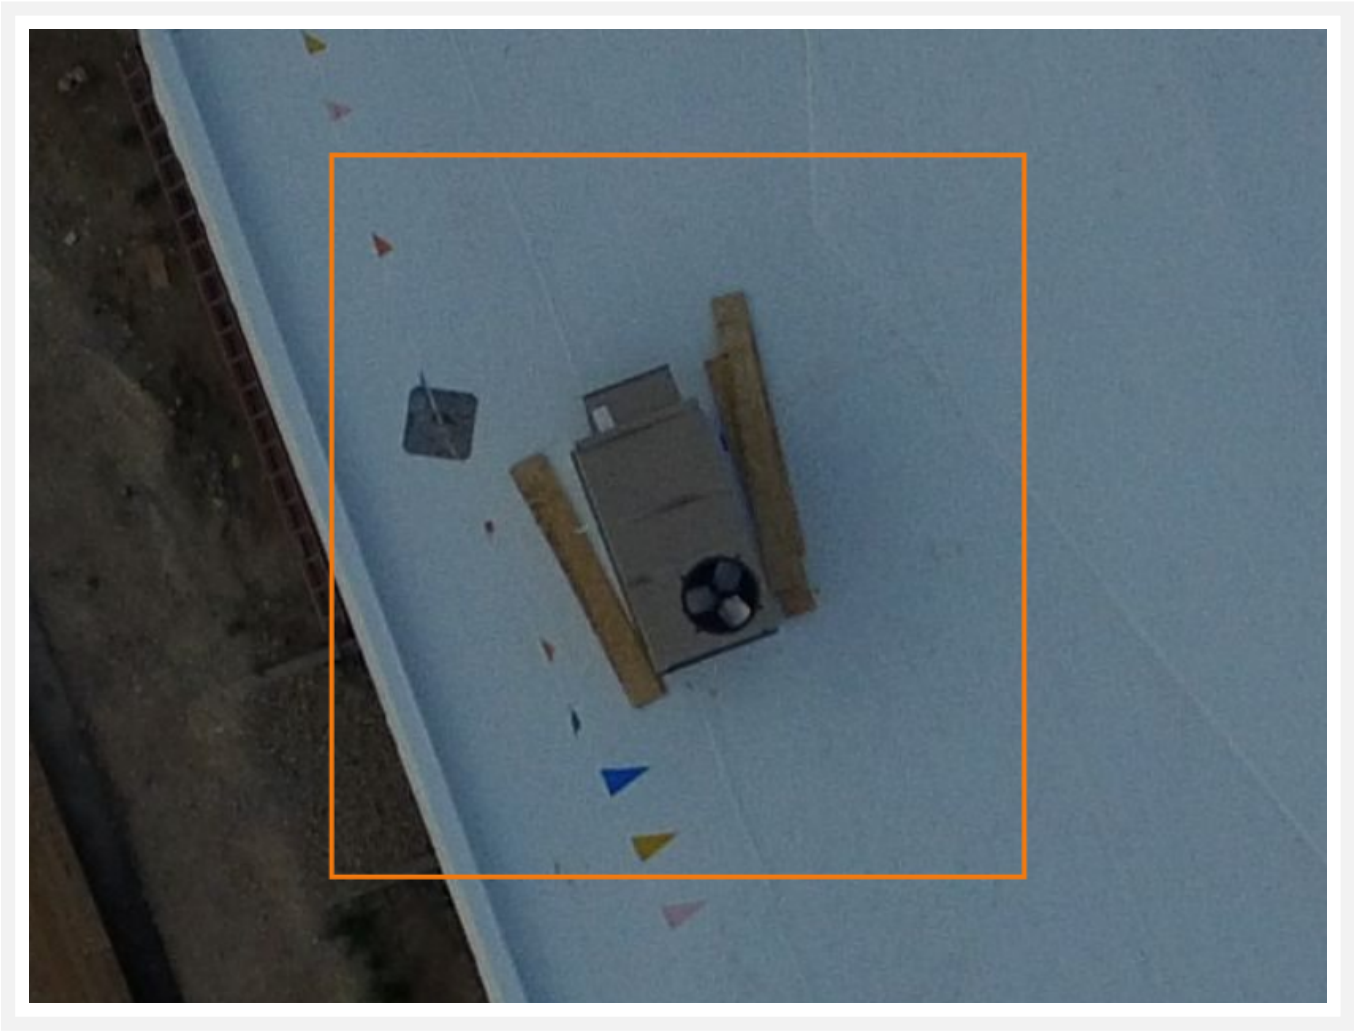
No. 4 OPEN

Plan Deviation

Curb installation

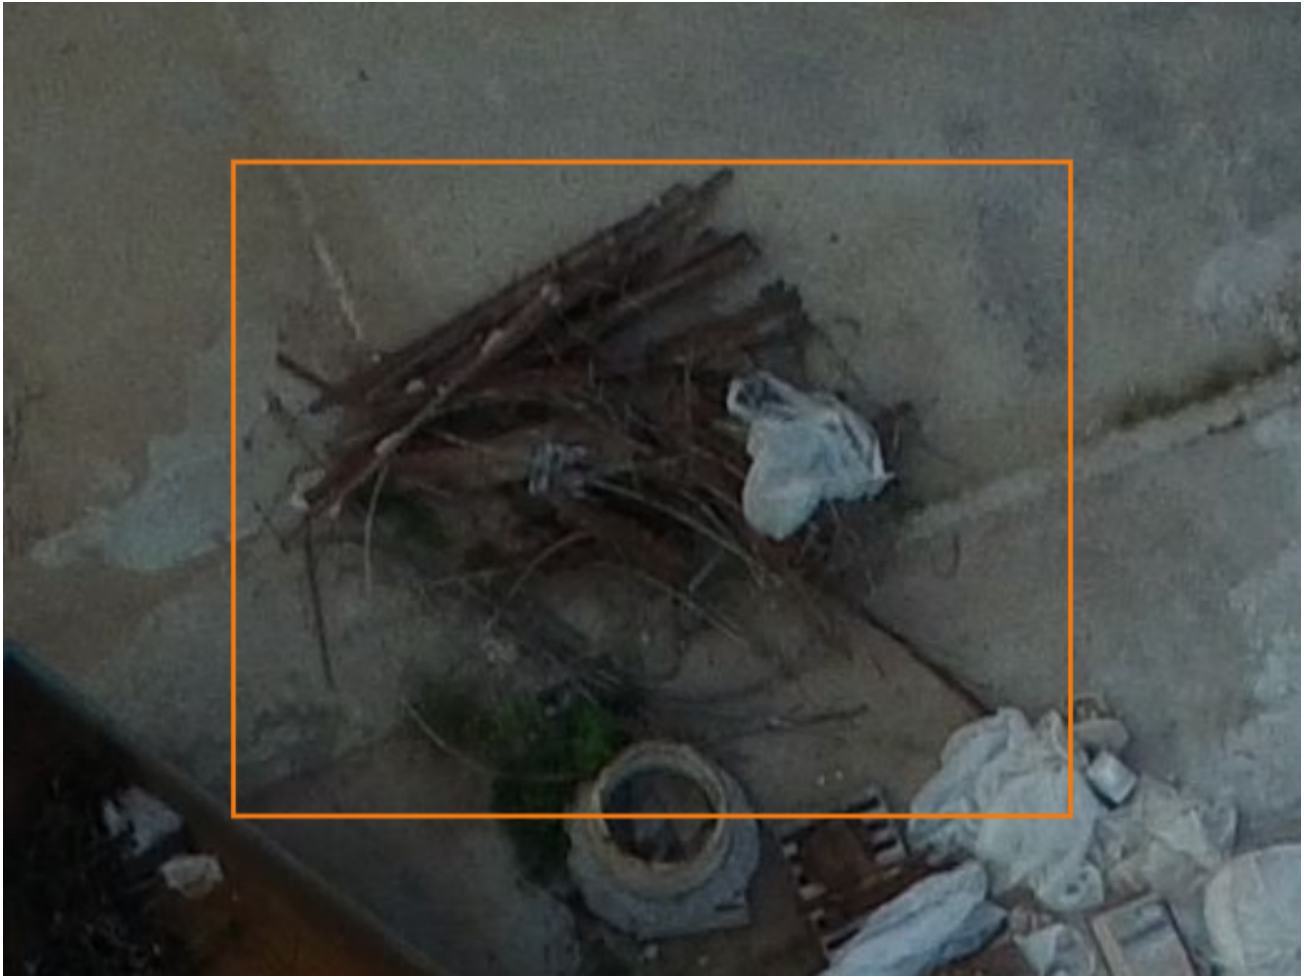
No. 5 OPEN***Captured:*** Aug 23, 2020 at 7:05am

Plan Deviation

Metal Recycle
