# UNDERSTANDING LITTLE TRAVERSE LAKE WATERSHED RESPONSES TO RAIN EVENTS

Fall 2024 – Spring 2025

*February 2026*

*David Skjaerlund, PhD*

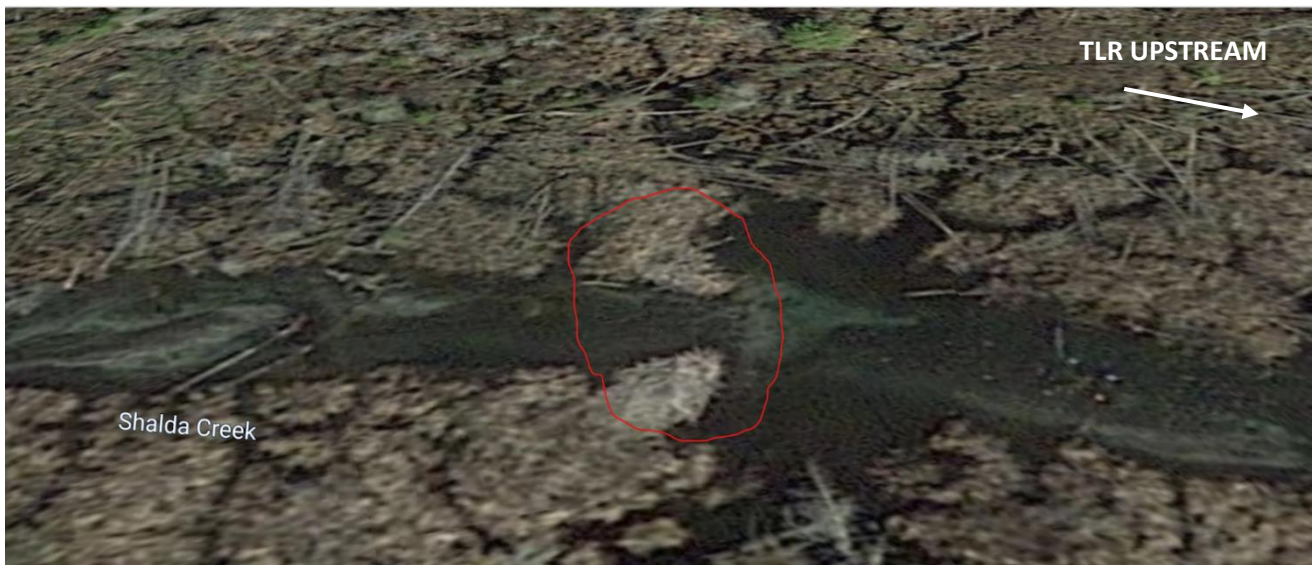
Beaver dam #1 is known as "Tweener Dam" located 1,823 ft (one third of a mile) downstream from CR 669. It can be reached via kayak from TRL In this picture, the dam has been torn out with 12' high stacks of sticks on each side following decades of dam removal. Notice the light-colored sediment that has accumulated upstream of the dam and also downstream. This dam has been documented to have a significant and direct impact on Shalda Creek levels at TLR Stream Outlet and on lake levels.

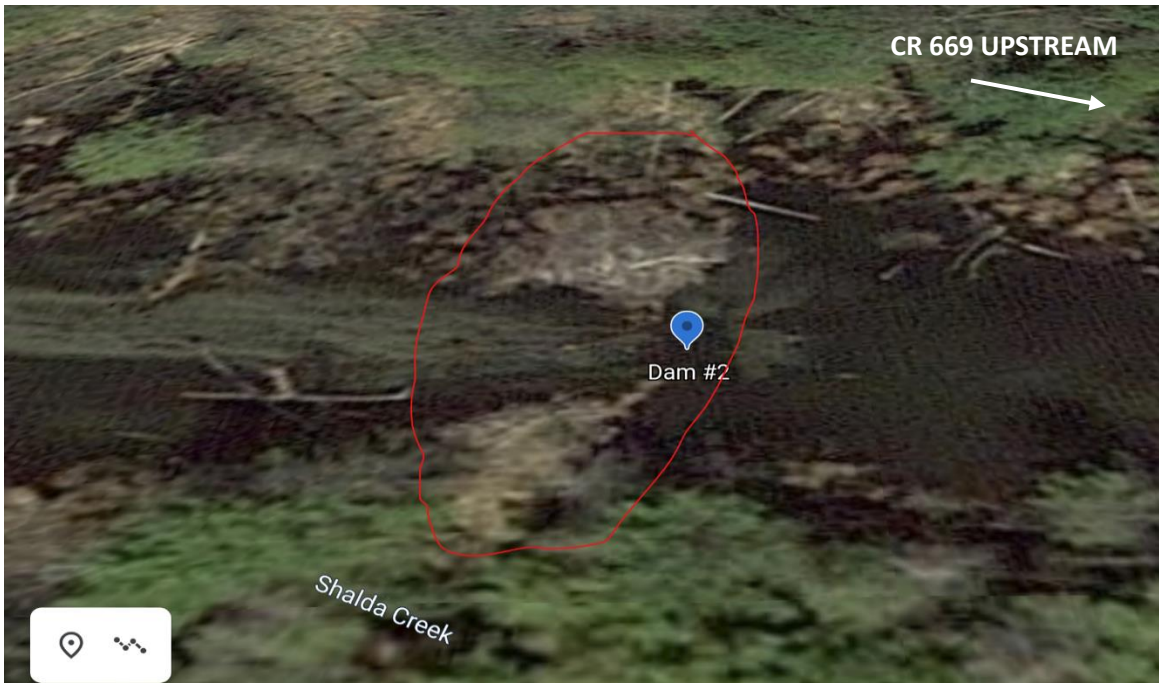
Beaver dam #2 is less than half a mile downstream of 669. In this picture, the dam has been torn out. Notice sediment downstream with water depth only a foot in that section. The width of cleared dam is narrower than stream channel width, with high stacks of sticks from numerous dam tear outs. This dam was rebuilt late summer 2024 and was cleared out March 30, 2025.

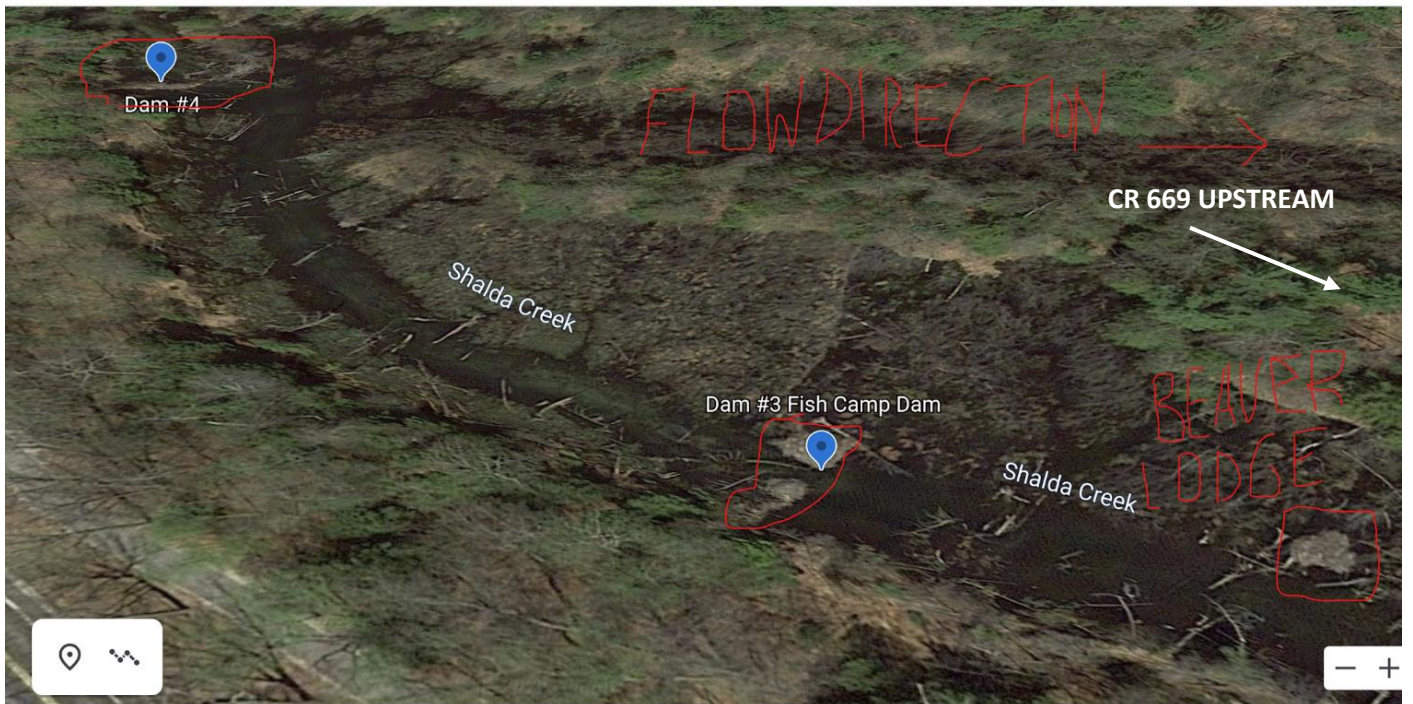
Beaver dam #3 is known as "Fish Camp Dam" as there was a cabin there many years ago. It is accessible walking from M-22 and is visible from the Heritage Trail. The stream width is only four feet at the cleared dam creating a stream choke point with high piles of sticks from dam removal over the years. Note the sediment and debris buildup downstream. Shalda Creek downstream of dam #4 is not navigable with a kayak due to extensive tree blowdown, debris buildup, older beaver dams that have collected sediment. A hike along the stream is very difficult.

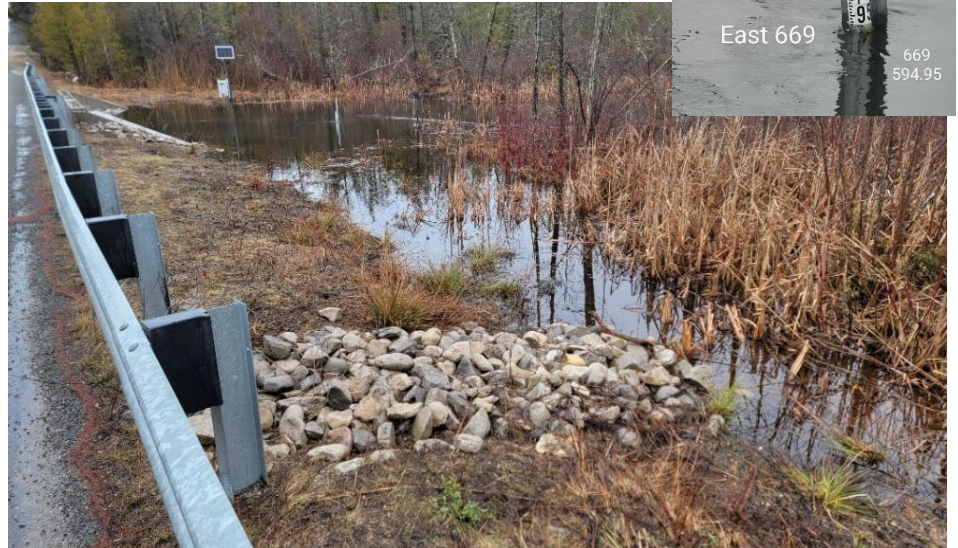
3/29/2025 Beaver dams present spring 2025, increased in size; water levels elevated with additional rainfall events; no air gap underneath CR 669 Bridge, accumulating debris; standing water in surrounding watershed; 594.95 on measuring stick. This is a second time a beaver dam downstream CR 669 has elevated water levels above the bottom of CR 669 Bridge.

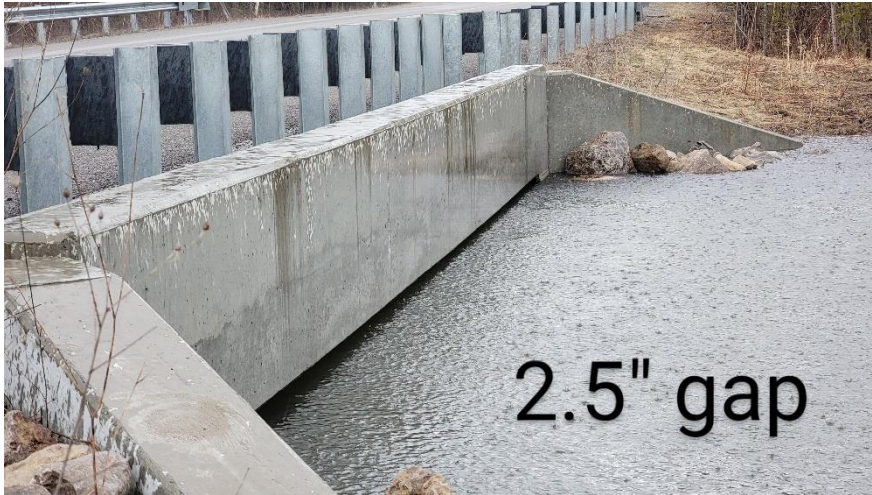
4/2/2025 Beaver dam removed noon 3/30/2025 following NPS permission. 594.75 on measuring stick at 4 pm; 2.5" airgap underneath CR 669 Bridge.

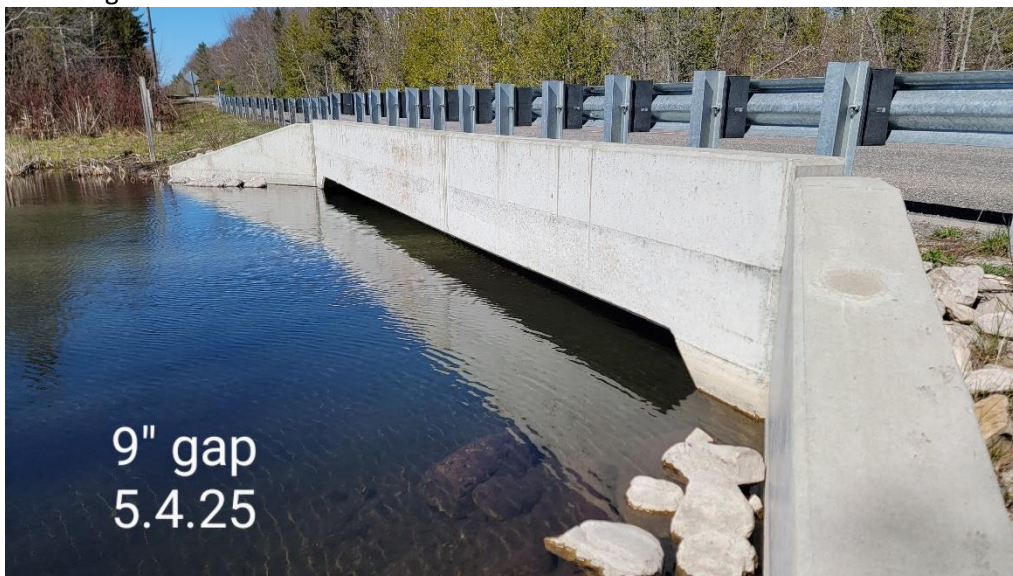
5/4/2025 Dam downstream CR 669 removed March 30, 2025; Water levels drop to 594.25; 9" air gap underneath CR 669 Bridge

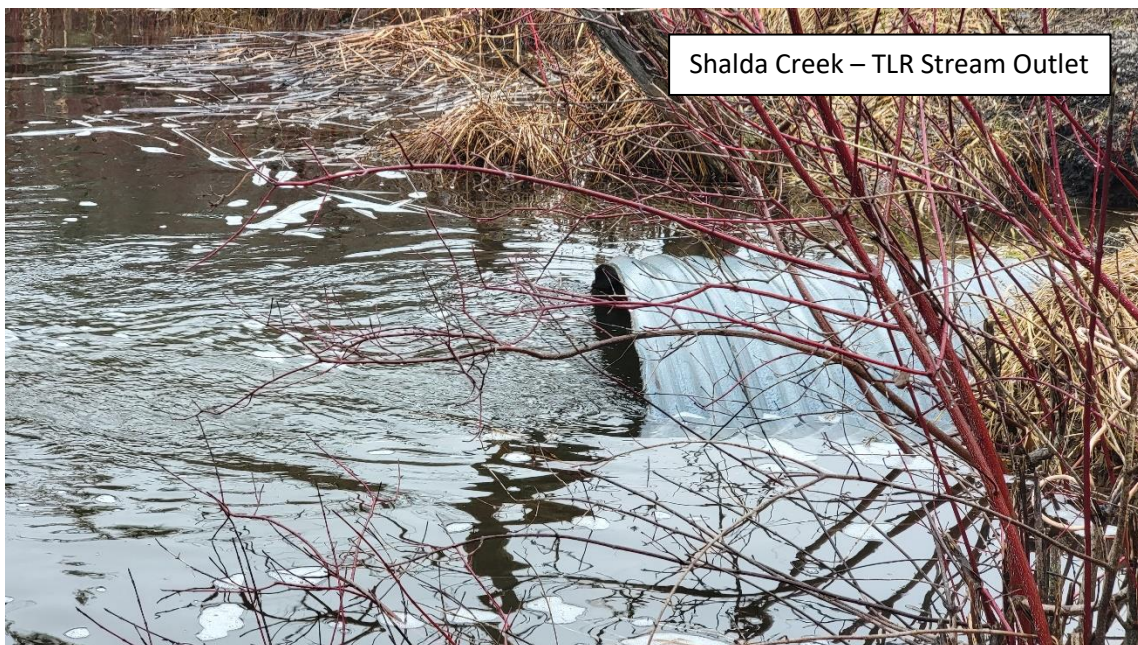
3/29/2025 – TLR Lake  
Inlet: 594.76 on the  
measuring stick. TLR  
Stream Outlet: 594.53  
on measuring stick,  
water 5" from top of  
culvert. Water in  
residential yards.

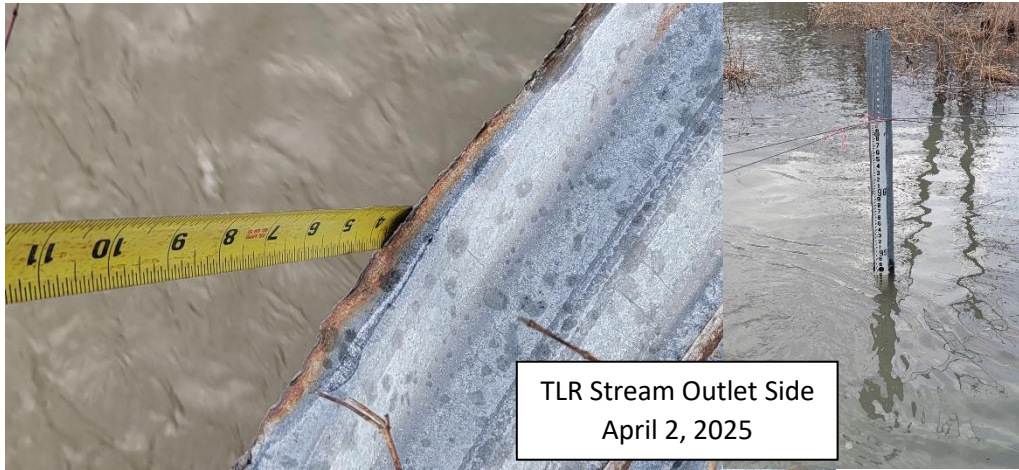
TLR Stream Outlet Side  
April 2, 2025

High water levels on April 2, 2025. TLR outlet side; 4" below top of culvert; 594.6 on measuring stick

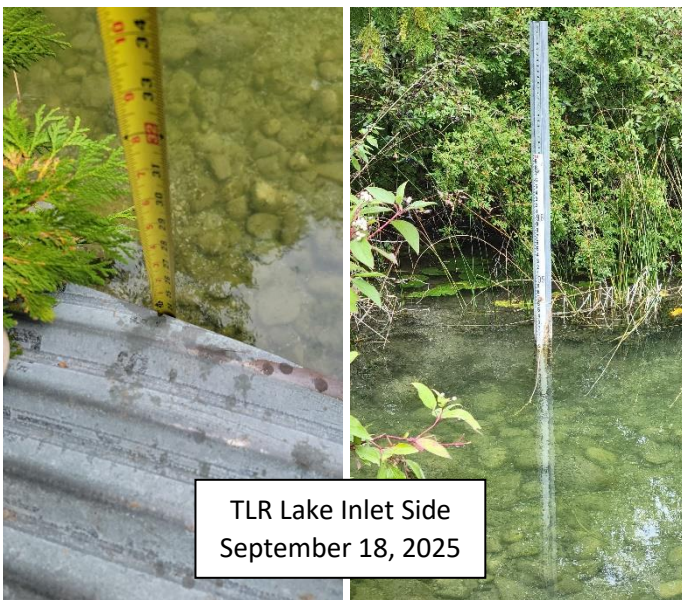
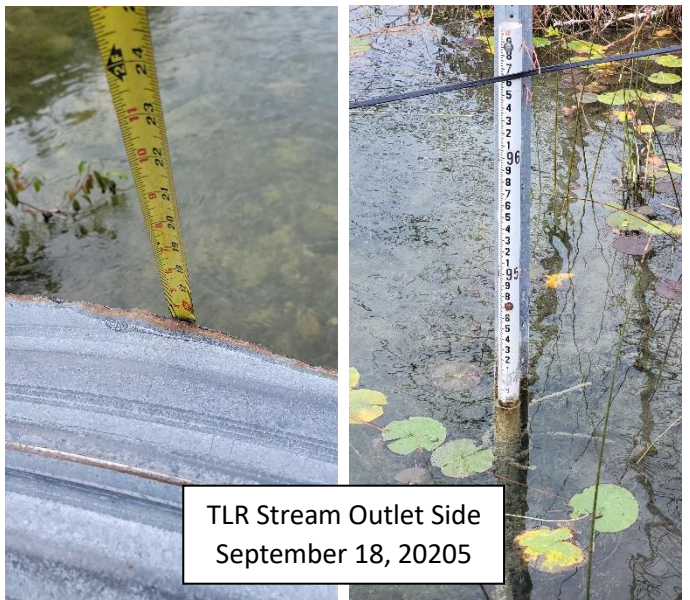
During lower summer levels on September 18, 2025, TLR Lake Inlet side level was 593.85 on measuring stick with water 24" from top of culvert. TLR Stream Outlet side level was on 593.4 measuring stick with water 15" from top of culvert.

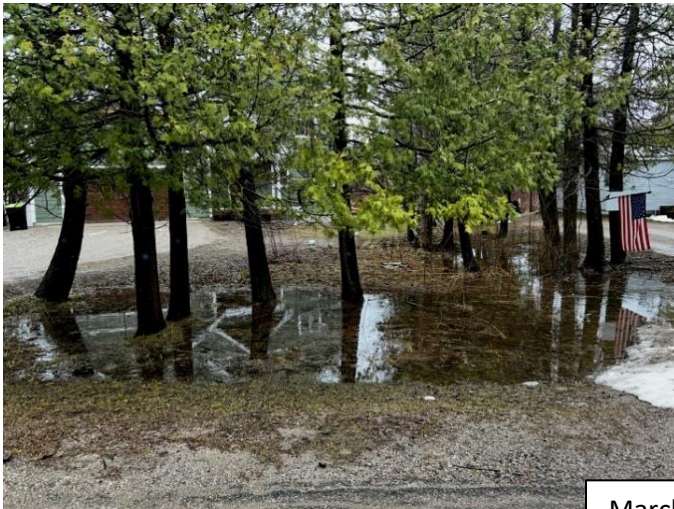
March 31, 2025

Yards had significant water on March 31 with LTL lake levels at 594.76. Flood waters were observed on April 2 with LTL lake levels reaching 595.1. Water was still standing in yards with LTL lake levels at 594.85 on April 9. At that level, water has been known to infiltrate some residential crawl spaces. Concerns about shoreline breaching, especially during high winds and significant wave activity, and elevated water tables begin when LTL levels reach 594.5.

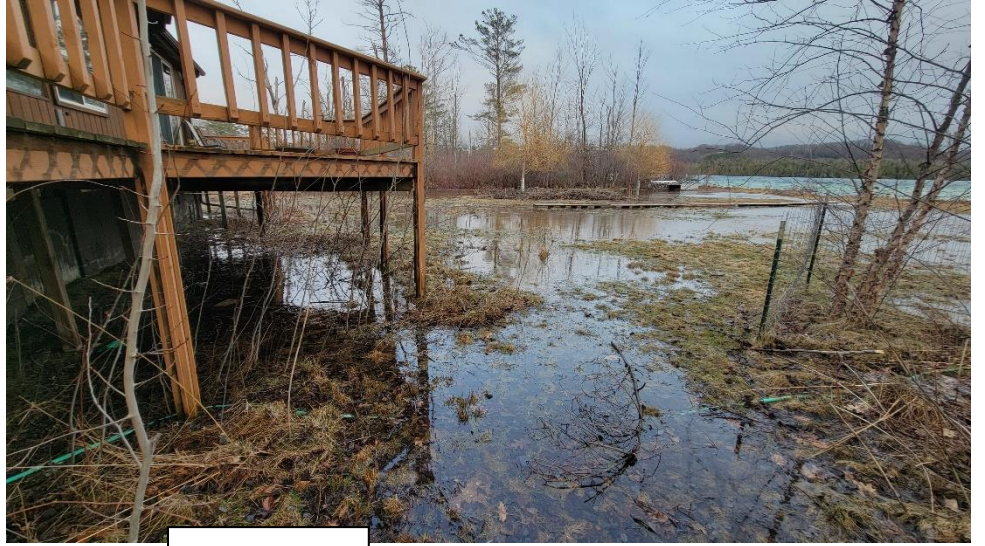
The high water levels during Spring 2025 caused water to overflow the banks of Little Traverse Lake. Highest water levels were observed April 2, 2025 after the rain ceased. The impact of flooding and high water levels include:

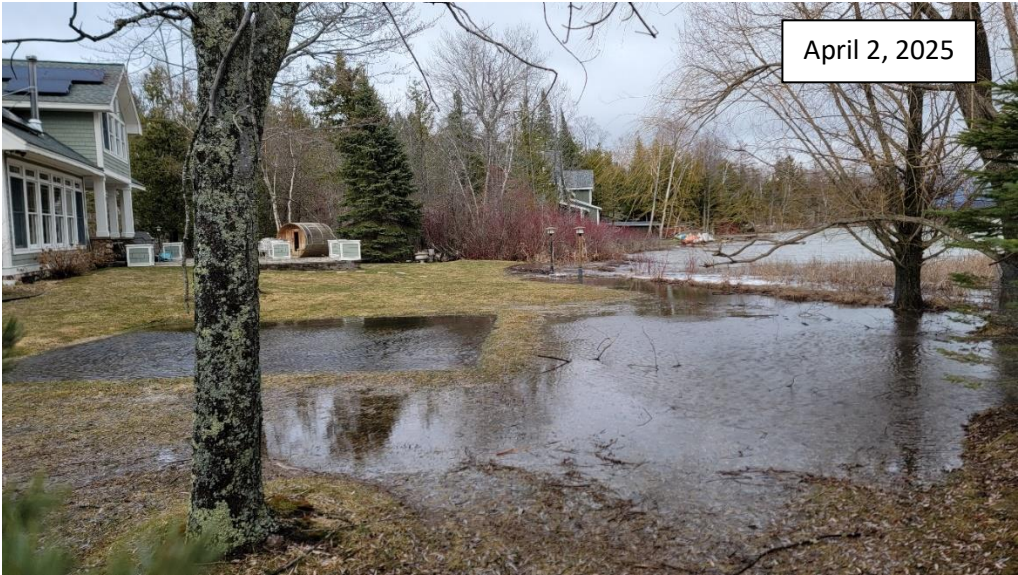
April 2, 2025

Relative comparison: April 2 – water overflowing shoreline bank; April 9 – 4" below shoreline bank; May 4 – 9" below shoreline bank; September 16 – 16" below shoreline bank

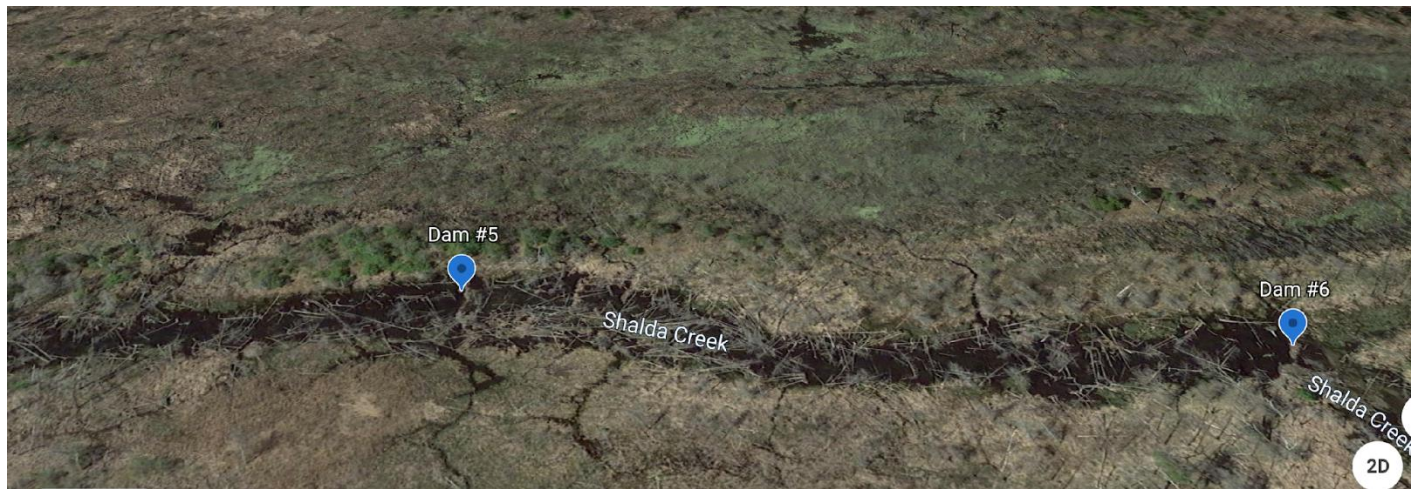
These photos taken June 2014 show the accumulation of debris that exists between Fish Camp and Lake Michigan. Shalda Creek has lots of beaver dam activity as well as tree blow down as trees die out with saturated water tables.

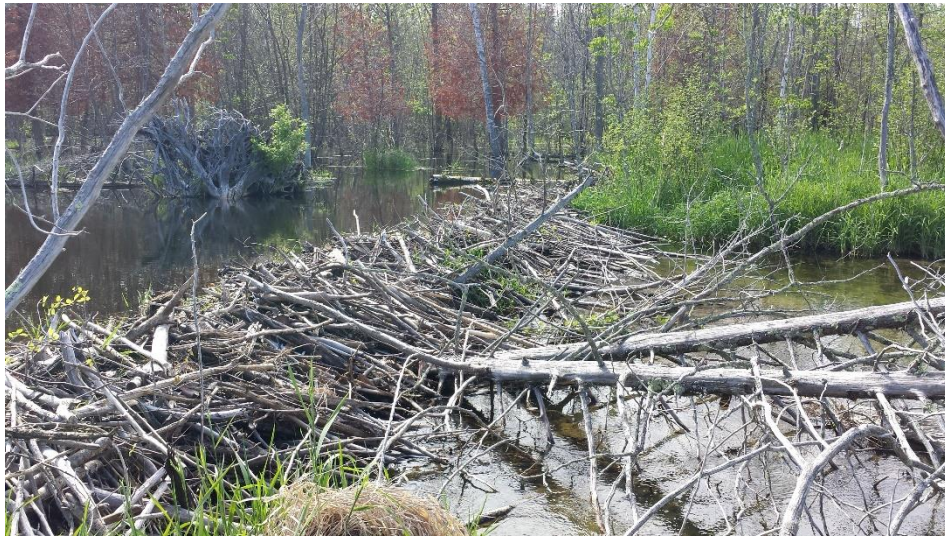
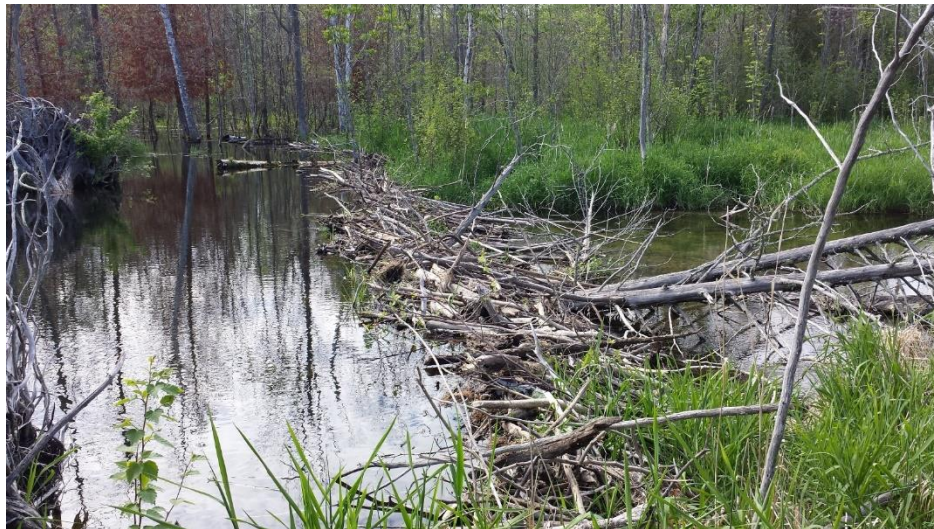
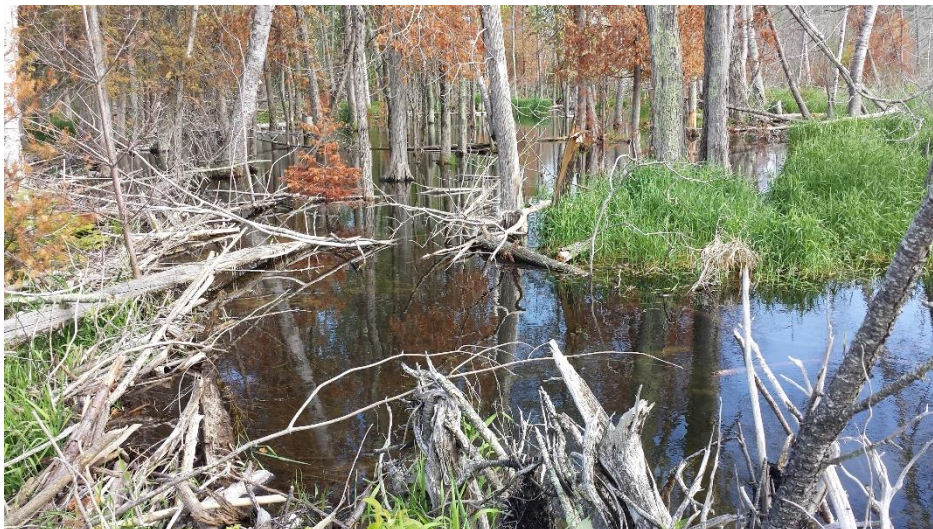
This beaver dam near the Fish Camp area was present June 2014 and finally removed October 2014 as part of the Gosling Czubak study. It is an example of how larger beaver dams can become over time if not maintained. The dams then collect sediment and if left untouched, will drastically alter the ecosystem with standing water upstream that then chokes off trees and creates a saturated and elevated watershed that has little capacity to absorb seasonal rain events, especially if significant. This process created Narada Lake is underway at Kelderhouse Road in Port Oneida.

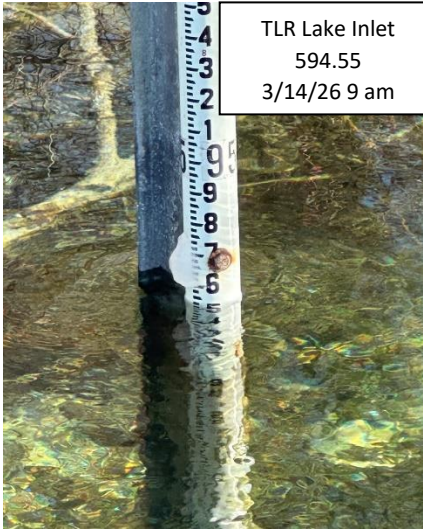
TLR Lake Inlet  
594.55  
3/14/26 9 am

Permission was finally granted by NPS and both dams were removed on Saturday, March 14, 2026 around 11 am. The Fish Camp Dam was holding back approximately 12" of water. The Tweener Dam was about 3-4' high from stream bottom to top. Water levels in LTL were high, measuring 594.55 on the TLR upstream measuring stick and 594.2 on the Shalda Creek side of TLR. The CR 669 level was 594.4 on the measuring stick.

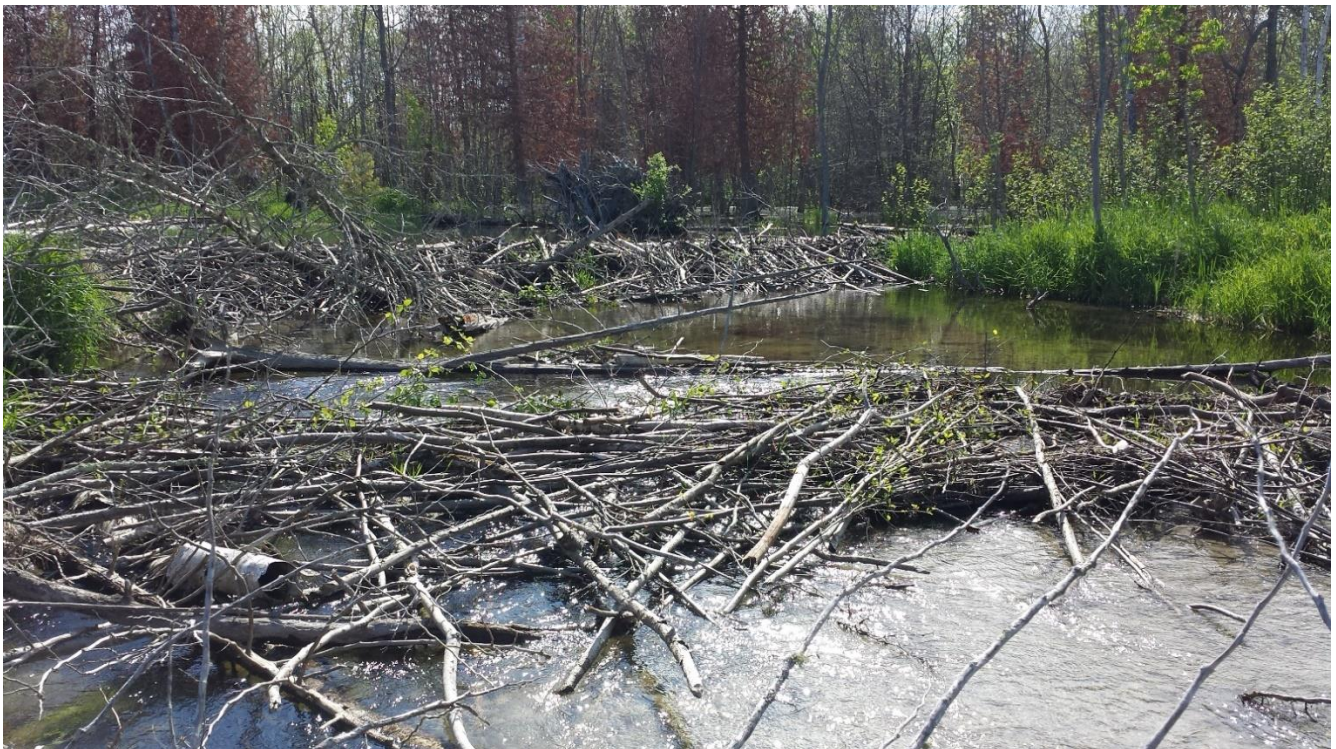
*Flash back photo of beaver dam June 2014*

P.S. Perhaps it is time to do a prescribed burn of the large beaver dam debris piles that have been growing in size over the past decades. This would aid in the ease of future beaver dam removal as well as potentially widen the stream at beaver dam pinch points.
