# LITTLE TRAVERSE LAKE WATER LEVEL INVESTIGATION

7/15/2014

Little Traverse Lake Property Owners  
Association

Prepared by: Gosling Czubak Engineering Sciences, Inc  
1280 Business Park Dr.  
Traverse City, MI 49686  
231-946-9191

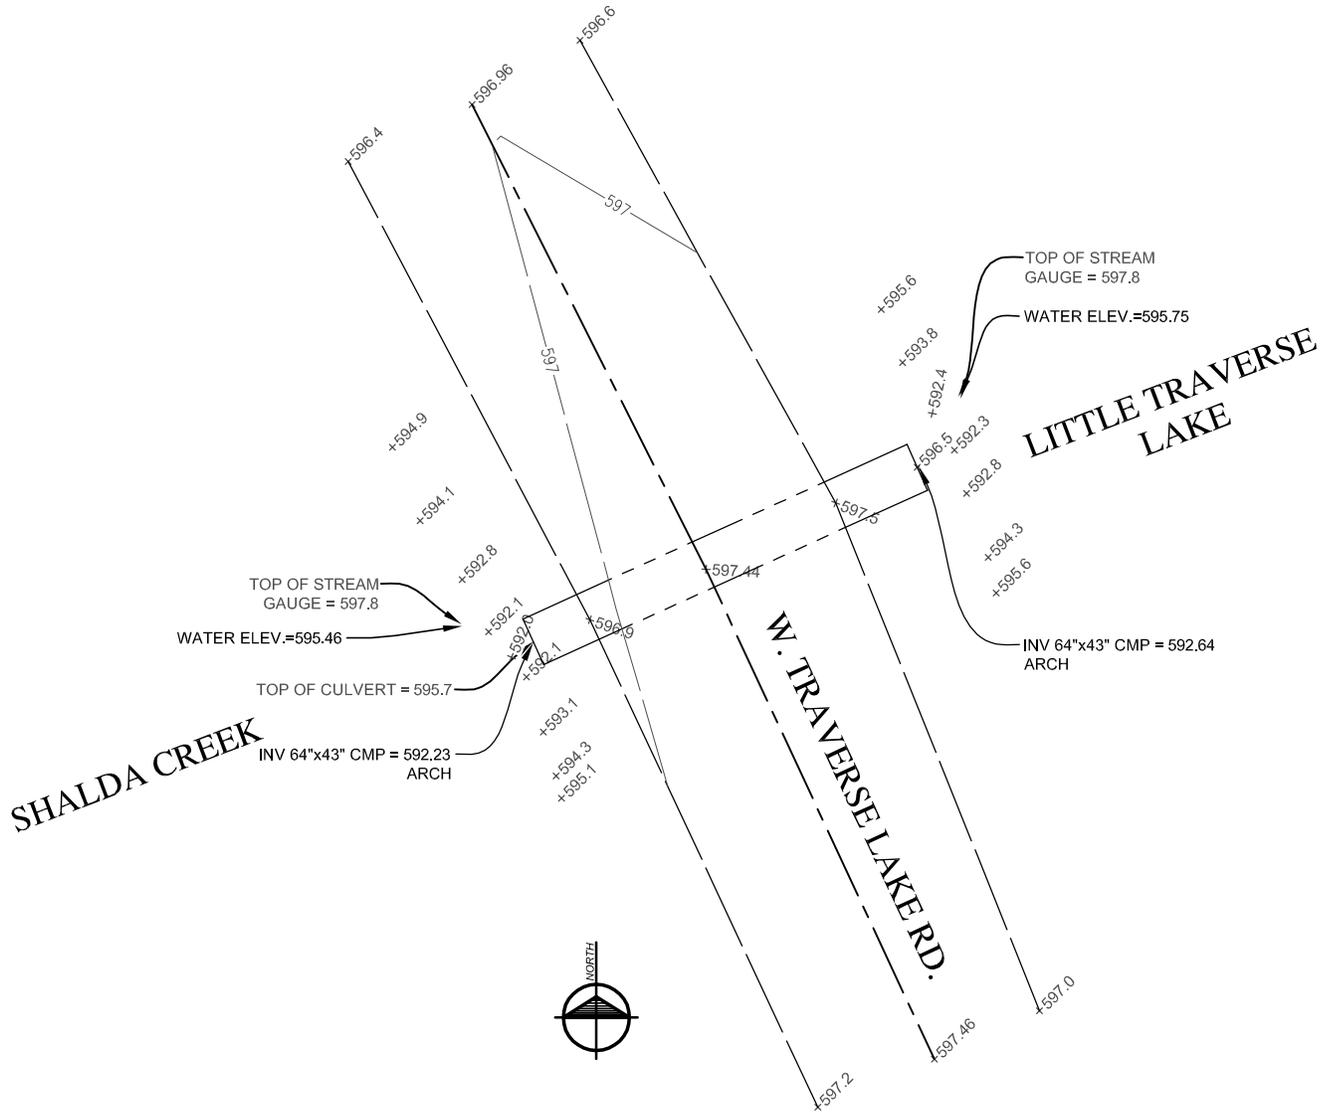
**W. TRAVERSE LAKE RD. CULVERT PLAN VIEW**  
 SCALE: 1" = 20'

Yes. The culvert at Traverse Lake Road normally experiences a high tailwater condition that limits the capacity of the culvert. At flows lower than about 60 cfs, capacity of the culvert would be improved if the tailwater condition is lowered. However, at flows greater than 60 cfs, the culvert operates under “inlet control” conditions. This means that no matter how low the tailwater condition is, the water can’t get into the inlet fast enough, so the headwater level will be about the same, regardless of the tailwater condition. See attached analysis outputs.

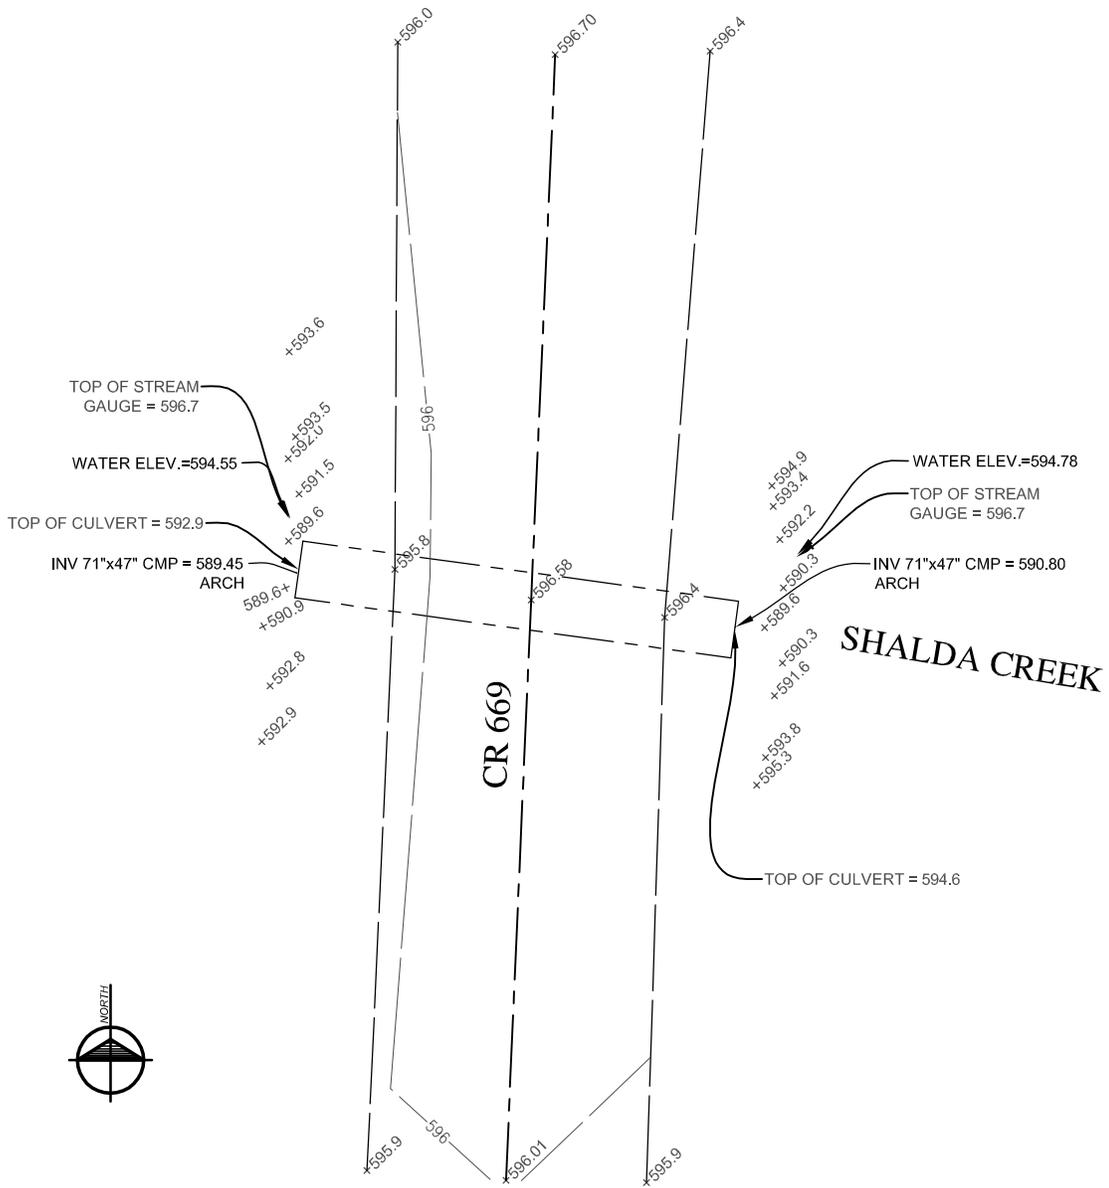
# CO. RD. 669 CULVERT PLAN VIEW

Yes, but to a lesser degree than the W. Traverse Lake Road culvert. This culvert also normally experiences a high tailwater condition that limits its capacity. At flows lower than about 120 cfs, capacity of the culvert would be improved if the tailwater condition is lowered. However, at flows greater than 120 cfs, the culvert operates under “inlet control” conditions. This means that the headwater level will be about the same, regardless of the tailwater condition. See attached analysis outputs.

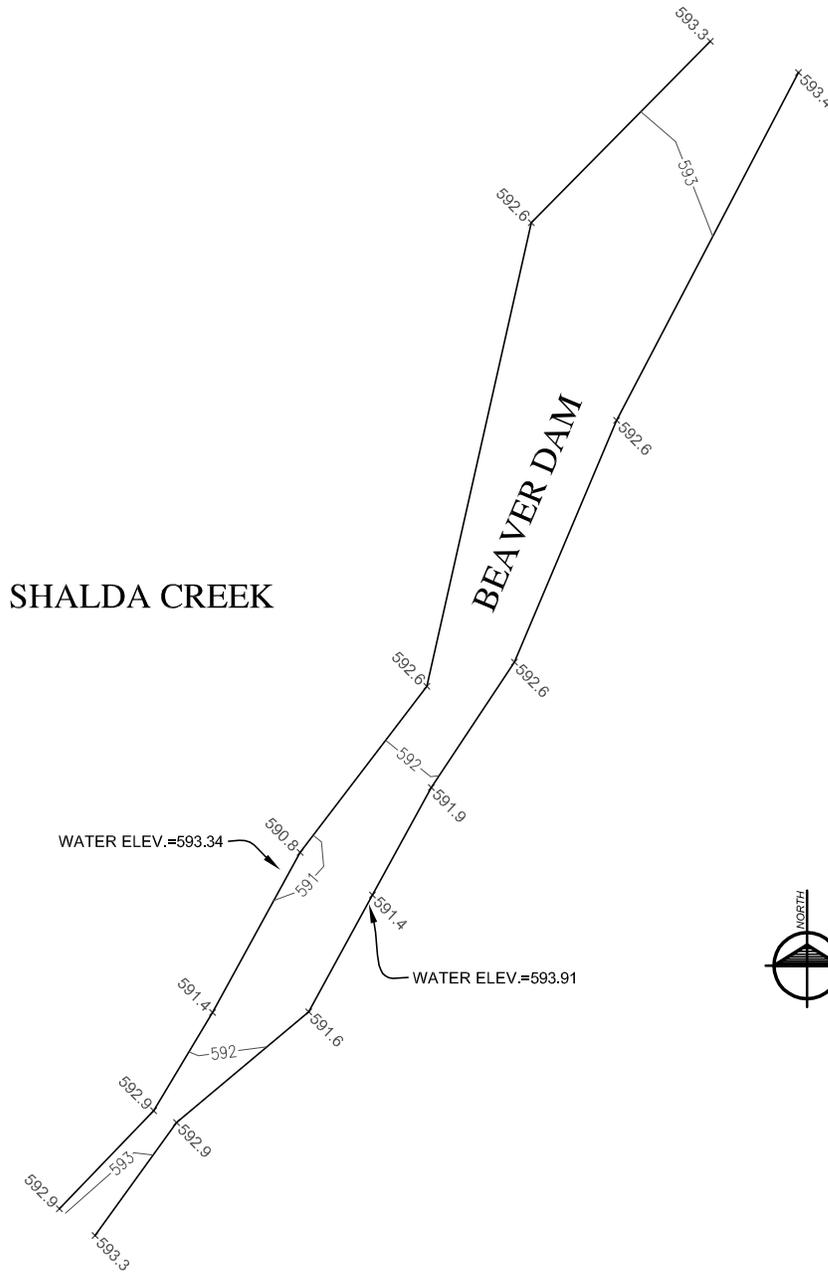
# BEAVER DAM PLAN VIEW

The location and size of the beaver dam is shown on the attached site plan and survey detail map. The water level difference across the dam was measured at 0.57' (6-7/8") in April, 2014. Beaver dam configurations are continuously changing and could impact water levels in different ways in the future.

Yes, depending on the flow conditions. As we have learned through this study, there is more than one beaver dam to consider. The way each dam affects creek flow and lake levels can vary at each dam location. A beaver dam does create a higher tailwater condition at the culverts than might naturally occur. So, removing the beaver dam under these flow conditions would lower the lake level.

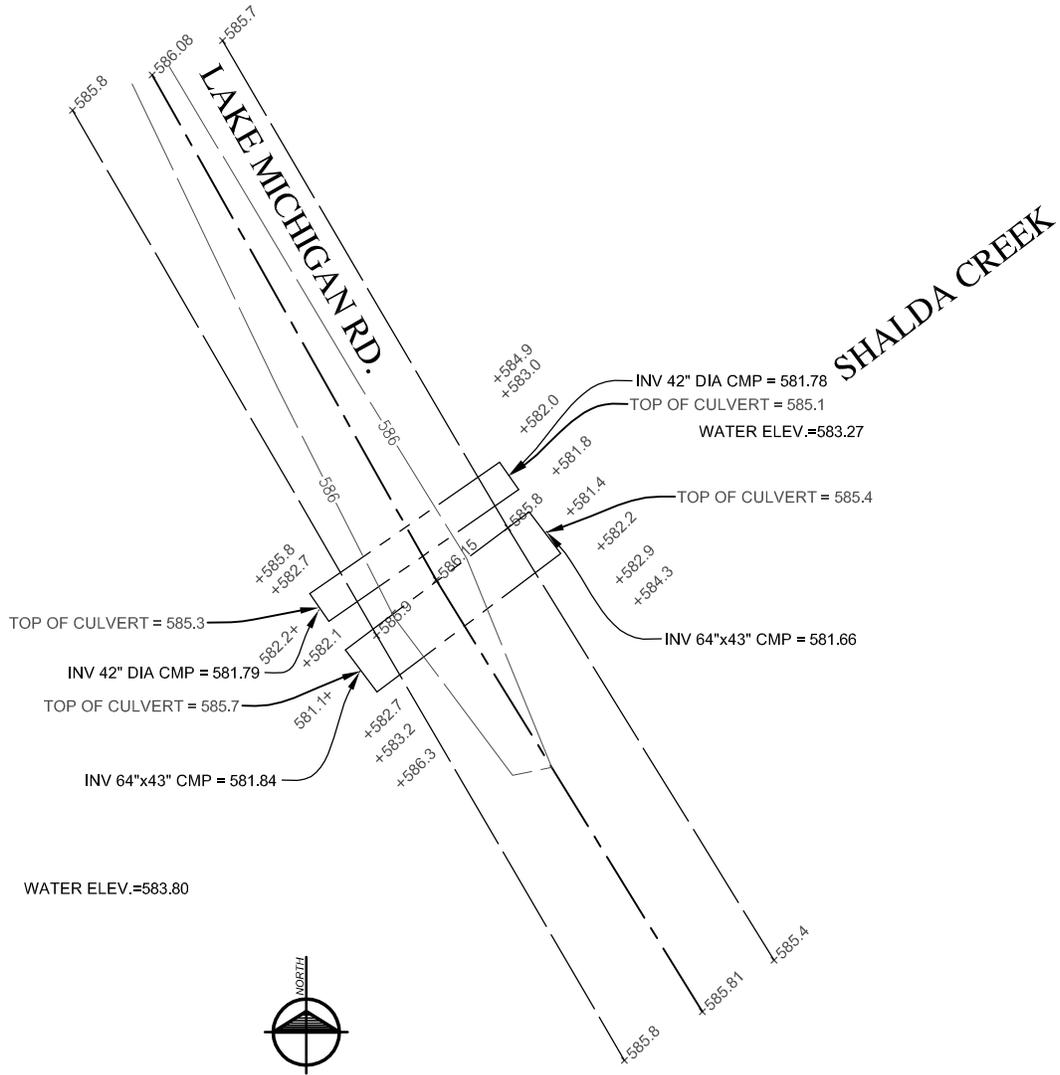
# LAKE MICHIGAN RD. CULVERT PLAN VIEW

The culvert on West Lake Michigan Road is actually two culverts. The dimensions are shown in the summary table in the “findings” section. The capacity of this culvert system is much greater than the upper culverts due to its larger effective opening and its relatively low tailwater condition. The culvert generally operates under inlet control and has a capacity of about 140 cfs before overtopping the top of the culvert.

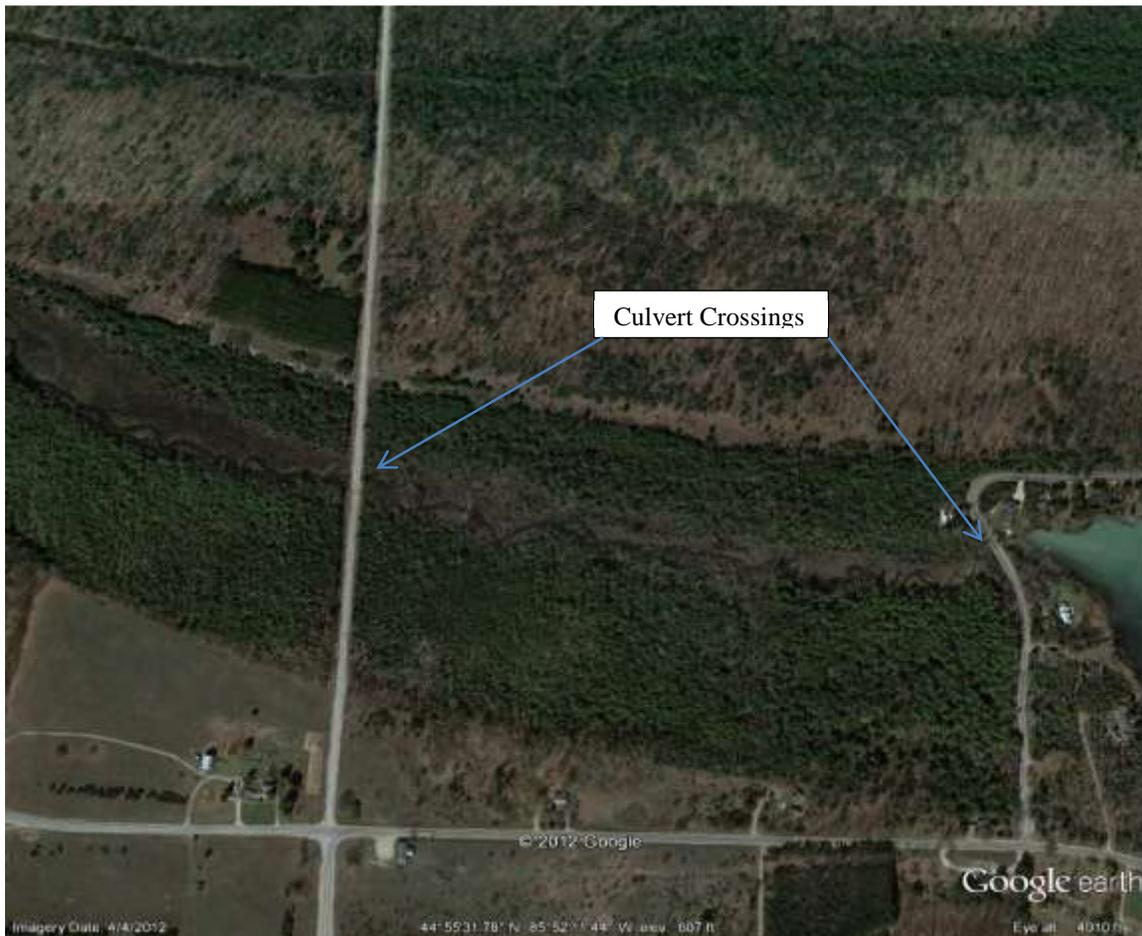
**Figure 1.** Google earth image of Shalda Creek immediately downstream of Little Traverse Lake, which is visible in the right of the image. Note the sinuosity of the channel and the relatively broad floodplain that supports extensive wetland vegetation visible as a brownish-grey corridor through the dark green upland timber.

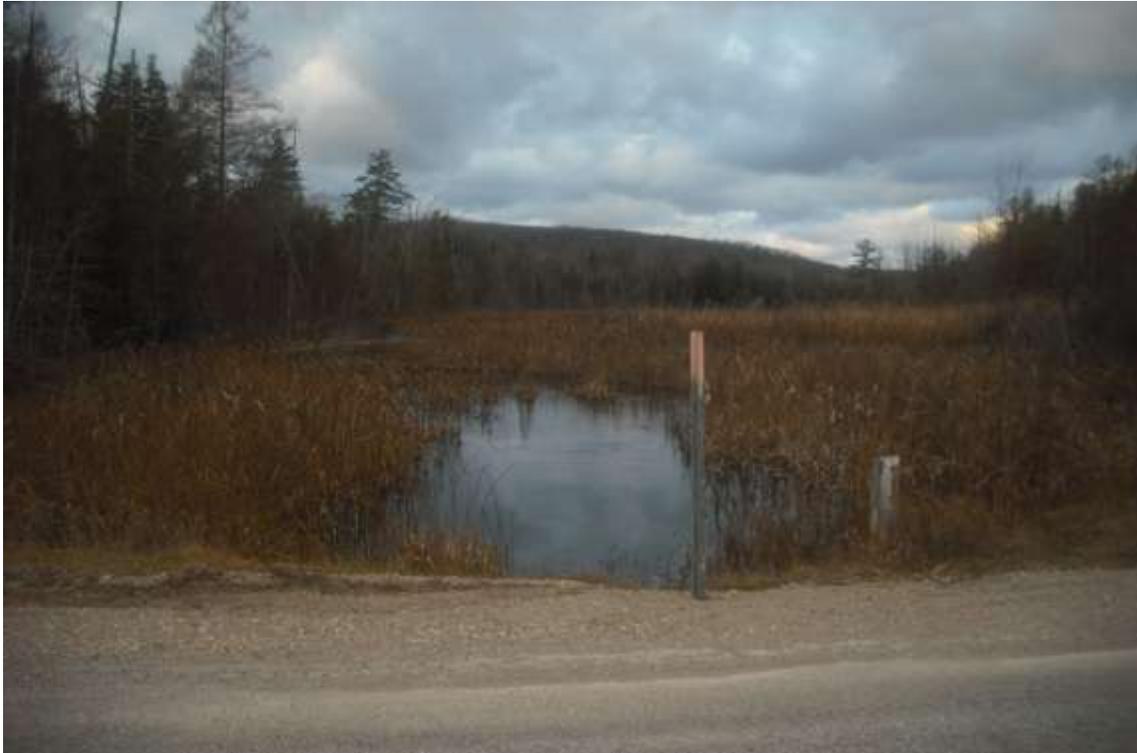
**Figure 2.** View of Shalda Creek immediately downstream from the LTL culvert. Note the extensive stands of aquatic/wetland vegetation present on both sides of the channel (NPS 2011).

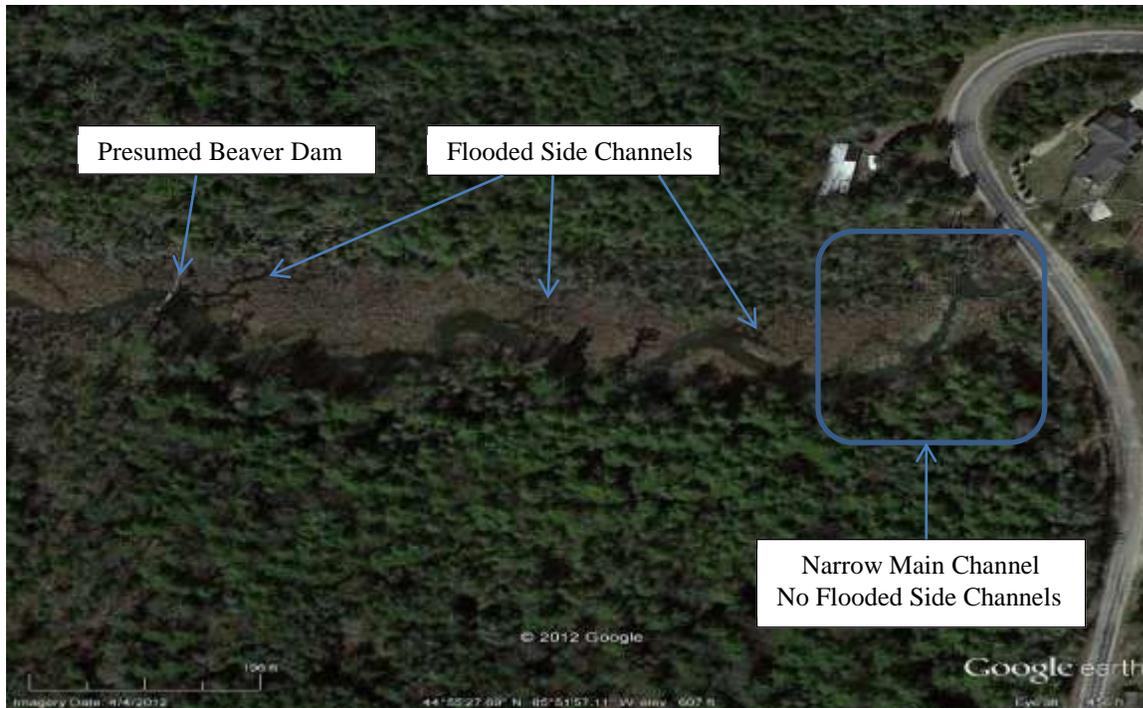
**Figure 3.** Google earth image from 4/4/2012 of Shalda Creek for about 750 feet downstream of LTL (just east of the road). Features to note include a presumed beaver dam and evidence of the resulting backwater effect: a relatively wide main channel and flooded side channels. Also note the relatively narrow main channel and the apparent lack of flooded side channels immediately downstream from LTL.
