# RESERVE STUDY

**The Preserve at Mayfield Ranch**  
**3451 Mayfield Ranch Blvd.**  
**Round Rock, TX**

**Date of Inspection: 12/6/2017**

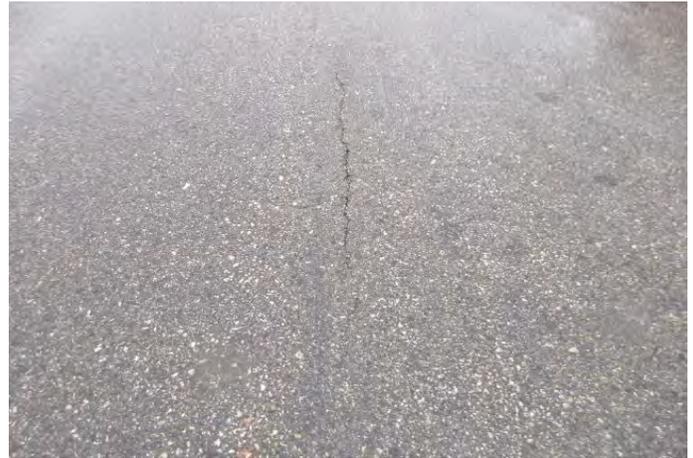
Small pavement crack

Special Conditions
<p>The asphalt pavement comprising the roads and supplemental parking areas are in good condition. We assume the base course was installed at the start of construction of the community and the wear course was installed more recently, possibly even in 2016. We recommend the Association budget for crack repairs, pavement patching and seal coat applications every 5 years beginning by 2021, except for when repaving occurs.</p>

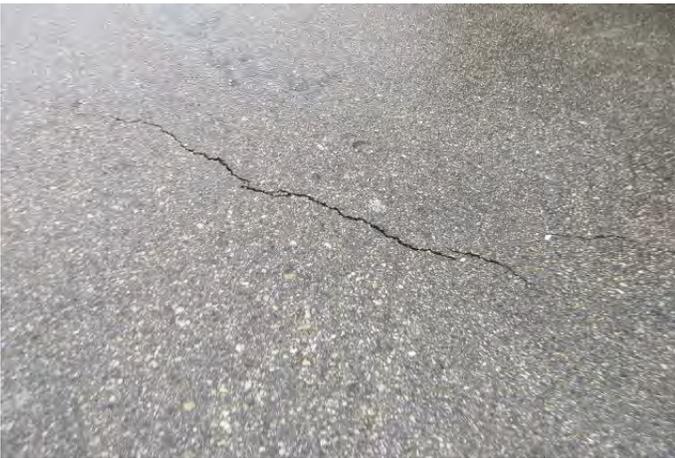
Small pavement crack

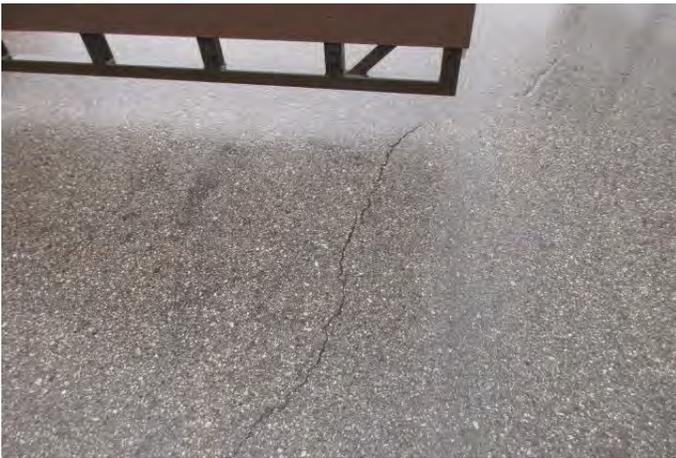
Small pavement crack

Special Conditions
<p>The asphalt pavement comprising the roads and supplemental parking areas are in good condition. We assume the base course was installed at the start of construction of the community and the wear course was installed more recently, possibly even in 2016. We recommend the Association budget for milling of the top 2 inches of pavement, base and wear course repairs, and overlayment of the pavement by 2034.</p>

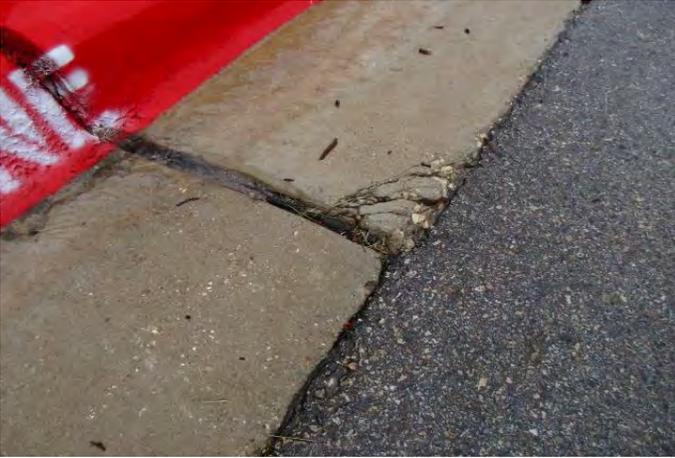
Cracked gutter

Special Conditions
<p>Concrete curbs and gutters line the streets throughout the community. Our present quantity includes the concrete ribbon curb on the east side of Sendero Spring Drive. We observe hairline cracks at the curbs and gutters and recommend the Association budget for replacement of up to 8.3% of the curbs and gutters by 2026, 2034 and 2044, in coordination with pavement repairs or mill and overlayment, due to their interrelated nature.</p>

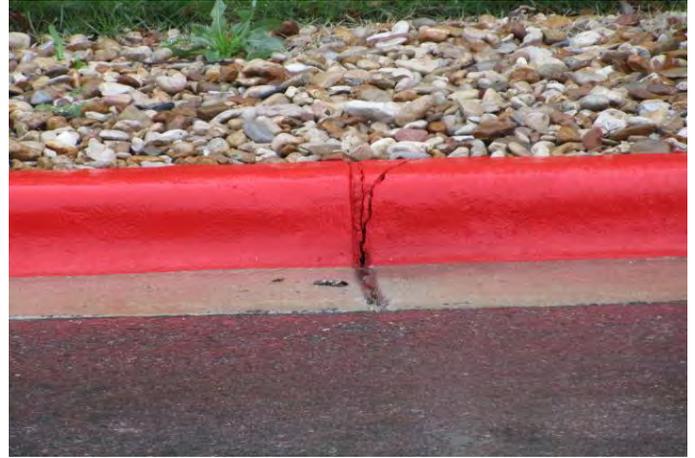
Cracked curb

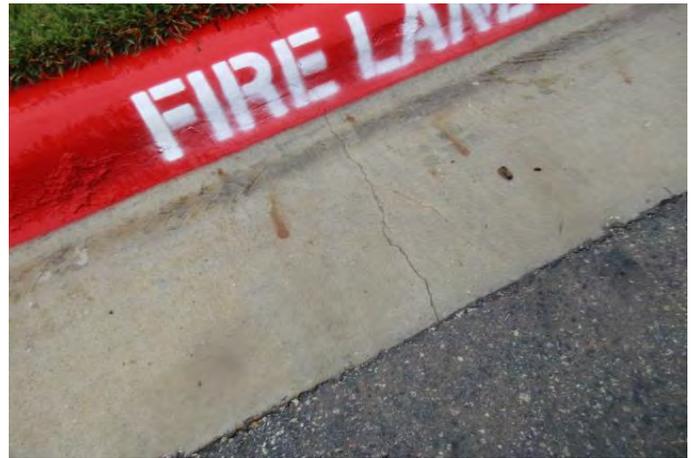
Cracked gutter

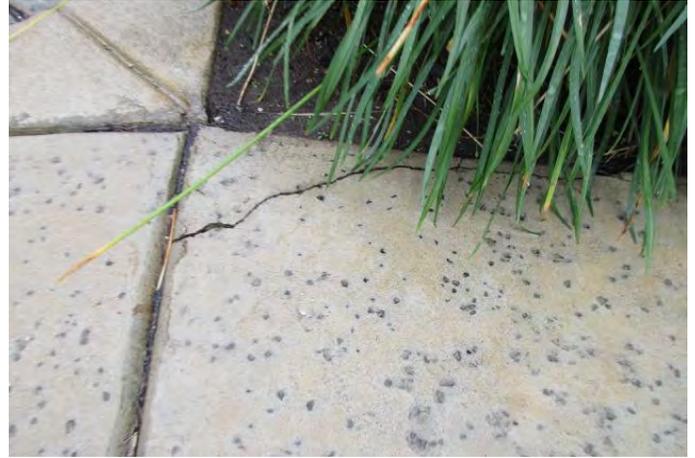
Cracked and spalled concrete sidewalk

Special Conditions
Limited locations of concrete sidewalks are located at the pool house, the community entrance and at the supplemental parking areas. The concrete is in good overall condition. We recommend the Association budget to replace up to 35% of the concrete sidewalks by 2034, in coordination with the street repaving project.

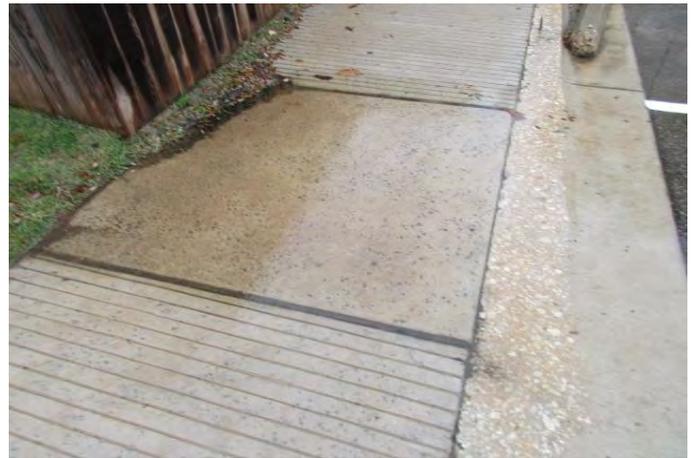
Low area at sidewalk that collects water

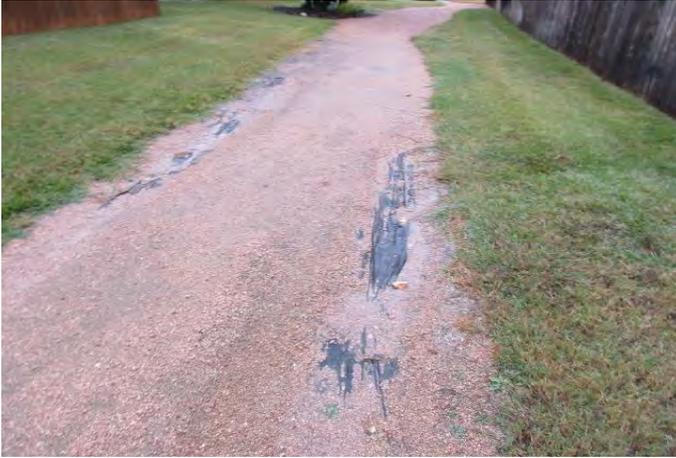
Eroded decomposed granite

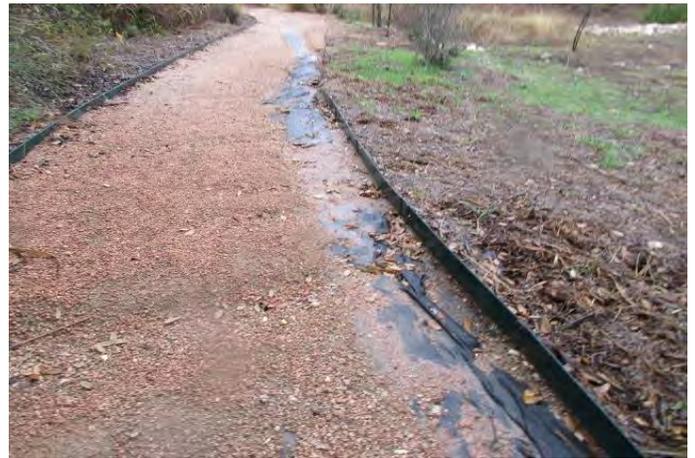
Erosion at path

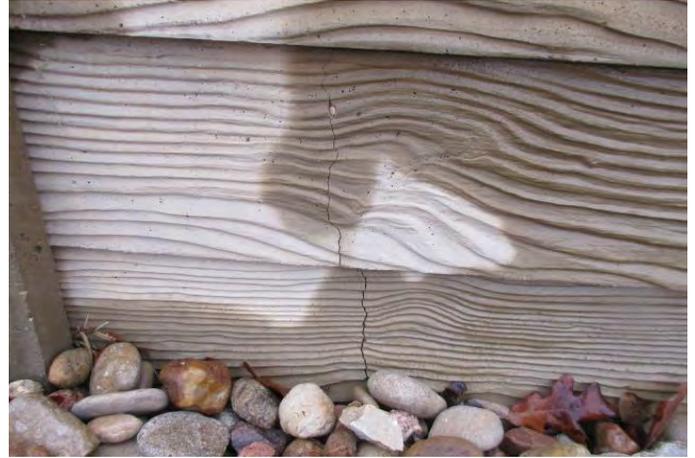
Crack at wall

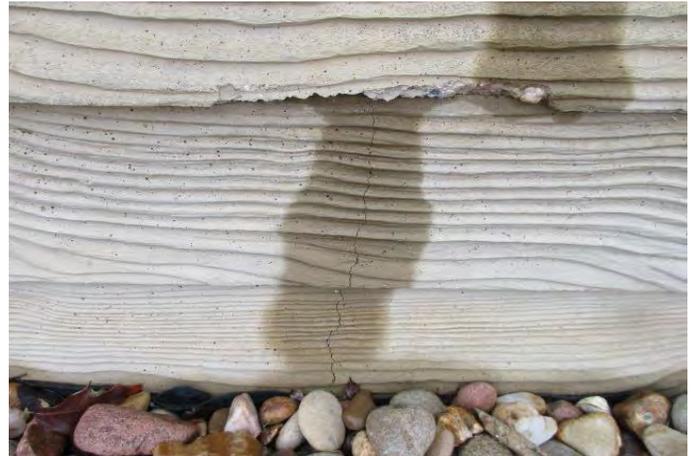
Crack at wall

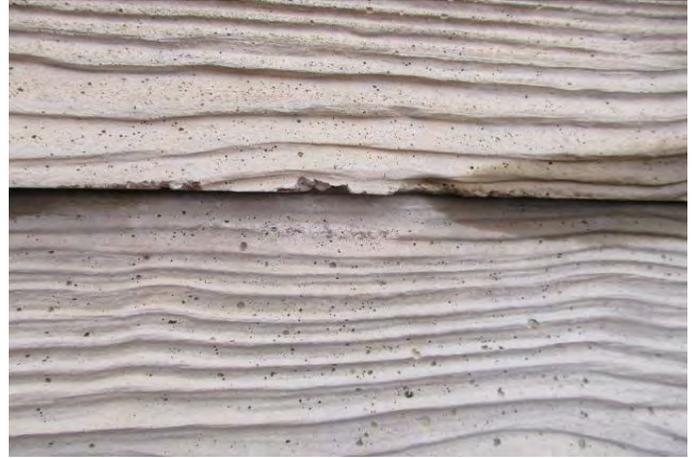
Deterioration of panel edge

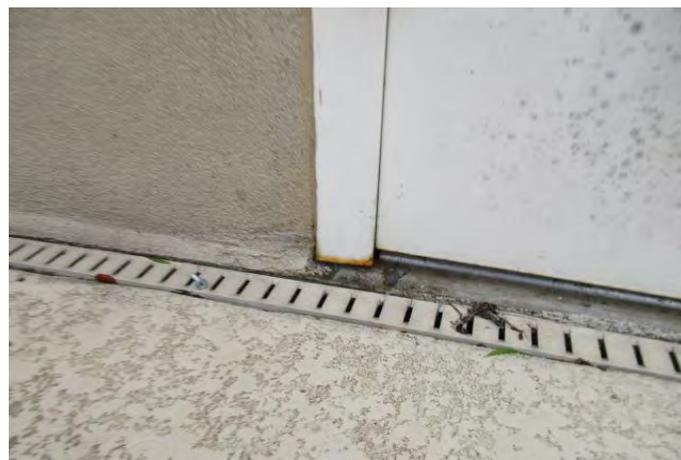
Rust at metal door frame

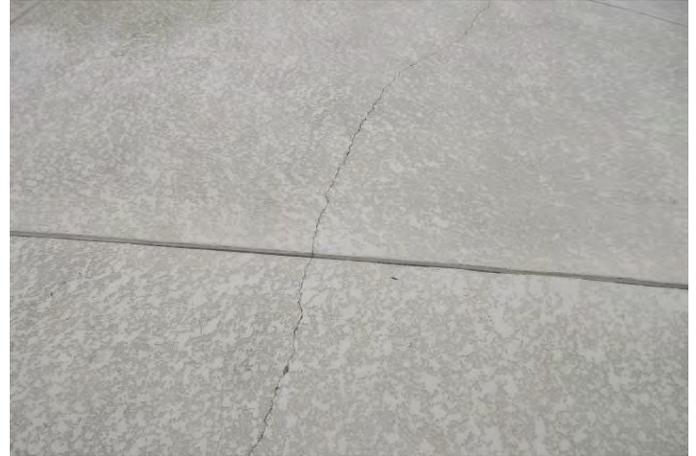
Pool deck coating crack

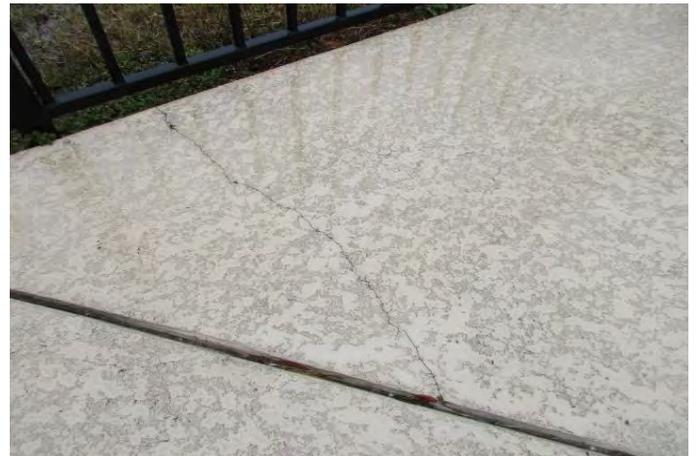
Crack at pool deck coating

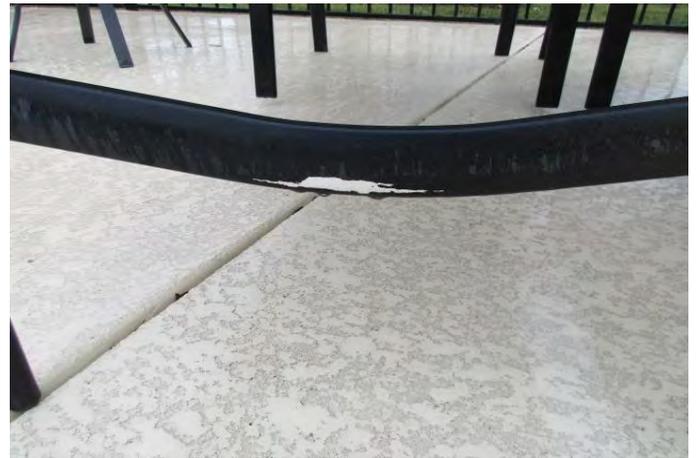
Finish deterioration at metal frame
