Preliminary Engineering Report  
Water System Improvements  
Florida River Estates Homeowner's Association, Durango,  
Colorado  
PWSID No. CO0134300  
July 9, 2019

Prepared By:  
Goff Engineering & Surveying Inc.  
126 Rock Point Drive  
Durango, Colorado 81301  
Phone: (970) 247-1705  
Project Engineer: Robert Harries, P.E.  
Project Number: 17-195

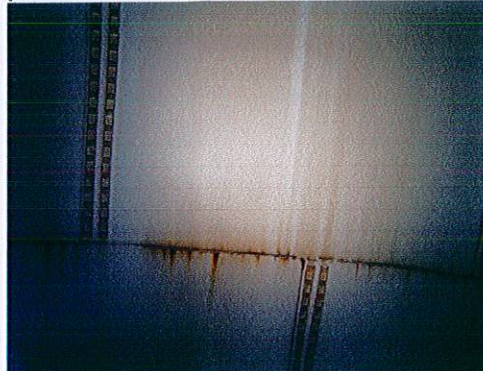
7. Interior sidewalls: Structural deficiencies, biofilm, sealant loss, any irregularities or other failure?	<input type="checkbox"/> Y <input checked="" type="checkbox"/> N		<b>Observed no film. Shell in good condition.</b>

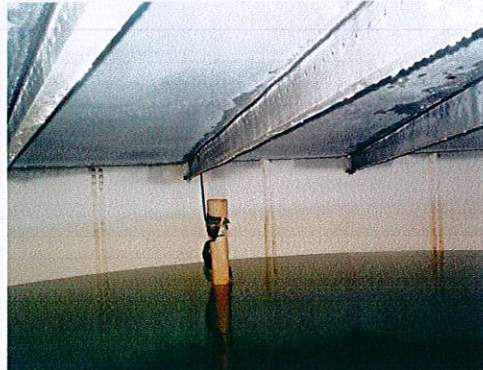
9. Interior hatch: Structural deficiencies, any irregularities or other failure?	<input type="checkbox"/> Y <input checked="" type="checkbox"/> N		<b>Tank has no roof hatch. Removed vent for access.</b>

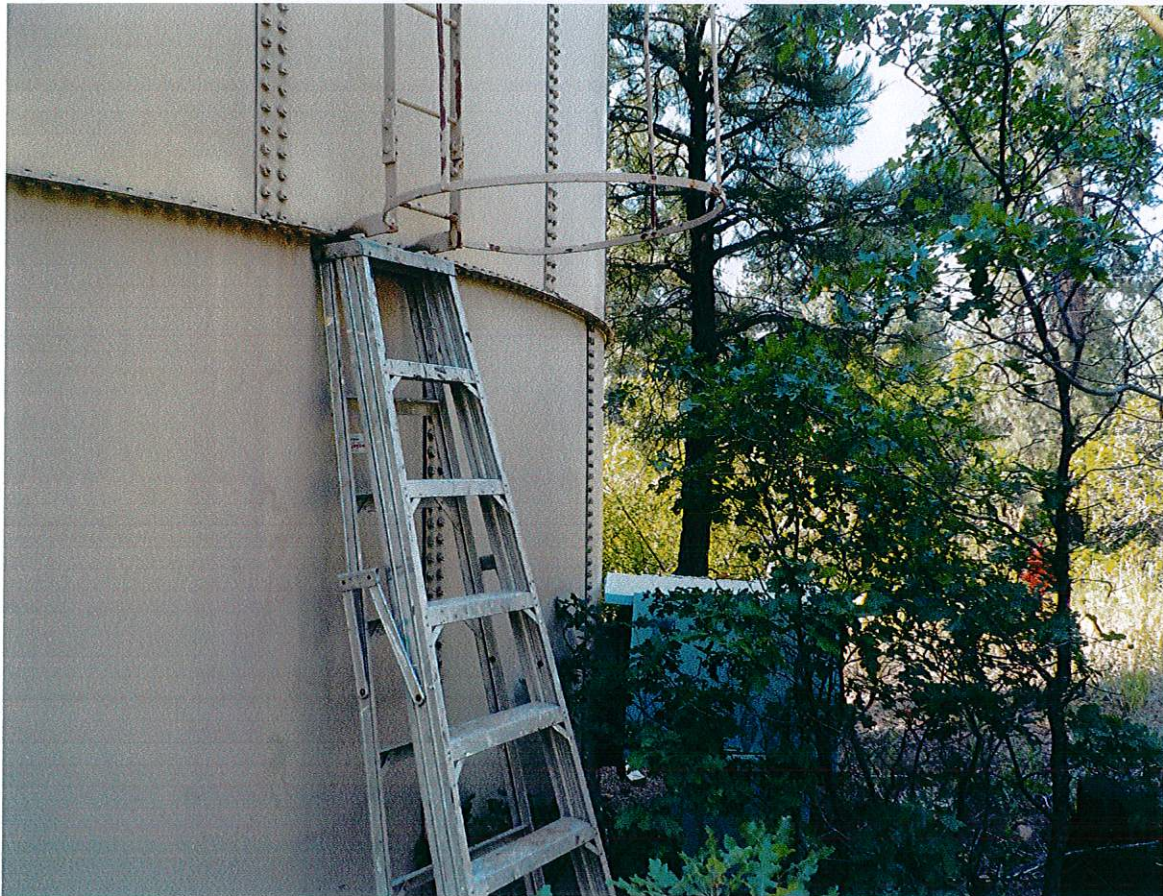
Exterior paint condition is good on the shell surface. Observed spot area's of light surface rust and peeling paint on the upper ring wall, next to the ladder.

Recommendations: We recommend cathodic protection be installed to control corrosion at the shell bolted seams. We recommend the installation of a roof hatch. The roof vent removal for entry is an unsafe entry method. The external ladder handrails need to be extended 3' above the landing surface. CW Divers can provide these recommended improvements. Inspect the reservoir in 4 years. For any questions regarding this inspection, contact Bill Donohue at 505-330-2531.

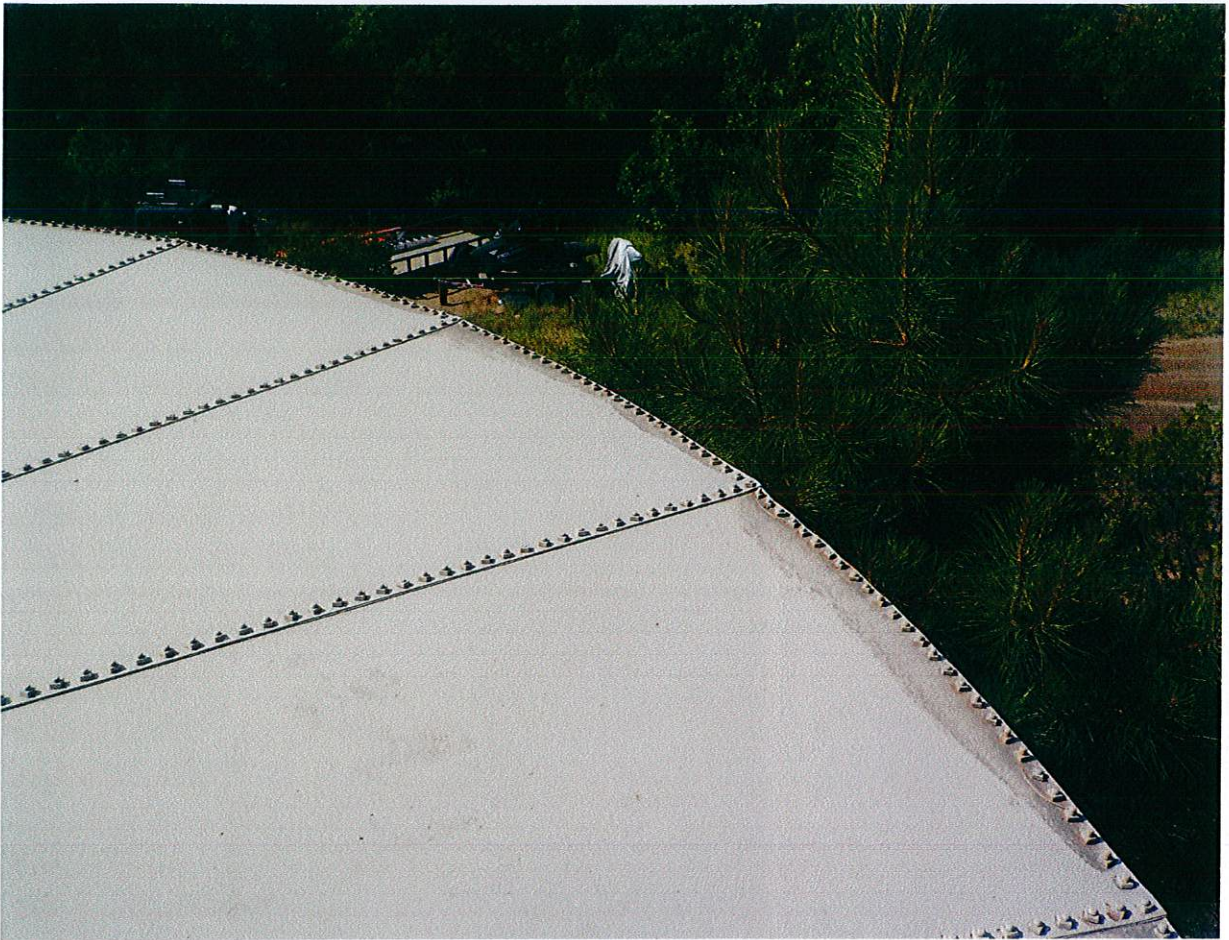
The roof is in good condition, no rust or peeling paint.

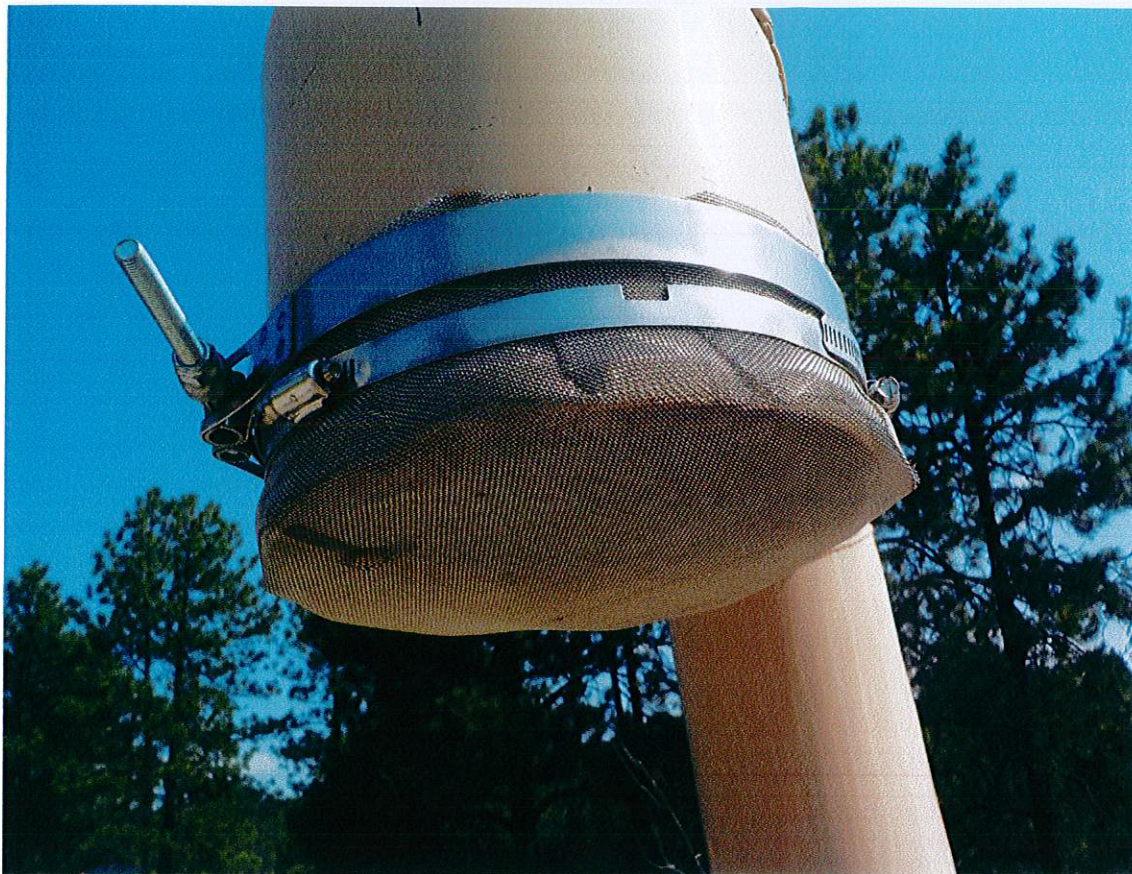
Vent screen is in place, securely fastened.

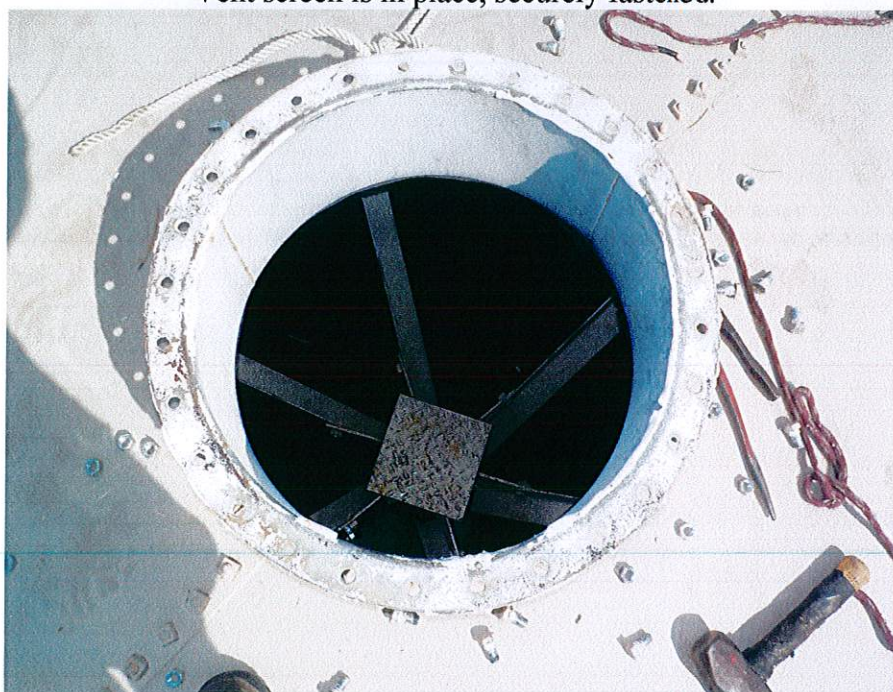
Removal of the vent is required to allow interior access

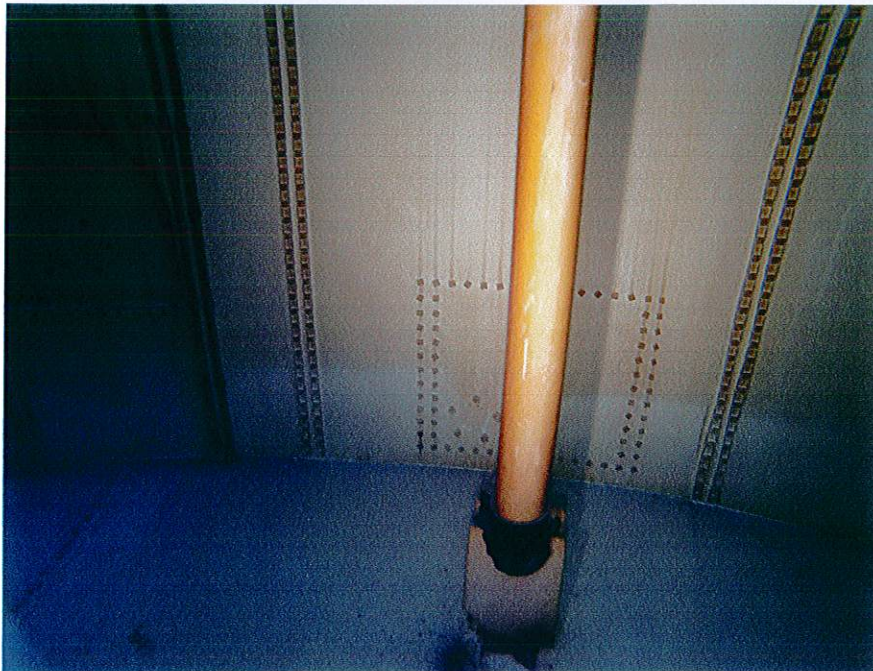
The overflow is PVC, piped thru the bolted shell

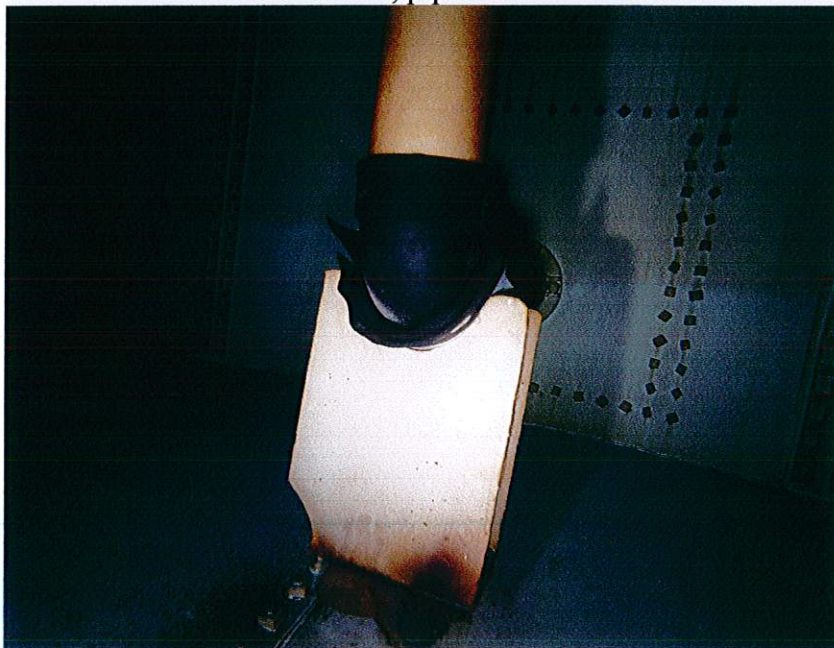
Bottom of overflow supported by a rock

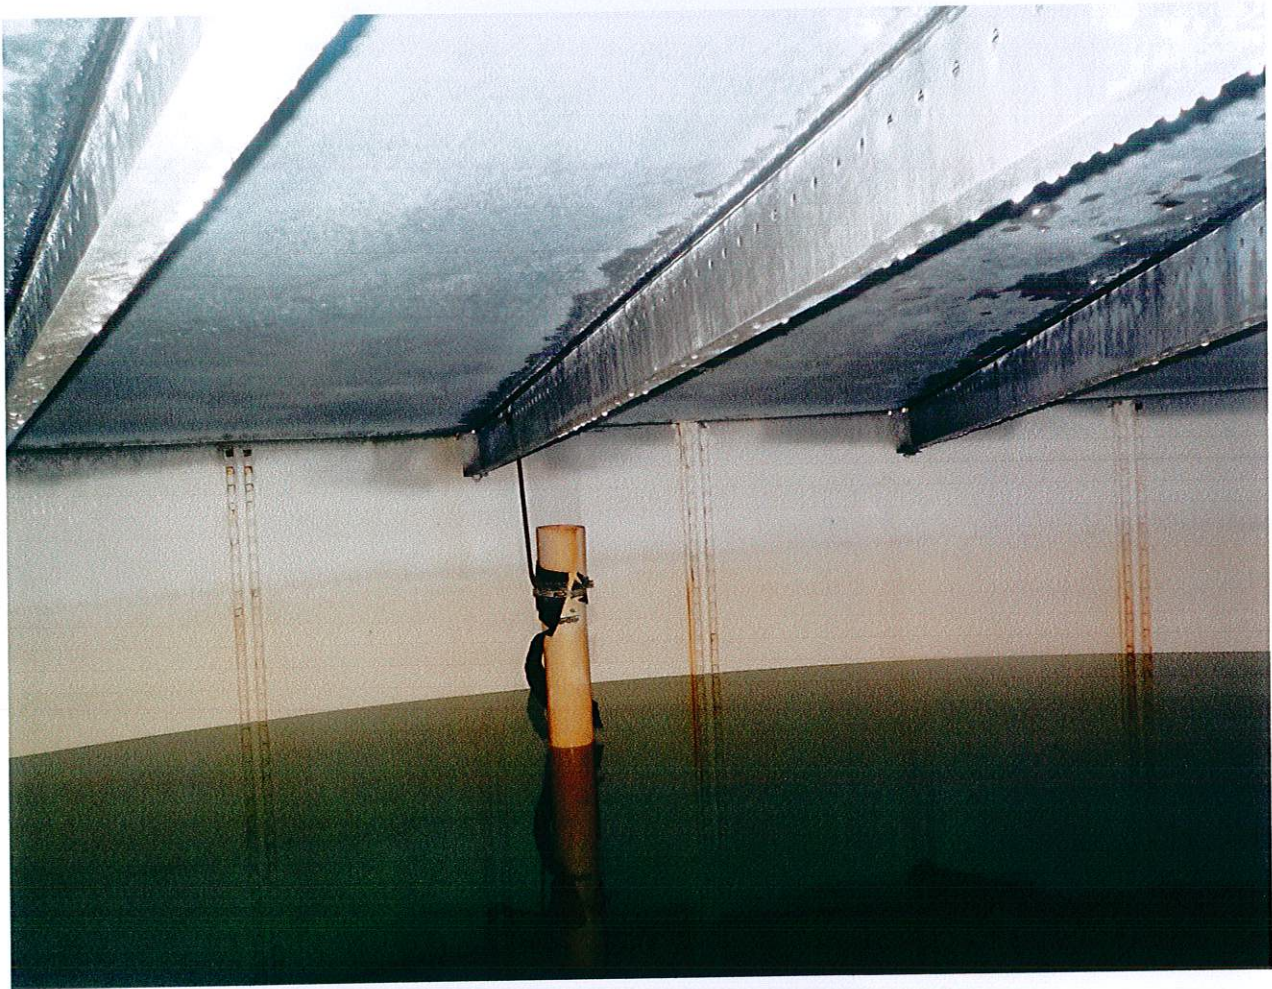
Rafters and ceiling plates are galvanized in good condition

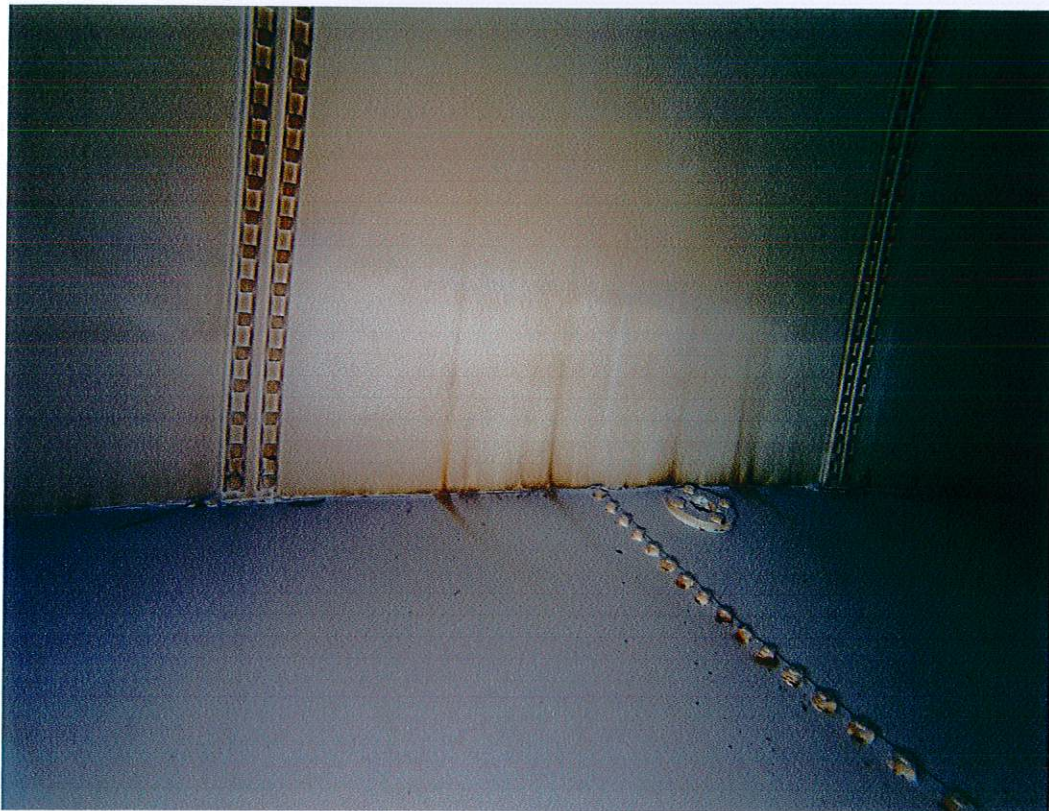
Minor corrosion at floor/shell area. Drain on floor.

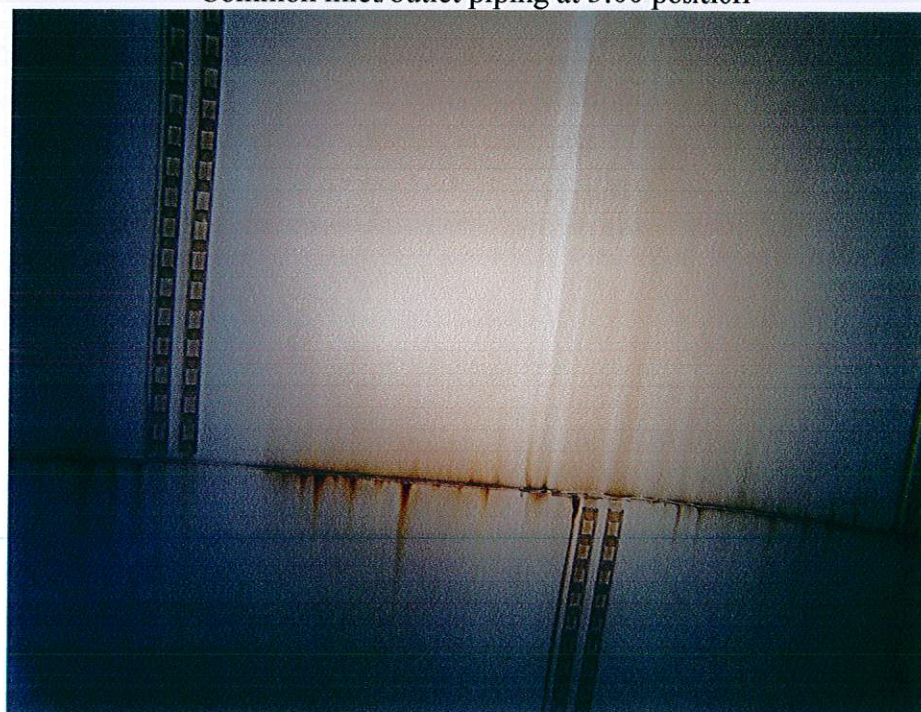
Minor corrosion on shell

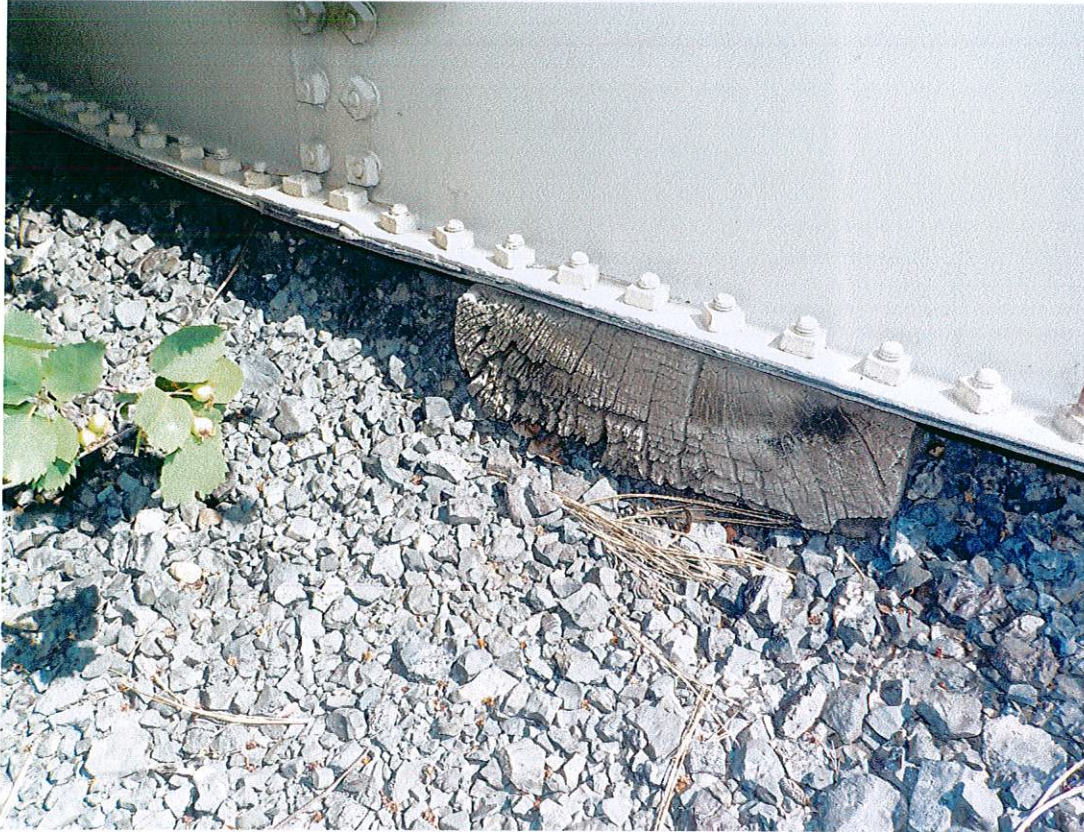
Wood skids for floor support
