Section 11.28 Storage Tank Rule Regulation No. 11 (5 CCR 1002-11) Comprehensive Inspection Checklist

System Name & PWSID:	Florida River Estates
Inspection Date:	06/22/2017
Inspector's Name:	Charles "Bill" Donohue NACE Inspector #763
Inspector's Phone:	1-505-330-2531
Inspector's Email:	CWDIVERS@MSN.COM
SDWIS Tank Name:	Main Tank
SDWIS Facility State ID:	CO-134300
Inspection Start & Finish Time [±] :	
Tank level [±] :	
Weather conditions [±] :	
List Sanitary Defects Identified by Inspection Item # (which are in bold)*:

RE: 100K gallon Main Tank, CO-134300 ROV Inspection

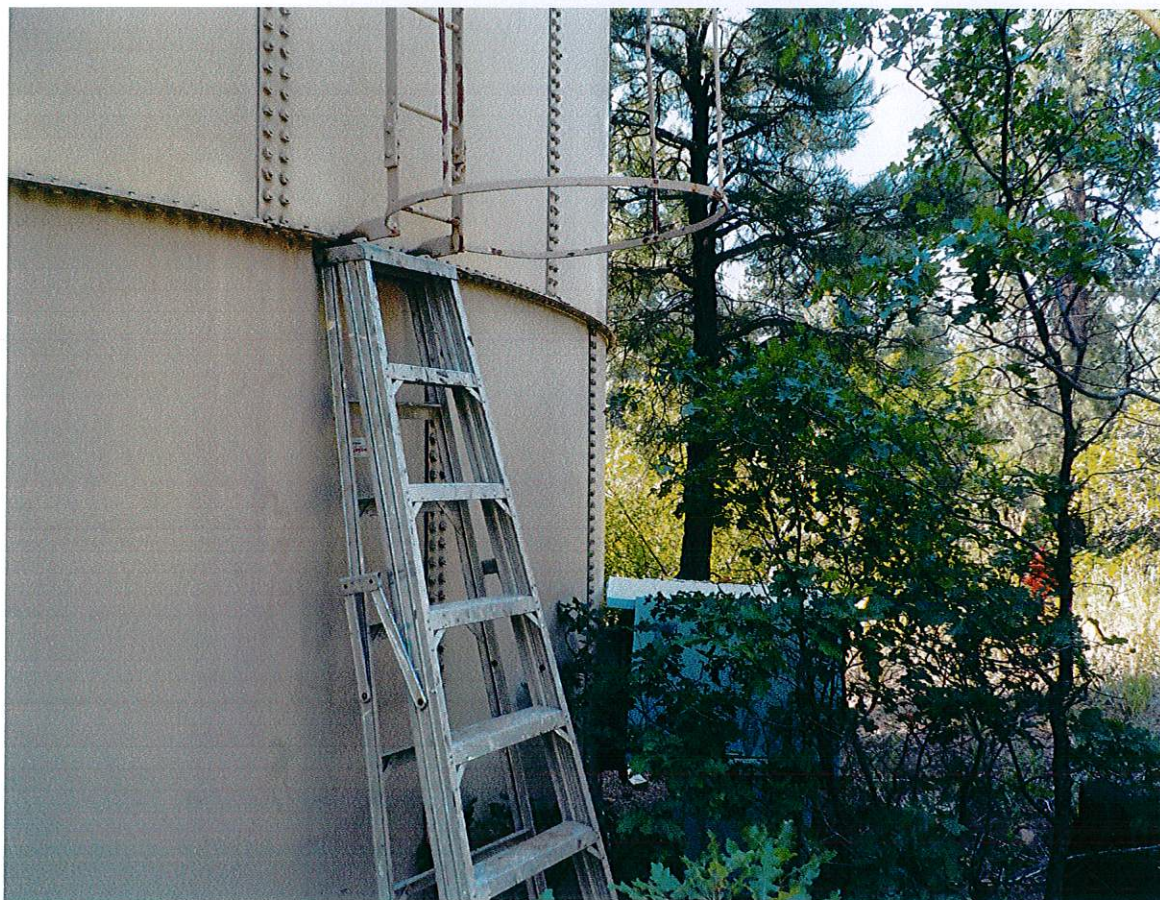
Exterior paint condition is good on the shell surface. Observed spot area's of light surface rust and peeling paint on the upper ring wall, next to the ladder.

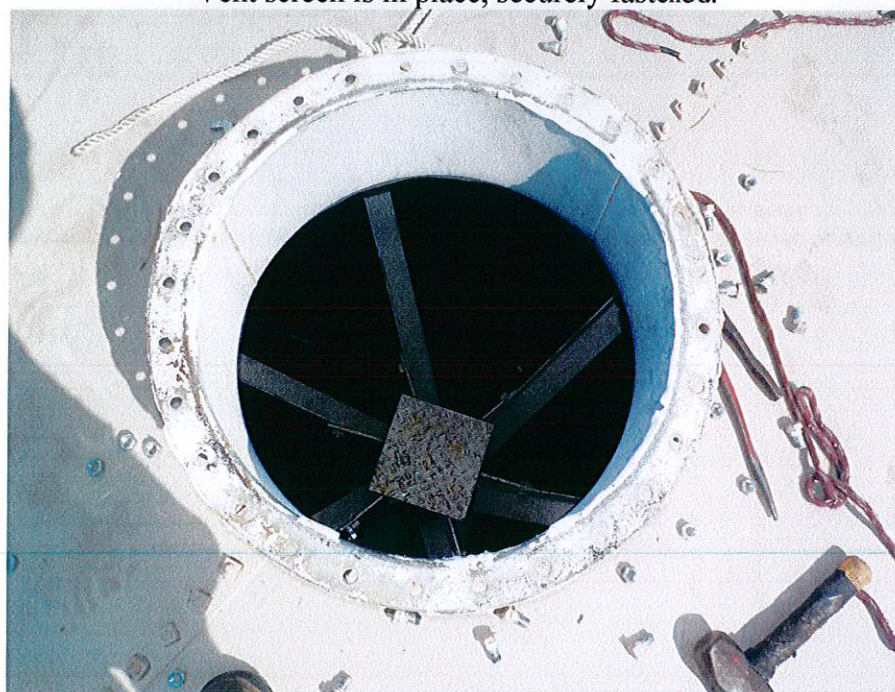
Removal of the vent is required to allow interior access

Recommendations: We recommend cathodic protection be installed to control corrosion at the shell bolted seams. We recommend the installation of a roof hatch. The roof vent removal for entry is an unsafe entry method. The external ladder handrails need to be extended 3' above the landing surface. CW Divers can provide these recommended improvements. Inspect the reservoir in 4 years. For any questions regarding this inspection, contact Bill Donohue at 505-330-2531.

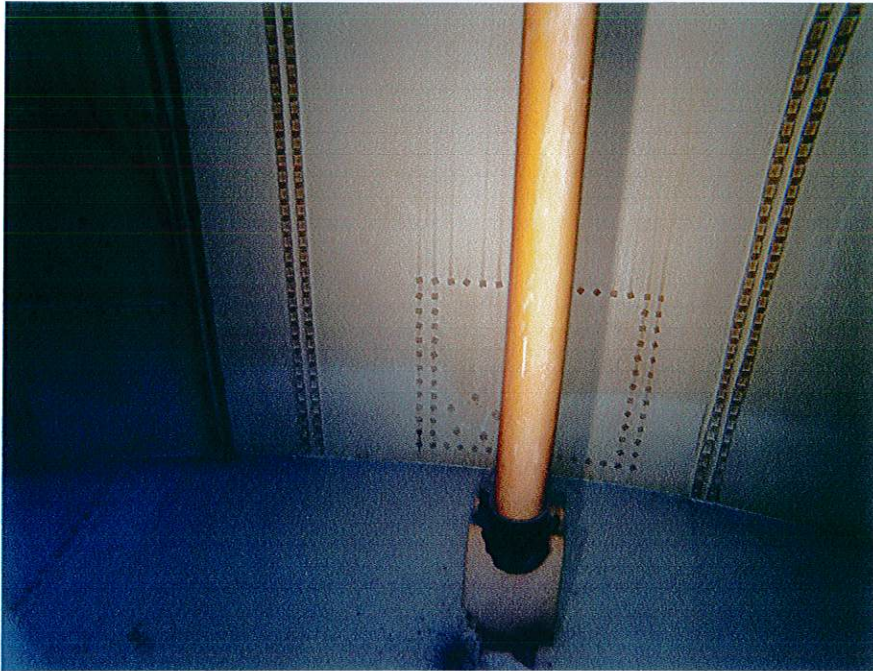
The overflow is PVC, piped thru the bolted shell

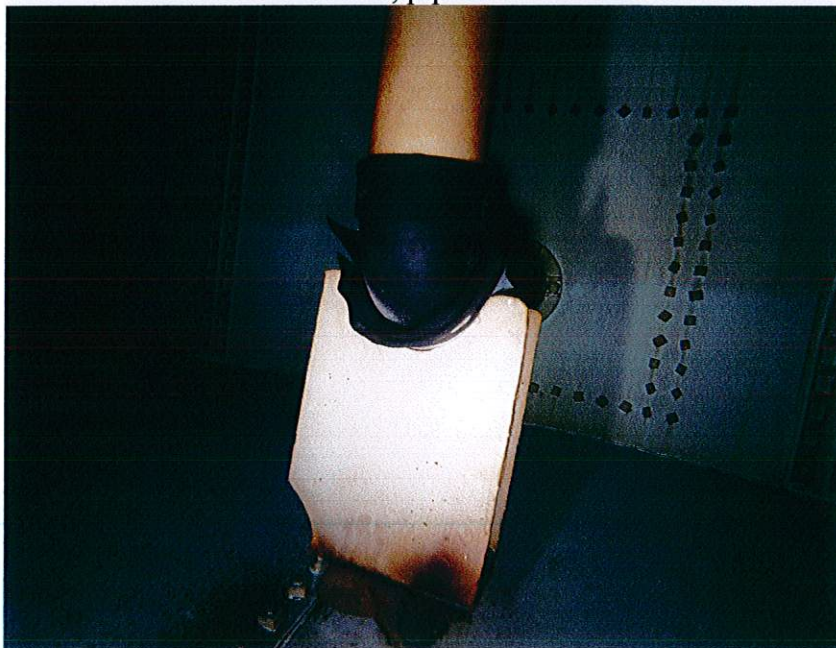
Bottom of overflow supported by a rock

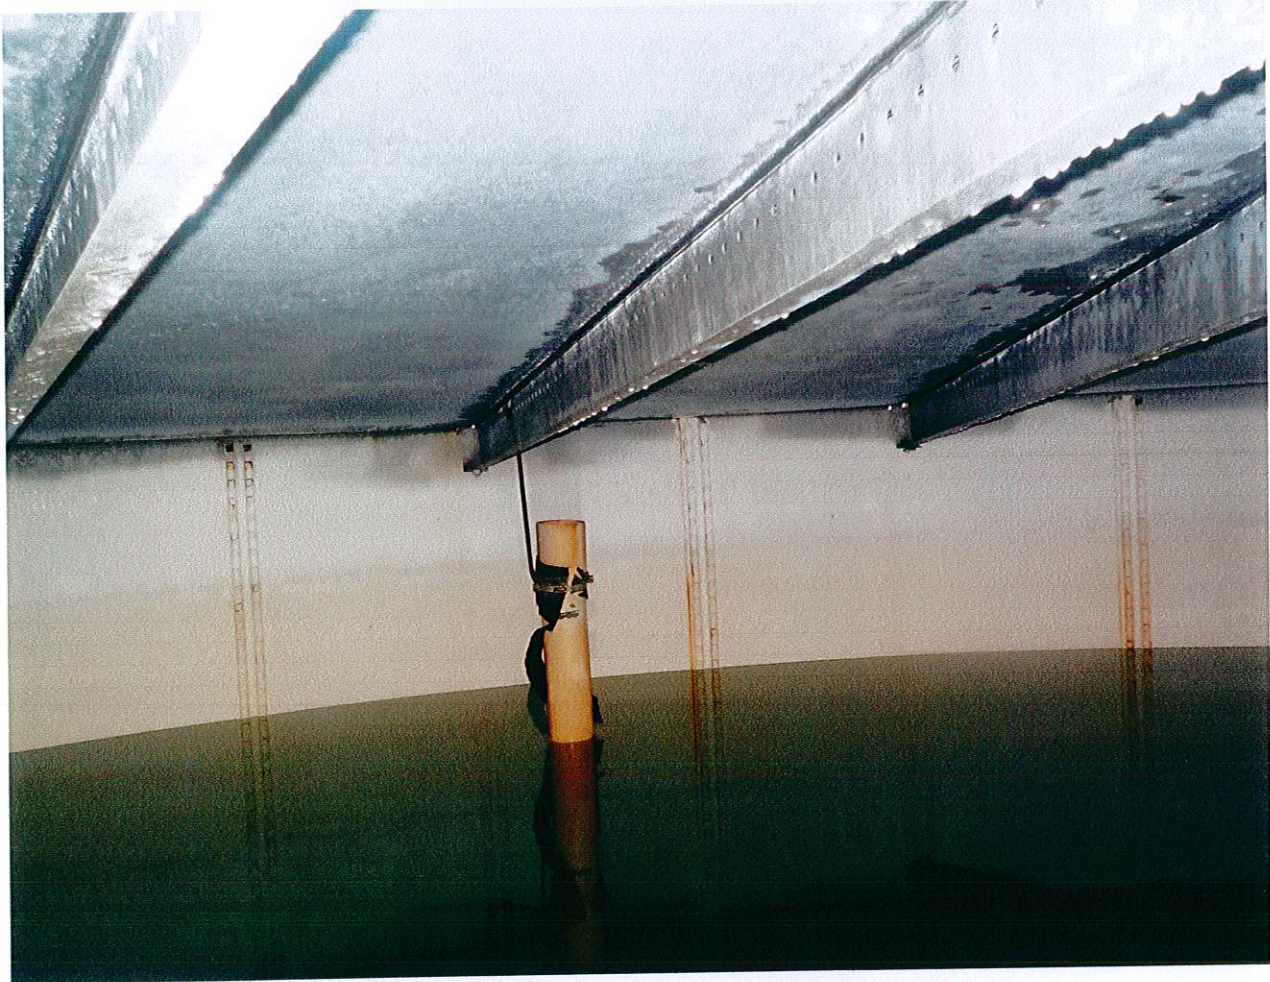
Rafters and ceiling plates are galvanized in good condition

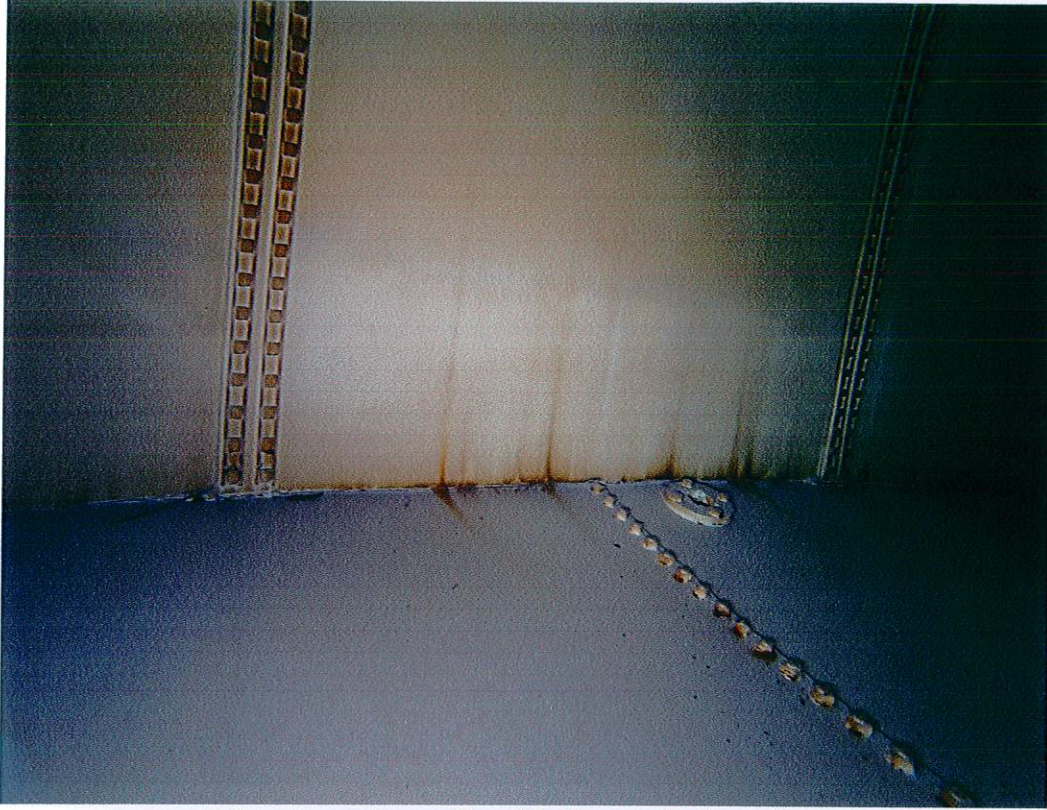
Minor corrosion at floor/shell area. Drain on floor.

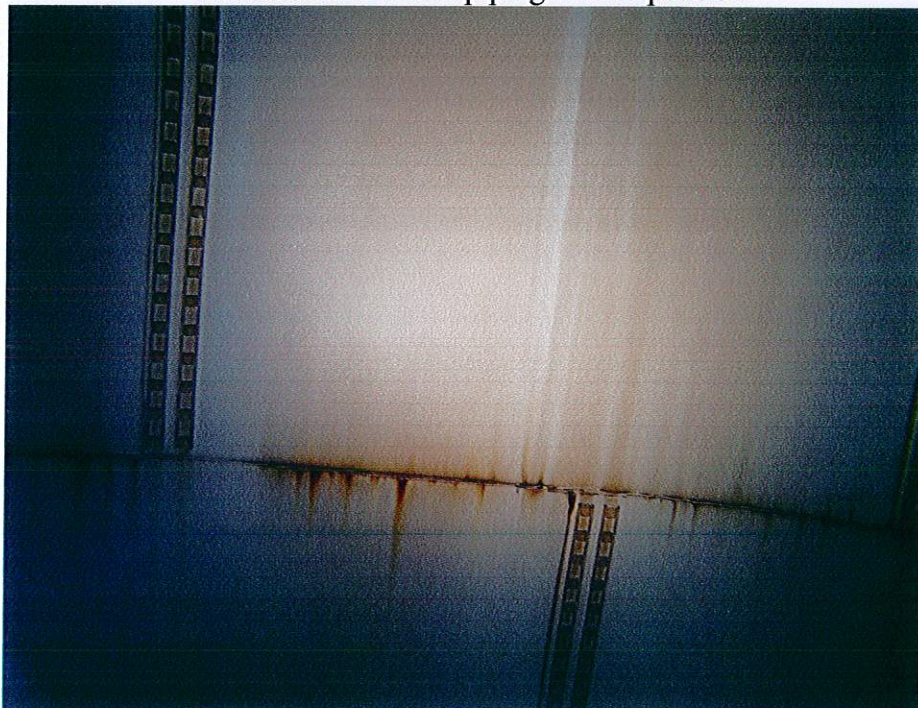
Minor corrosion on shell

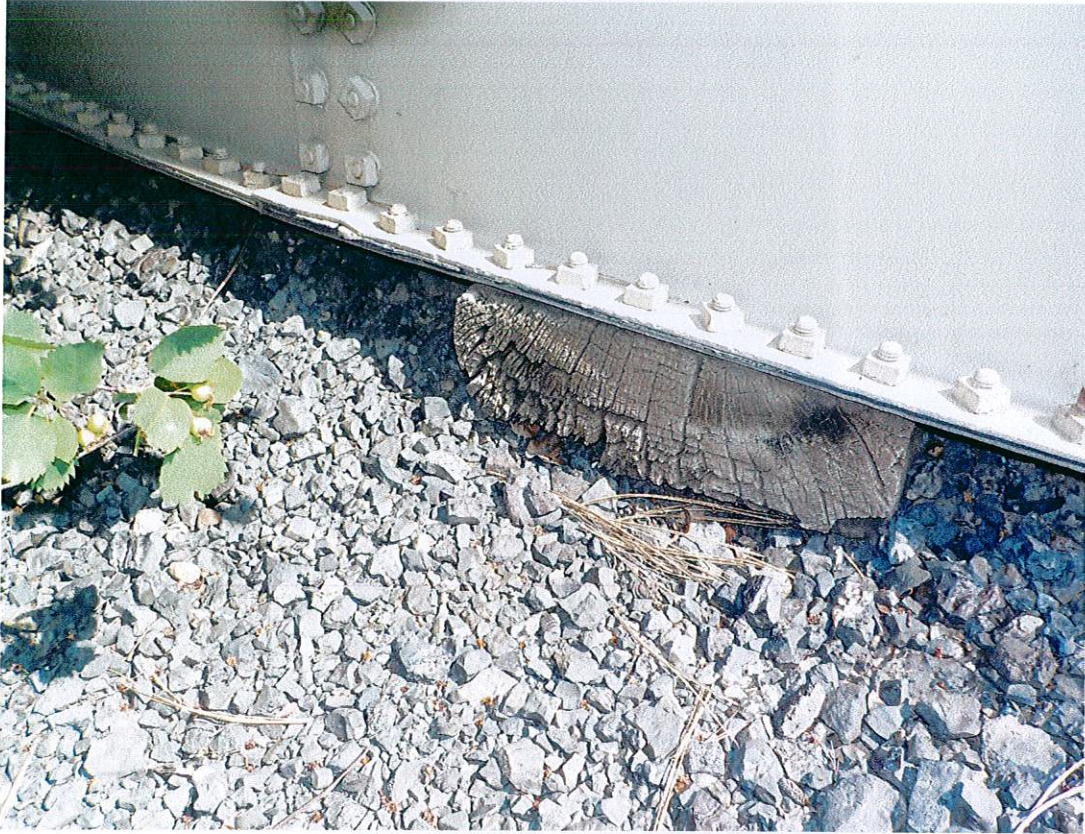
Wood skids for floor support
