February 14th, 2024

Re: Watersedge H Condominium
Structural Integrity Reserve Study (SIRS)
15461 Pembridge Drive
Delray Beach, Florida 33484
UES Project No: 6011.2300191.0000

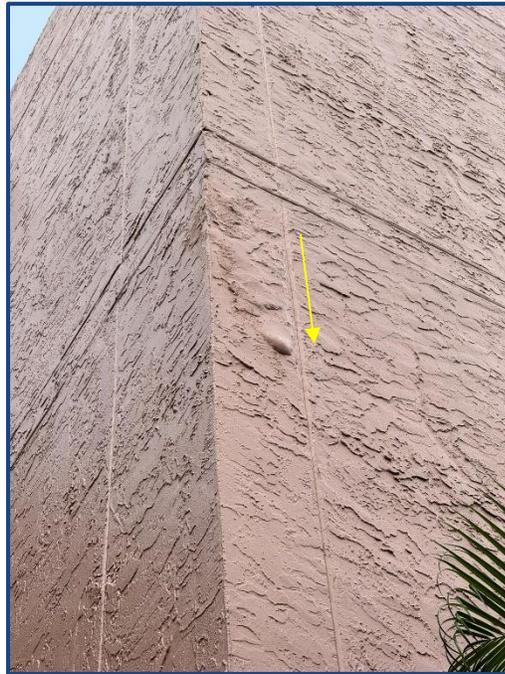
- Spalling/cracking observed at several areas within the building's catwalks/corridors and unit balconies. While these areas are not substantial at the time of inspection, continued exposure to the elements will further deteriorate these areas and expand the spalling/cracking observed. See Appendix B photographs 9 and 19-26.

Photograph No. 9: Blistering paint observed at building edge.

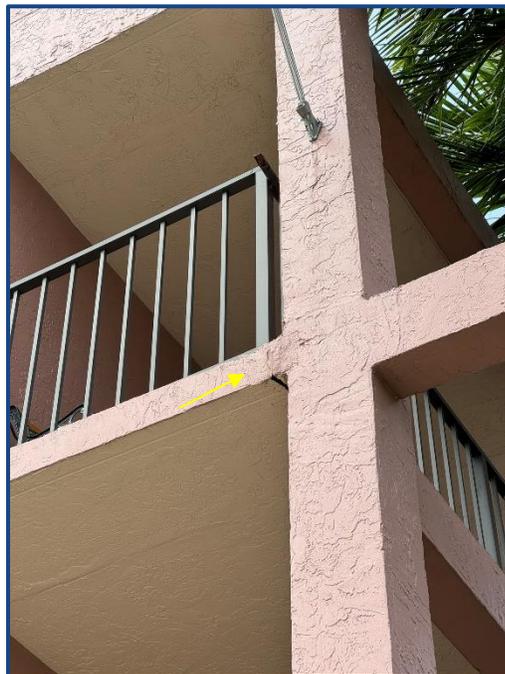
- Deteriorated expansion joint observed near the elevator on several floors. Deteriorated expansion joint allows water intrusion into the reinforcement along the concrete edge which with time compromises the strength of the section. See Appendix B photographs 10 and 11.

Photograph No. 10: Deteriorated expansion joint observed at 3rd floor near elevator.

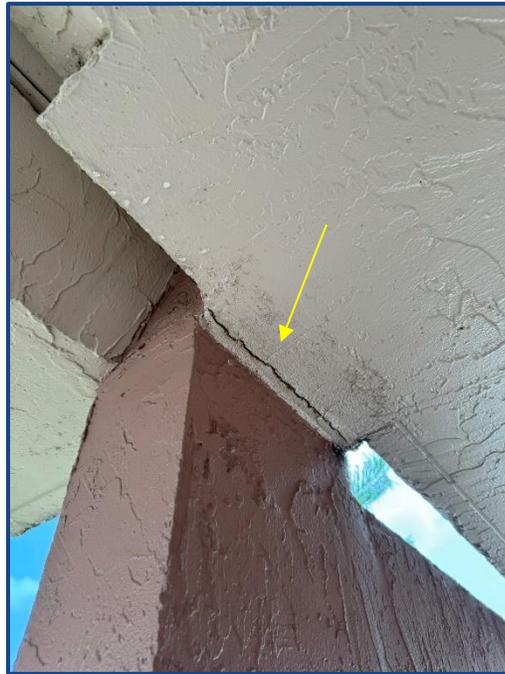
Photograph No. 11: Deteriorated expansion joint observed at 3rd floor near elevator.

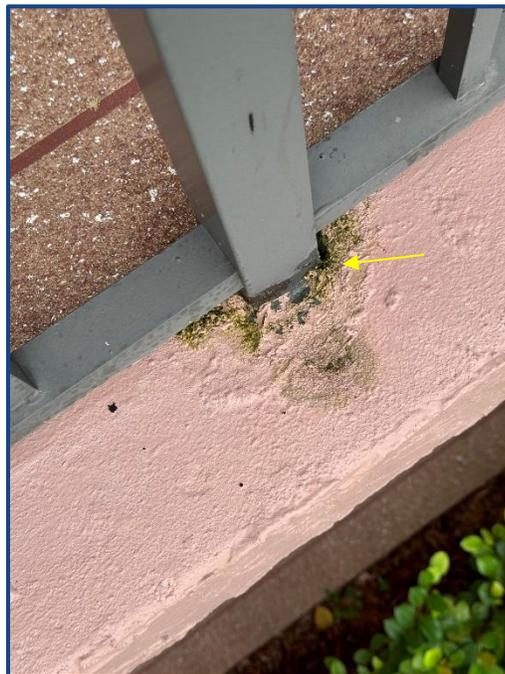
- Damaged railing post pockets were observed at several locations along the building's catwalks/corridors. A significant portion of the building's railing system exhibited signs of water intrusion within the pocket. This creates a condition where mold can accumulate and then the water percolates into the concrete slab causing corrosion, spalling, cracking, and other damages. See Appendix B photographs 12-17.

Photograph No. 12: Deteriorated railing post pocket observed near unit 208.

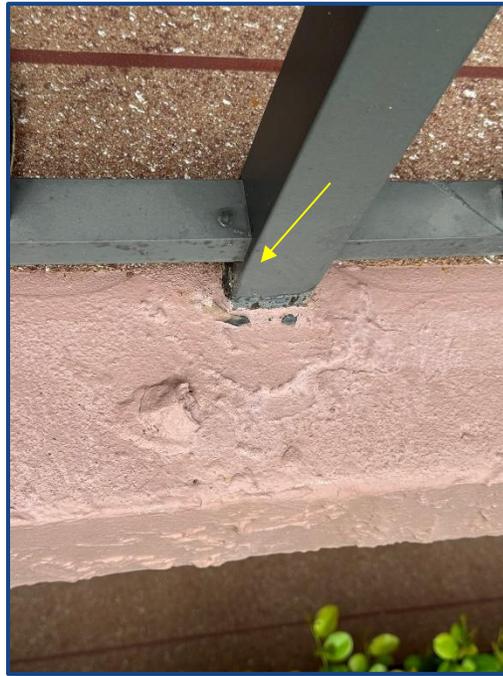
Photograph No. 13: Deteriorated railing post pocket observed near unit 208.

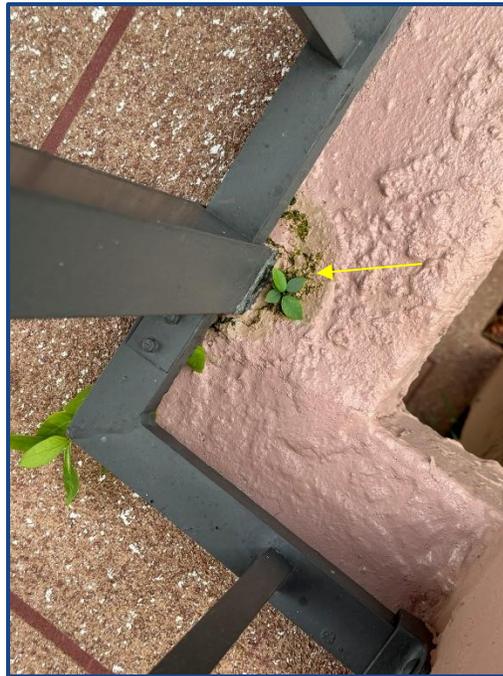
Photograph No. 14: Deteriorated railing post pocket observed near unit 208.

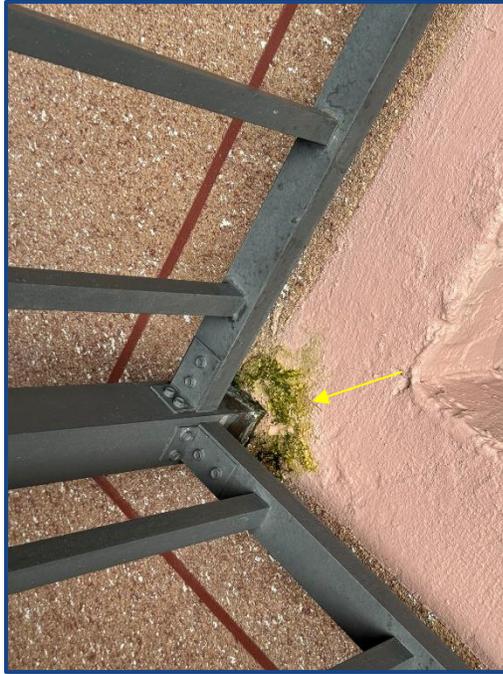
Photograph No. 15: Deteriorated railing post pocket observed near unit 213.

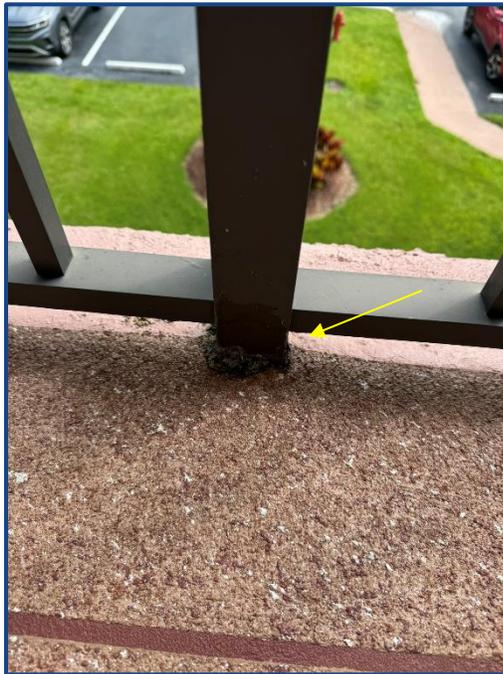
Photograph No. 16: Deteriorated railing post pocket observed near unit 310.

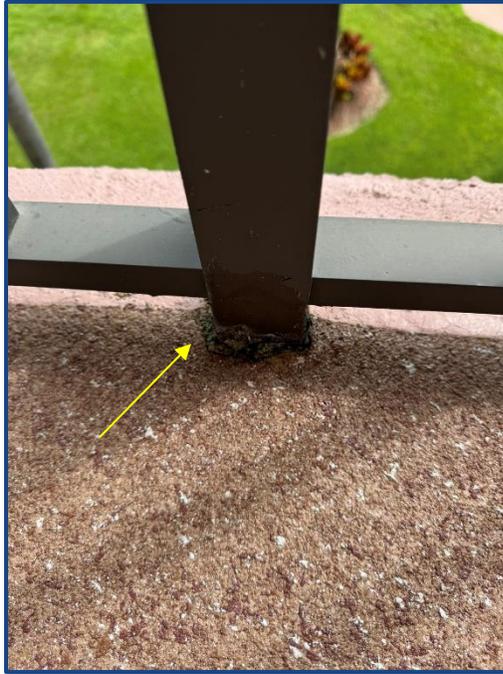
Photograph No. 17: Deteriorated railing post pocket observed near unit 310.

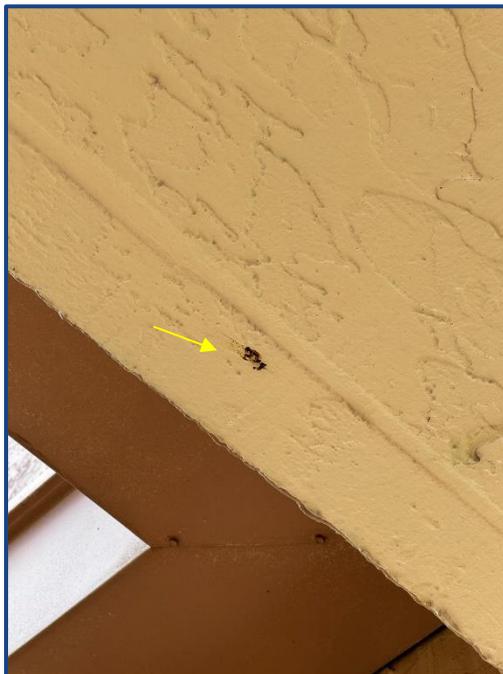
Photograph No. 18: Rust spot observed overhead near unit 310.

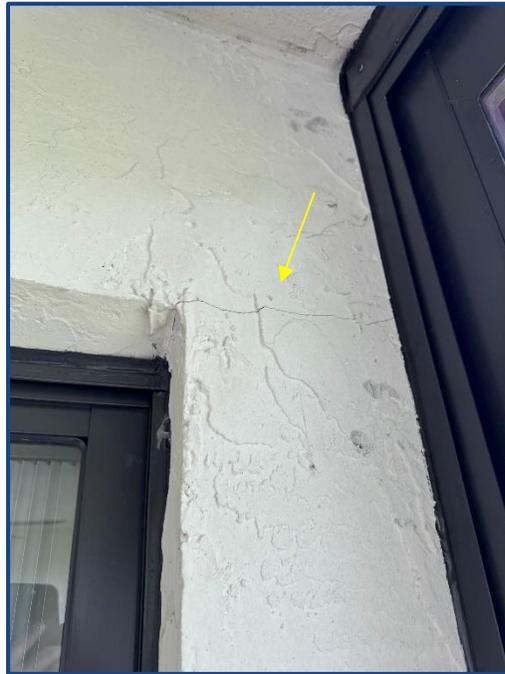
Photograph No. 19: Unit 108: Wall cracking observed near unit sliding glass door.

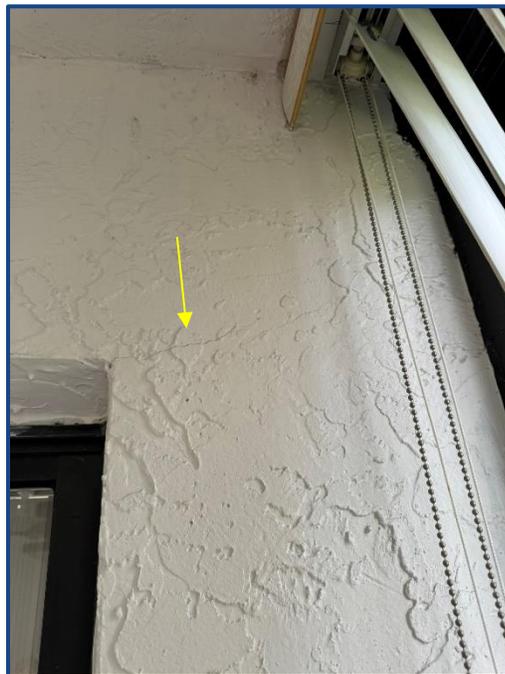
Photograph No. 20: Unit 106: Wall cracking observed near unit sliding glass door.

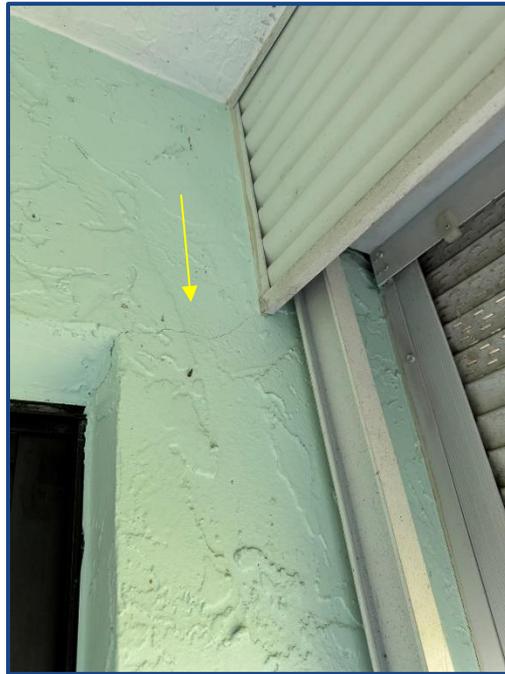
Photograph No. 21: Unit 104: Wall cracking observed near unit sliding glass door.

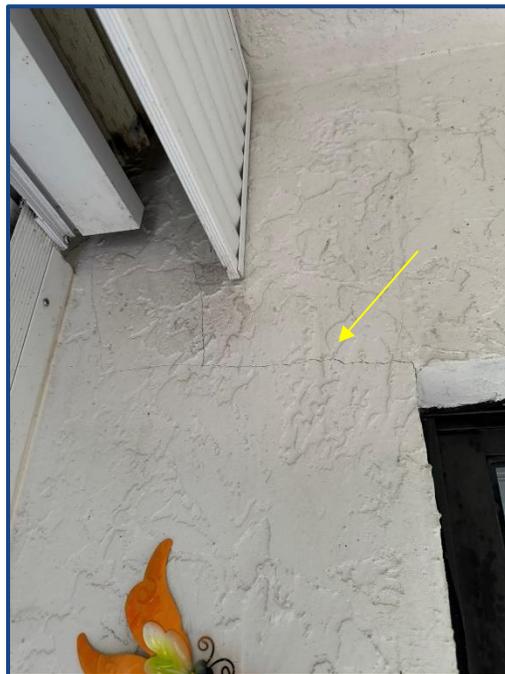
Photograph No. 22: Unit 103: Wall cracking observed near unit sliding glass door..

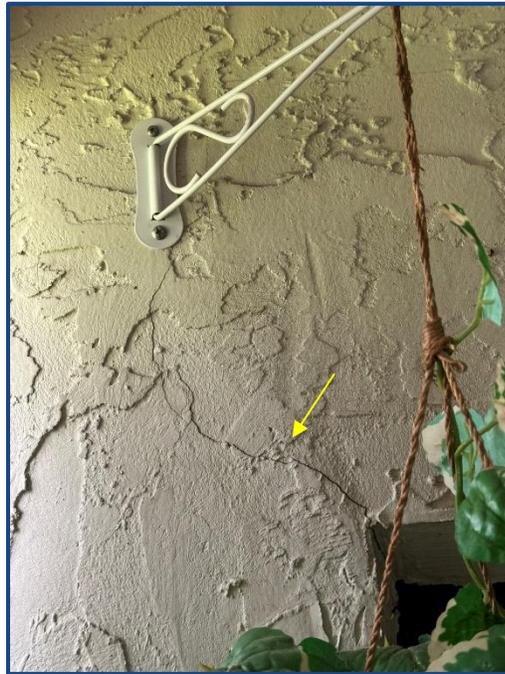
Photograph No. 23: Unit 101: Wall cracking observed near unit sliding glass door.

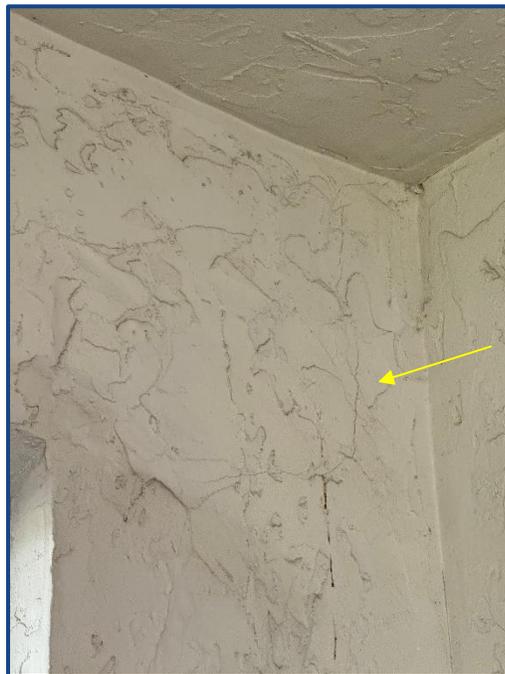
Photograph No. 24: Unit 101: Wall cracking observed near unit sliding glass door.

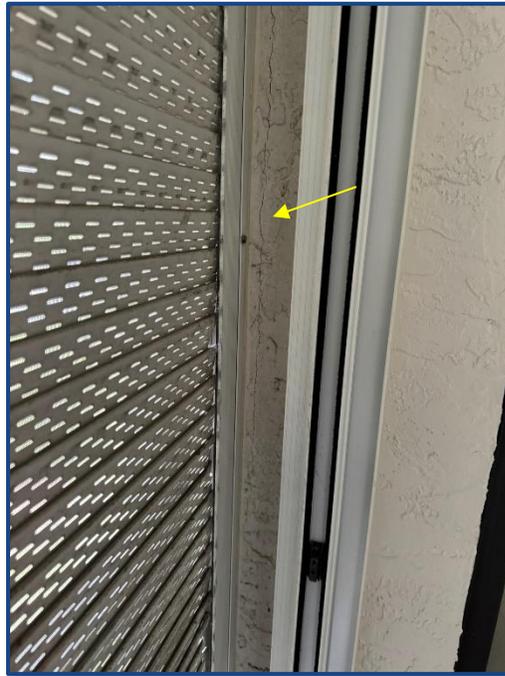
Photograph No. 25: Unit 205: Wall cracking observed near balcony enclosure.

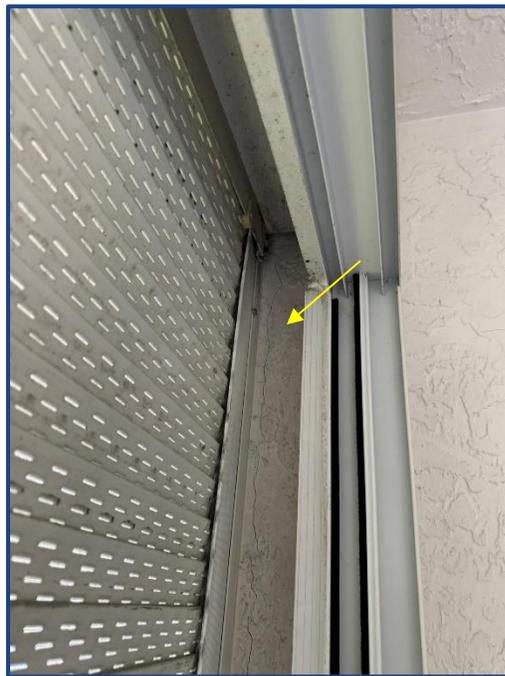
Photograph No. 26: Unit 205: Wall cracking observed near balcony enclosure.

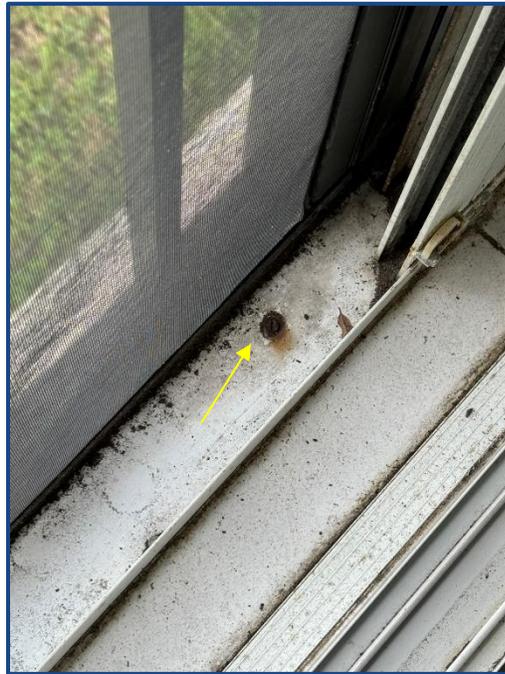
- Deteriorated/rusted fasteners observed at unit 205's aluminum enclosure bottom rail. Several other fastener heads were rusting within the unit balconies. See Appendix B photograph 27.

Photograph No. 27: Unit 205: Deteriorated fasteners observed at aluminum enclosure bottom rail.

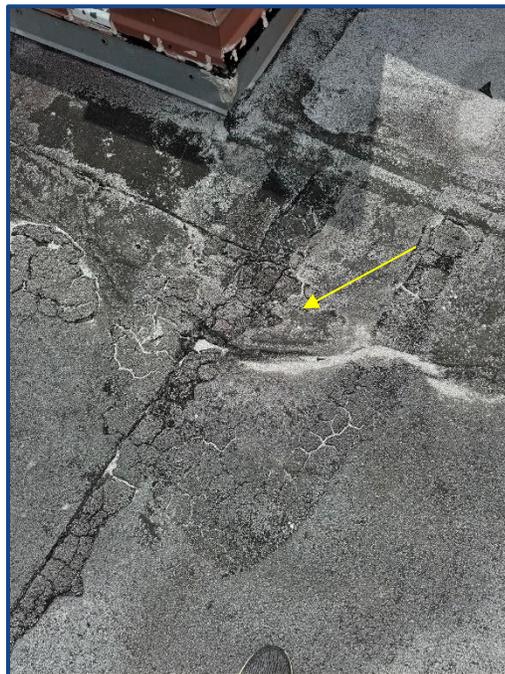
- The roof is in fair condition with ponding and damaged areas observed on the roof. Evidence of previous ponding was observed at the time of inspection. Several areas of the roof were cracked and blistering. See Appendix B photographs 28-31.

Photograph No. 28: Cracked and blistered roofing system observed.

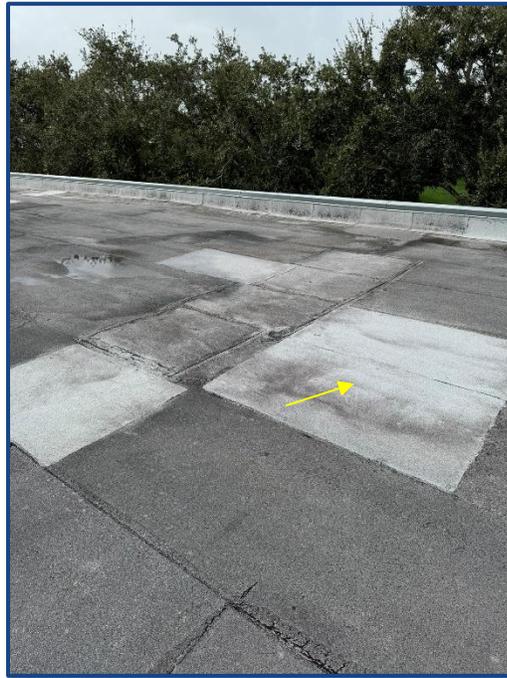
Photograph No. 29: Previous roofing repairs observed at the roof.

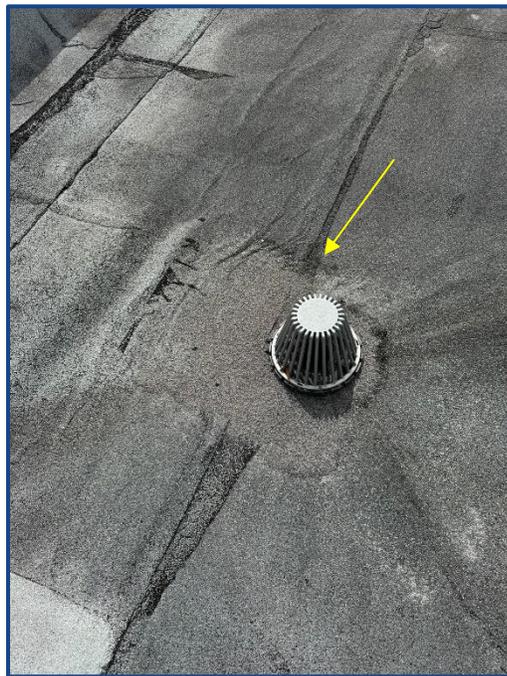
Photograph No. 30: Debris buildup near roof drain.

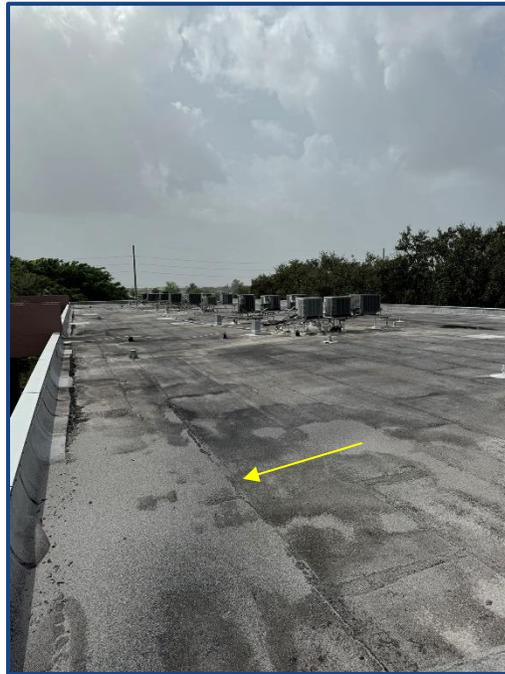
Photograph No. 31: Debris buildup from previous ponding water observed.
