PHASE I MILESTONE INSPECTION

Watersedge H Condominium

15461 Pembridge Drive

Report Date January 5th, 2024

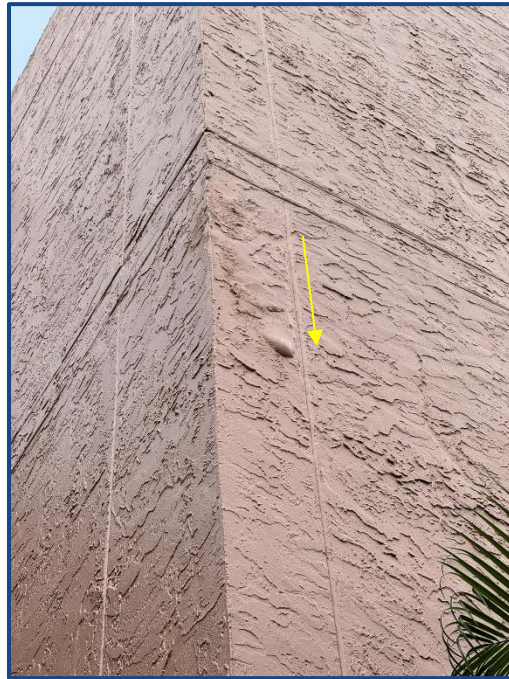
- Spalling/cracking observed at several areas within the building's catwalks/corridors and unit balconies. While these areas are not substantial at the time of inspection, continued exposure to the elements will further deteriorate these areas and expand the spalling/cracking observed. See **Appendix B** photographs 9 and 19-26.

Photograph No. 9: Blistering paint observed at building edge.

- UES recommends the repair of all spalled and cracked areas observed at the catwalks, and unit balconies. UES recommends the retention of a licensed engineer to prepare specifications/drawings for the repairs required in all areas. Once permits are obtained, a licensed engineer shall be responsible for ensuring that all repairs are done as per the permitted specifications/drawings. Expansion joint detailing should be performed as well along with these repairs.

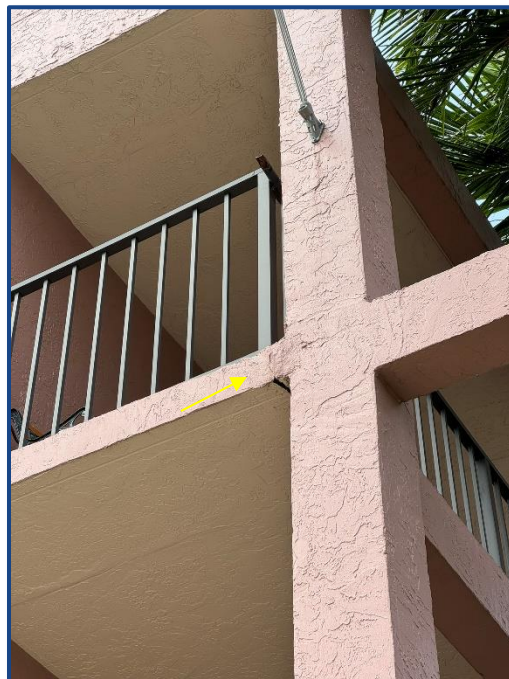
- Deteriorated expansion joint observed near the elevator on several floors. Deteriorated expansion joint allows water intrusion into the reinforcement along the concrete edge which with time compromises the strength of the section. See **Appendix B** photographs 10 and 11.

Photograph No. 10: Deteriorated expansion joint observed at 3rd floor near elevator.

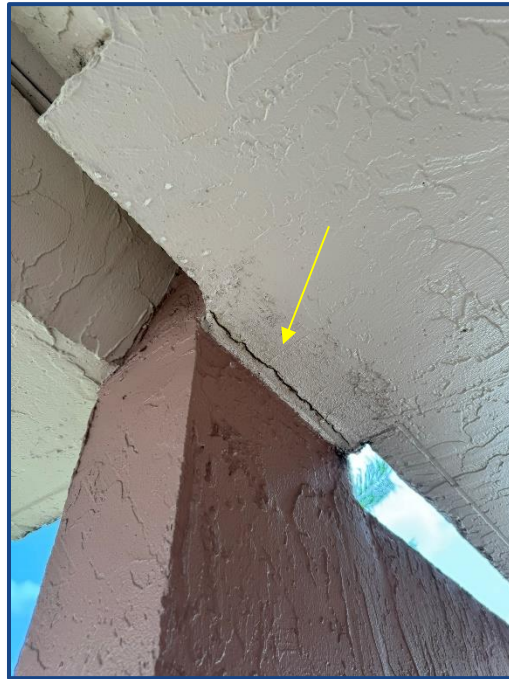
Photograph No. 11: Deteriorated expansion joint observed at 3rd floor near elevator.

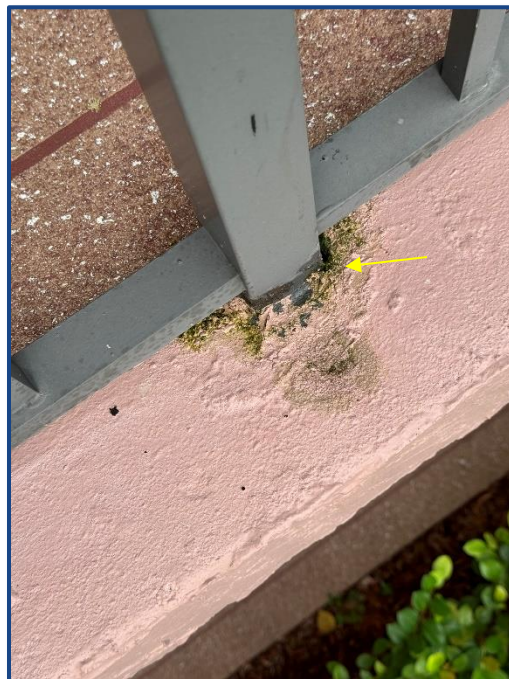
- Damaged railing post pockets were observed at several locations along the building's catwalks/corridors. A significant portion of the building's railing system exhibited signs of water intrusion within the pocket. This creates a condition where mold can accumulate and then the water percolates into the concrete slab causing corrosion, spalling, cracking, and other damages. See **Appendix B** photographs 12-17.

Photograph No. 12: Deteriorated railing post pocket observed near unit 208.

- UES recommends the repair of all damaged railing post pockets to prevent water intrusion into the surrounding concrete slab. The structural integrity of all the railing posts is to be accessed during this time to ensure that all railings are able to resist horizontal loads as per section 1607.8 of the Florida Building Code – Building, 2020 7th ED (2020 FBC-B).

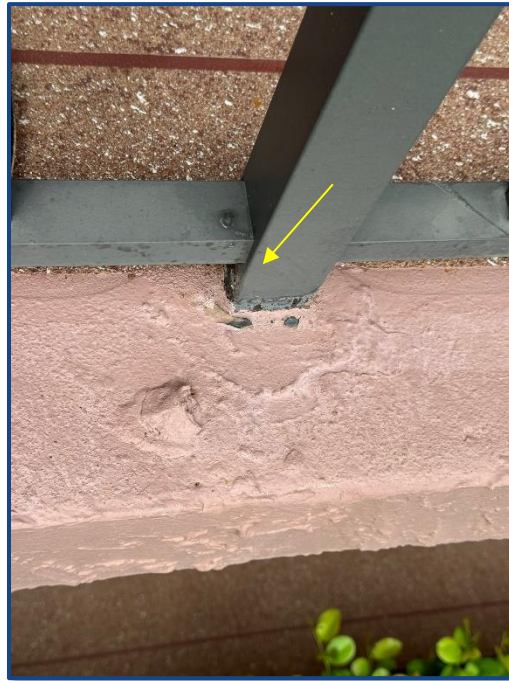
Photograph No. 13: Deteriorated railing post pocket observed near unit 208.

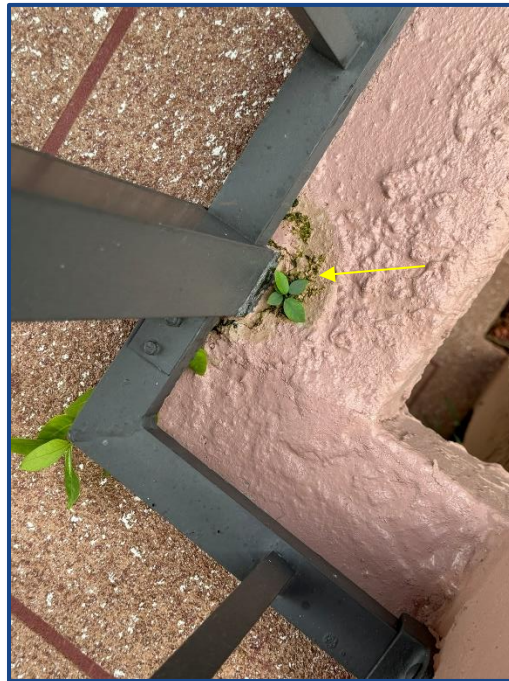
Photograph No. 14: Deteriorated railing post pocket observed near unit 208.

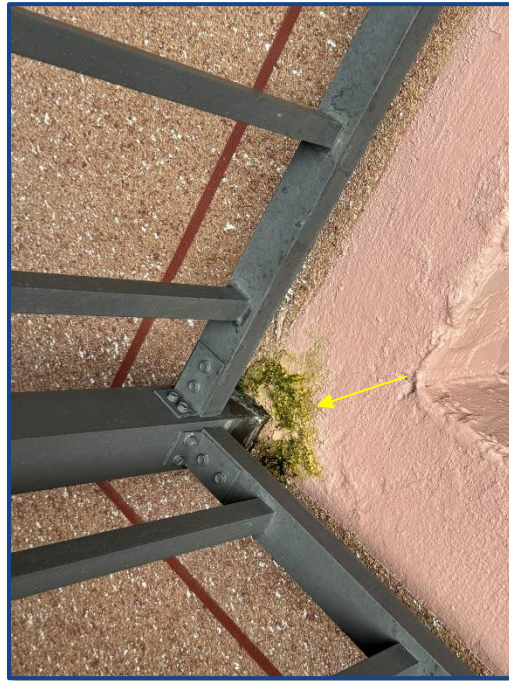
Photograph No. 15: Deteriorated railing post pocket observed near unit 213.

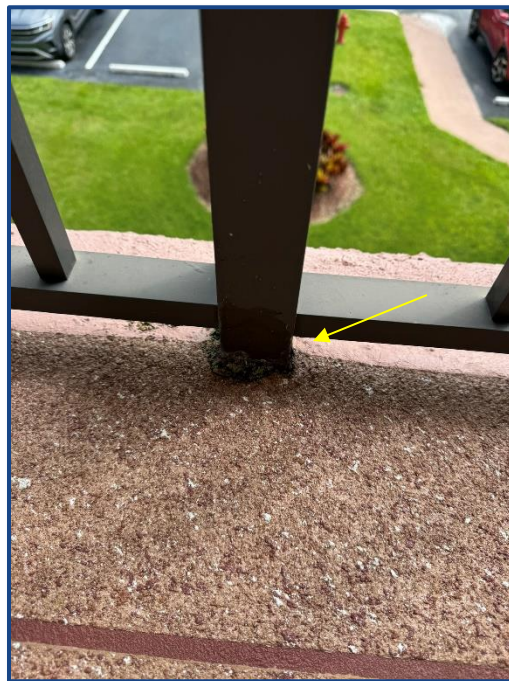
Photograph No. 16: Deteriorated railing post pocket observed near unit 310.

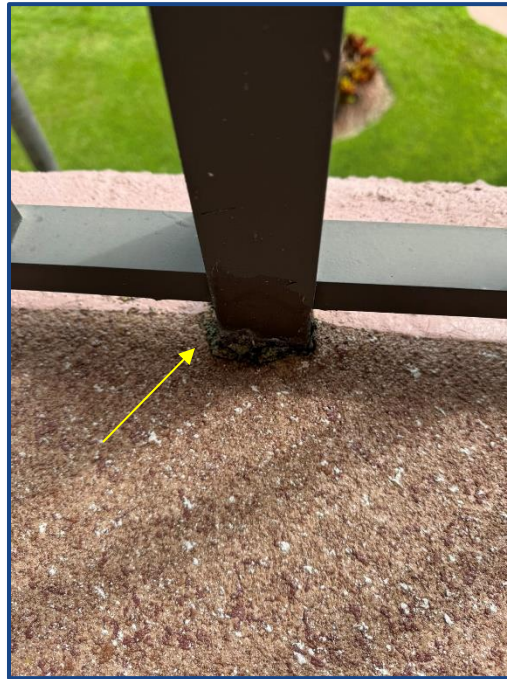
Photograph No. 17: Deteriorated railing post pocket observed near unit 310.

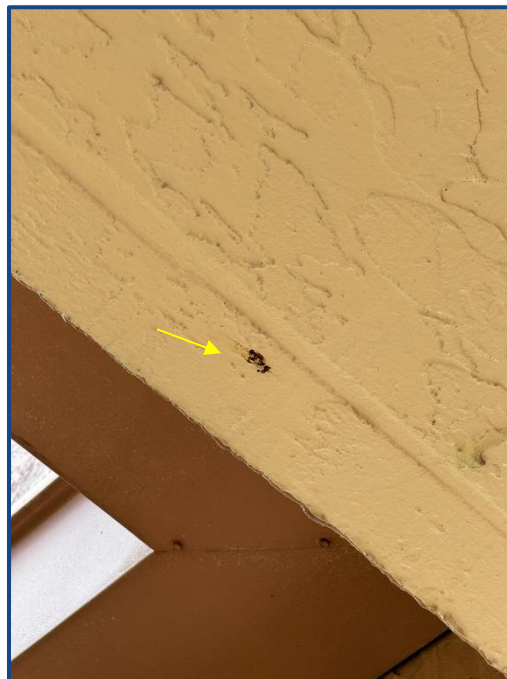
Photograph No. 18: Rust spot observed overhead near unit 310.

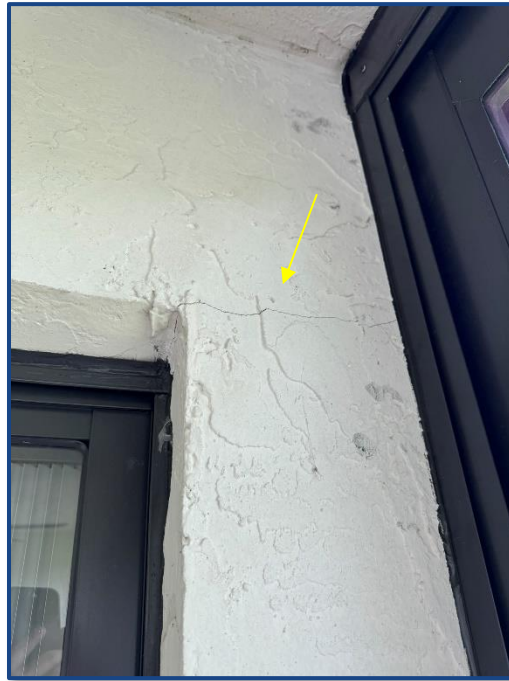
Photograph No. 19: Unit 108: Wall cracking observed near unit sliding glass door.

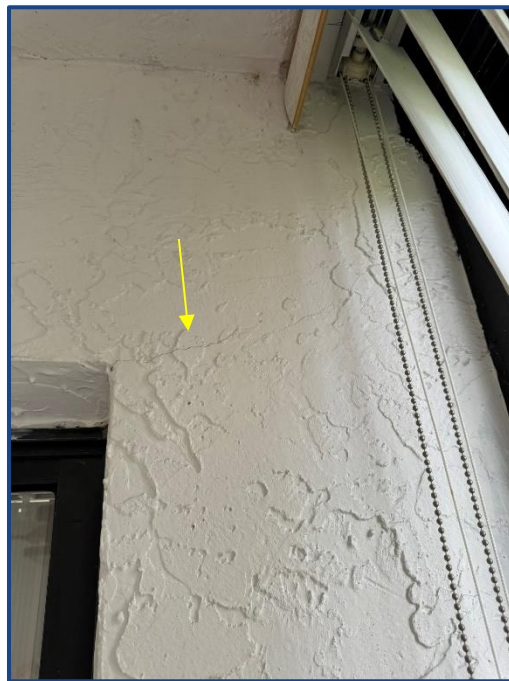
Photograph No. 20: Unit 106: Wall cracking observed near unit sliding glass door.

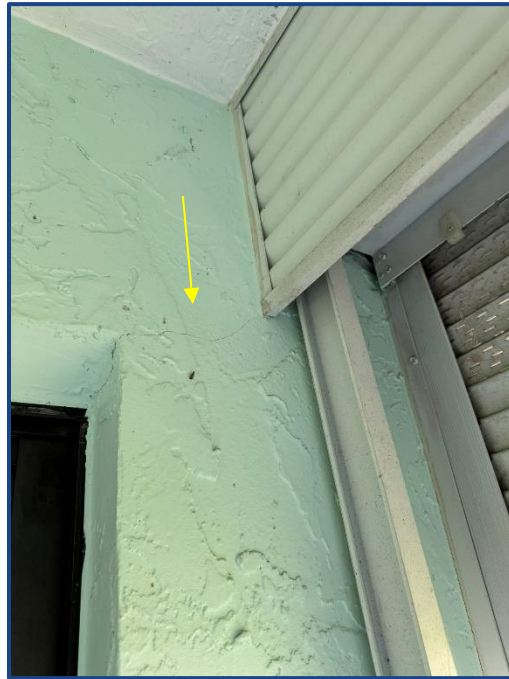
Photograph No. 21: Unit 104: Wall cracking observed near unit sliding glass door.

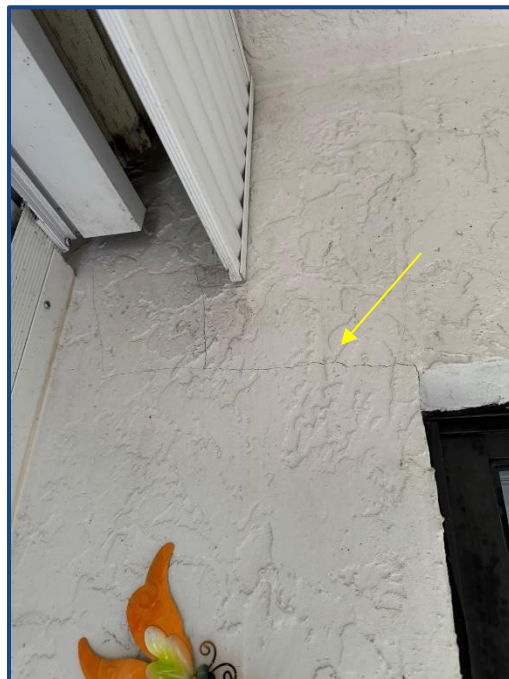
Photograph No. 22: Unit 103: Wall cracking observed near unit sliding glass door..

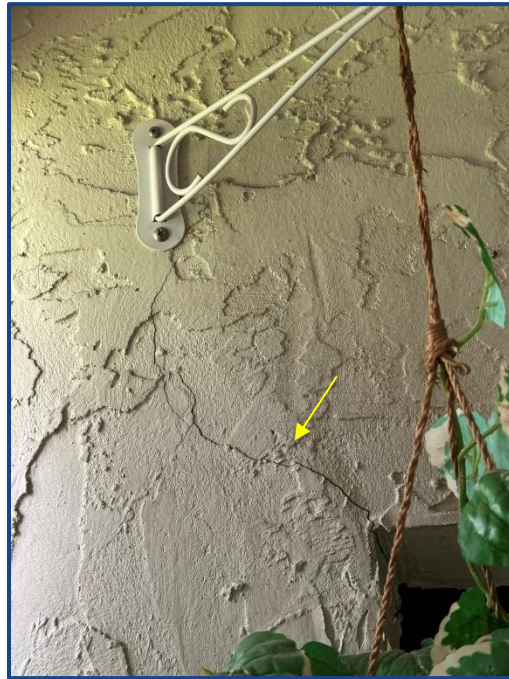
Photograph No. 23: Unit 101: Wall cracking observed near unit sliding glass door.

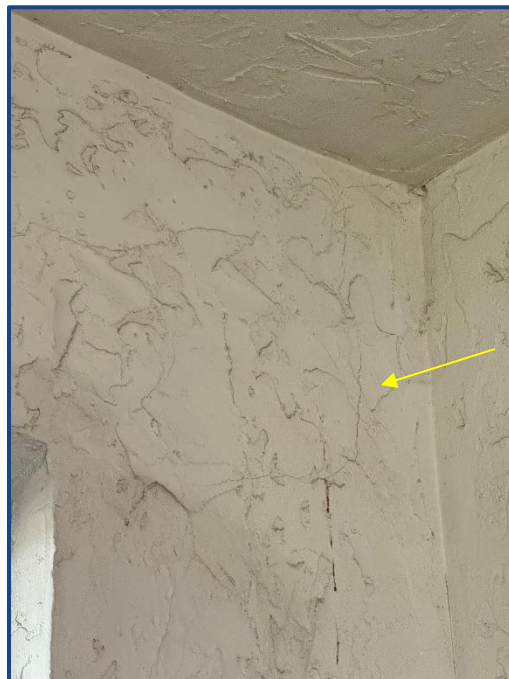
Photograph No. 24: Unit 101: Wall cracking observed near unit sliding glass door.

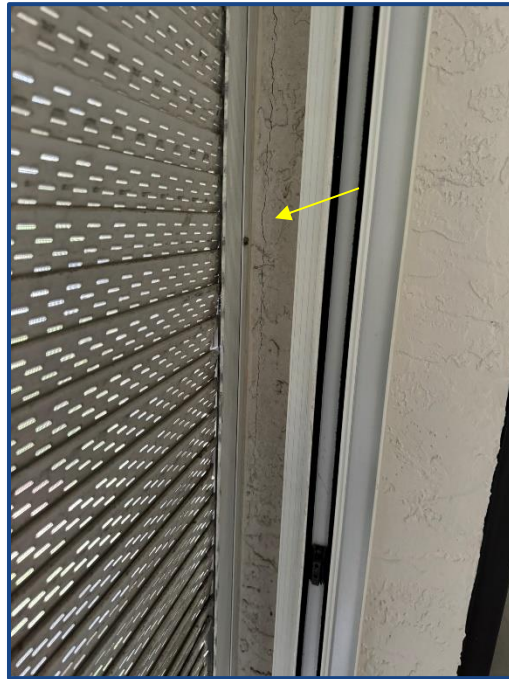
Photograph No. 25: Unit 205: Wall cracking observed near balcony enclosure.

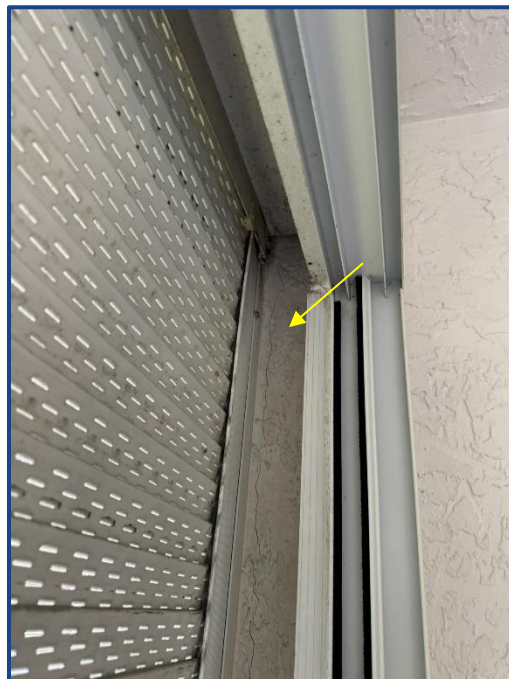
Photograph No. 26: Unit 205: Wall cracking observed near balcony enclosure.

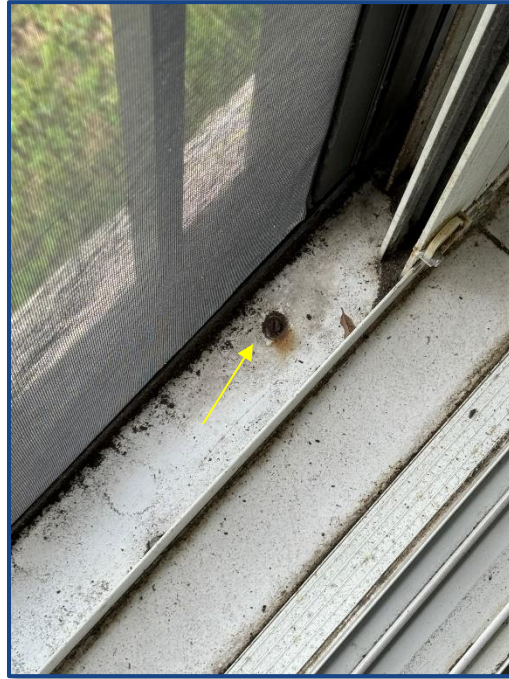
- Deteriorated/rusted fasteners observed at unit 205's aluminum enclosure bottom rail. Several other fastener heads were rusting within the unit balconies. See **Appendix B** photograph 27.

Photograph No. 27: Unit 205: Deteriorated fasteners observed at aluminum enclosure bottom rail.

- UES recommends the replacement of all exposed fasteners with new stainless-steel fasteners. Any compromised fastener pockets are to be repaired prior to installation of the new fastener.

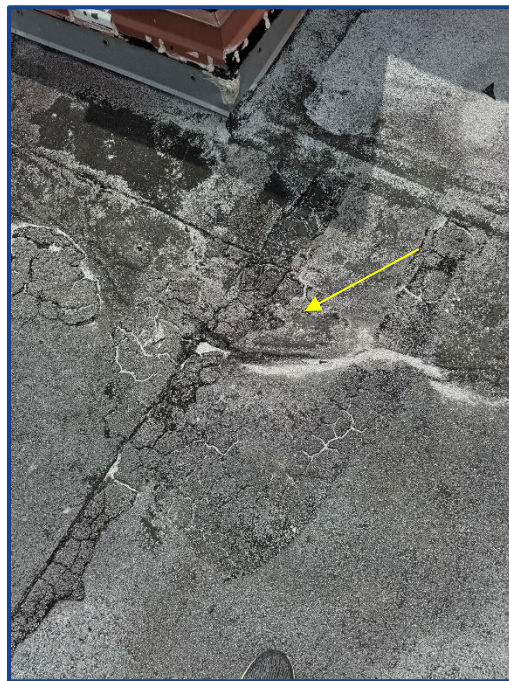
- The roof is in fair condition with ponding and damaged areas observed on the roof. Evidence of previous ponding was observed at the time of inspection. Several areas of the roof were cracked and blistering. See **Appendix B** photographs 28-31.

Photograph No. 28: Cracked and blistered roofing system observed.

- UES recommends the repair of all damaged roof systems per manufacturer’s recommendations. We highly recommend full removal of the existing system to address any damaged wood members and installation of a new roofing system designed by a license engineer. Expansion joint detailing at the roof should be performed as well along with any roof repairs.

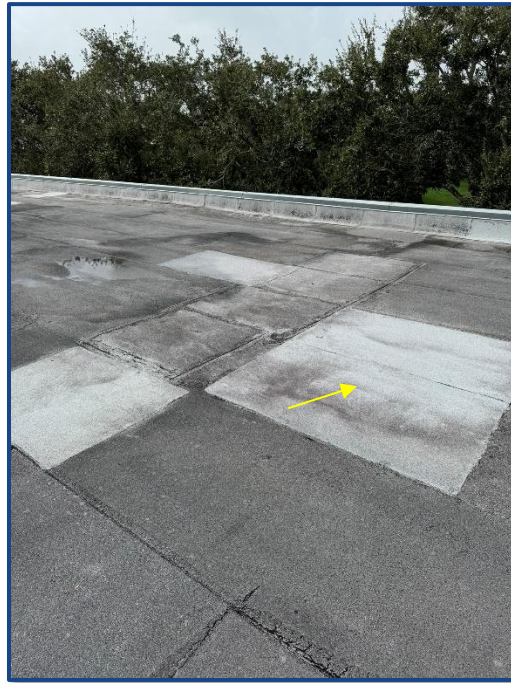
Photograph No. 29: Previous roofing repairs observed at the roof.

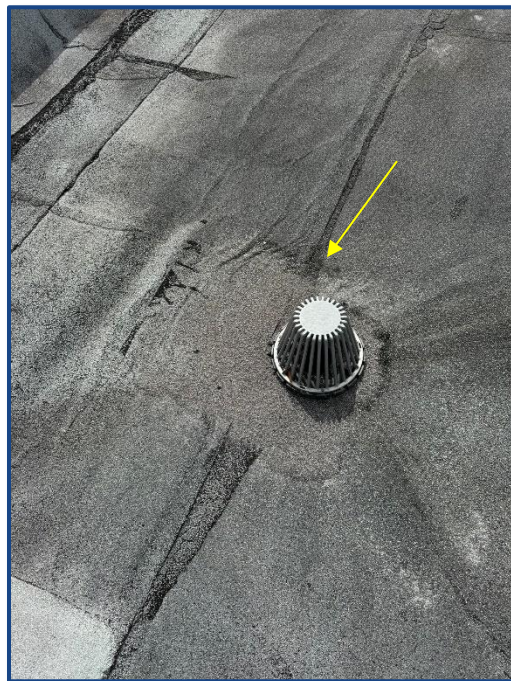
Photograph No. 30: Debris buildup near roof drain.

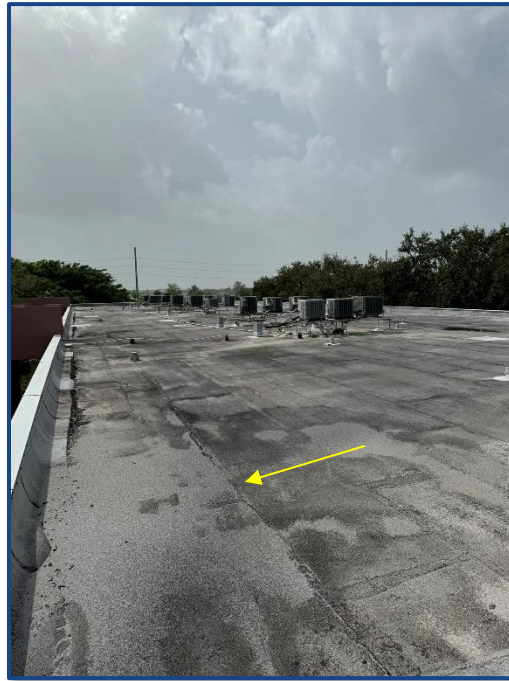
Photograph No. 31: Debris buildup from previous ponding water observed.
