**Inspection reference: 040824BITTEKER**

**Home Inspection Report**  
**112 Glenview Dr**  
**White Rock NM 87547**

**April 8, 2024**

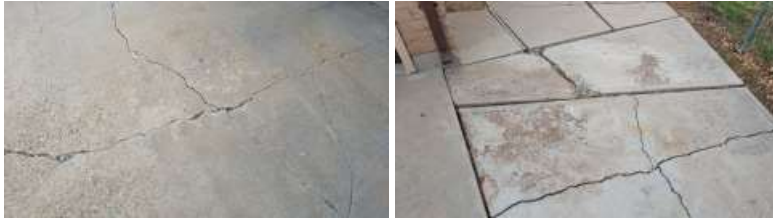
**Driveway Condition:**

The concrete has large cracks from movement or age. Although cracking is not uncommon with older pours, the surface should be evaluated for repair or for re-surfacing. The concerns are tripping hazards and further damage.

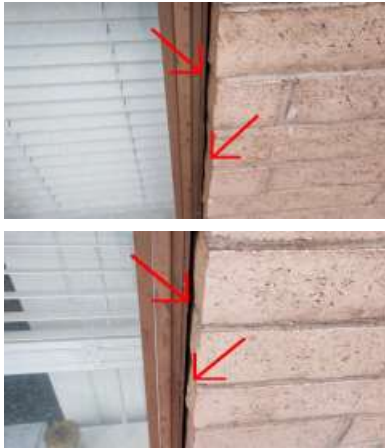
**Window Condition:**

The perimeters of the windows are open, gapped, where the brick meet the windows at several locations. This may be by design; typically, the openings should be caulked, sealed, to help prevent potential water and pest entry into the structure. Additional consultation is recommended to confirm if sealing is required. Address and correct the issue, if necessary. Refer to the photos for examples and for clarification.

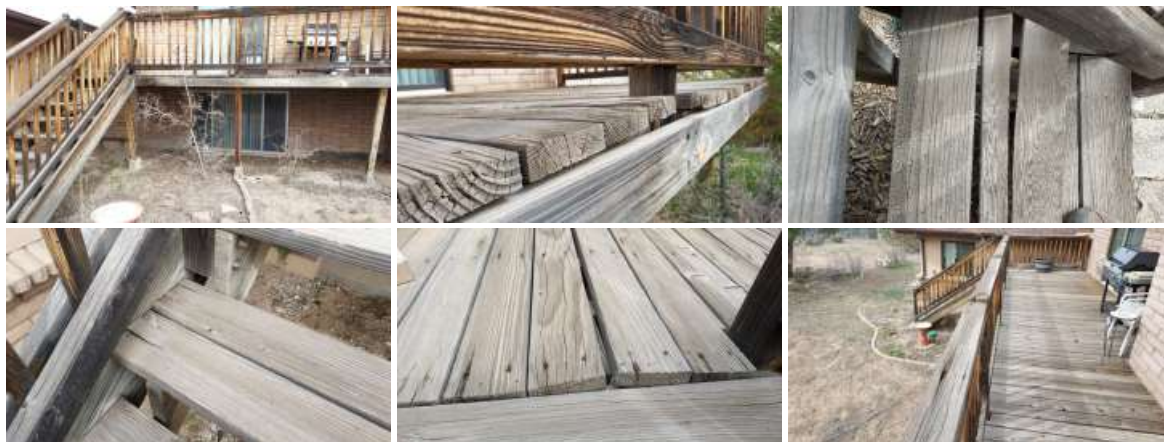
**Deck Condition:**

The deck has not been maintained, sealed; exposed wood is susceptible to deterioration. The wood is damaged, at multiple places, and the railing is loose. Also, there is no metal flashing where the deck meets the wall, and the ledger / rim-board is beginning to pull-away. Consulting with an experienced contractor about the proper course of action, including re-building, is advised. The concern is overall deck-safety.

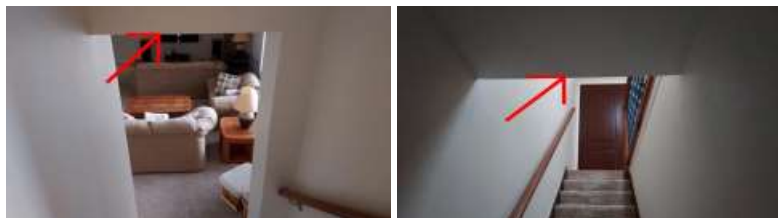
### Staircases:

The clearance, headroom at the west and east staircases into the lower-level, is considered too low; 6'4" or more is suggested, and alterations are recommended, if practical. Use with caution. (For comparison, most doors typically have about 6'8" of clearance, headroom.)
