Inspection reference: 040124CORDIER

Home Inspection Report
3964 Sycamore St #B
Los Alamos NM 87544

April 1, 2024

Prepared for:
Linda Cordier

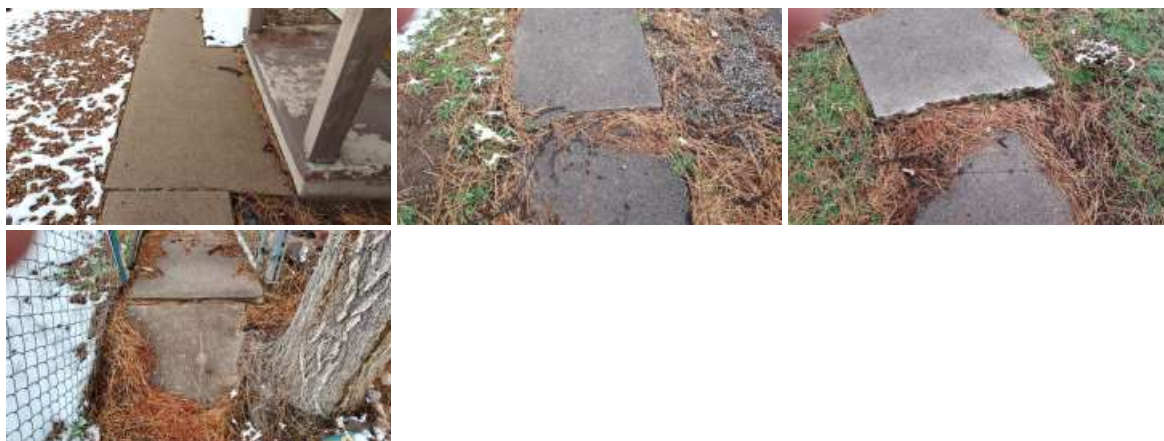
Walkway Condition:

The east-walkway material has settled and lifted. Resetting is recommended; the current condition is considered a tripping hazard.

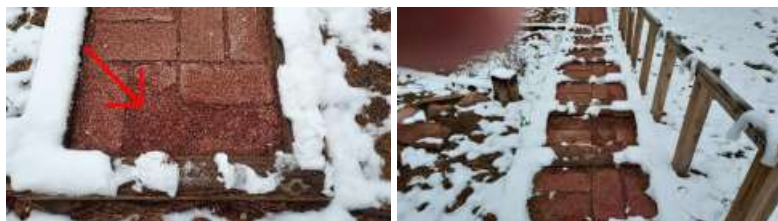
Walkway Condition2:

The west-walkway step-material has settled, and it is damaged in multiple locations. Resetting is recommended; the current condition is considered a tripping hazard.

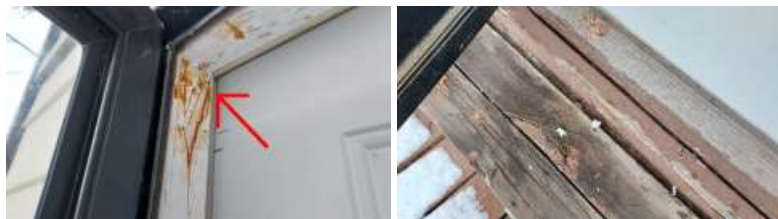
Door Condition:

The jamb, step, and trim, at the east door, are damaged. Any damaged wood should be repaired, or replaced, and sealed as necessary. Exposed wood is susceptible to damage.

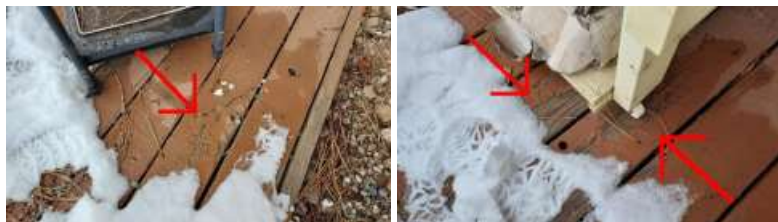
Deck Condition2:

The deck was snow covered, during the inspection, and was minimally visible, but the deck should be scraped and sealed based on the visible portions.

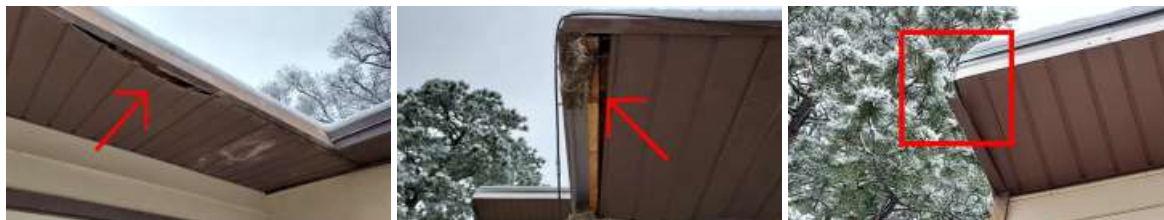
Material and Condition:

The fascia and soffit are metal. The metal is both loose and missing at the east side. Any loose or missing metal should be secured, or replaced, as necessary.

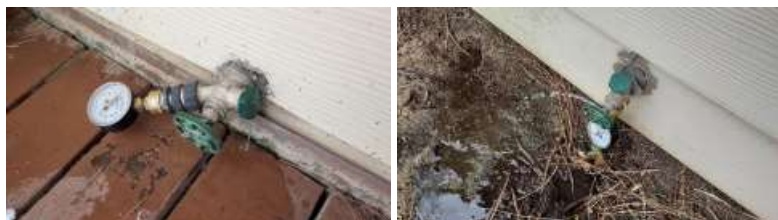
Hose Connections:

The hose connections leak and do not maintain pressure when in use. Servicing, or replacement, is recommended to avoid wasting water.
