PERRY INSPECTION REPORT

557 Todd Loop
White Rock, NM 87547

MARCH 11, 2024

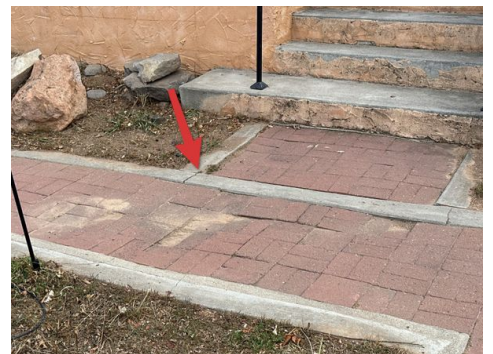
2.2.1 Walkways

Settling or lifting of the brick walkway surface was noted at the south exterior. Any movement that varies $\frac{3}{8}$ of an inch or more may cause someone to trip and fall. Recommend having this condition corrected.

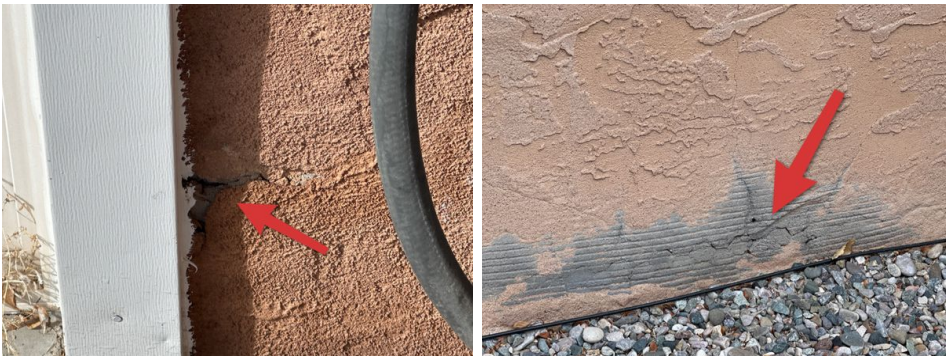
3.2.1 Coverings & Conditions

The stucco finish is peeling/open at the living room south exterior and primary bedroom east wall. Recommend having the stucco further evaluated for repair.

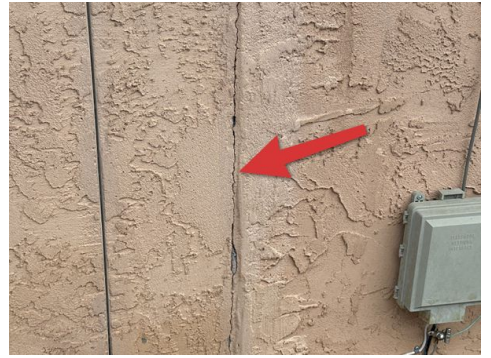
3.2.2 Coverings & Conditions

CRACKS (ADDITION)

Cracks in the stucco finish from movement were noted at the east exterior wall. It is common for cracks to occur where an addition has been attached to the original structure.

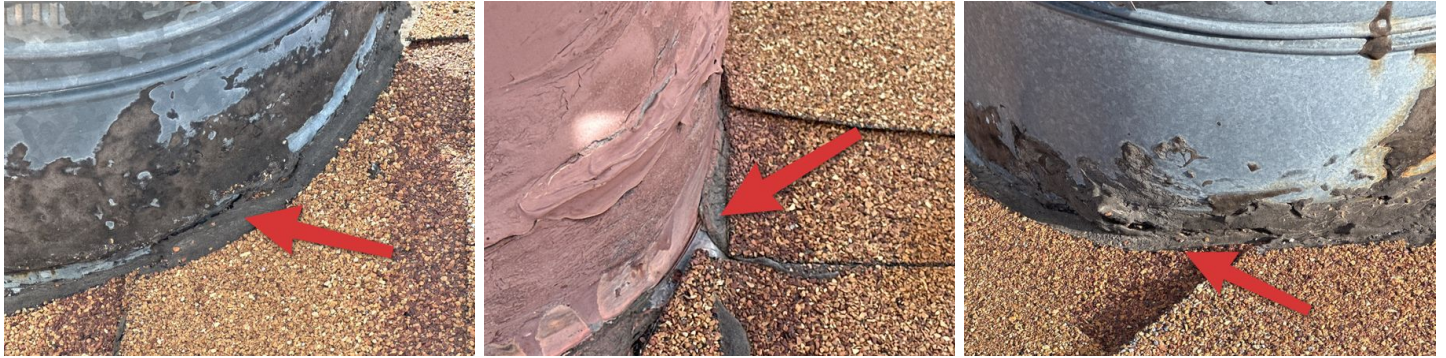
4.3.1 Roof Material & Conditions

MINERAL FLASHING (TOUCH UP)

The mineral flashing is showing signs of minor wear and will need maintenance at multiple locations. A maintenance sealing of the mineral flashing is suggested to prolong the life of the roof.

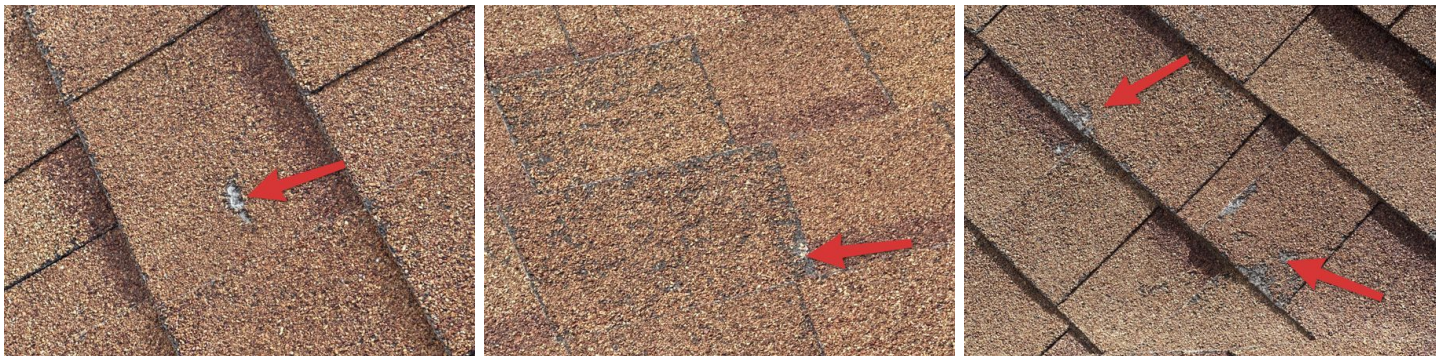
4.3.2 Roof Material & Conditions

SHINGLES - TYPICAL MAINTENANCE

TYPICAL MAINTENANCE RECOMMENDED. This usually consists of repair/replacement of damaged/missing shingles. This maintenance should help insure the weather tightness of the building and should be performed on a regular basis. Recommend consulting with a roofing contractor about the roof condition and course of action.

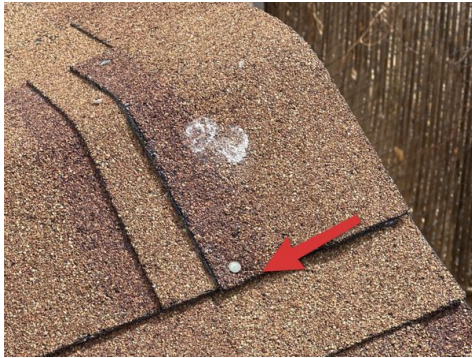
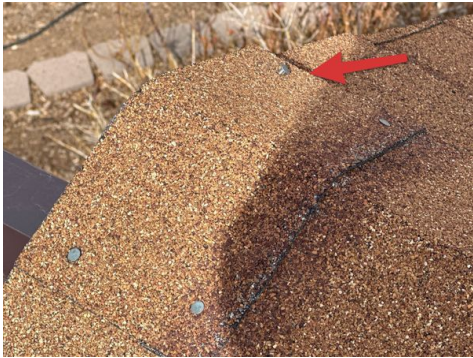
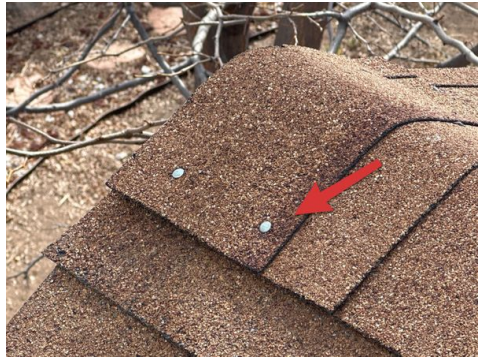
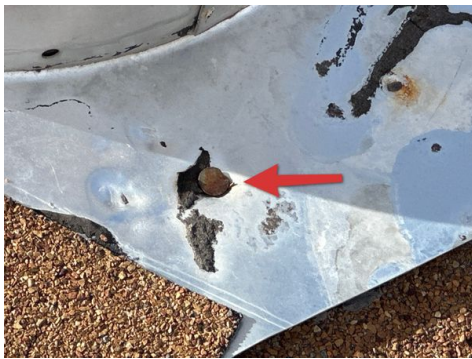
4.3.3 Roof Material & Conditions

SHINGLES (EXPOSED NAIL HEADS)

Multiple exposed nail heads and areas of top nailing were noted and should receive a dab of tar to protect nail heads from rusting away or leaking.

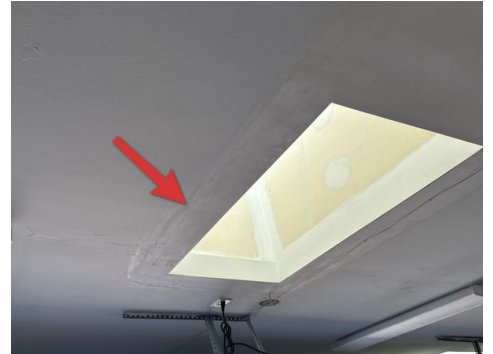
PAST REPAIR (COSMETIC)

The ceiling drywall covering was noted to have signs of past repair. This condition is cosmetic and no action is required.

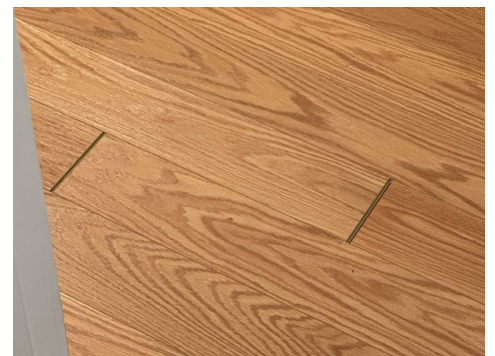
The wood flooring at the hallway has gaps at the surfaces. This condition is cosmetic and can be repaired as desired.

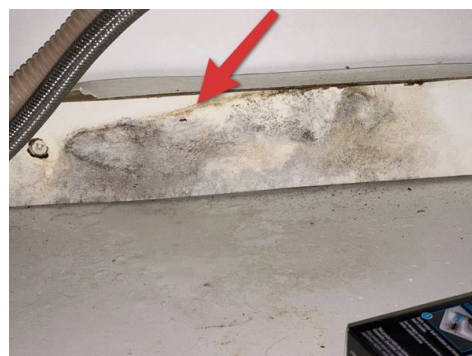
DAMAGE/MICROBIAL SINKCAB

Moisture staining/damage to the bottom of the sink cabinet was noted from an active leak. The area was wet at the time of the inspection. Evidence of Microbial Growth was noted. Recommend having this condition further evaluated.

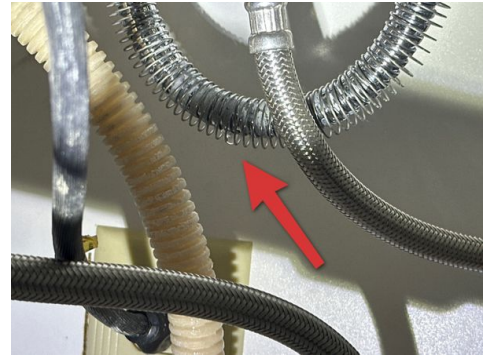
15.14.1 Sink Fixture

**SINK FIXTURE LEAK (FAUCET HOSE)**

The sink fixture was noted to be leaking at the faucet hose when the fixture was in use. Recommend consulting with a plumbing contractor for repairs.

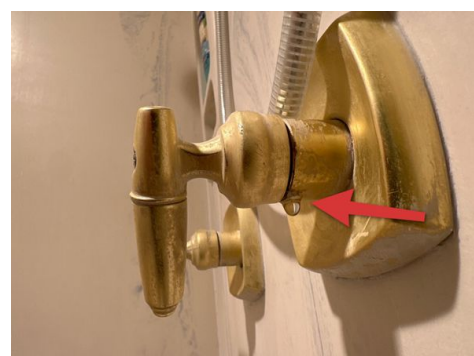
FIXTURE (LEAK IN USE)

The shower fixture was noted to be leaking at the handle when the fixture was in use. Recommend consulting with a plumbing contractor for repairs.

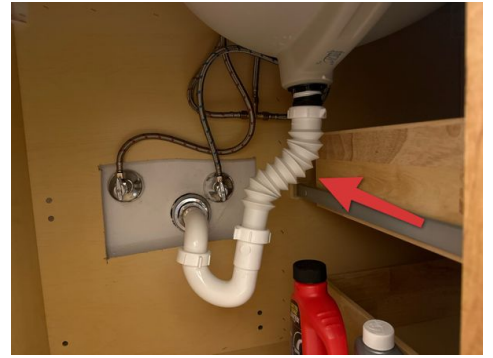
FLEX CONNECT

The sink drain was noted to have a flex connector installed. This type of flexible connector is known to cause particles to build up in the pipe and clog.

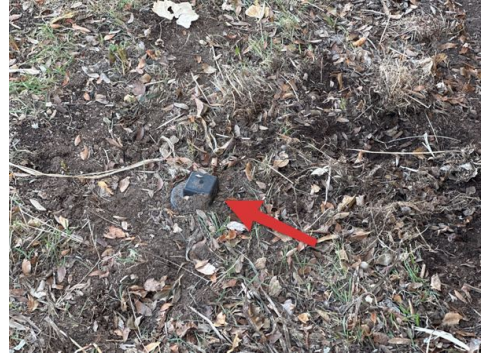
RAISE CLEAN OUTS

The clean outs are located near or below the grade of the soil. Recommend having the clean outs raised or the soil removed to prevent the clean outs from becoming buried or hidden.

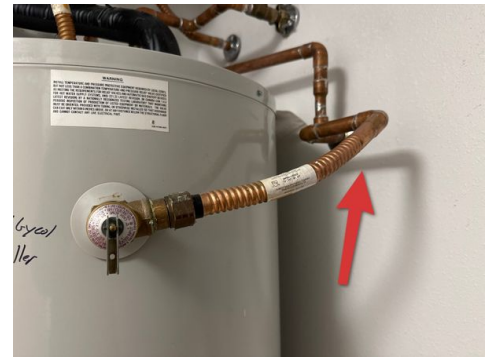
**TPR - UPHILL (REPAIR)**

The unit TPR valve (Temperature and Pressure Relief) drain line has not been installed properly. The drain line is not to be installed flowing uphill. This can cause failure of the TPR valve.

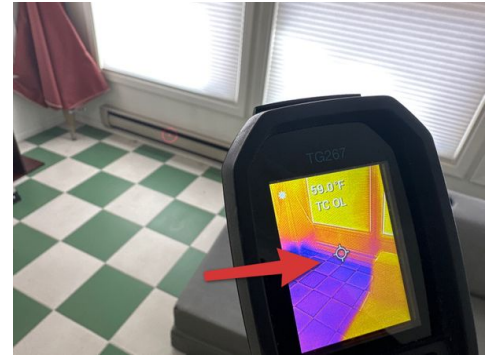
22.1.1 Electric Heat

UNIT - INOP

The electrical heating system at the west bonus room baseboards did not respond to calls from the thermostat to heat. Recommend having this condition further evaluated.

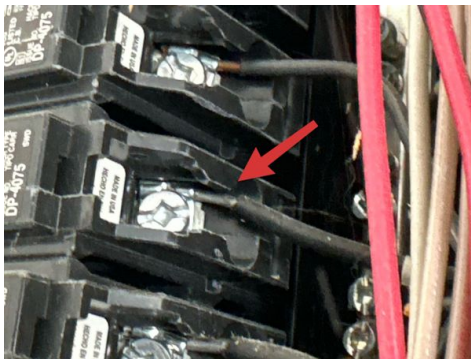
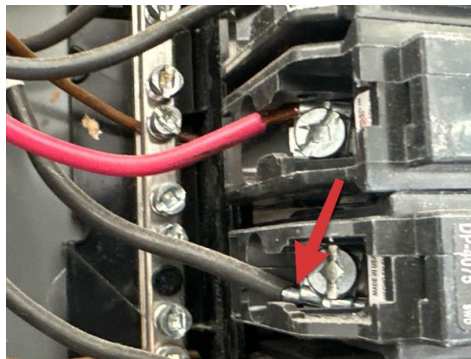
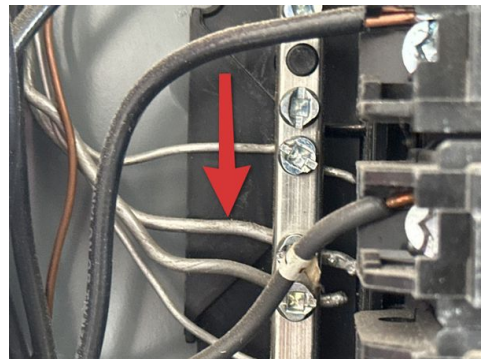
24.6.1 Conductors - Branch Wiring

ALUM SAFETY

Aluminum branch wiring was noted. Aluminum solid strand wiring, used on 110volt circuits, has been known to be unsafe. The wiring may fail at the terminals to outlets, switches and wiring connections. The wiring connections to the outlet/switches/fixtures and terminals need to be evaluated. Attaching a copper wire, known as "Pig Tailing", may be required. Pig Tailing should be done with a connector that has been approved for this application and installed by a licensed electrical contractor. Recommend having the wiring further evaluated by an electrical contractor.

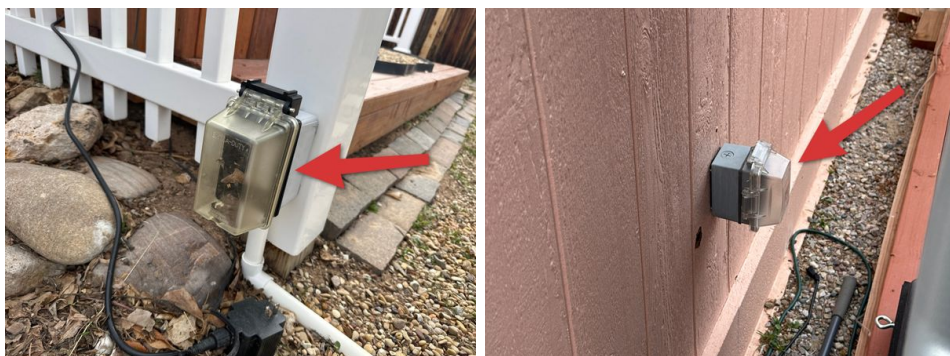
24.15.1 Outlets/Switches - Exterior

**NO POWER**

The outlets (x2) located at the south exterior water feature and shed did not have power at the time of the inspection. The outlets may be on a switch or is not correctly wired. Recommend consulting with an electrical contractor.

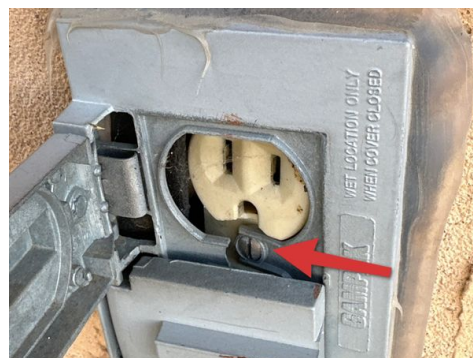
24.15.2 Outlets/Switches - Exterior

**EXTERIOR COVER (DAMAGED)**

The outlets (x1) at the main entry north exterior have a damaged exterior cover. A cover is required for exterior outlets to increase safety and prevent a possible shock hazard. Recommend consulting with an electrical contractor for repairs for the increased safety of the home.

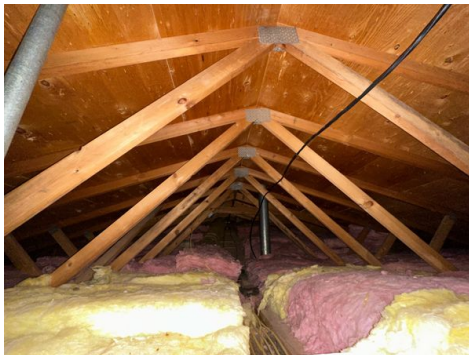
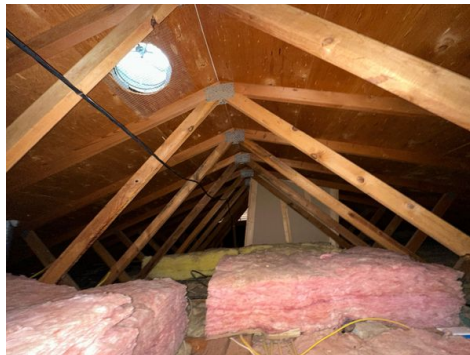
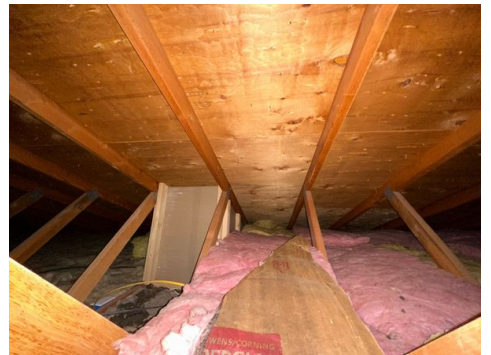
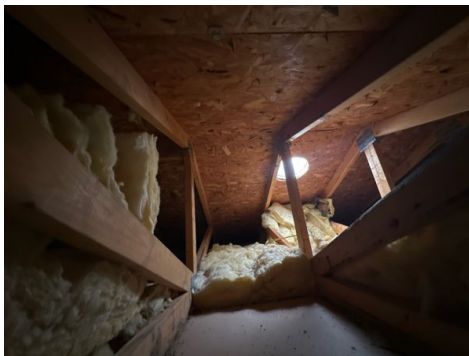
ACCESS DOOR (LIMITED)

The access to the attic was limited to viewing from the access door. The attic does not have a floor or a walkway to safely walk on in the attic space.
