PERRY INSPECTIONS

PERRY INSPECTION REPORT

869 Estates Dr
Los Alamos, NM 87544

APRIL 3, 2024

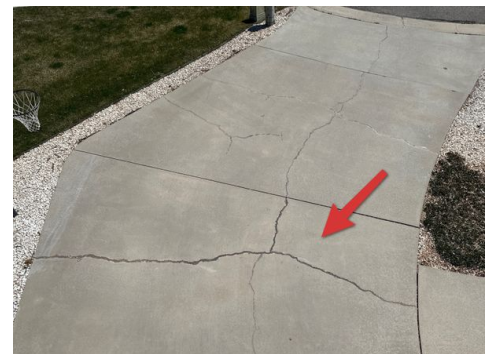
CRACKS (MOVEMENT)

Cracks in the concrete driveway were noted. This condition suggests that settling or movement of the slab has occurred.

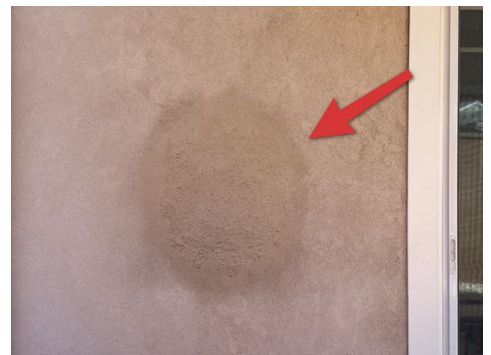
3.2.1 Coverings & Conditions

TYPICAL CRACKS/PAST REPAIR (MONITOR/COSMETIC)

Hairline cracks and past crack repairs were noted and are considered normal. If any crack opening become 1/8 inch or larger, it is recommended to have the crack repaired.

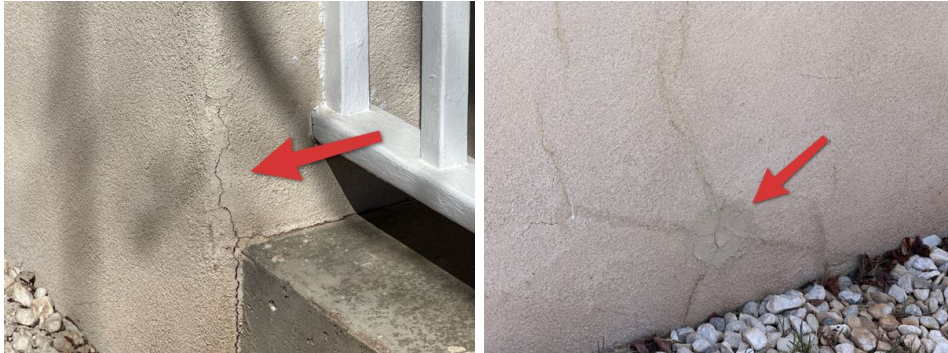
3.2.2 Coverings & Conditions

STUCCO CRACK 1/8IN

The stucco finish is cracking at the entry porch southeast exterior and kitchen/dining area south exterior. Crack openings that are an 1/8 inch wide or wider need to be repaired to prevent water entry behind the stucco.

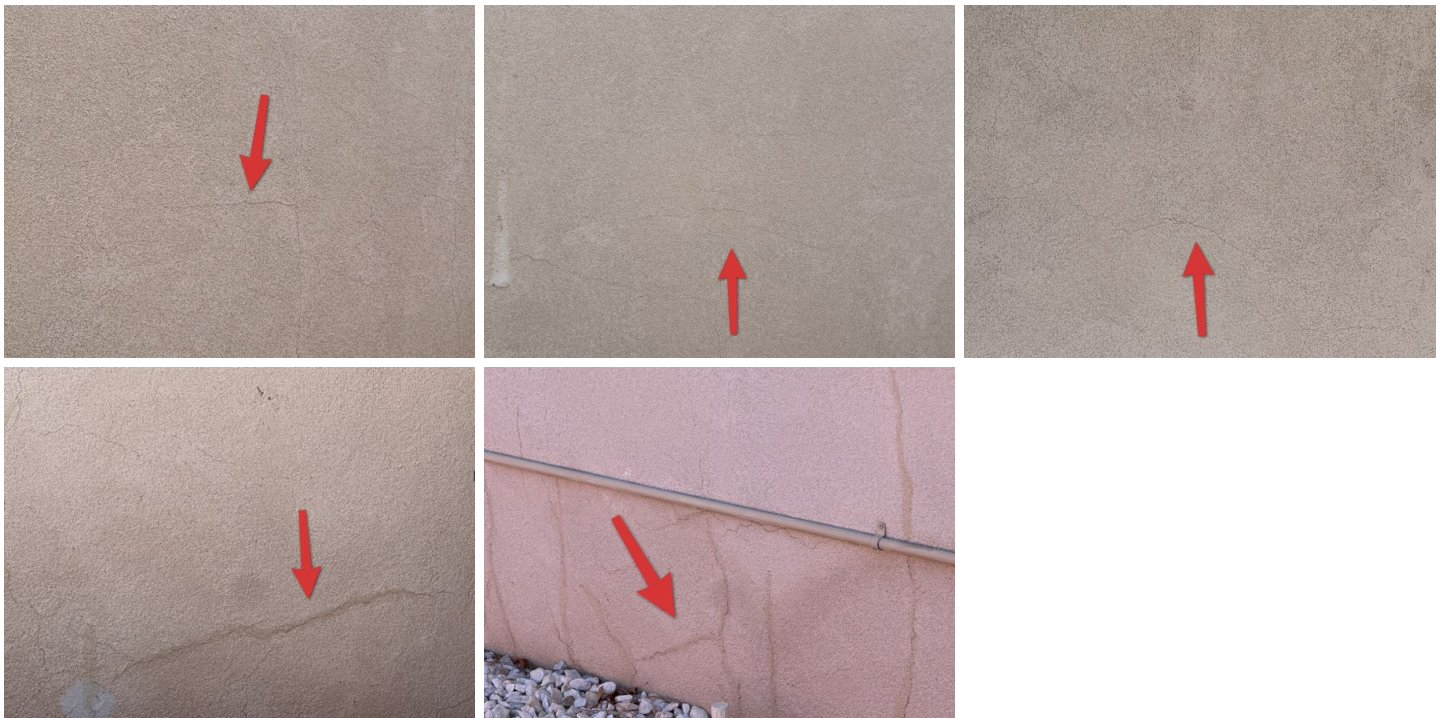
3.2.3 Coverings & Conditions

HORIZONTAL CRACK (MULTIPLE)

Horizontal cracking of the stucco was noted at multiple locations. This can indicate that the sheathing or stucco netting (wire) was not properly installed.

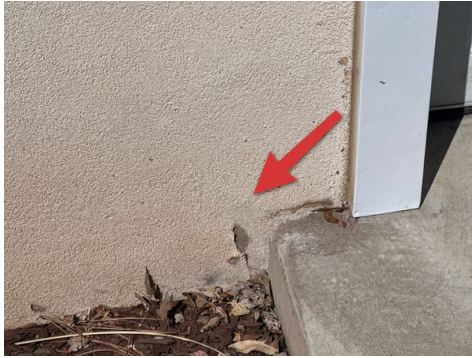
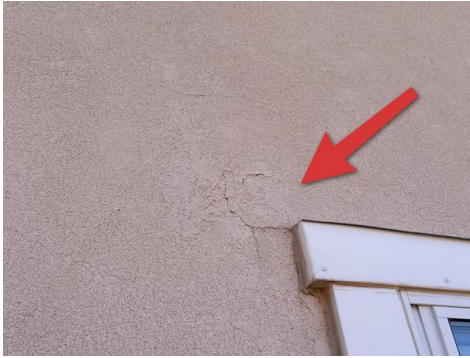
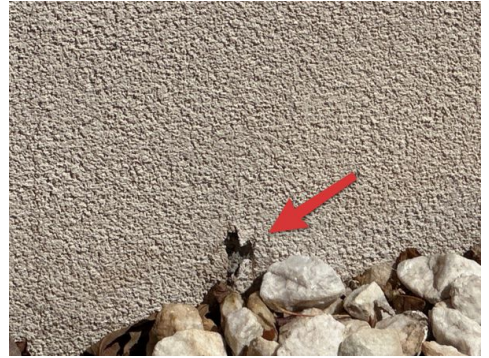
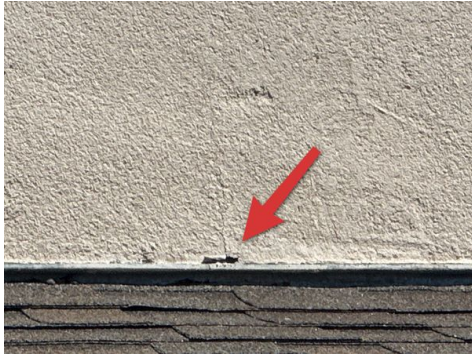
3.2.4 Coverings & Conditions

STUCCO PEELING (MULTIPLE)

The stucco finish is peeling at multiple locations. Recommend having the stucco further evaluated for repair.

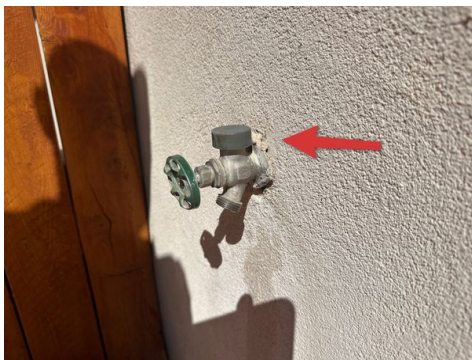
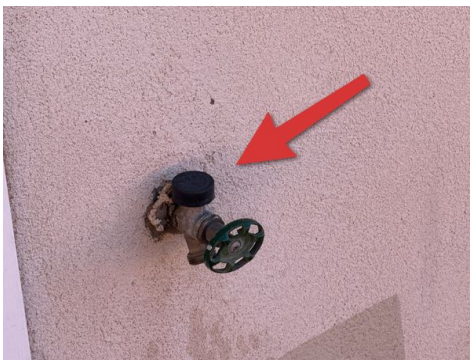
3.5.1 Hose Bibs

NOT SECURED

The hose bib at the south and west exterior wall is not properly secured. This can allow movement and possible damage to the plumbing system. Recommend having the hose bib properly secured to the wall.

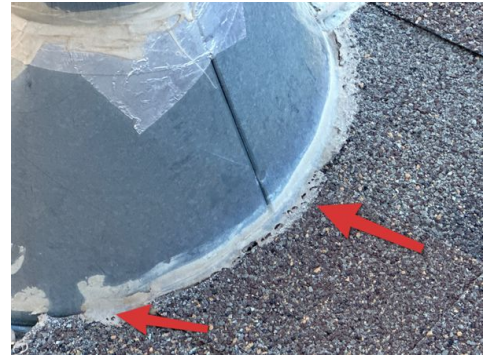
4.3.1 Roof Material & Conditions

The mineral flashing is showing signs of typical wear and will need maintenance at the roof penetrations. A maintenance sealing of the mineral flashing is suggested to prolong the life of the roof.

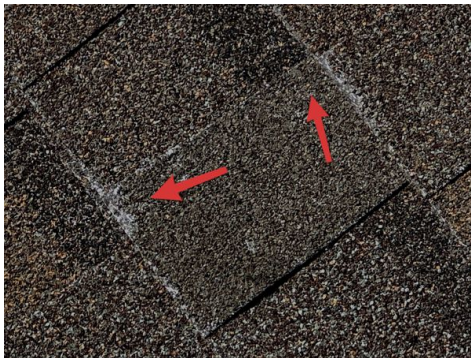
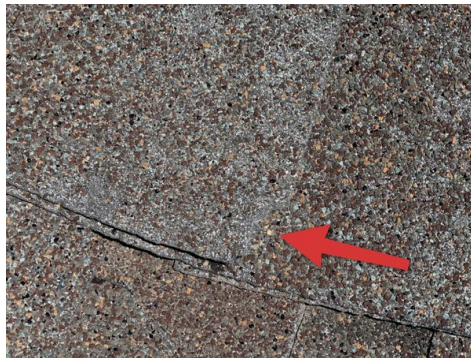
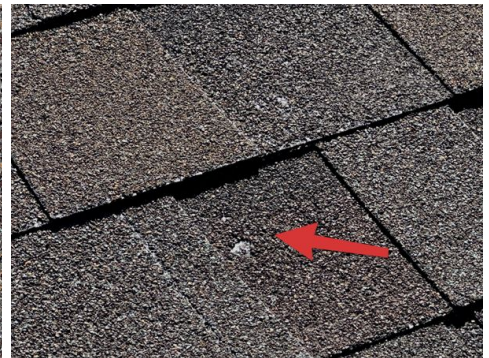
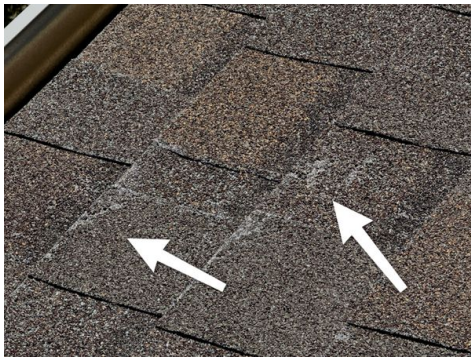
4.3.2 Roof Material & Conditions

SHINGLES (CRACKING)

Cracking and clawing of multiple shingles was noted and is the result of long term weathering and an advanced shingle age. Felts are showing through. Recommend consulting with a roofing contractor about the roof condition and course of action.

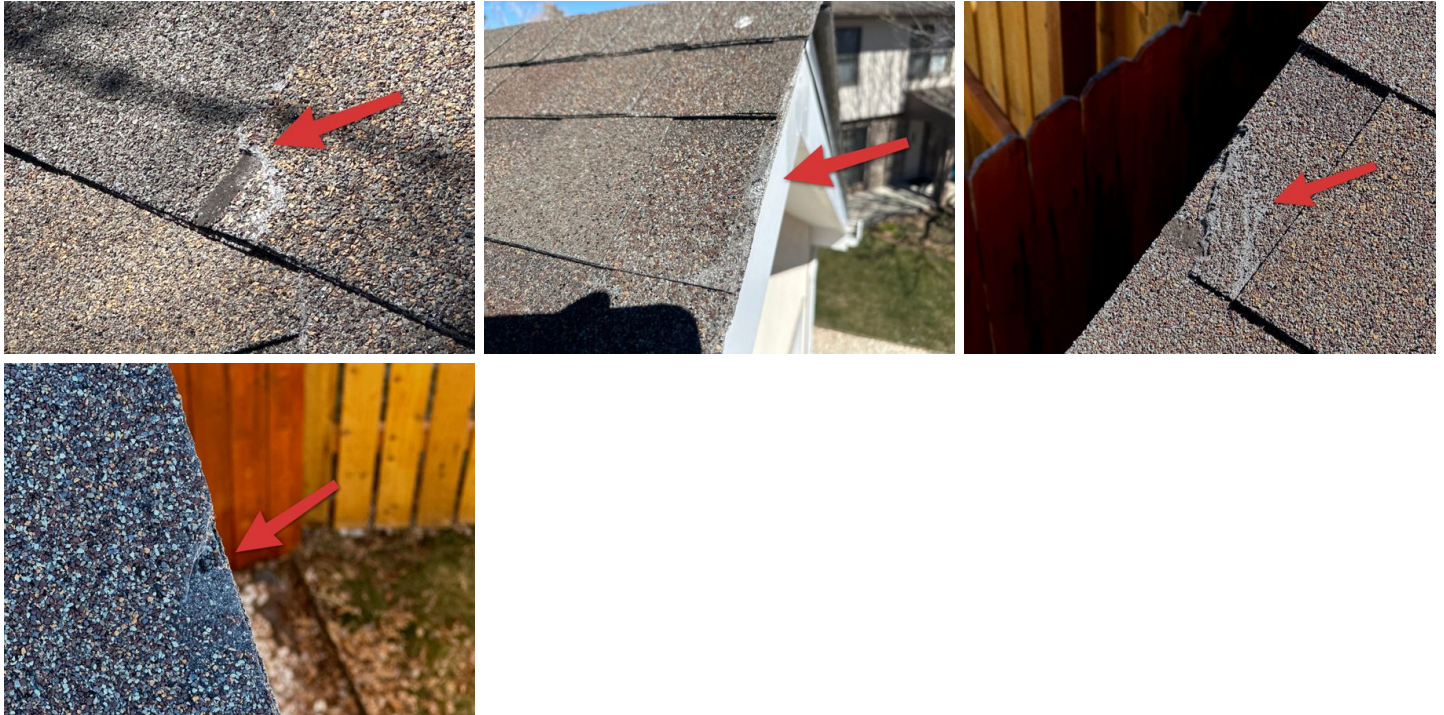
4.3.3 Roof Material & Conditions

SHINGLES - TYPICAL MAINTENANCE

TYPICAL MAINTENANCE RECOMMENDED. This usually consists of repair/replacement of any damaged/missing shingles. This maintenance should help insure the weather tightness of the building and should be performed on a regular basis. No major problems detected at this time. Recommend consulting with a roofing contractor about the roof condition and course of action.

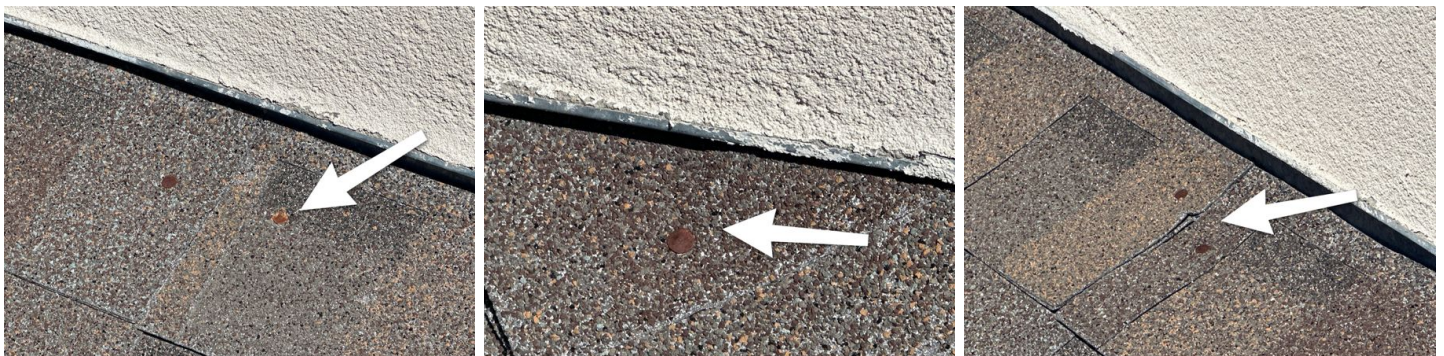
4.3.4 Roof Material & Conditions

SHINGLES (EXPOSED NAIL HEADS)

Multiple exposed nail heads and areas of top nailing were noted and should receive a dab of tar to protect nail heads from rusting away or leaking.

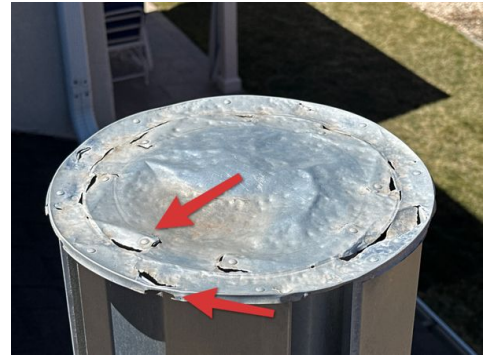
4.4.1 Roof - Plumbing and Exhaust Vents

**DAMAGED VENT CAP**

The boiler/water heater exhaust pipe cap is damaged. Recommend having the vent cap repaired.

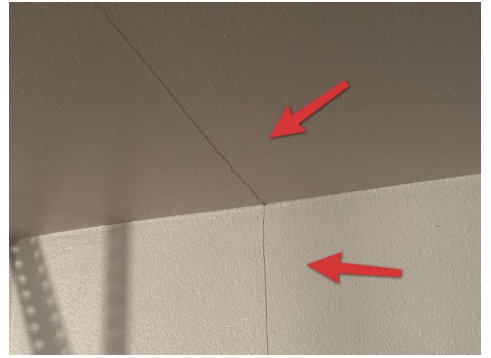
DRYWALL CRACK (TYPICAL)

The west and north wall/ceiling covering has a crack in the drywall. The cracking is the result of movement of the home. This type of cracking is common in new and older homes and is cosmetic.

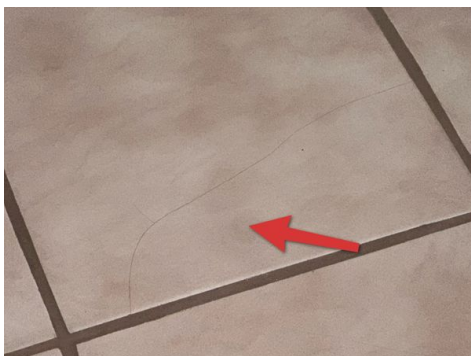
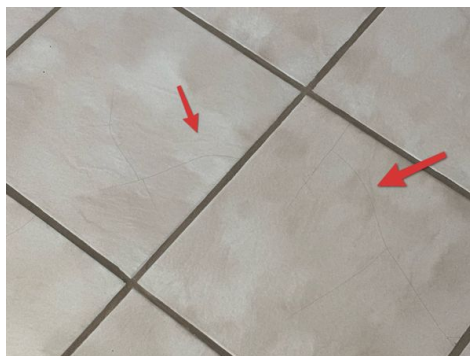
TILE CRACKED (COSMETIC)

Multiple floor tile at the hallways are cracked/damaged. This condition is cosmetic and no action is required.

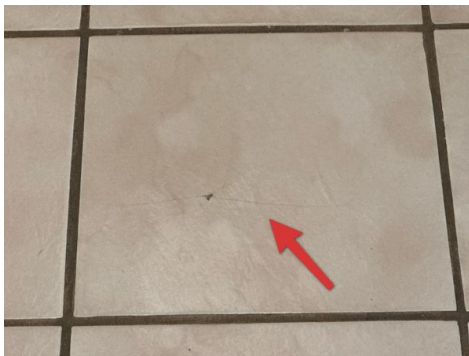
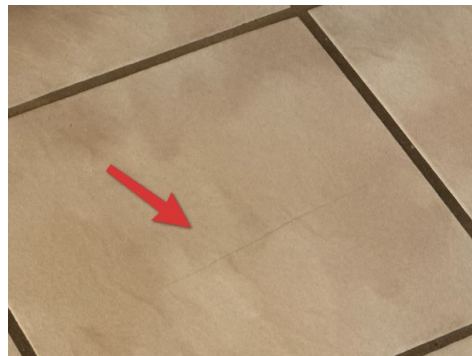
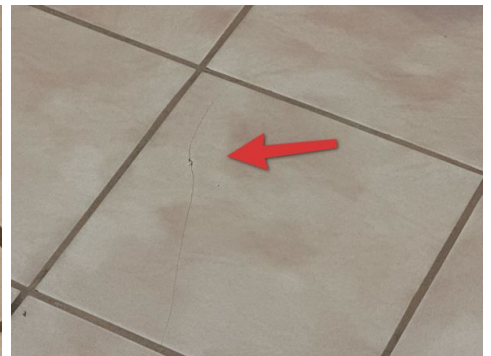
TILE CRACKED (COSMETIC)

The floor tile is cracked/damaged. This condition is cosmetic and no action is required.

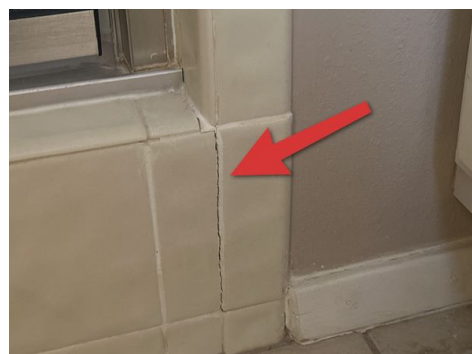
The exterior tile surround is in need of caulking/grout maintenance at the corner edge of the shower. Recommend applying caulking to seal the tile surround.

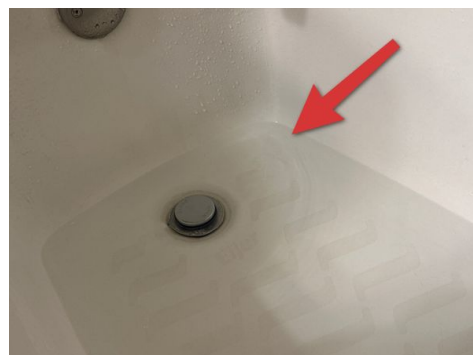
The tub was noted to be draining slowly. This indicates that the drain may be obstructed and needs to be cleared. Recommend consulting with a plumbing contractor for repairs.

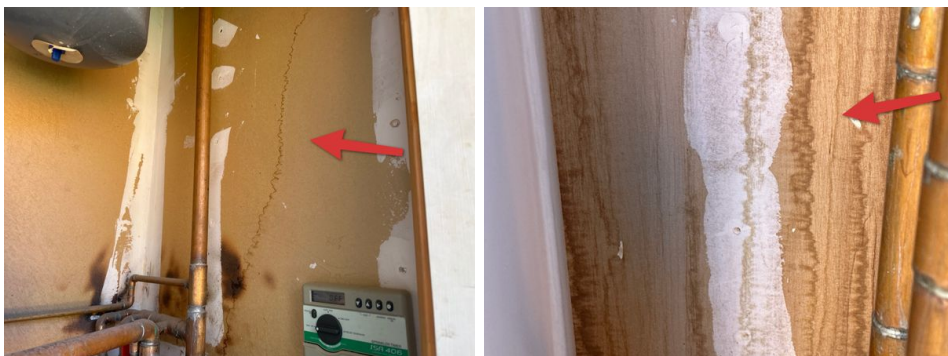
MOISTURE STAINING (DRY)

Multiple walls have moisture staining on the surface. The condition indicates that a leak had occurred. The area was dry at the time of the inspection. Recommend monitoring this condition during heavy rainfall.

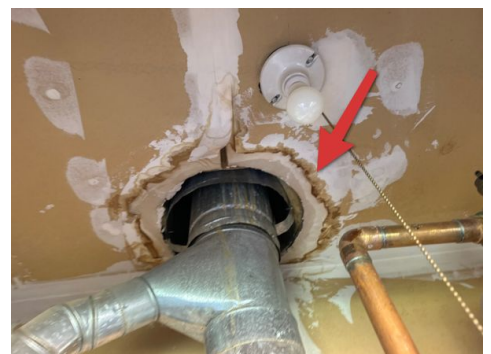
21.3.1 Mechanical Room/Closet - Ceiling

MOISTURE STAINS (DRY)

The ceiling has moisture stains noted on the surface. The water staining indicates there was a past leak and the area was noted to be dry at the time of the inspection. Recommend monitoring the area(s) during heavy rain fall for active leaks.

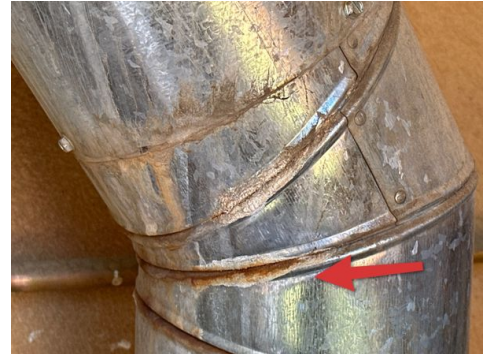
**WATER STAINS (EXHAUST VENT)**

Water stains from past water entry into the exhaust vent pipe was noted. The area was dry at the time of the inspection. Recommend monitoring the area during heavy rain fall for possible leaks. Recommend making repairs if water entry is noted.

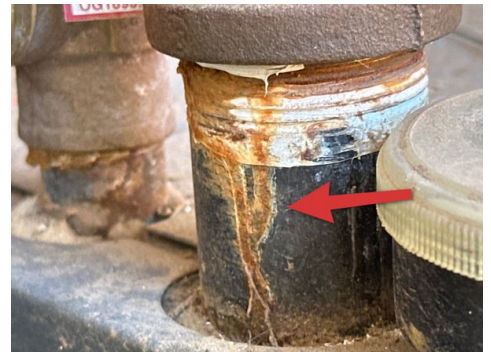
**DIELECTRIC UNION (PAST LEAK)**

The dielectric union shows signs of past leakage of water. No active leaks were observed at this time. The part should be evaluated for repairs. Recommend consulting with a plumbing and boiler heating contractor for any maintenance/further evaluation.

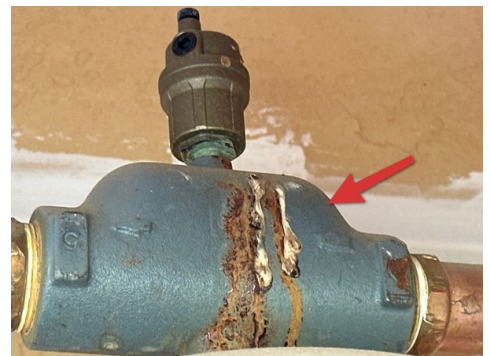
24.1.5 Boiler - 1

**AIR SEPARATOR (PAST LEAK)**

The air separator shows signs of past leakage of water. No active leaks were observed at this time. Recommend consulting with a plumbing and boiler heating contractor for any maintenance/further evaluation.

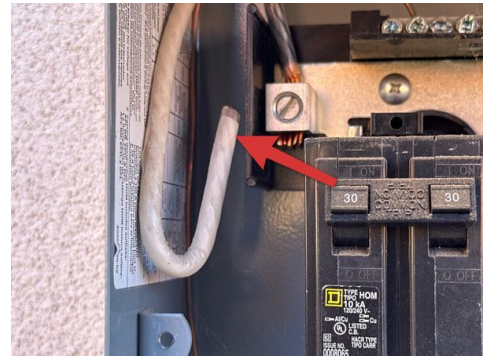
26.12.1 Electrical Sub- Panel(s) Condition

WIRING (IMPROPER TERMINATION)

An electrical wire (x1) located inside the electrical sub panel was noted to be improperly terminated/not connected. Recommend having this condition further evaluated and a wire nut installed to improve the safety of the home.

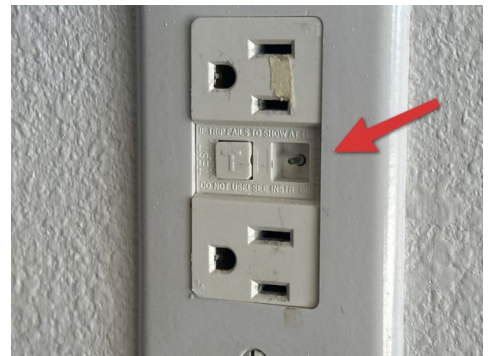
26.15.1 Outlets/Switches - Garage

OUTLET DAMAGE

The outlets (x1) located at the garage north wall are damaged and should be replaced. Recommend consulting with an electrical contractor for repairs for the increased safety of the home.

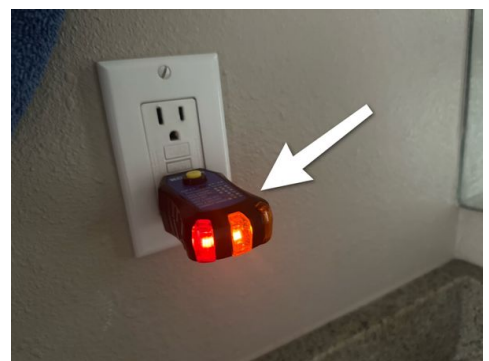
26.17.1 Outlets/Switches - Bathrooms

REVERSE POLARITY

The outlets (x1) located at the hallway bathroom are wired incorrectly. The wiring to these outlets should be evaluated to correct this condition. Recommend consulting with an electrical contractor for repairs for the increased safety of the home.
