Upper Clark Fork Slicken Assessment Report

July 2020

Slicken Assessment Report

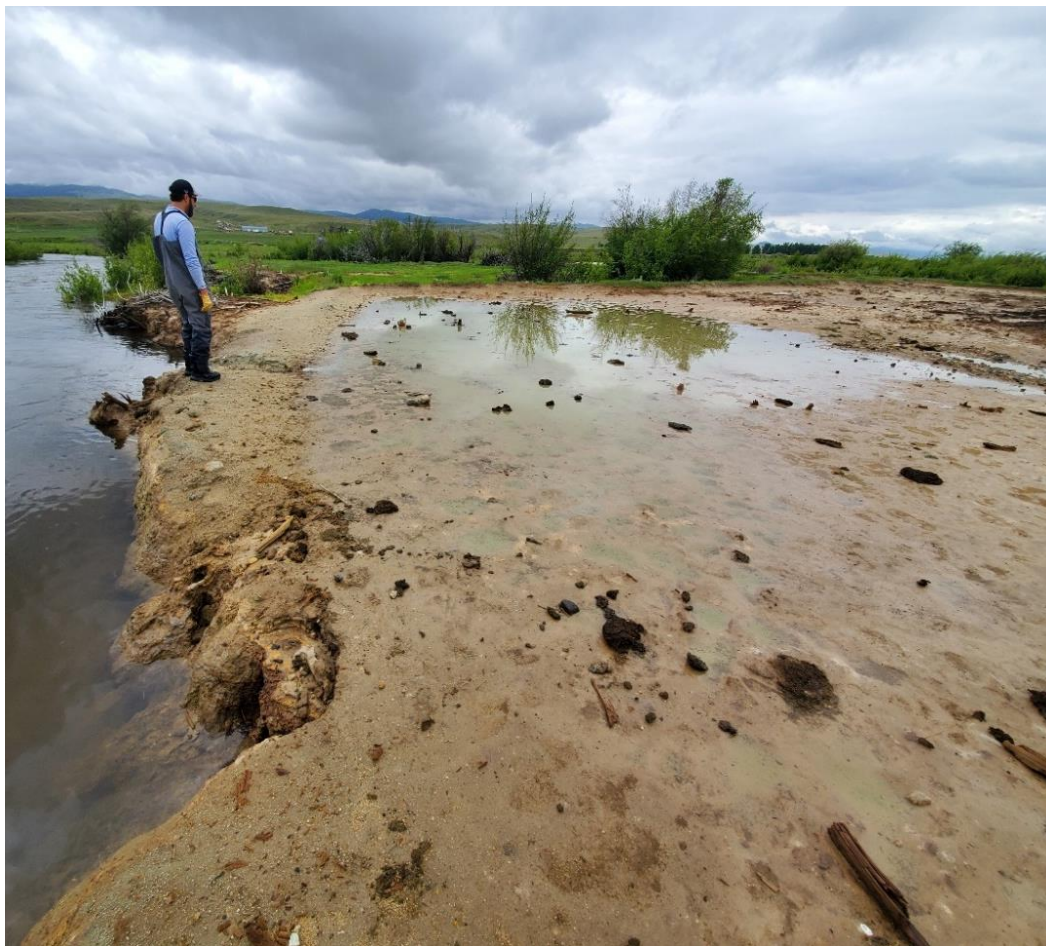
Figure 1. Example of a high-hazard floodplain “slicken” contaminated with high levels of metals including copper and arsenic. The person in the foreground is standing on a crumbling berm that is at risk of complete failure.

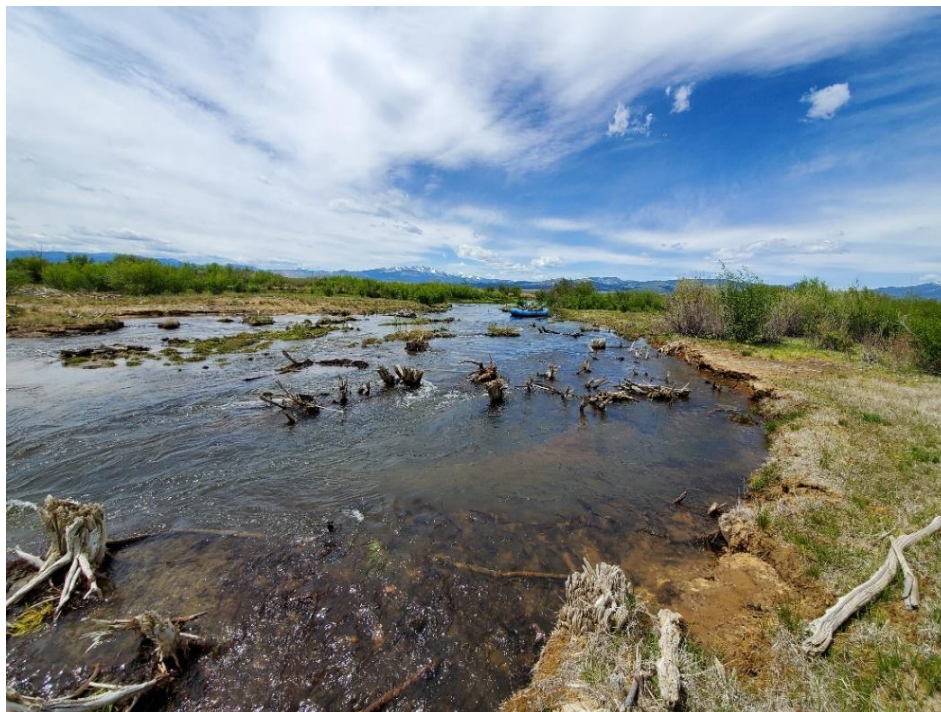
Although the condition of the slickens varied considerably, there were some consistent trends noted, especially in the higher-hazard slickens. Many of the most visibly-contaminated slickens are located on meander tabs that have relatively low elevations (compared to surface water and adjacent floodplain elevation). These meander tab slickens tend to see berm failures at both the top and bottom of the tabs (related to distinct geomorphological forces). In some of the extremely high avulsion hazard slickens head-cutting was noted at the upstream end of the tab with significant down-cutting observed at the lower end. In some instances, these avulsions have matured to the point where much of the exposed contaminated material has been washed downstream (Figure 4).

Figure 4. Newly-formed side channel through a slicken on a meander tab.

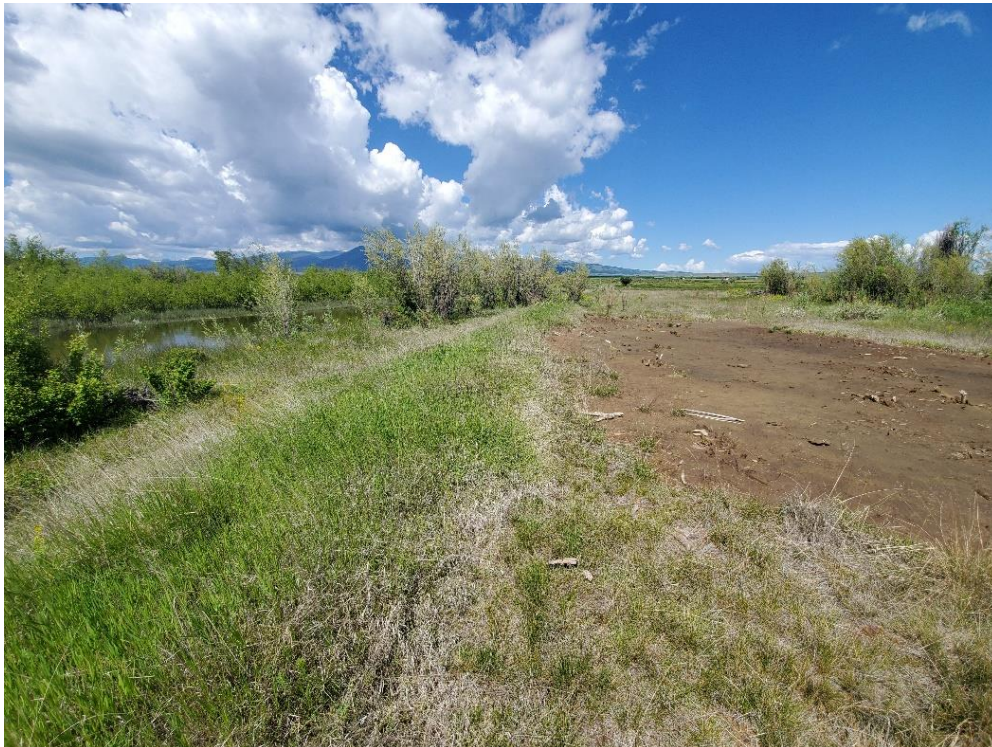
Figure 7. An intact berm on slicken #94. Note that the berm is vegetated and keeps slicken material out of the river (on the left).

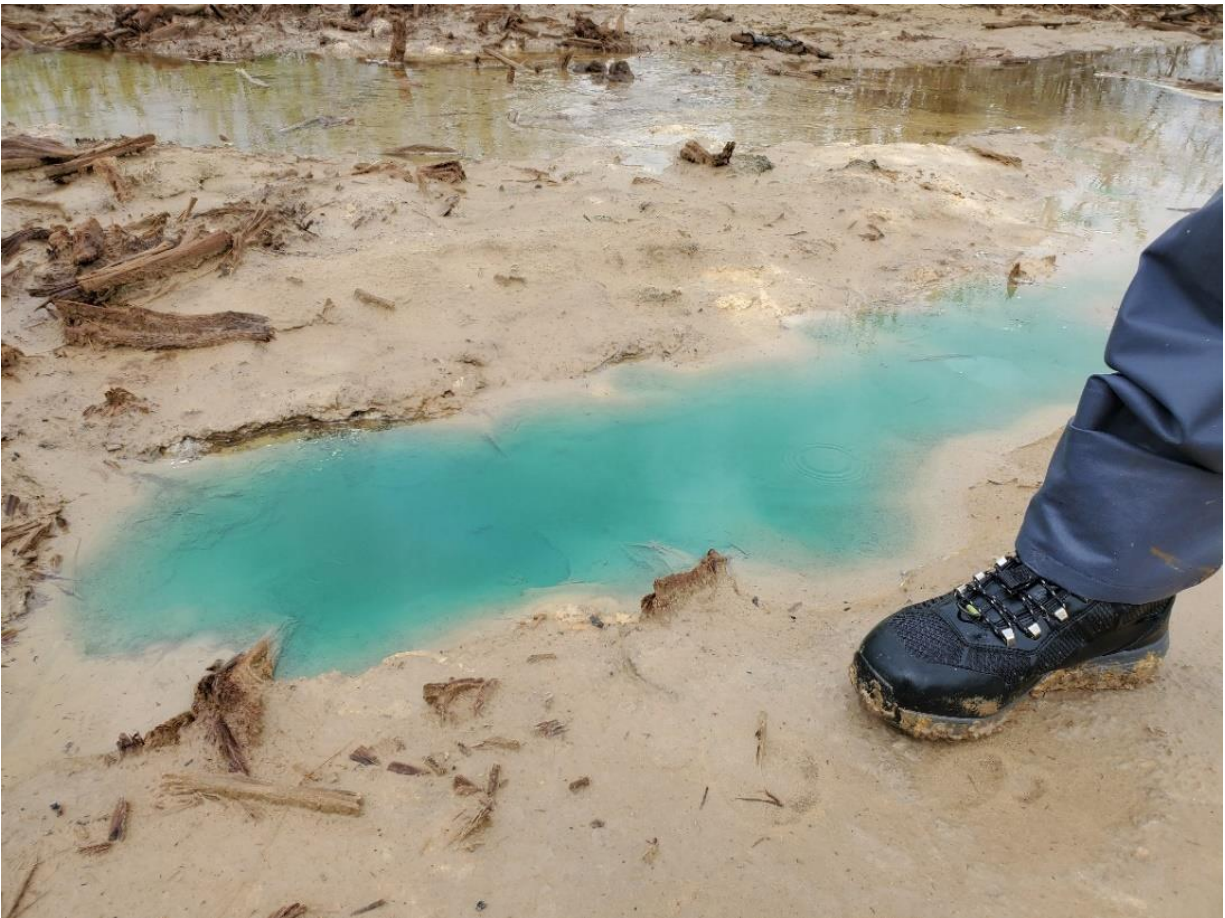
Figure 8. Ponded water on slicken #6.

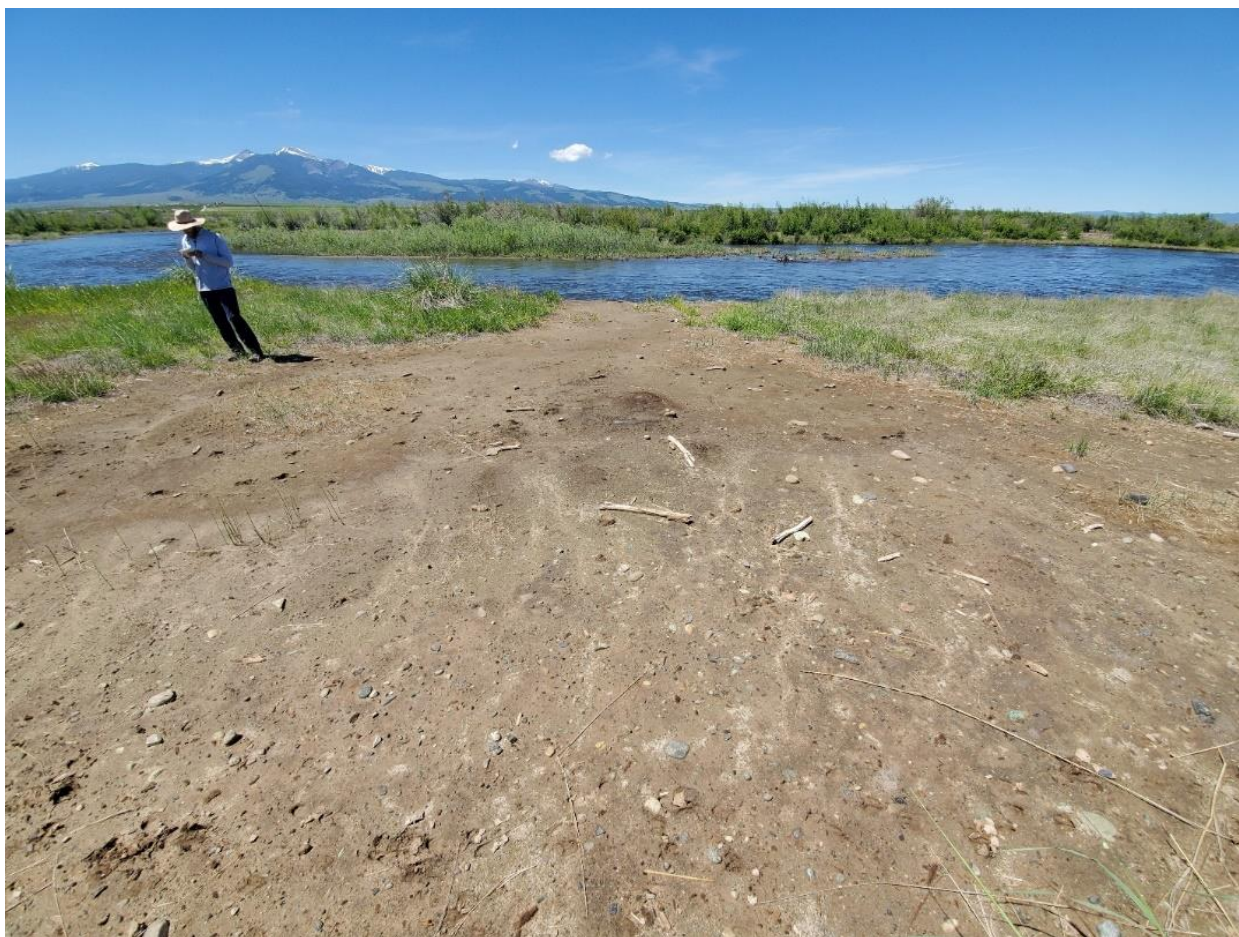
Figure 9. Clear flow path leading from slicken #83 (a small but severe slicken located between Sager Lane and Deer Lodge) to the Clark Fork River.

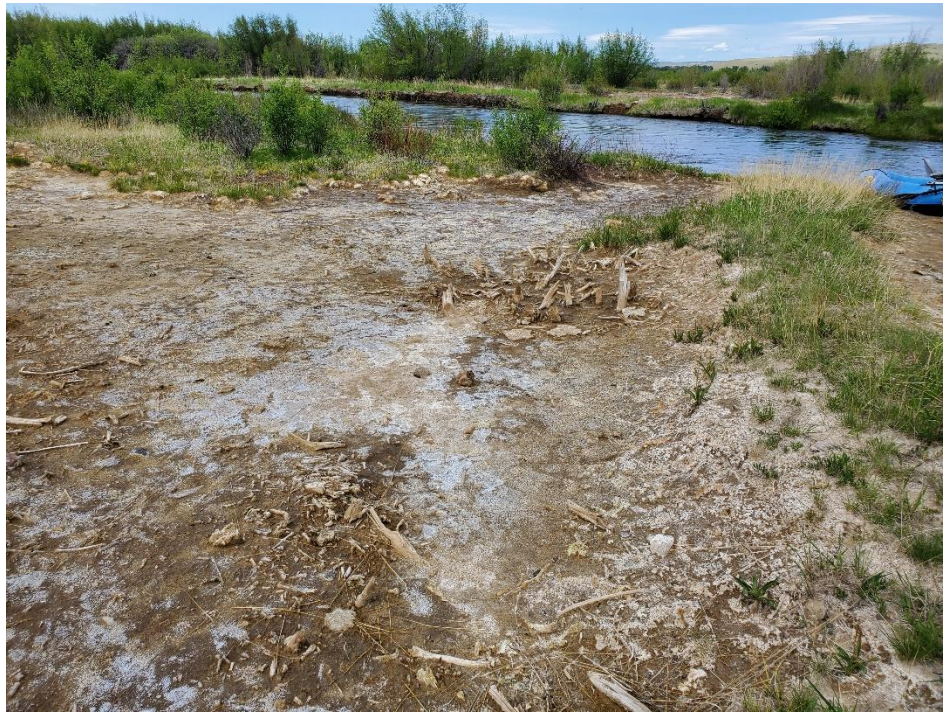
ID#22, **SER = 4** (AR=3): Built-up salts on this slicken will flow into the river during a rainfall event.

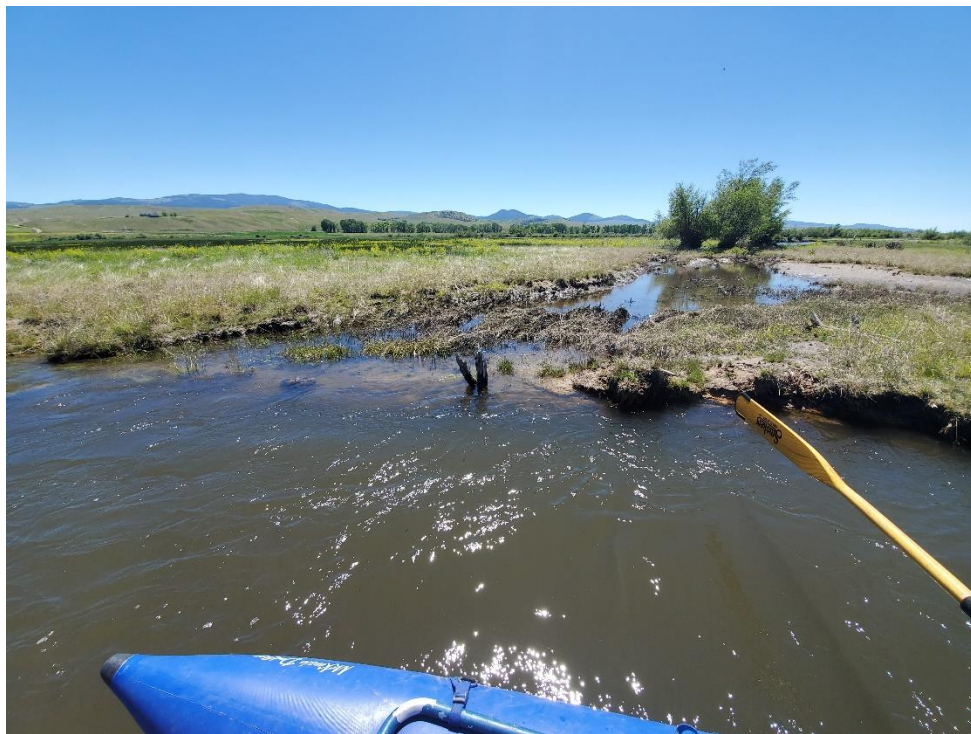
ID#74, **AR=4** (SER=3): Slicken is inundated and connected, and channel-forming processes are evident.

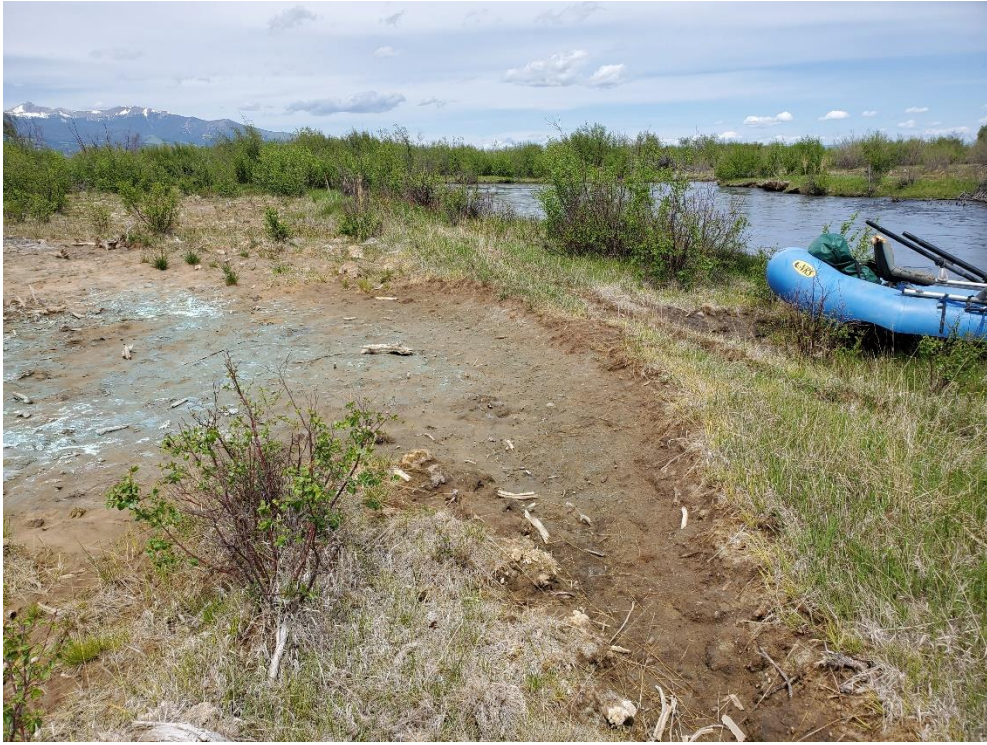
ID#11, **SER=3** (AR=2): Large, severe slicken, but berm is partially intact, reducing SER.

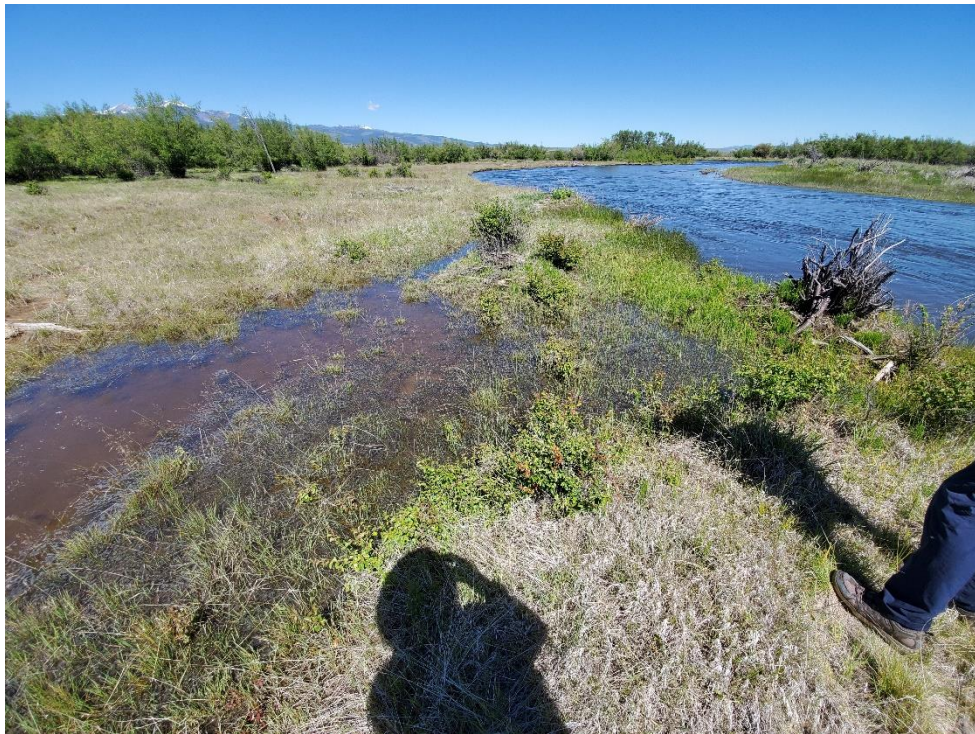
ID#71, **AR=3**, (SER=3): Evidence that river was flowing through slicken, but not at the time of the survey.

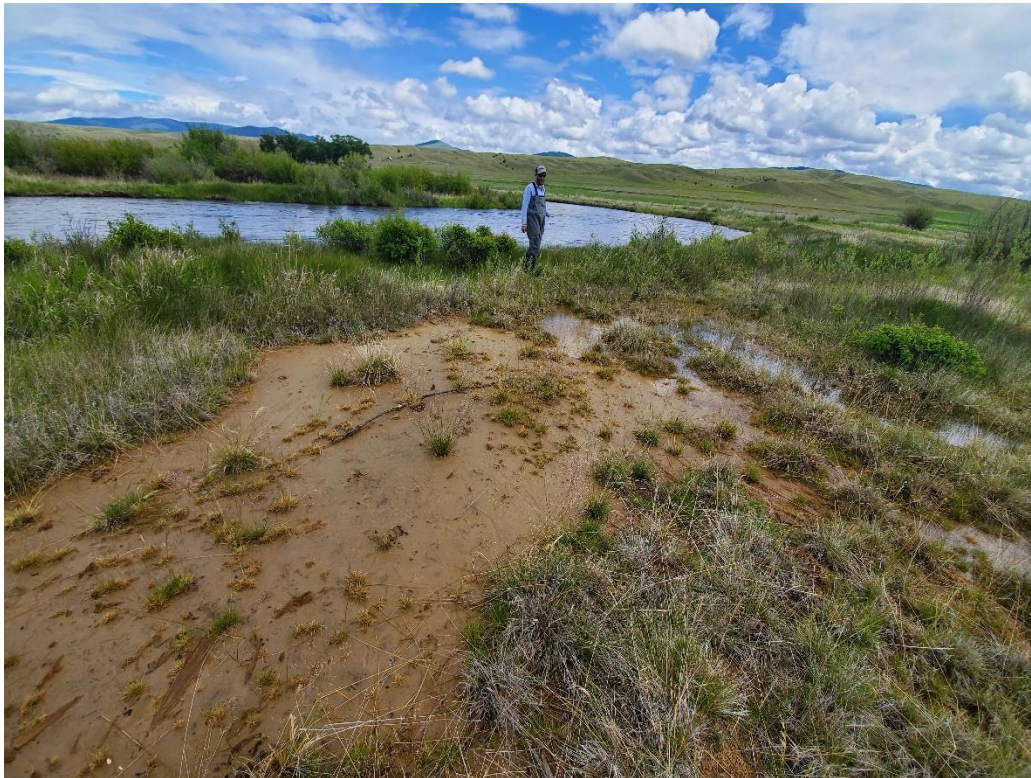
ID#31, **SER=2, AR=2**: A good example of a berm keeping contamination from contacting the river.

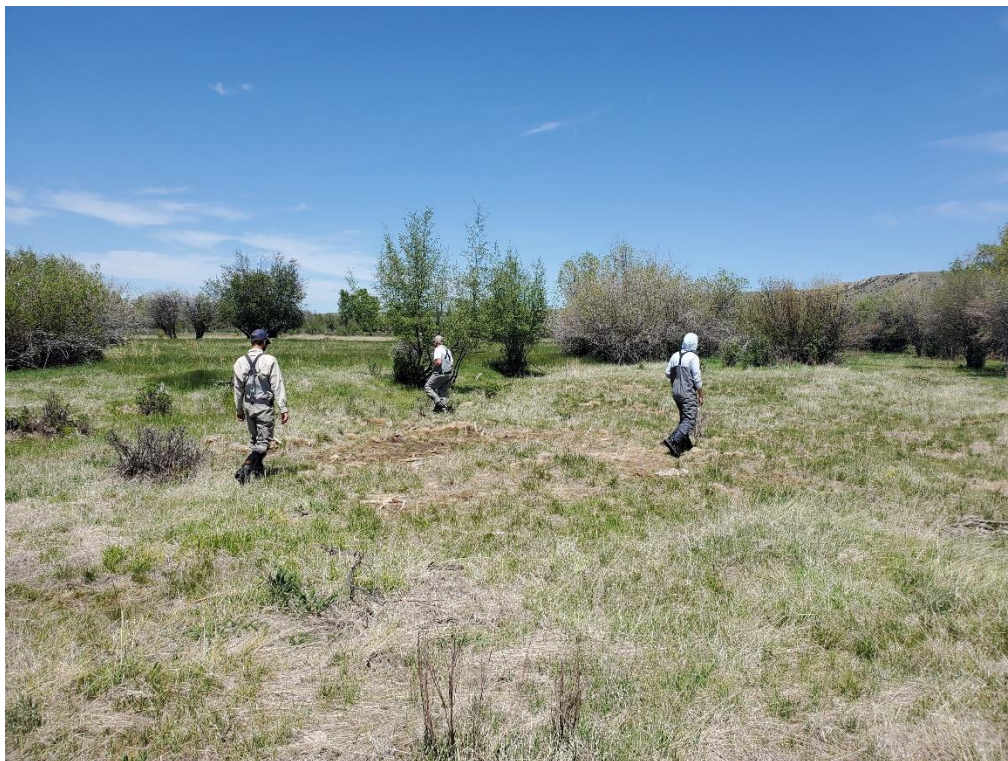
ID#60, **SER=1, AR=1**: A spotty and mostly-vegetated slicken located away from the river.
