Upper Clark Fork Slicken Assessment Report

February 2022

Slicken Assessment Report

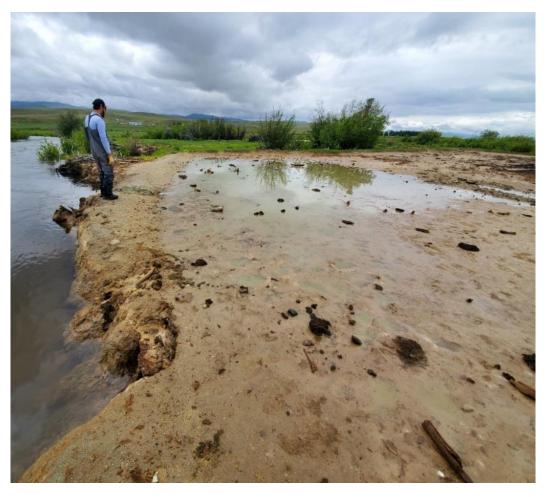
Figure 1. Example of a high-hazard floodplain "slicken" contaminated with high levels of metals including copper and arsenic. The person in the foreground is standing on a crumbling berm that is at risk of complete failure.

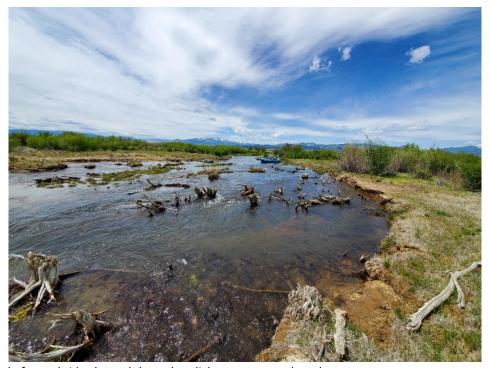
Although the condition of the slickens varied considerably, there were some consistent trends noted, especially in the higher-hazard slickens. Many of the most visibly-contaminated slickens are located on meander tabs that have relatively low elevations (compared to surface water and adjacent floodplain elevation). These meander tab slickens tend to see berm failures at both the top and bottom of the tabs (related to distinct geomorphological forces). In some of the extremely high avulsion hazard slickens head-cutting was noted at the upstream end of the tab with significant down-cutting observed at the lower end. In some instances, these avulsions have matured to the point where much of the exposed contaminated material has been washed downstream (Figure 4).

Figure 4. Newly-formed side channel through a slicken on a meander tab.

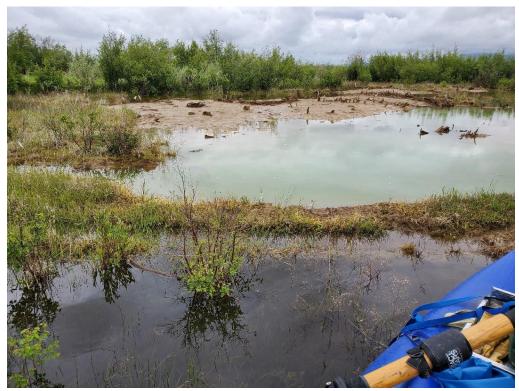
Furthermore, contaminated shallow surface water was noted ponding at the downstream end of several of the severely-contaminated slickens. In some instances, this ponded water was just inches from the lip of a berm on the downstream end of a meander tab. These particular slickens pose an extremely high risk to the river during rainfall events. When the lower berm on these tabs is overtopped due to excessive surface runoff, contaminated water interacts directly with the river (Figure 5). This is the same mechanism that was documented on Slicken #6 after the September 2019 fish kill and is suspected to be a primary pathway transporting heavy metals in-channel during rainfall events (via aqueous and suspended sediment form).

Figure 5. Partially-functioning berm on slicken #4. The berm contains some contaminated water, but is in danger of being overtopped during high river flows.

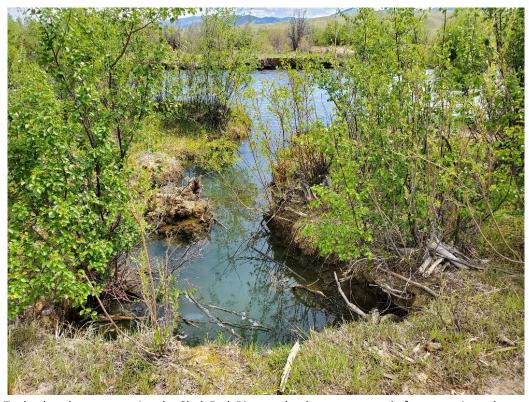
In addition to direct surface connection, there was also clear evidence of contaminated groundwater interaction. At several of the severely contaminated slickens, teal-stained water was noted lingering in slack water areas on the downstream end of the meander tabs (Figure 6). This contaminated water is interacting directly with the Clark Fork River and potentially impacting aquatic resources downstream.

Figure 6. Teal-colored water entering the Clark Fork River at the downstream end of a contaminated meander tab on slicken # 4.

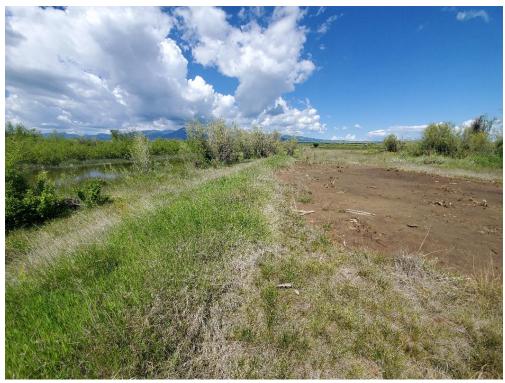
Figure 7. An intact berm on slicken #94. Note that the berm is vegetated and keeps slicken material out of the river (on the left).

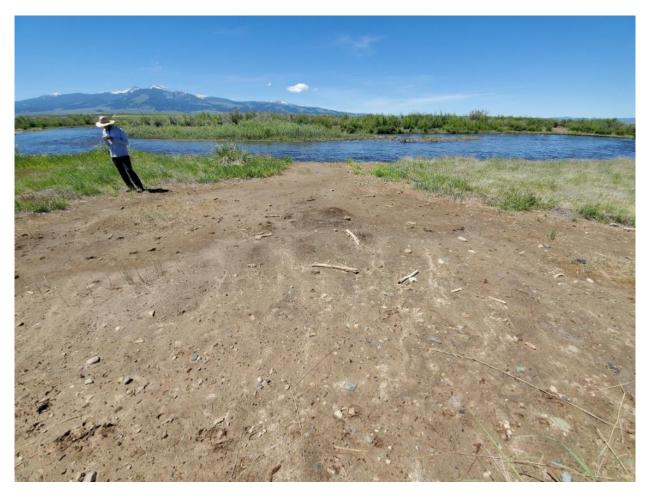
Figure 9. Clear flow path leading from slicken #83 (a small but severe slicken located between Sager Lane and Deer Lodge) to the Clark Fork River.

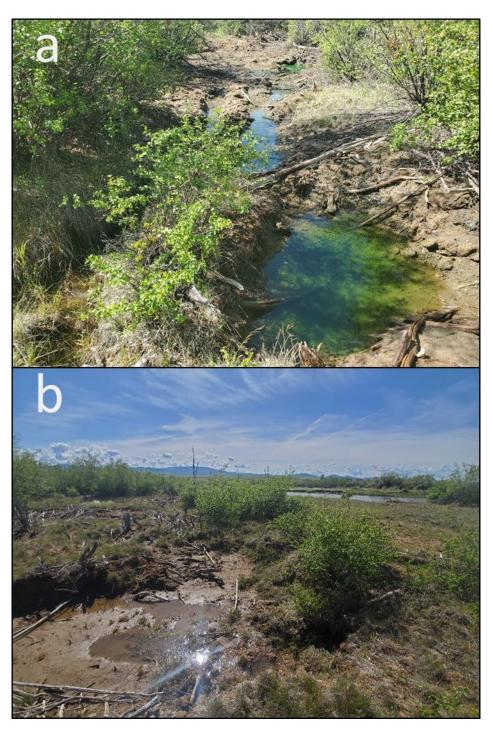
In some cases, slicken avulsions are caused by the direct erosive power of the river. These avulsions are often found on the downstream end of meander tabs where backwaters and eddies form. In other cases, avulsions may form from head-cutting caused by surface runoff over slickens. This surface runoff collects at the lowest point and can form a flow channel and head-cut (Figure 10).

Figure 10. The photos above show an avulsion channel that has formed from surface runoff and erosion of slicken #95 (a large, high risk slicken between Sager Lane and Deer Lodge). Photo "a" is on the lower, downstream portion of the meander tab, photo "b" was taken at the top of the tab. This channel is headcutting toward the upstream end of the meander tab and is within a few meters of causing the river to avulse into the slicken.

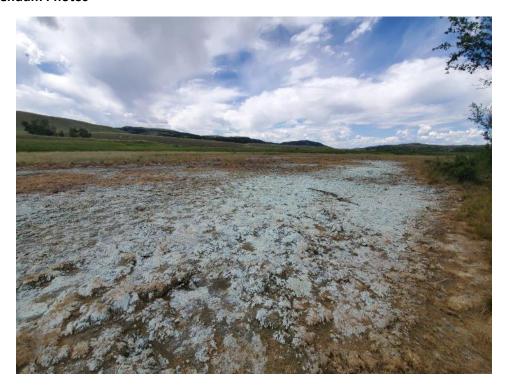
ID #151: This abandoned oxbow slicken is incredibly expansive, covering approximately 12 acres.

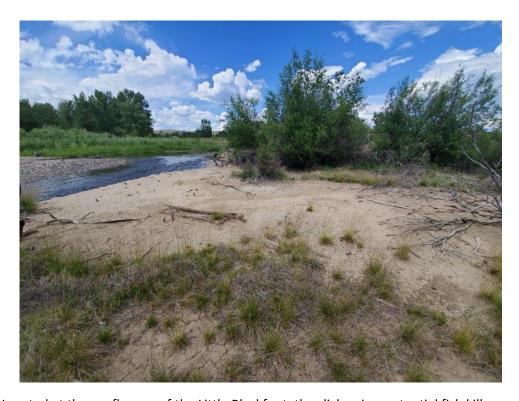
ID #154: Located at the confluence of the Little Blackfoot, the slicken is a potential fish killer.

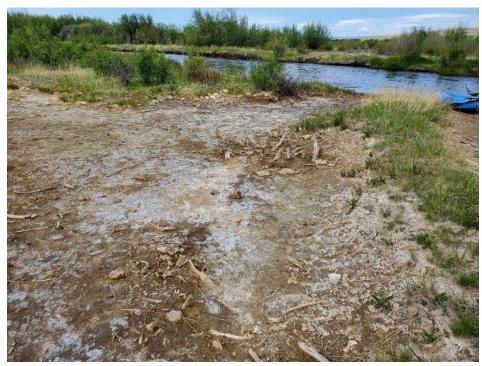
ID#22, **SER = 4** (AR=3): Built-up salts on this slicken will flow into the river during a rainfall event.

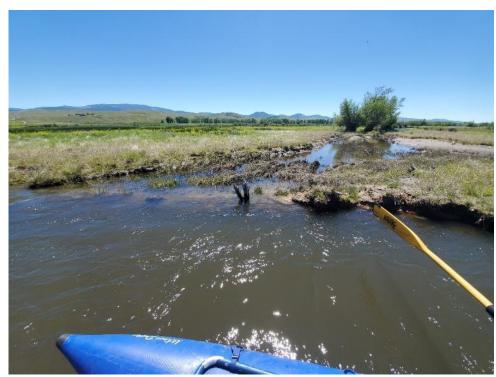
ID#74, AR=4 (SER=3): Slicken is inundated and connected, and channel-forming processes are evident.

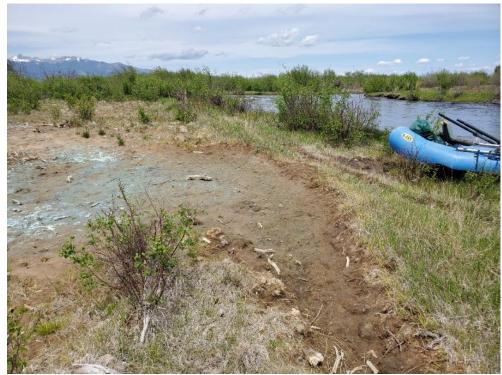
ID#11, **SER=3** (AR=2): Large, severe slicken, but berm is partially intact, reducing SER.

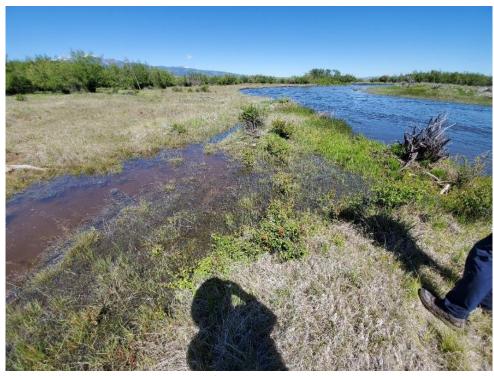
ID#71, AR=3, (SER=3): Evidence that river was flowing through slicken, but not at the time of the survey.

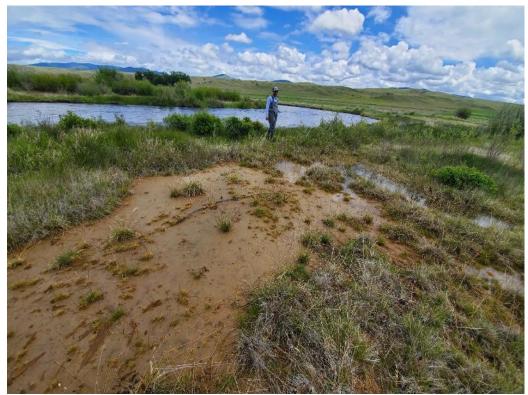
ID#31, **SER=2**, **AR=2**: A good example of a berm keeping contamination from contacting the river.

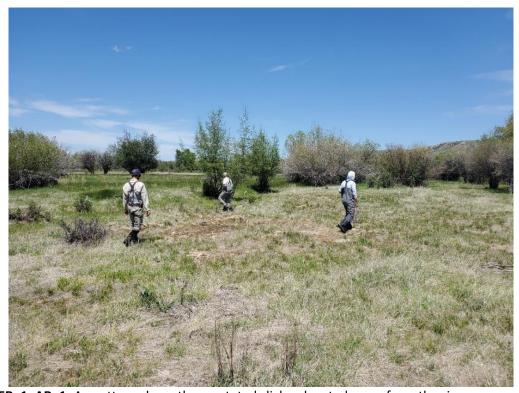
ID#60, **SER=1**, **AR=1**: A spotty and mostly-vegetated slicken located away from the river.
