Superior Value Property Service

Commercial Inspection Report

1234 Commercial St. , Dallas, TX 75080
Inspection prepared for: The Commercial Company.
Date of Inspection: 5/14/2024 Time: 8:00 am
Weather: 75 Degrees

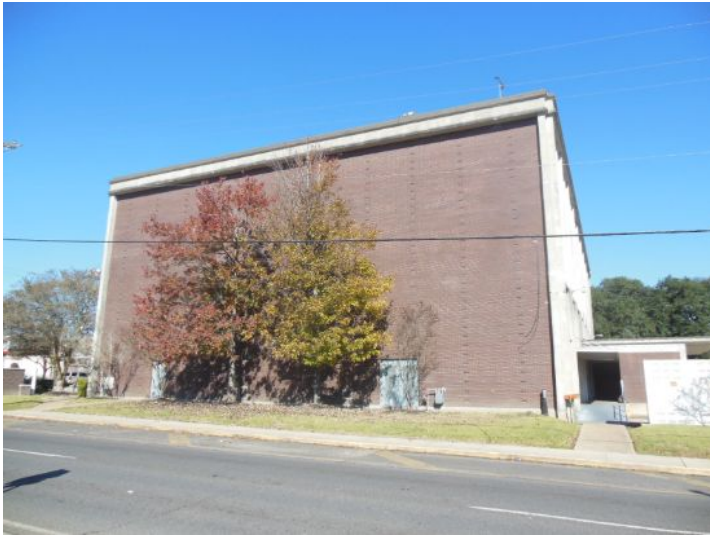
Right Side

- Missing mortar in various areas. Recommend ongoing maintenance.

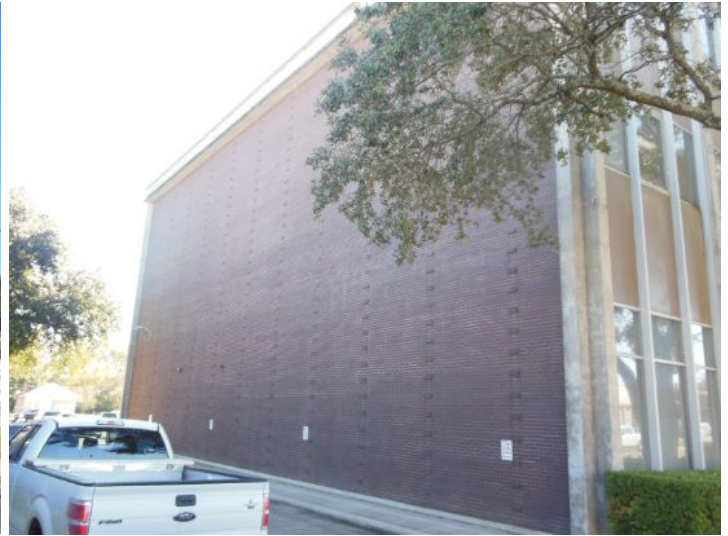
Left Side - Brick Exterior

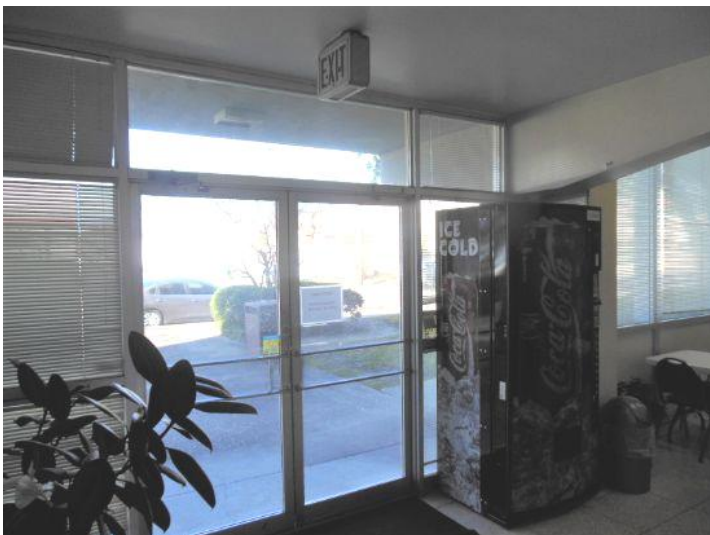
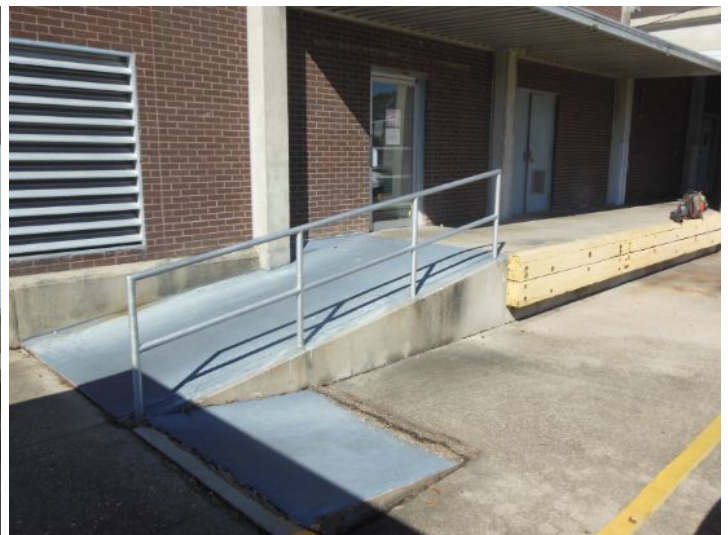
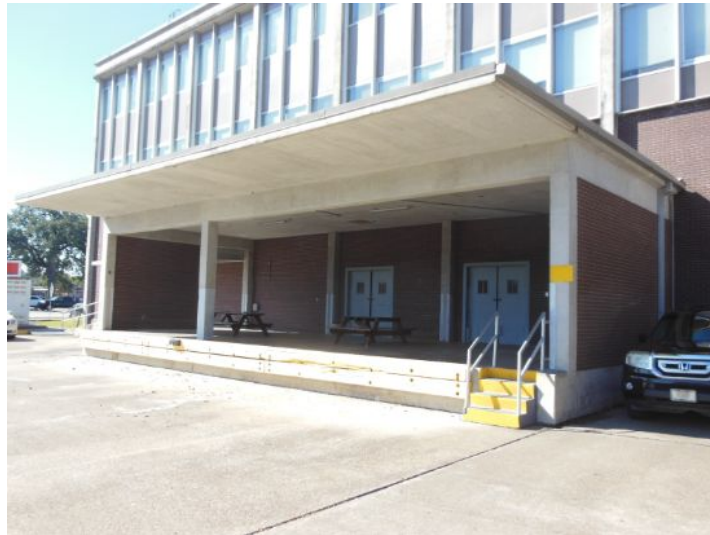
- Main Entry door is aluminum storefront material with tempered glass

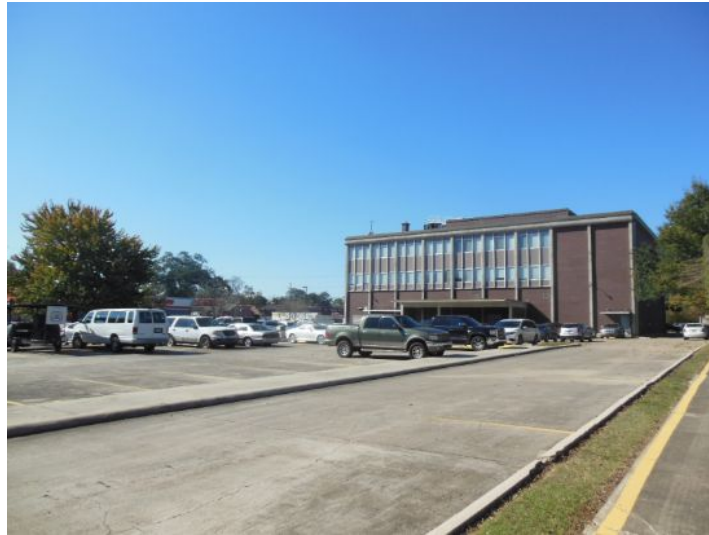
Materials: Concrete
