*Superior Value Property Service*  
Property Inspection Report

1234 Main St, Alexandria, LA 71301  
Inspection prepared for: Client Jones  
Date of Inspection: 12/11/2023 Size: 1810 sqft  
Weather: 72 degrees

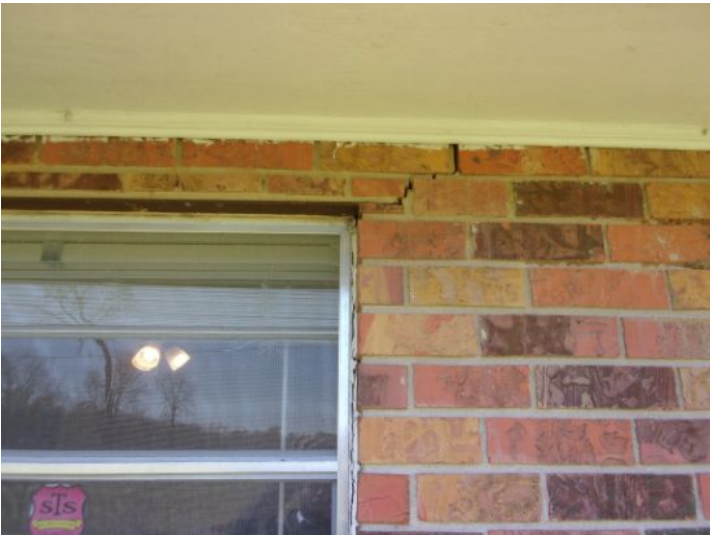
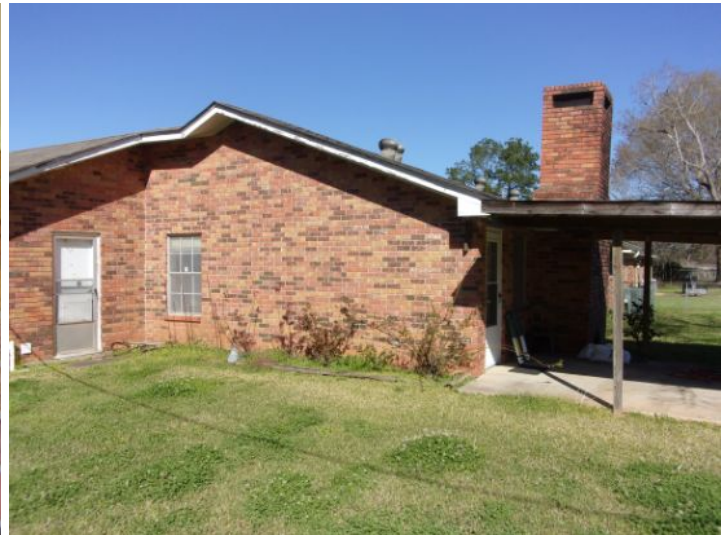
- Paint is peeling
- Cracks observed within brick siding at several areas. Recommend further evaluation and repair by qualified contractor.

Peelings paint at fascia siding.

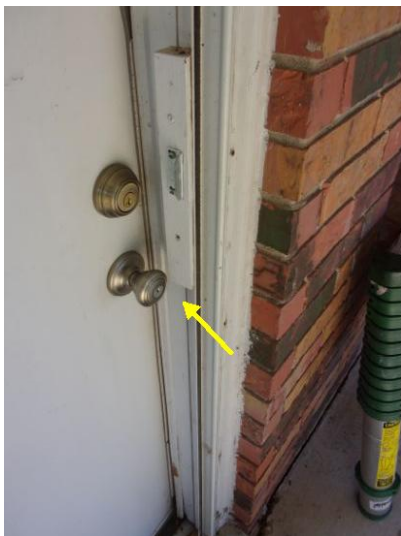
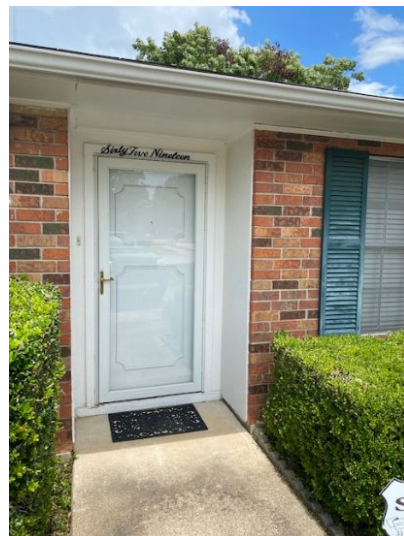
- The rear door has an irregularly repaired jamb that has created a pinch point safety concern.
