**Revised**  
**FULL RESERVE STUDY**  
**Antigua**  
**Condominium**

**Ocean City, Maryland**  
**Inspected - May 21, 2020**  
**Revised - February 11, 2021**

Antigua Condominium  
Ocean City, Maryland

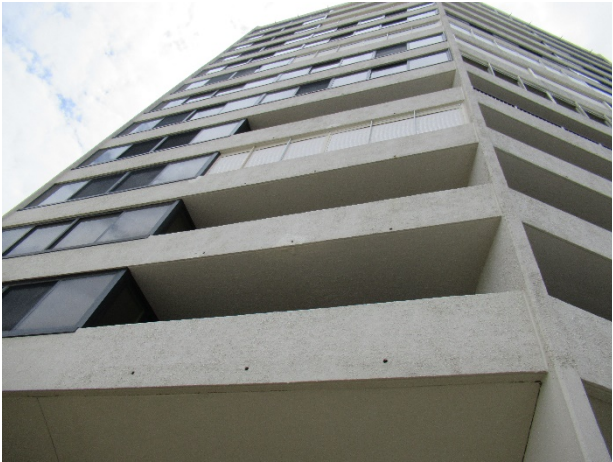
**Condition:** Good overall

**Typical exterior balconies**

**Useful Life:** Capital repairs including a close-up visual inspection, patching of delaminated concrete, routing and filling of cracked concrete, and waterproof coating applications every 8- to 12-years.

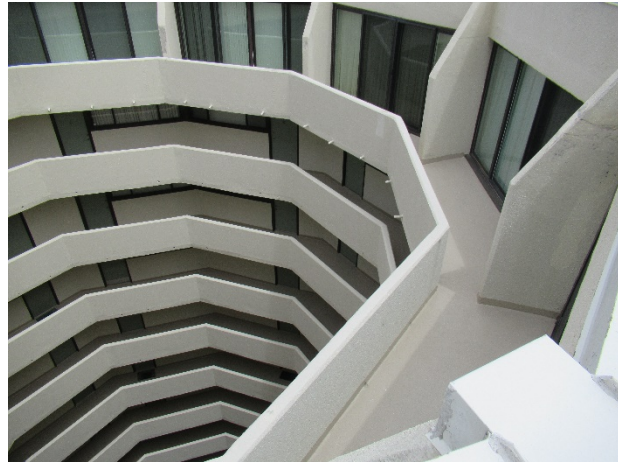
**Interior balcony overview (14<sup>th</sup> floor only)**

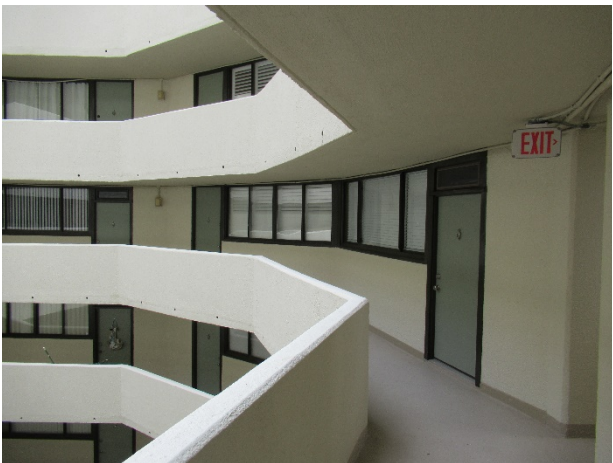
**Typical interior walkway overview**

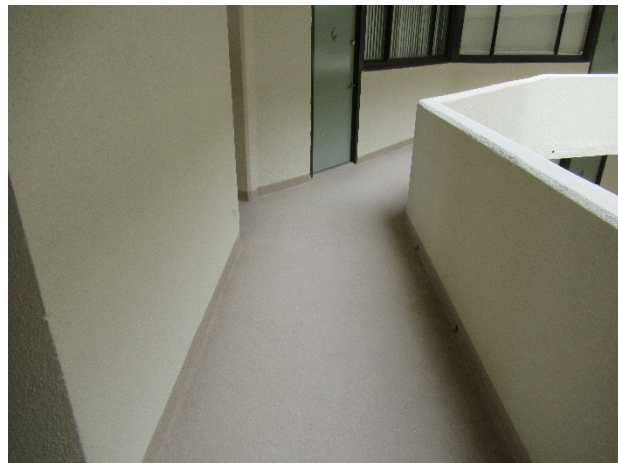
**Interior walkway surface**

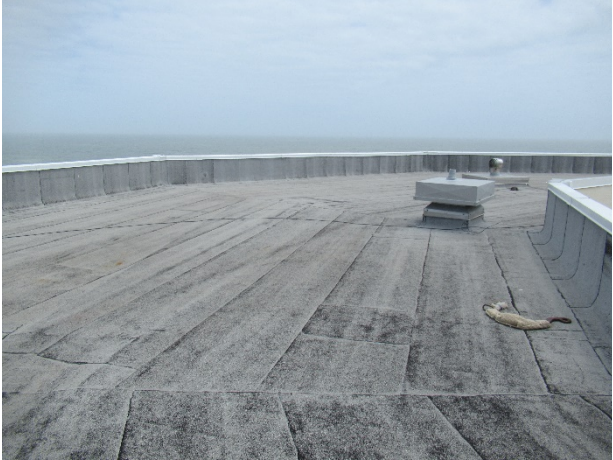
**Condition:** Fair overall with previous repairs and general deterioration evident.

**Roof overview**

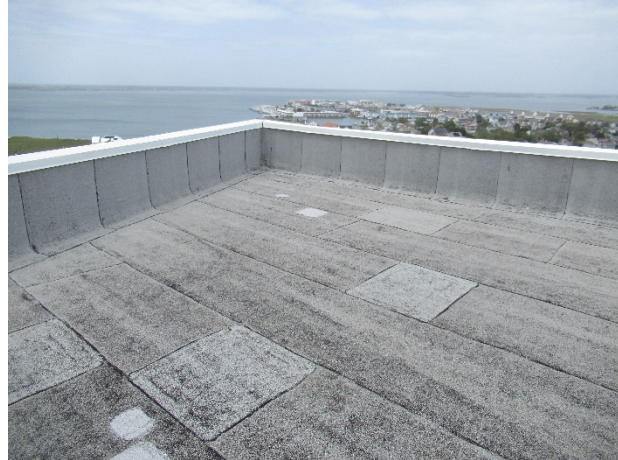
**Roof overview**

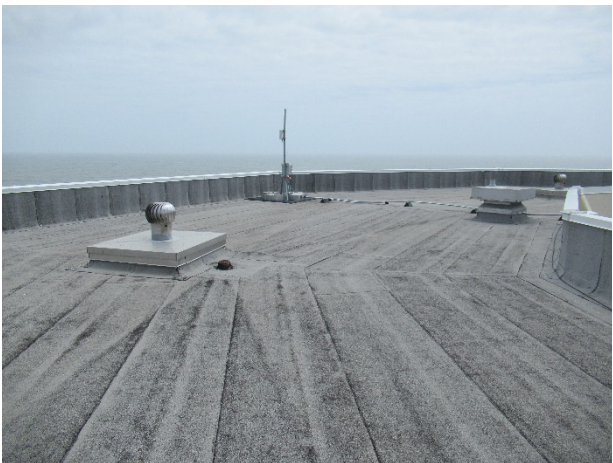
**Roof overview**

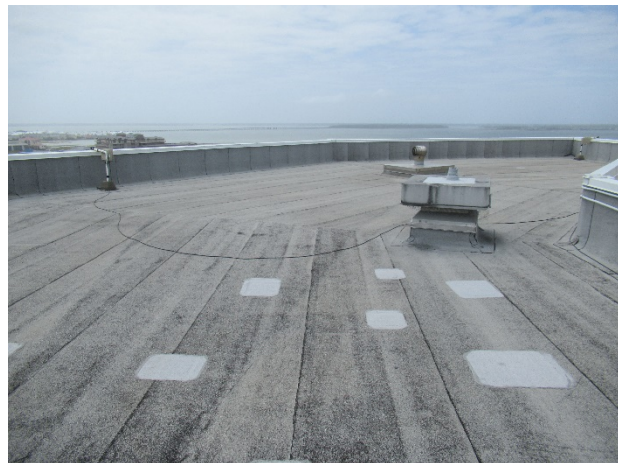
**Previous roof repairs**

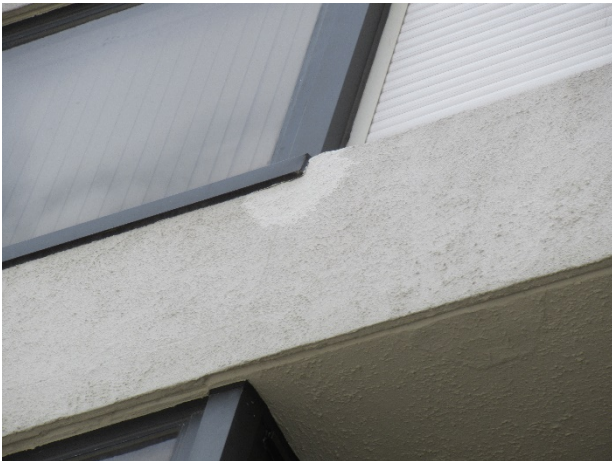
**Condition:** Good to fair overall with previous repairs, finish deterioration and trapped water evident

**Previous stucco repair at window**

**Useful Life:** We recommend inspections, repairs and paint finish applications every 8- to 10-years.

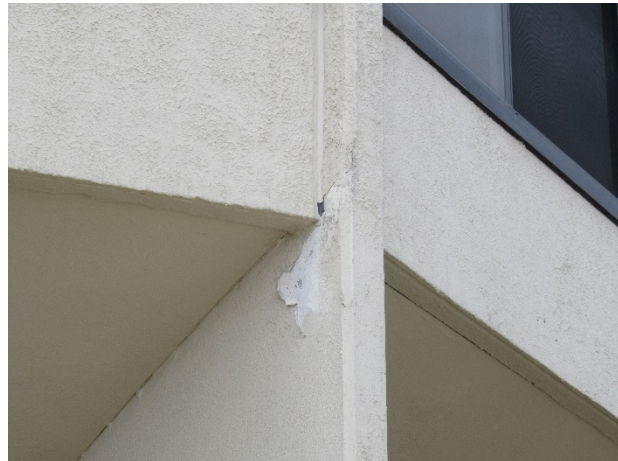
**Stucco finish deterioration**

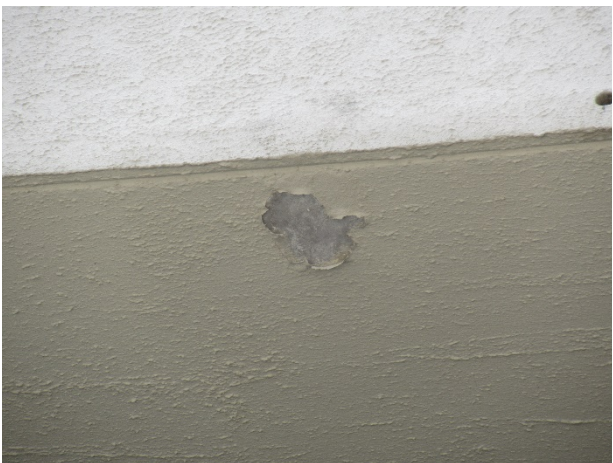
**Stucco finish deterioration at soffit**

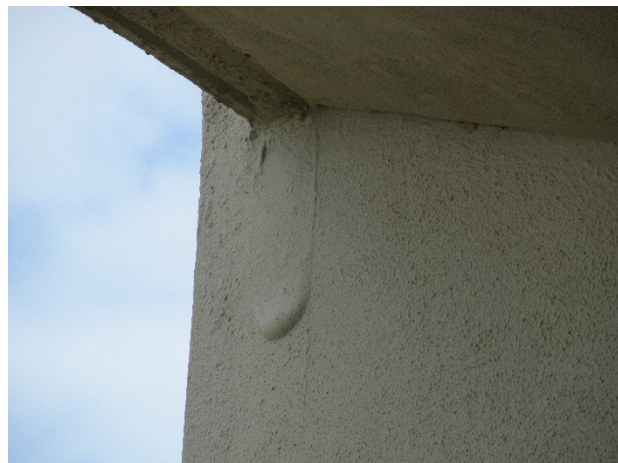
**Water trapped behind stucco coating**

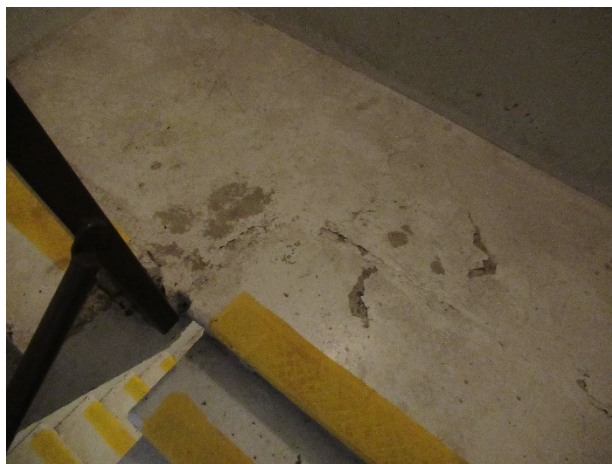
**Conditions:** Fair overall with finish deterioration evident

**Stairwell paint finish deterioration**

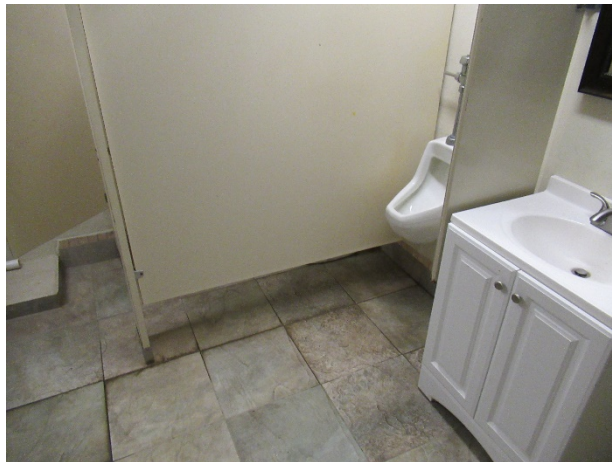
**Condition:** Fair overall with general deterioration evident

**Rest room floor covering, partition and plumbing fixture overview**

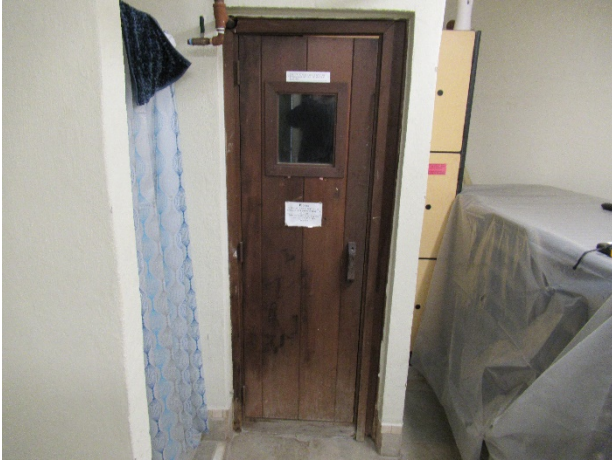
**Condition:** Fair overall with wood deterioration evident

**Sauna door**  
Note: Wood deterioration.

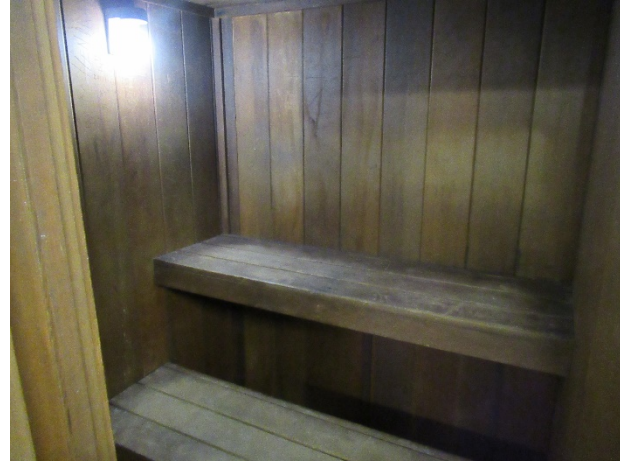
**Sauna interior**  
Note: Wood deterioration.

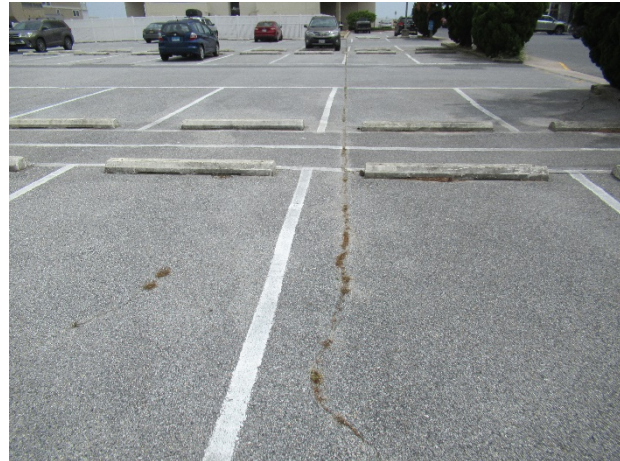
**Condition:** Fair overall with cracks and deterioration evident

**Parking area overview**  
**Note: Cracks and deterioration.**

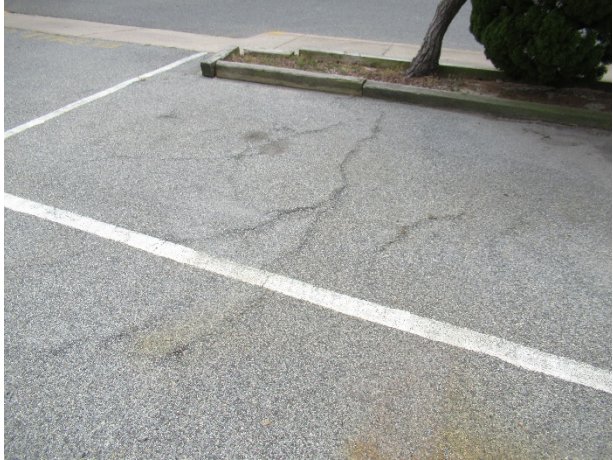
**Pavement cracks and deterioration**

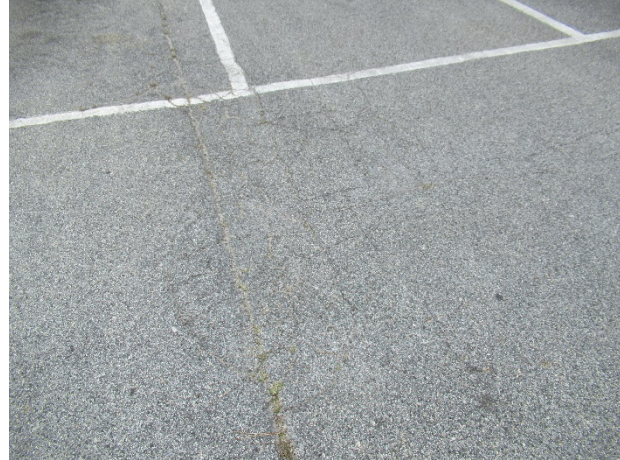
**Pavement cracks and deterioration**

application of two or more new lifts of asphalt. We recommend mill and overlayment on asphalt pavement that exhibits normal deterioration and wear. We recommend total replacement of asphalt pavement that exhibits severe deterioration, inadequate drainage, pavement that has been overlaid multiple times in the past or where the configuration makes overlayment not possible. Based on the apparent visual condition and configuration of the asphalt pavement, we recommend the mill and overlay method of repaving followed by the total replacement method of repaving at Antigua.

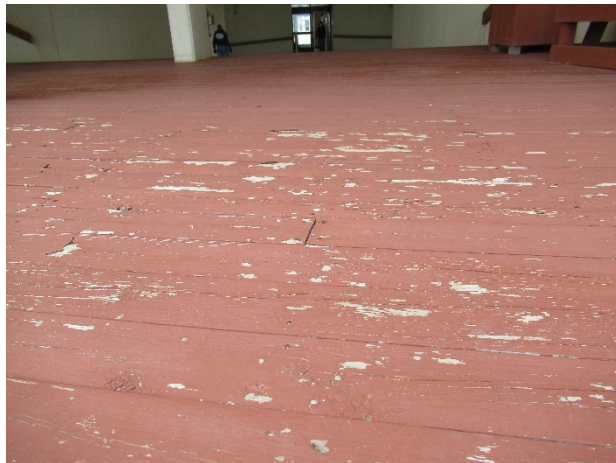
**Condition:** Reported unsatisfactory

**Paint finish deterioration**

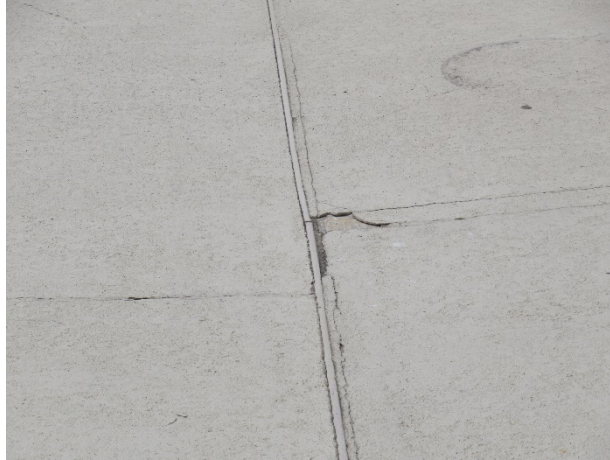
**Condition:** Fair overall with coating deterioration and cracks evident; we assume the 2020 coating and repair event remedied these deficiencies.

**Coating deterioration and cracks**

**Useful Life:** The useful life of a concrete pool deck is up to 60 years or more with timely repairs. We recommend the Association conduct inspections, partial replacements and repairs to the deck every 8- to 12-years in conjunction with coating replacements.
