# What Happened on I95?

June 19, 2023

Brian L. Bullock, Founder Road Aware Safety Systems LLC

## Tanker Fire Causes I95 Collapse

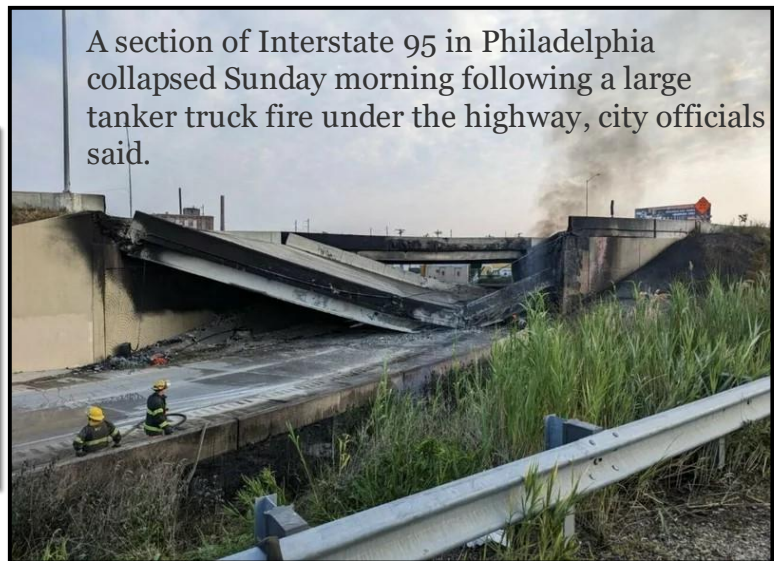
A section of Interstate 95 in Philadelphia collapsed Sunday morning following a large tanker truck fire under the highway, city officials said.

The proximate cause was a tanker truck fire that ignited on Cottman Avenue where it passes beneath the I95 roadway. The intensity and duration of the fire weakened the steel supporting beams for the overpass to the point that they could no longer support the northbound portion of the roadway.

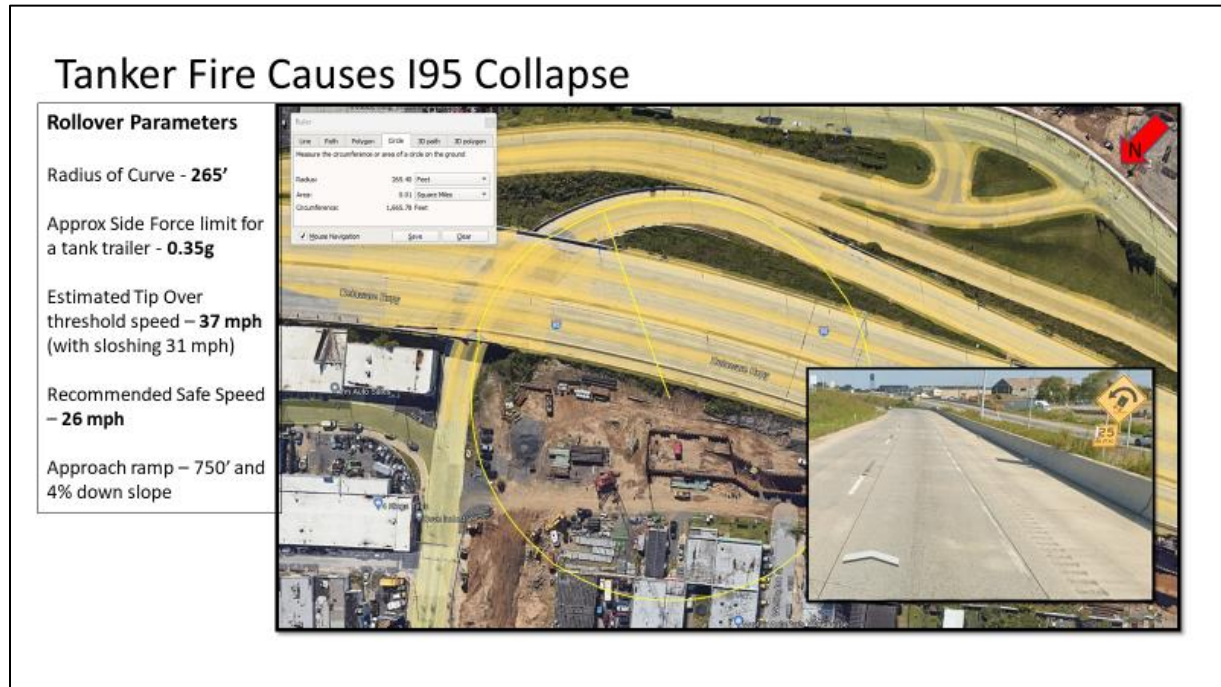
An exit off I95 northbound feeds traffic onto Cottman Ave. It is unlikely that there was conflicting traffic since there is no entrance to the northbound freeway at Cottman Ave. The pictures of the scene suggest that the most intense portion of the fire occurred on the north edge of the underpass. The north edge was also the location where the first responders were pouring water to contain the fire. Video shows the semi-truck descending the ramp and then impacting the barrier on the right side precipitating an immediate explosion. All of this suggests

that the driver lost control of the vehicle, hit the barrier and the tanker rolled over onto the right edge of the Cottman roadway, rupturing one or more tanks which fed the resulting fire.

As shown above, the Cottman exit has a tight radius curve that requires a semi-truck to slow down after leaving the traffic lanes on I95. There is a 750 ft. approach to the curve with a 4% downslope. This provides ample time to slow to a safe speed before entering the curve. The tip over threshold speed for a tanker is approximately 37 mph (with some variation depending on the condition of the tires, undercarriage, and trailer). If it was a partial load the tip over threshold speed could be much lower due to sloshing (approximately 31 mph).

We may never know unless the tractor was equipped with a dash cam that somehow survived the conflagration. **Road-Aware** has been developed to alert truck drivers and provide recommended safe speeds\* on curves and descents based on their vehicle and load. It is our aspiration that using this system would help prevent this type of disaster, loss of life, and destruction. The use of **Road-Aware** in several field trials has been instrumental in improving driver performance in critical sections of the roadway where geometry if not approached properly can lead to tragedy as happened here. See more at [www.road-aware.com](http://www.road-aware.com)
