**MICHIGAN  
INFRARED  
CONSULTING LLC**

Customer	John Q Customer
Address	16144 Forder Hwy
City State Zip	Detroit Michigan 48146
Date	2/28/11
Time of Day	6:30 am
Weather	Sunny 37 degrees Winds light and varible House faces West
Inspector	Certified Thermographer

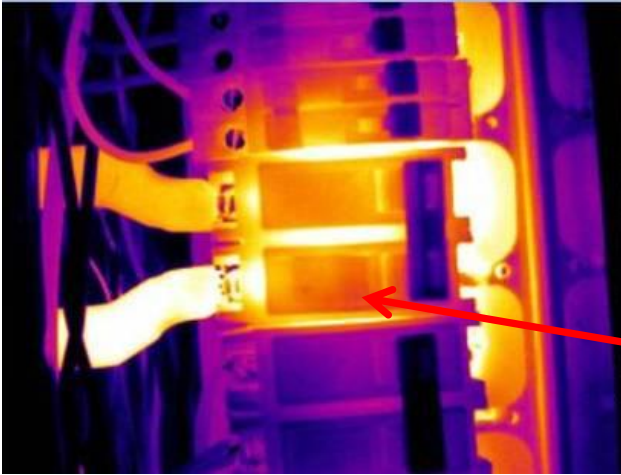
Location	Main Electrical Service Panel
Date/Time	2/28/11 7:00am
Issue	Faulty Breaker
Recommendation	See Notes below

**Air infiltration** around windows should be evaluated by a window specialist. Correction may include the installation of new weather striping and caulking. Correction of areas that appear to have **inadequate insulation or no insulation** are not easily remedied. Walls and floor areas that may need serviced may require the removal of drywall or other wall coverings and would require them to be re-installed, finished and painted. You will need to consult with an installation specialist regarding this condition. **Moisture** intrusion should always be confirmed with a moisture meter. **Electrical faults** should be evaluated by a licensed Electrician.

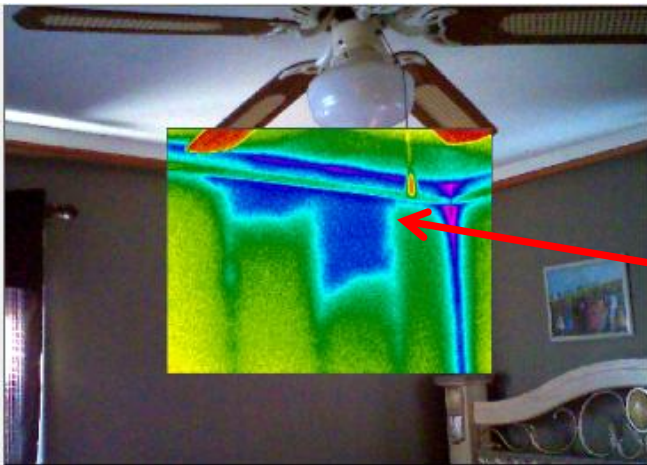
Location	Rear Bedroom Wall facing West
Date/Time	2/28/11 8:00am
Issue	Insulation Void
Recommendation	See Notes below

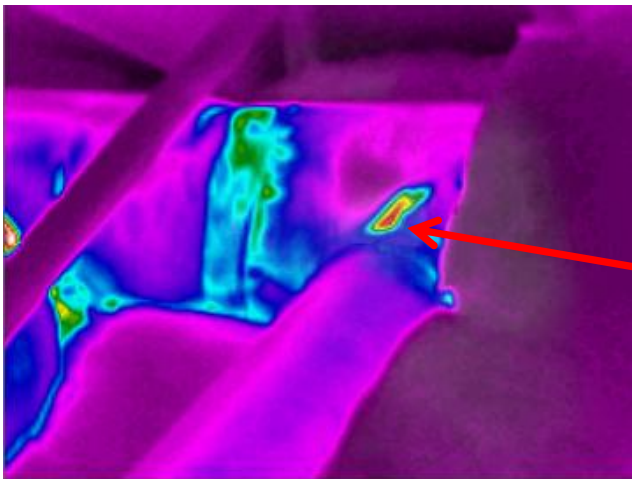
Location	Attic Main Heating/Cooling Trunk line
Date/Time	2/28/11 4:00pm
Issue	Gaps
Recommendation	See Notes below

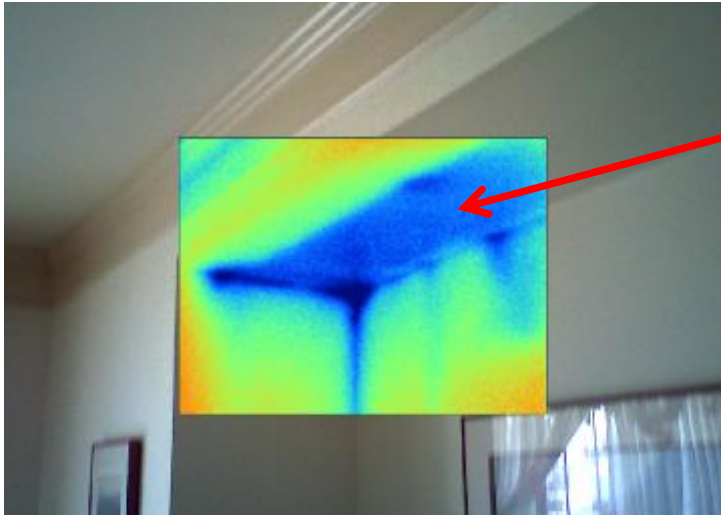
Location	Living Room South Wall Adj to Master Bedroom South
Date/Time	2/28/11 9:00am
Issue	Insulation Void
Recommendation	See Notes below
