STANDARD PROPERTY & TIMBER PEST REPORT

Report number: **1637784963172**
Inspection date: **25-11-2021**
Client: **Sample**
Property address: **Sample Street, Gold coast**

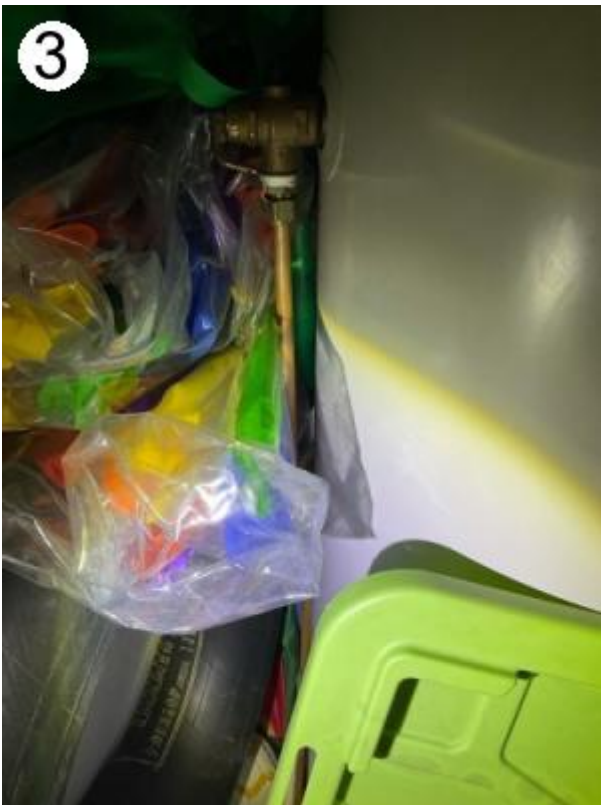
#3. Showing no tempering value

No tempering valve fitted to hot water system. Recommend a plumber rectify to reduce the risk of burns.

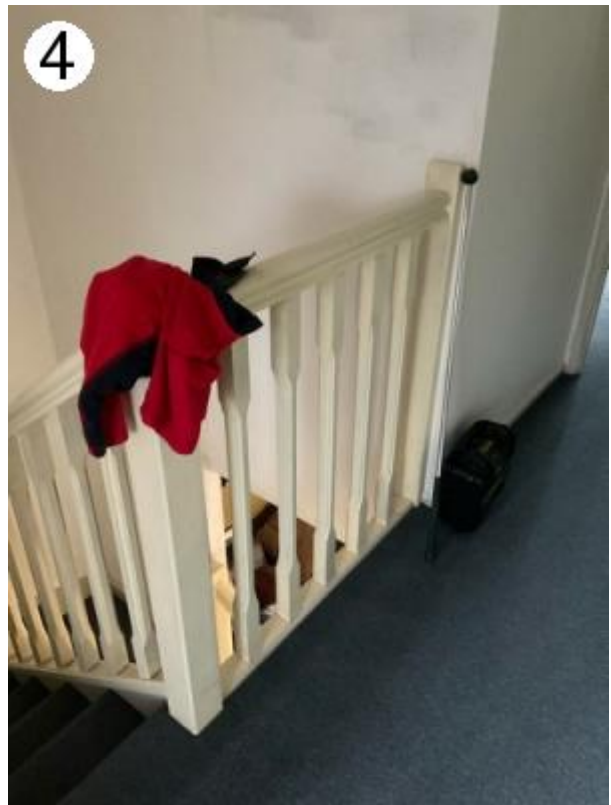
#4. Showing insufficient balustrades

Insufficient balustrades to internal areas, should be minimum 1m high with gaps not greater than 125mm to reduce the risk of people falling. Recommend a carpenter rectify.

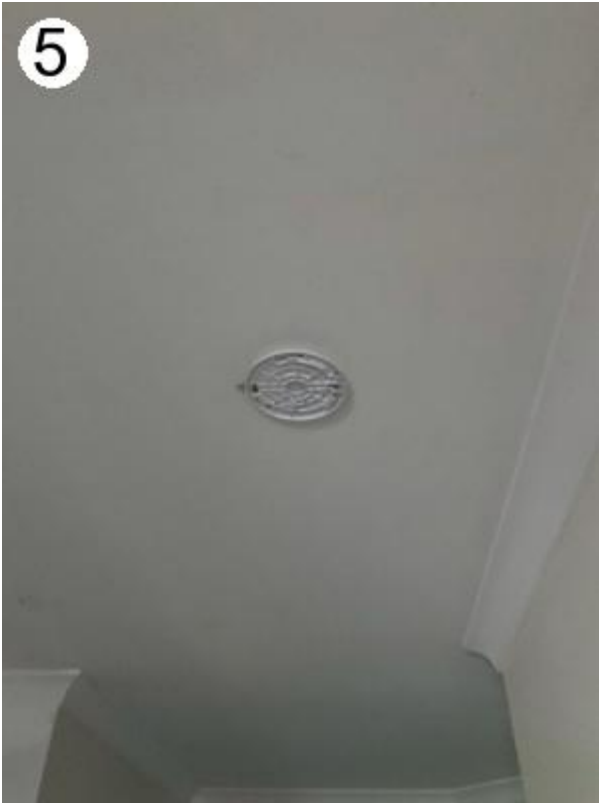
#5. Showing disconnected smoke alarm

A smoke alarm disconnected on upper floor. Recommend an electrician rectify to reduce the risk of fires.

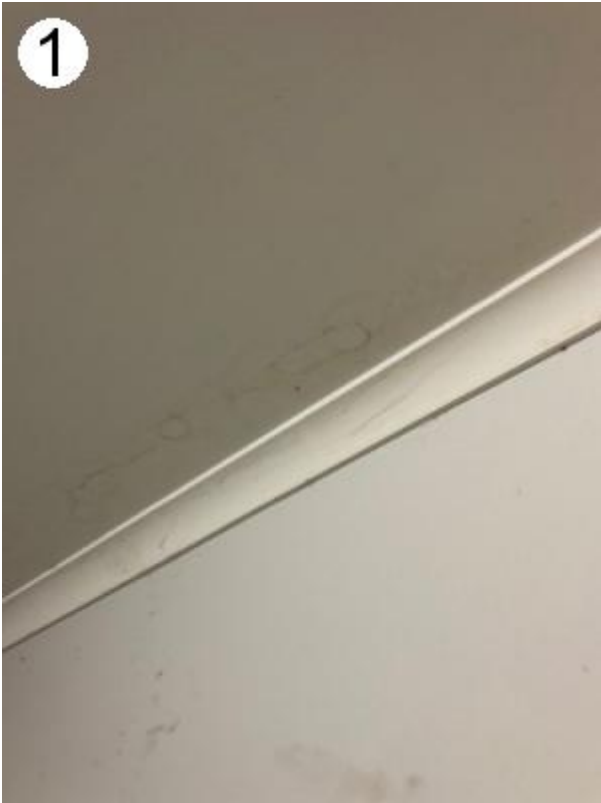
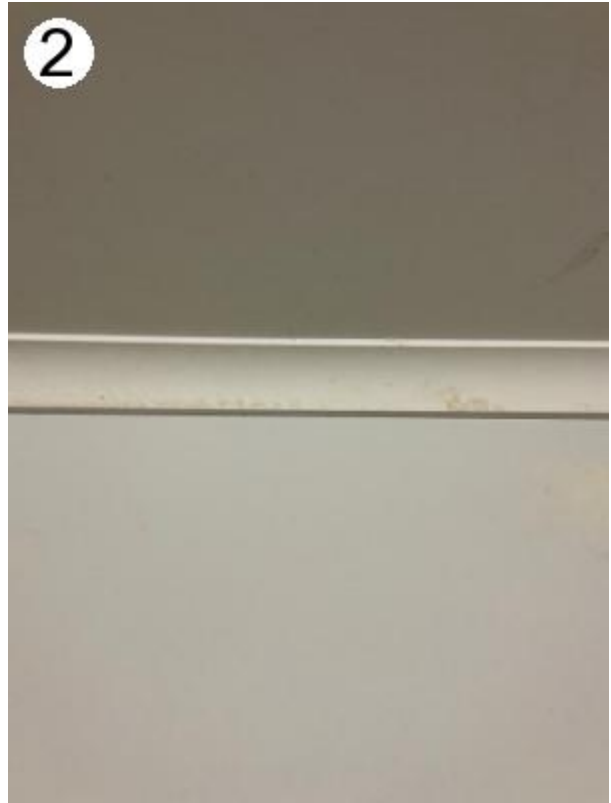
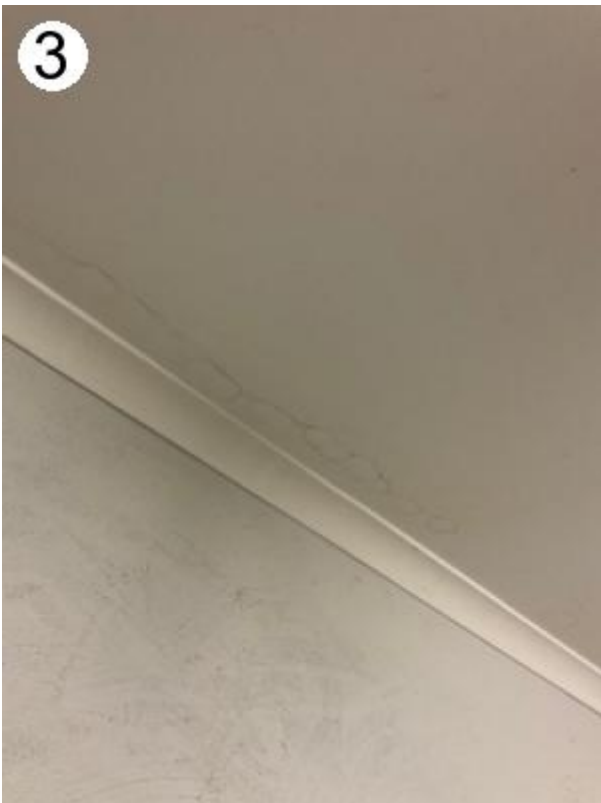
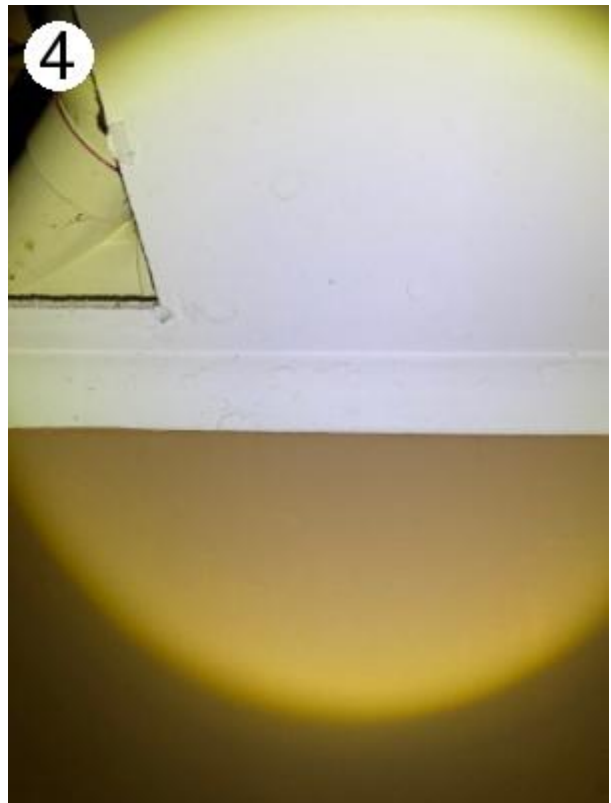
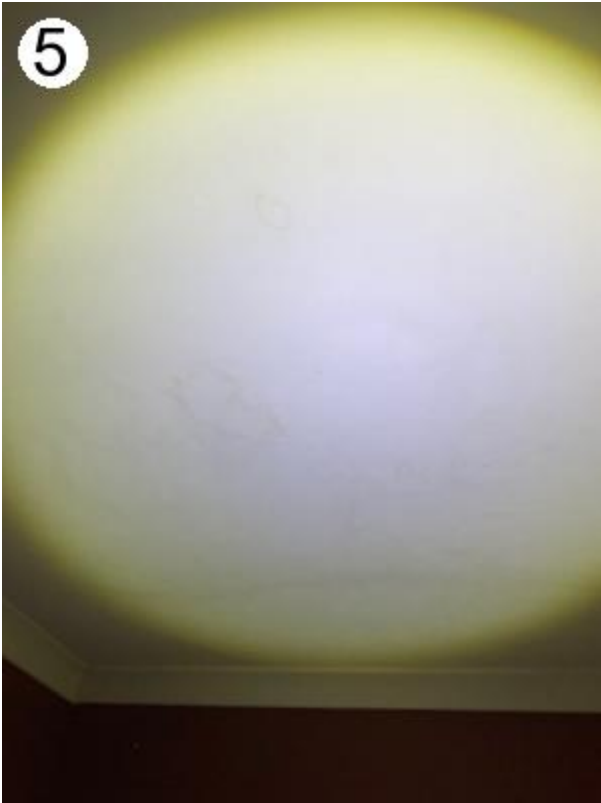
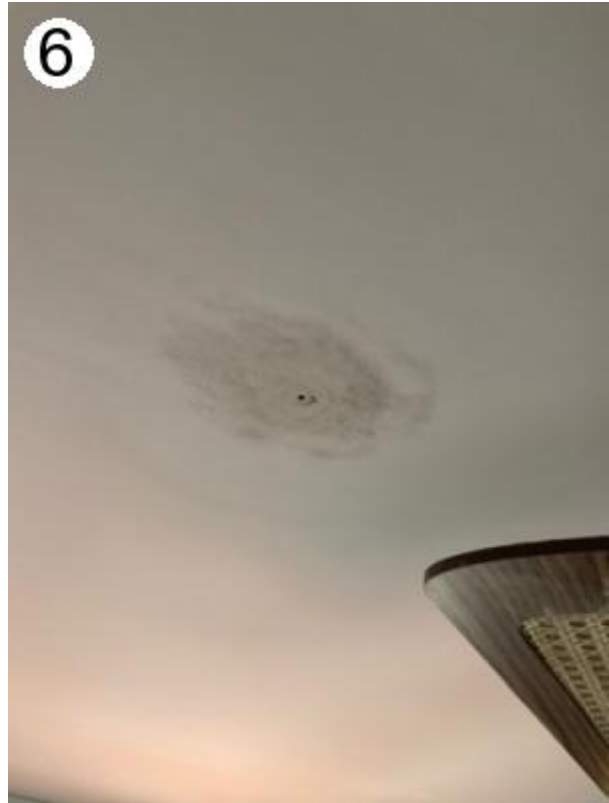
Moisture stains to garage, laundry, front bedroom and bathroom ceilings, no excessive moisture was detected at the time of inspection. Recommend to monitor for any further changes and contact a builder for further invasive investigation if required to reduce the risk of further deterioration.

#1. Showing example of the stains

Recommend further invasive investigation to areas with signs of moisture to determine if there is any concealed damage.

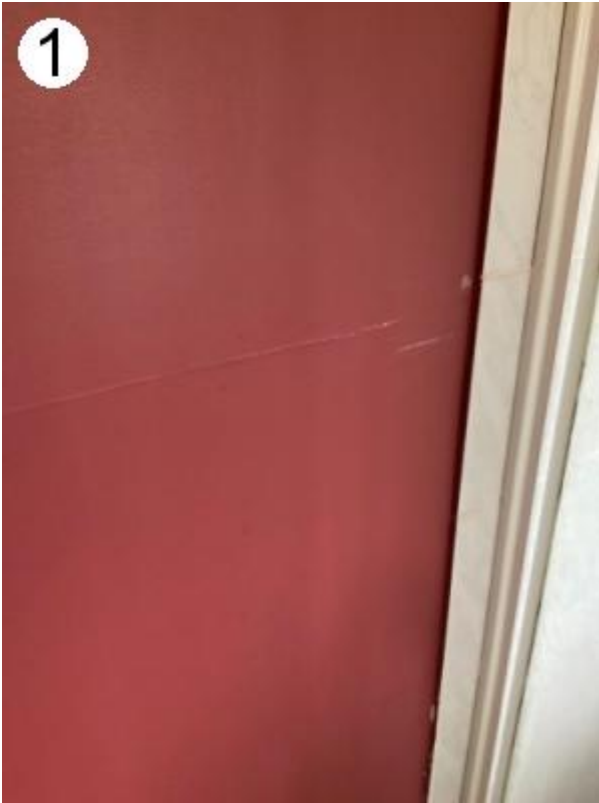
Movement cracks to wall in main bathroom. Recommend a plasterer rectify to reduce the risk of further deterioration.

#1. Showing the cracks

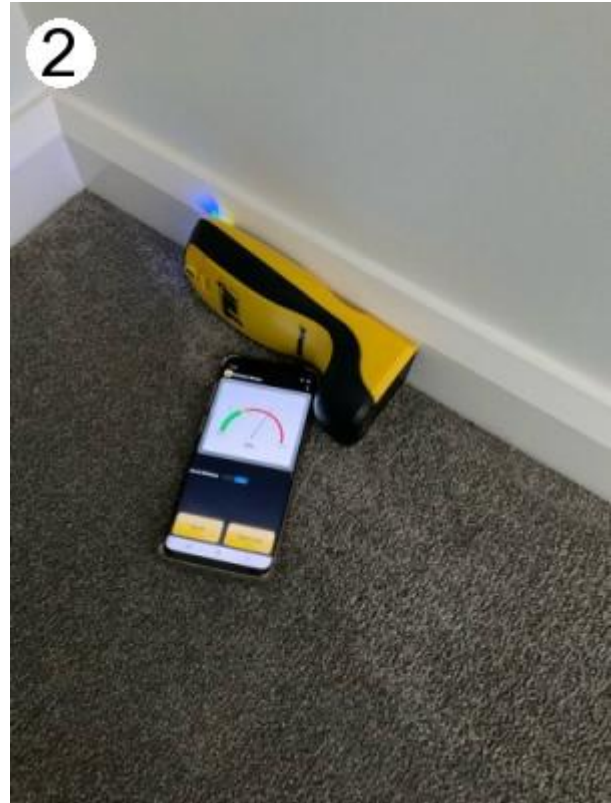
High moisture reading to wall outside ensuite shower. Recommend a builder for further invasive investigation to determine if there is any concealed damage to framing and cause of high moisture.

#2. Showing high moisture

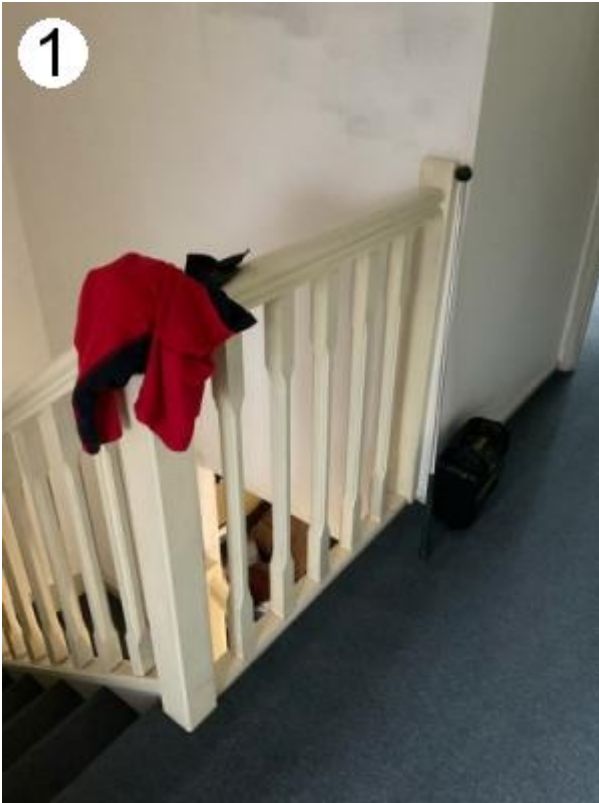
The following evidence of Major Defects was found
Insufficient balustrades to internal areas, should be minimum 1m high with gaps not greater than 125mm to reduce the risk of people falling. Recommend a carpenter rectify.

#1. Showing insufficient balustrades

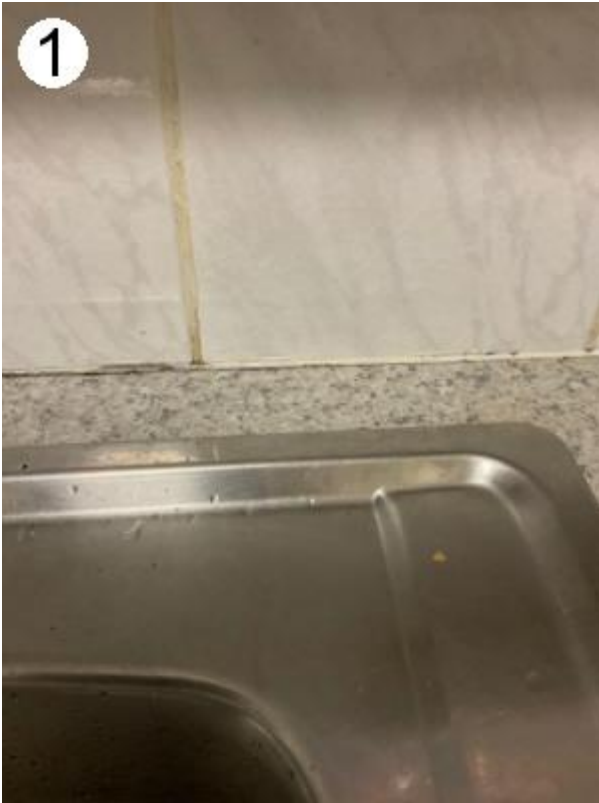
The following evidence of Major Defects was found
Cracked sealant/grout to kitchen and laundry splash backs. Recommend a plumber rectify to reduce the risk of water leaks and damage.

#1. Showing kitchen splash back

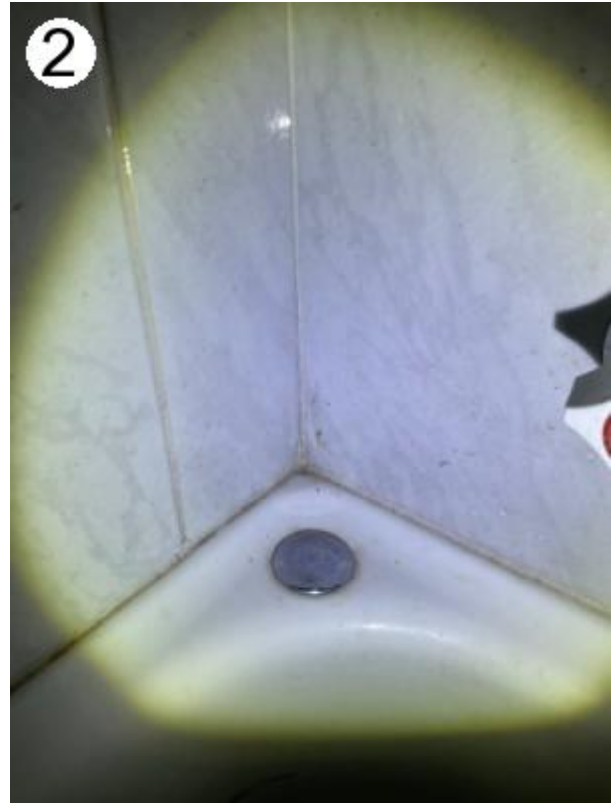
#2. Showing laundry splash back

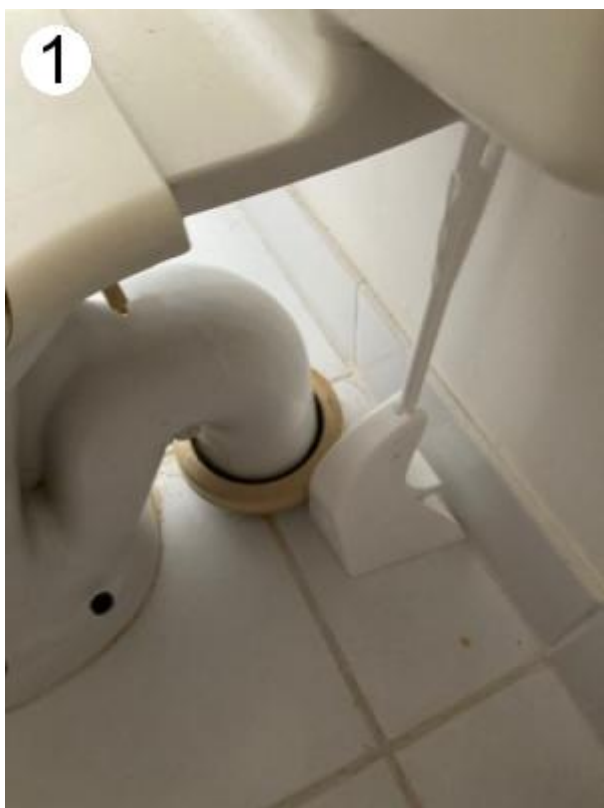
#1. Showing leaking toilet

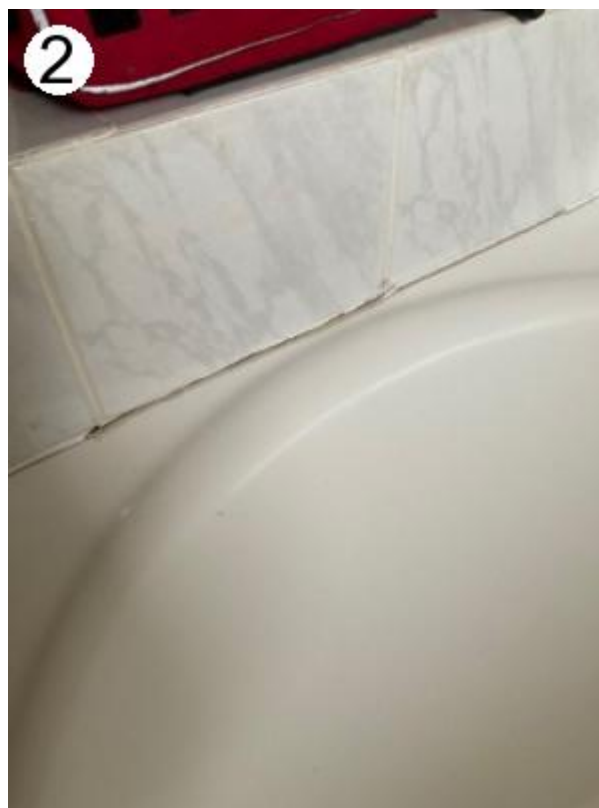
#2. Showing example of the sealant

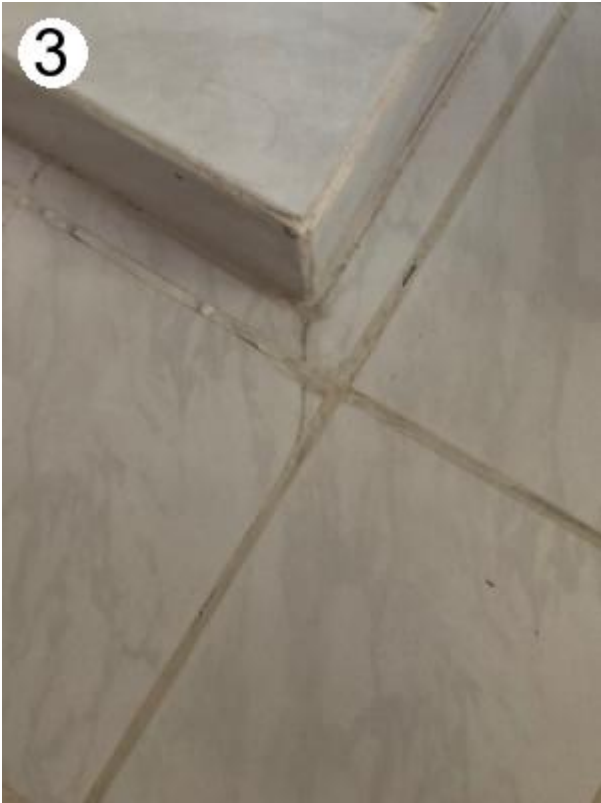
#3. Showing example of cracked tiles

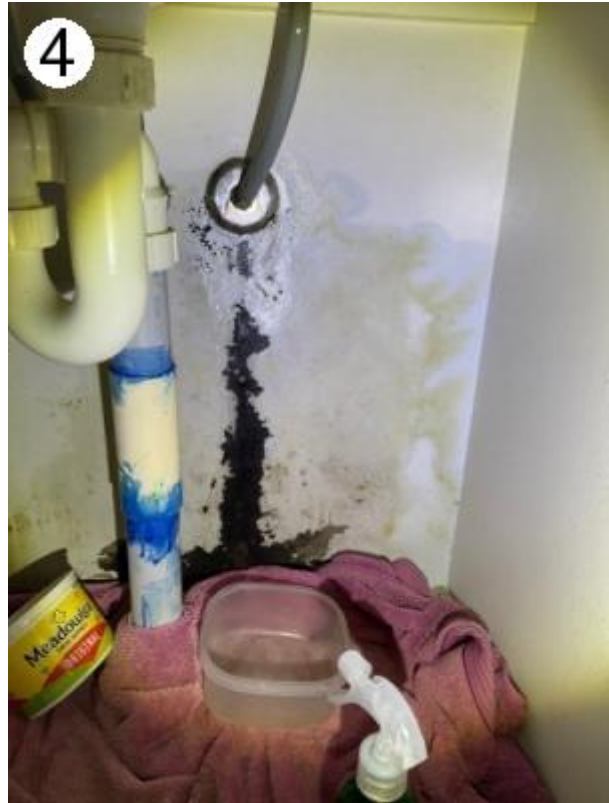
#4. Showing vanity moisture

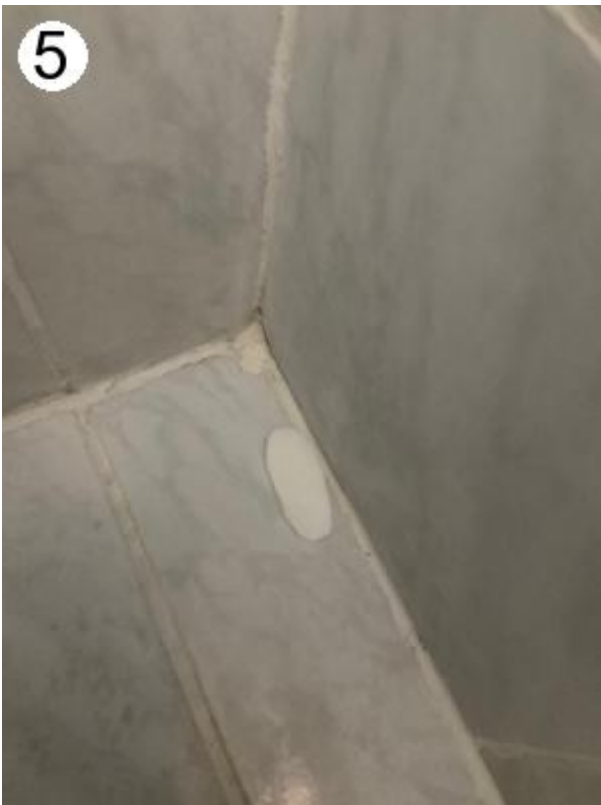
#5. Showing example of the sealant

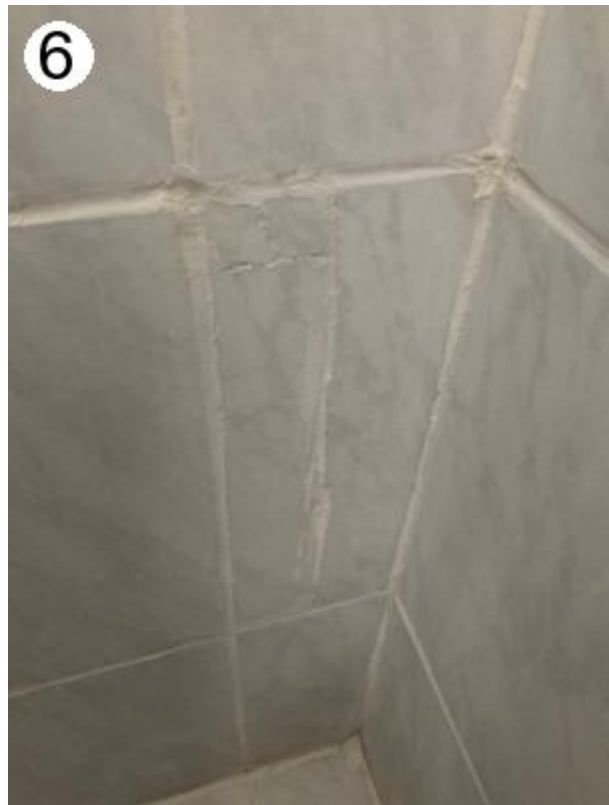
#6. Showing example of the cracked tiles

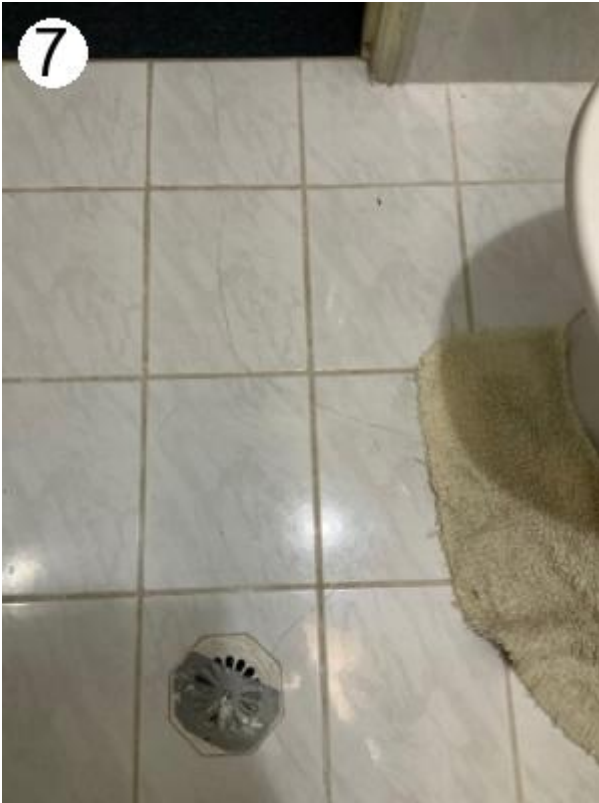
#7. Showing example of the cracked tiles

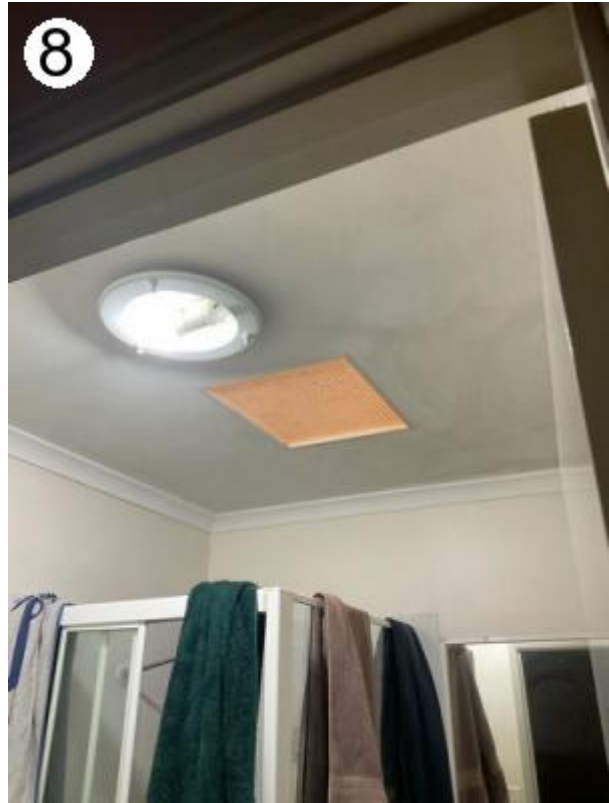
#8. Showing no exhaust fan

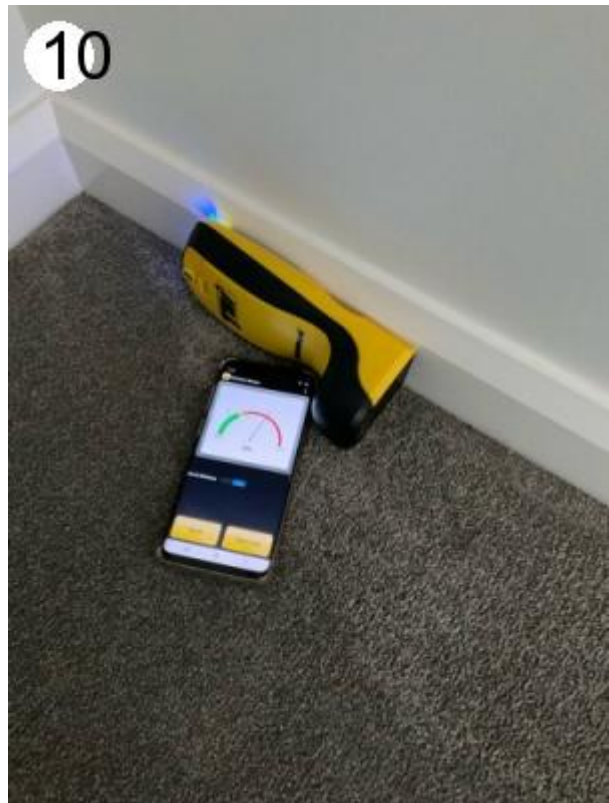
High moisture reading to wall outside ensuite shower. Recommend a builder for further investigation to determine if it is easily repaired or requires waterproofing.

#10. Showing high moisture

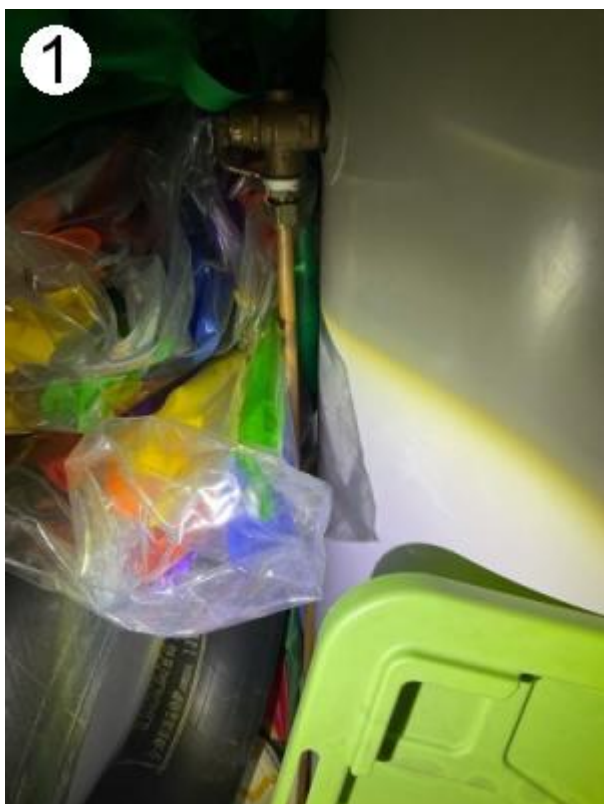
#1. Showing no tempering value

Recommend a plumber rectify to reduce the risk of burns.

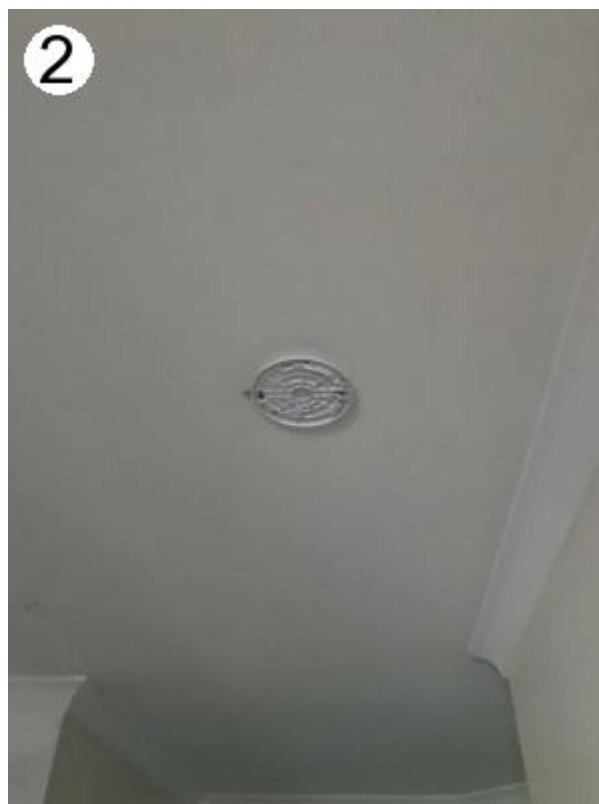
A smoke alarm disconnected on upper floor. Recommend a electrician rectify to reduce the risk of fires.

#2. Showing disconnected smoke alarm

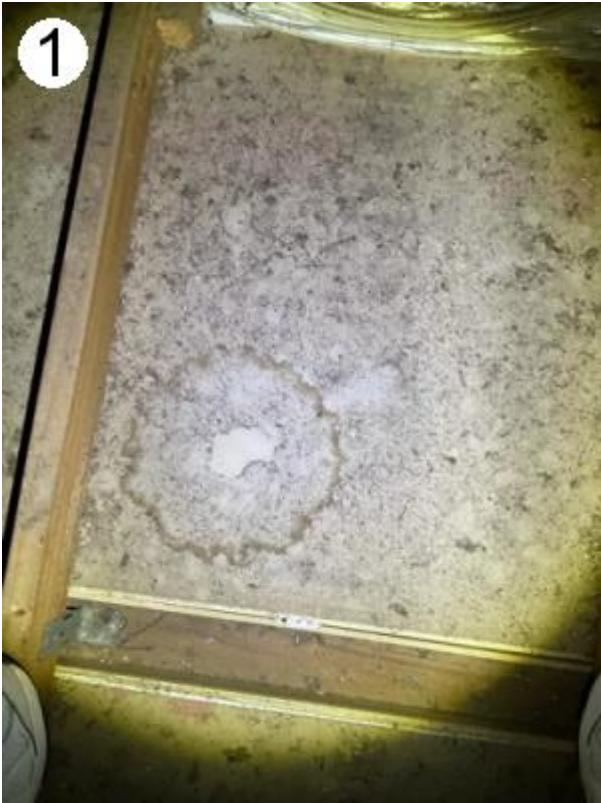
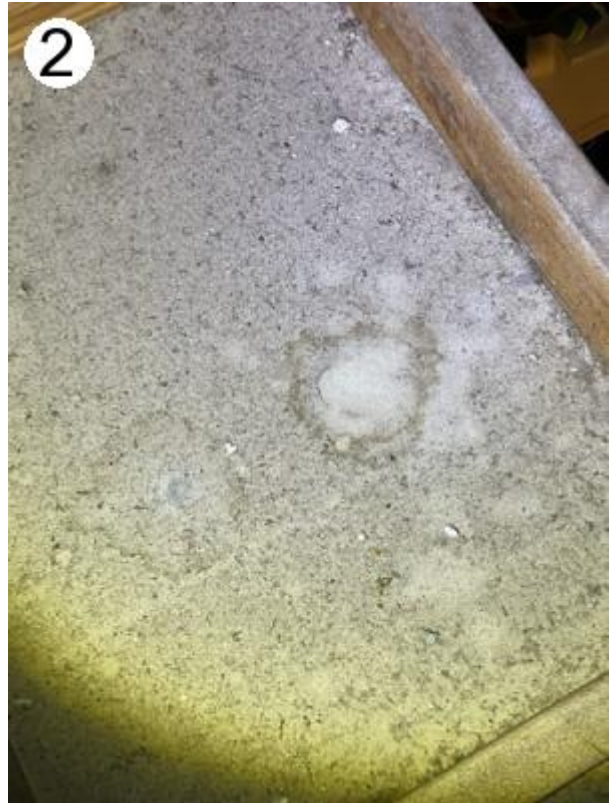
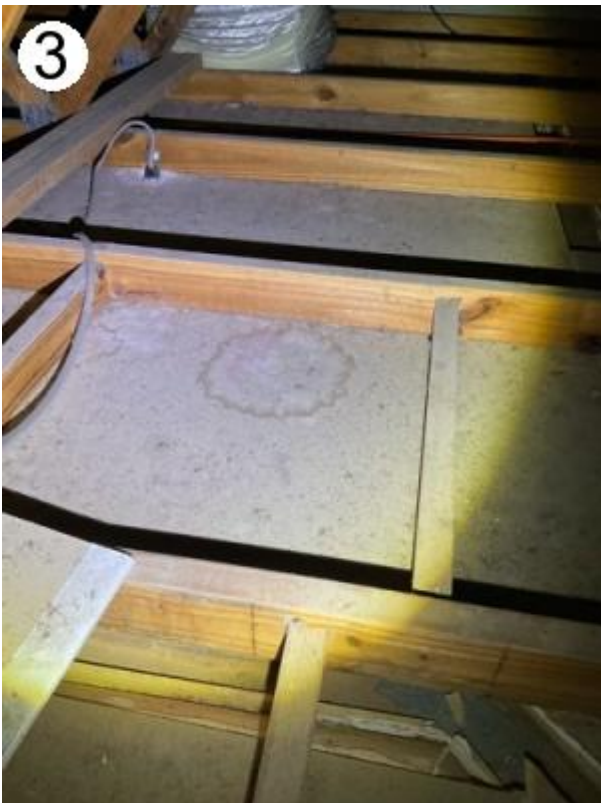
The following evidence of Major Defects was found
Many moisture stains on ceiling. Recommend a roofer install sarking under tiles to reduce the risk of water leaks and damage.

#1. Showing example of the moisture stains

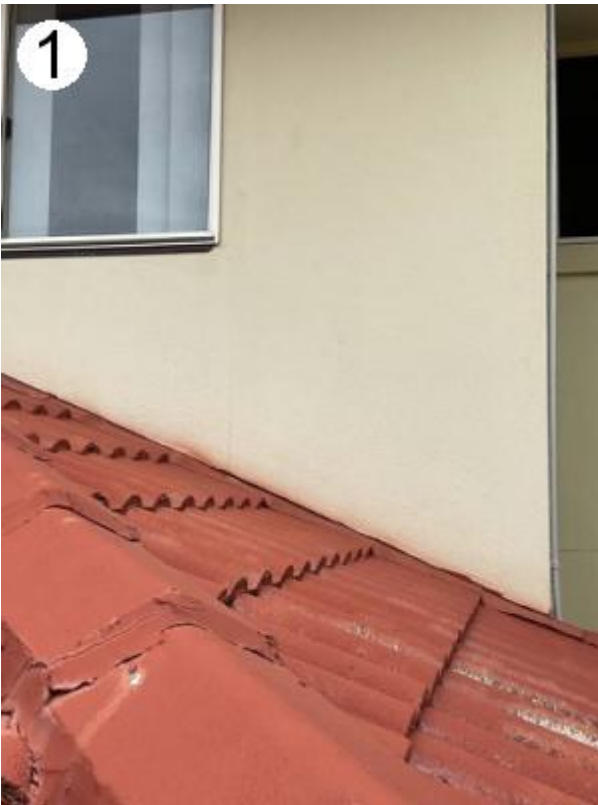
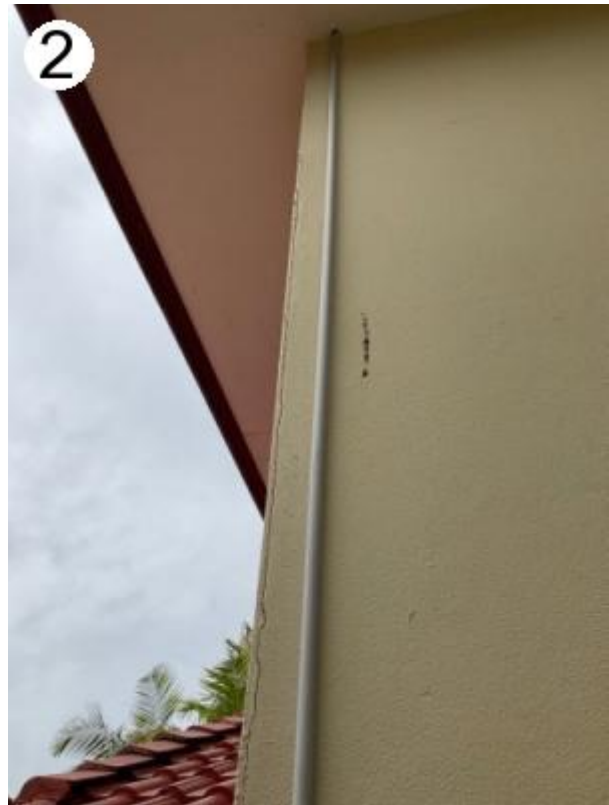
Movement cracks to cladding on front of house. Recommend a builder rectify to rectify the risk of further deterioration and water leaks.

#1. Showing example of the cladding

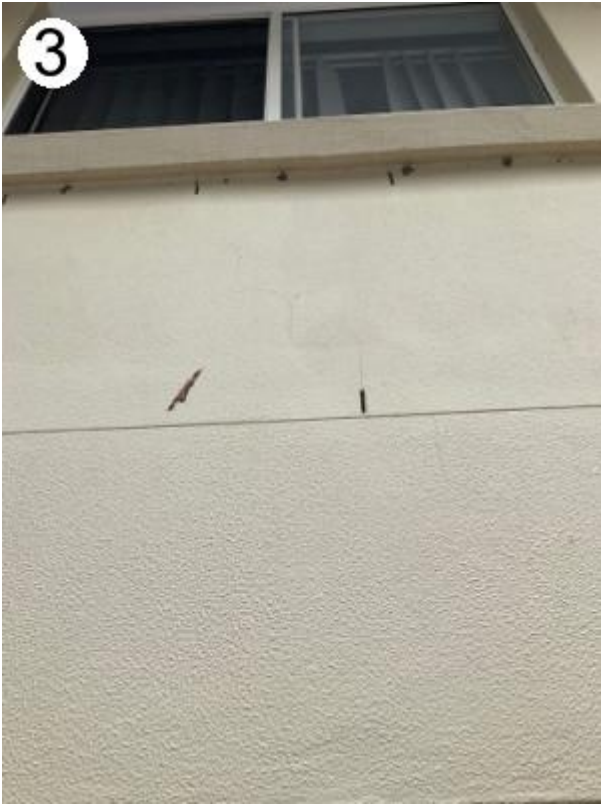
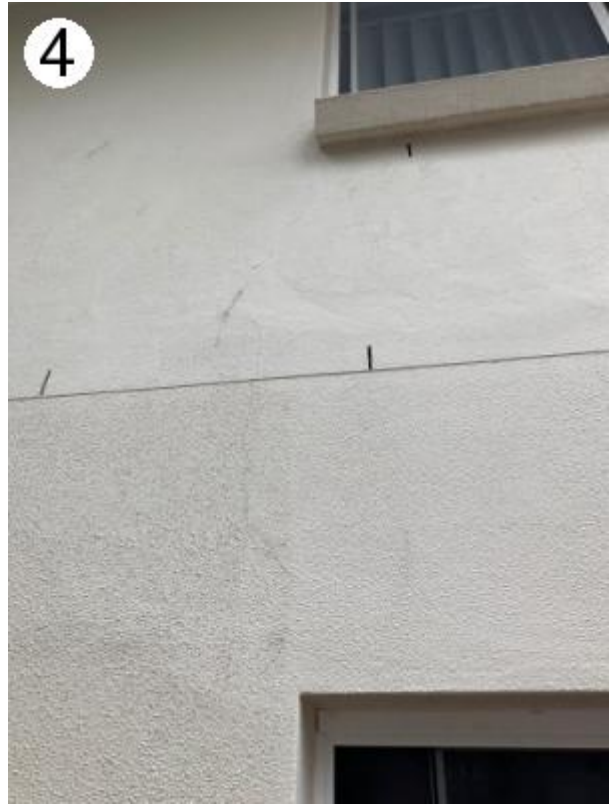
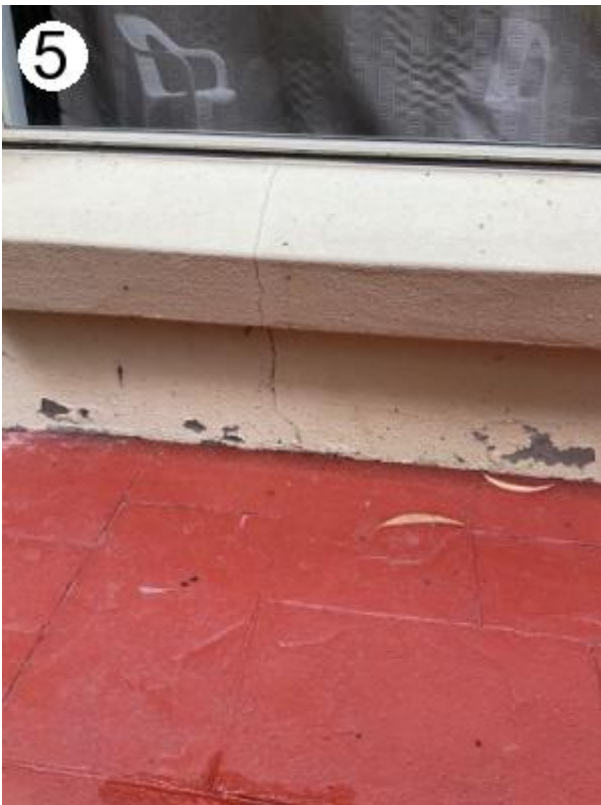
Movement cracks to rear brick wall. Recommend to monitor for any further changes and contact a structural engineer for further advice if required.

#3. Showing example of the brickwork

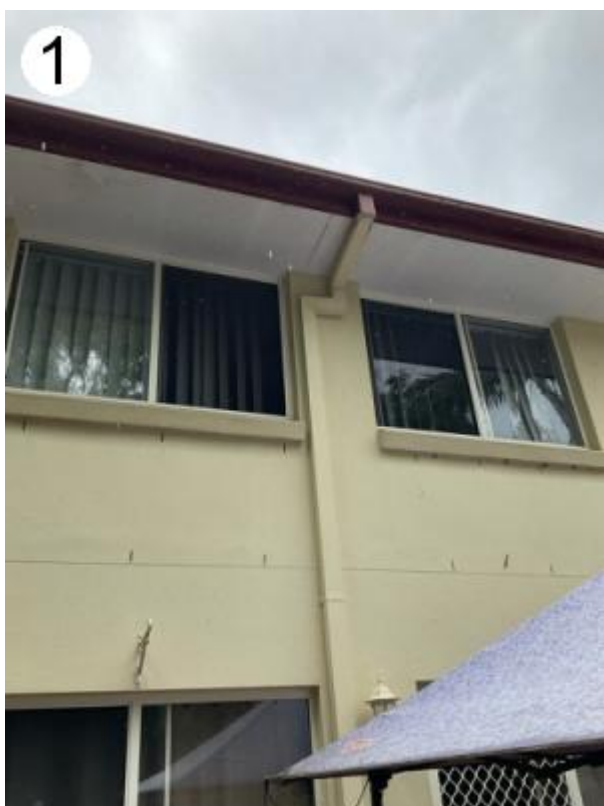
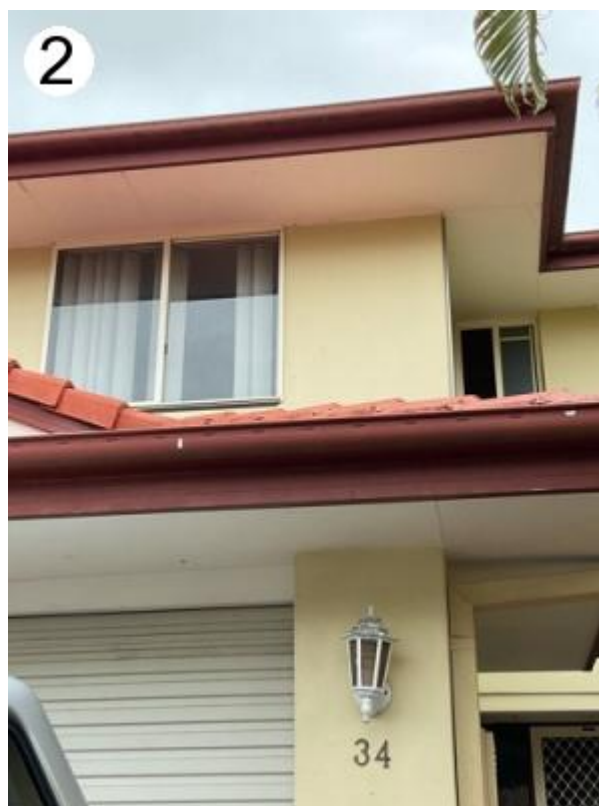
No fall prevention to upper level windows. Windows that are below 1.7m from inside floors height, and that have a fall height of more than 2m or more from inside floor height should have security screens fitted or made to open a maximum of 125mm. Recommend a carpenter rectify to reduce the risk of people falling.

#1. Showing example of the windows

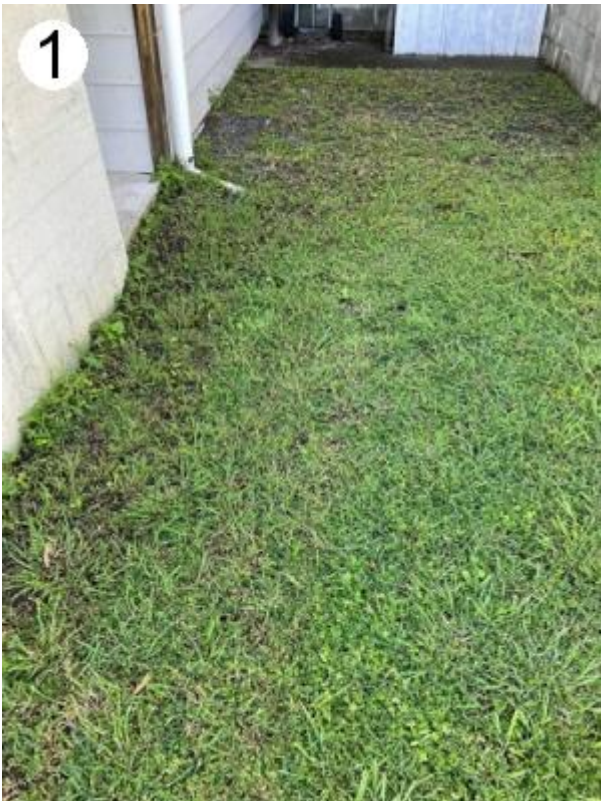
The following evidence of Major Defects was found
Poor surface drainage to parts of the property. Recommend a plumber or landscaper rectify to reduce the risk risk footing movement and other moisture related issues.

#1. Showing example of poor surface drainage

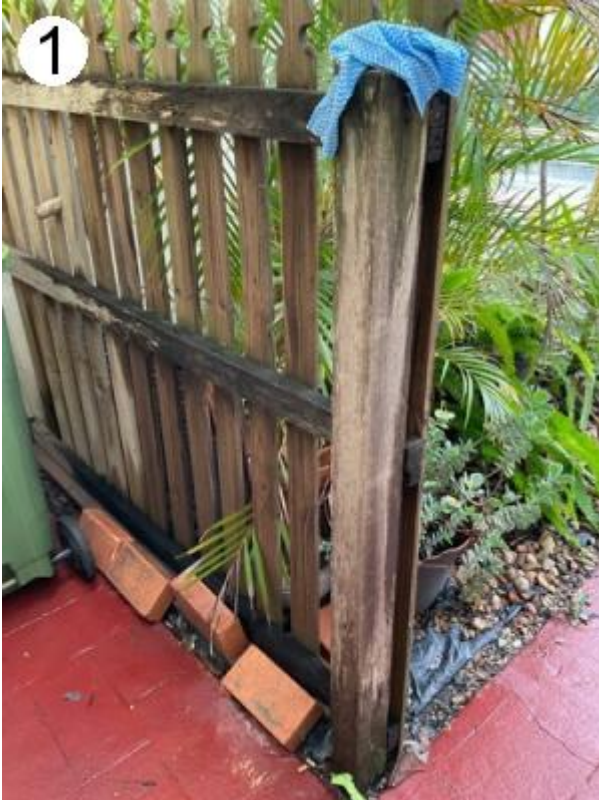
Wood rot to parts of the fences. Recommend a carpenter remove the effected parts of the timbers ensuring that no timbers are in contact with the ground and that any exposed timbers are painted to maximise the life of the timbers.

#1. Showing example of the rot

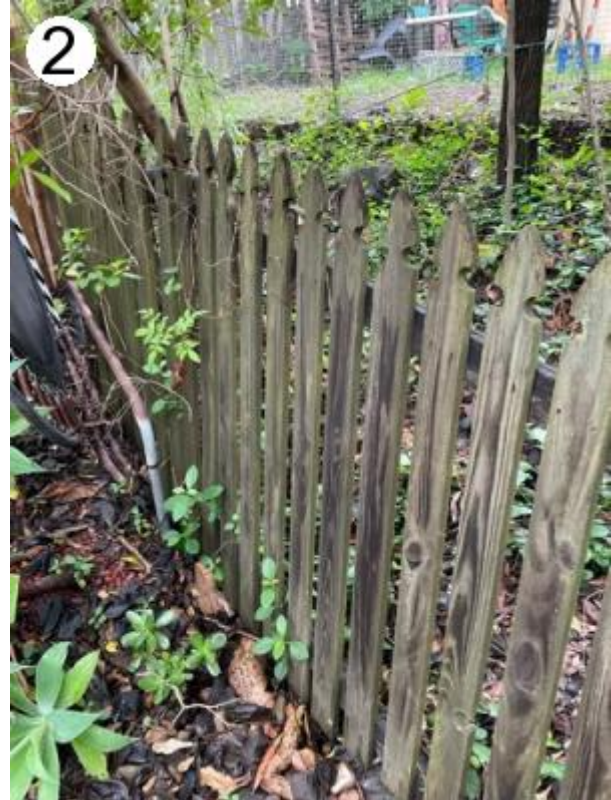
Fences leaning in parts. Recommend a carpenter rectify to reduce the risk of further deterioration.

#2. Showing example of the rot and leaning fences

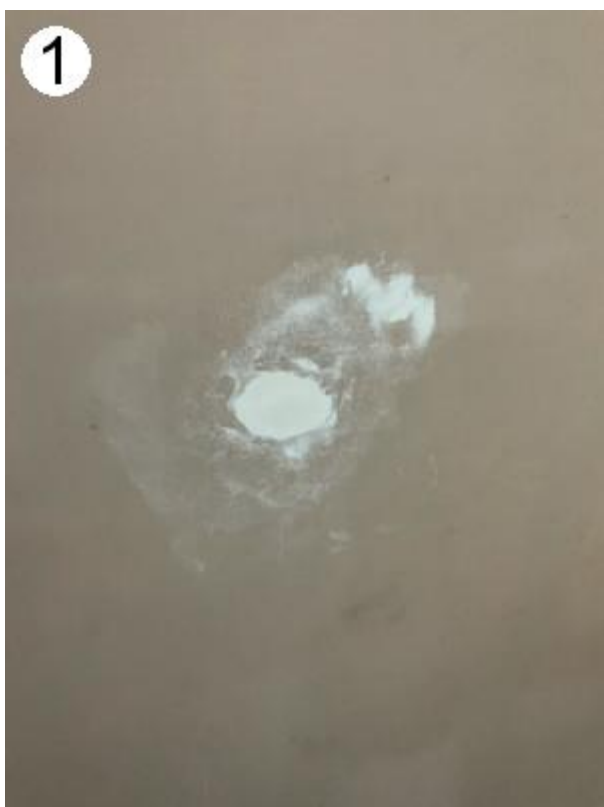
#1. Showing example of the patches

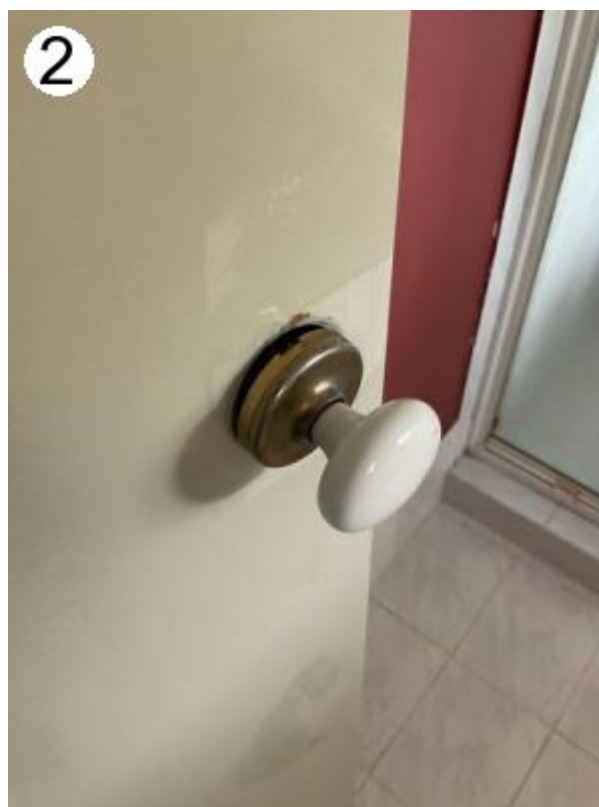
#2. Showing the door handle

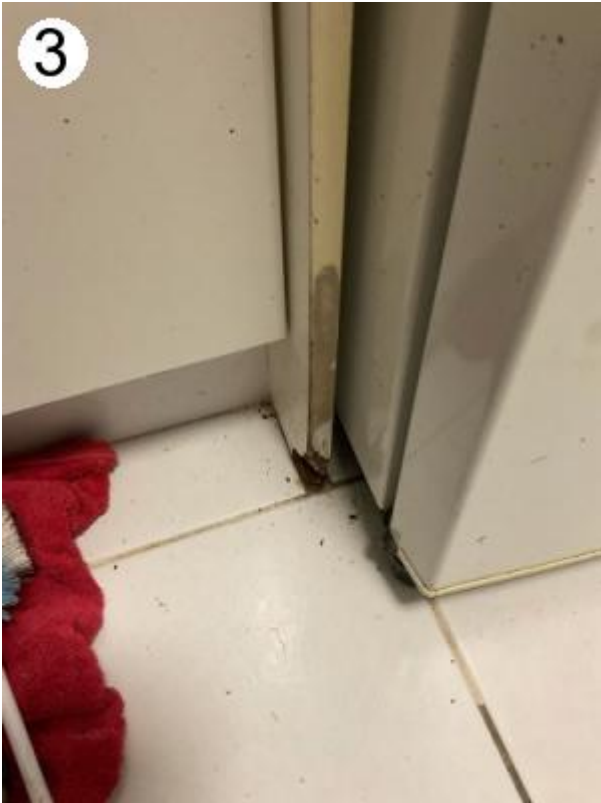
#3. Showing example of the cabinets

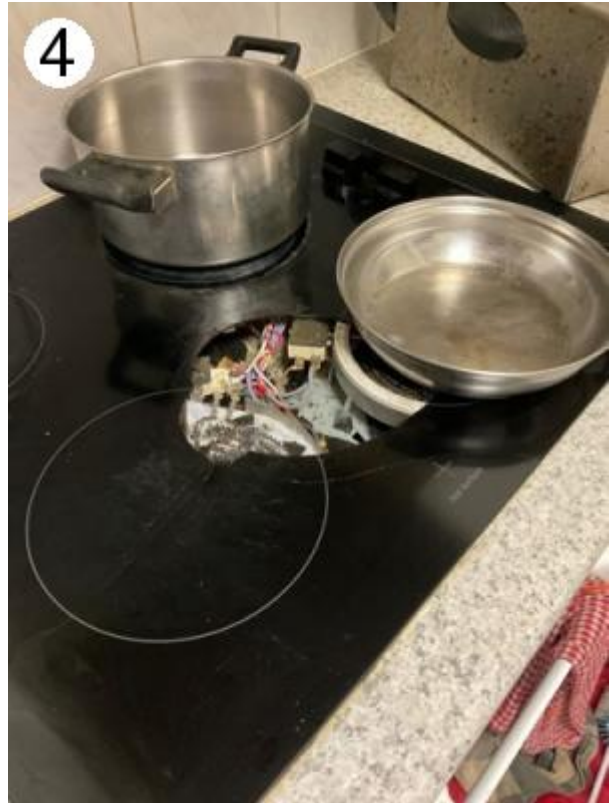
#4. Showing the cooktop

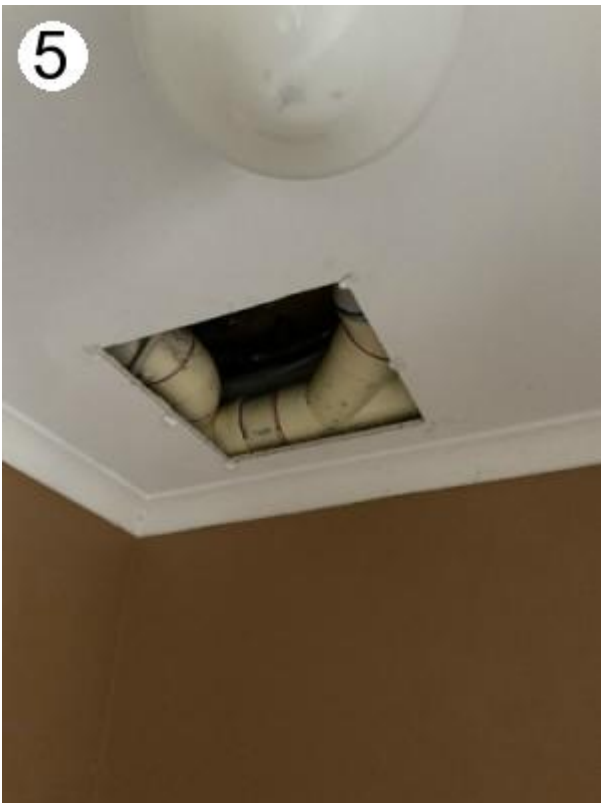
#5. Showing hole in ceiling

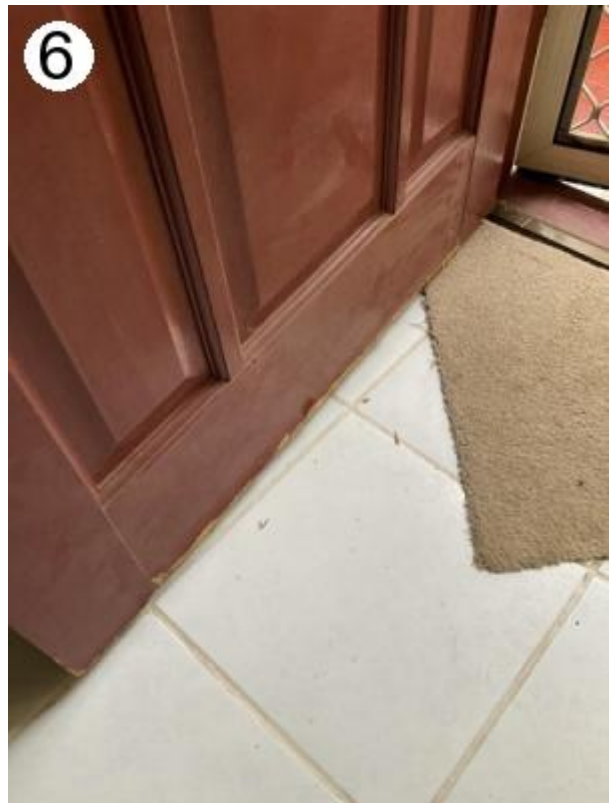
#6. Showing front door

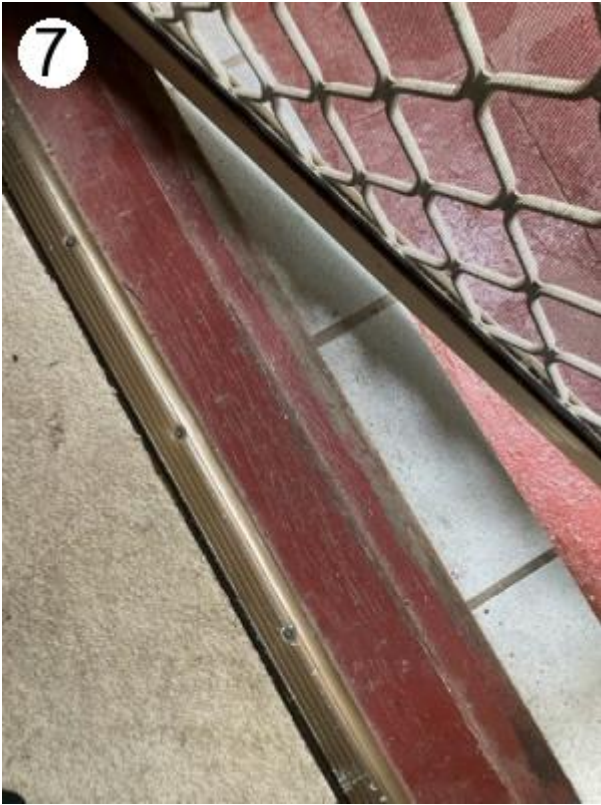
#7. Showing example of exposed weathered timbers
