STANDARD PROPERTY & TIMBER PEST REPORT

Report number: **1637784963172**
Inspection date: **25-11-2021**
Client: **Sample**
Property address: **Sample Street, Gold coast**

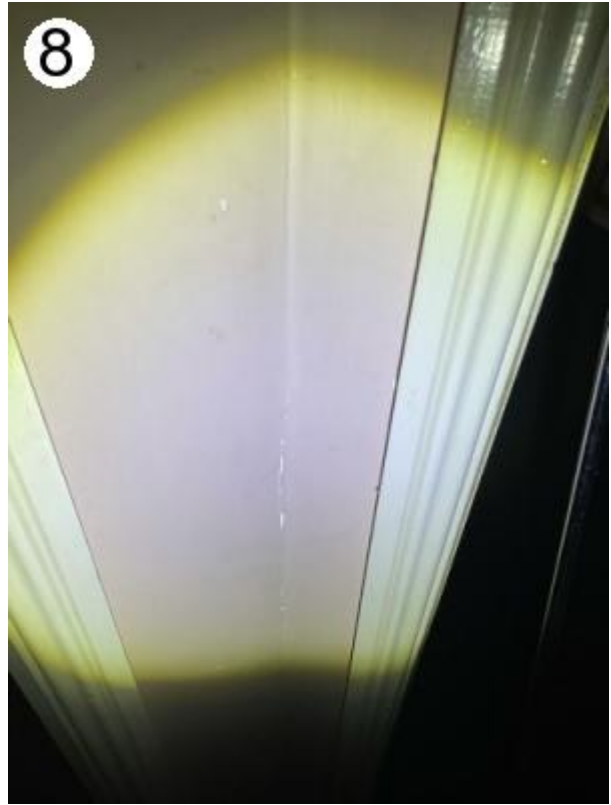
#8. Showing example of internal wall cracks

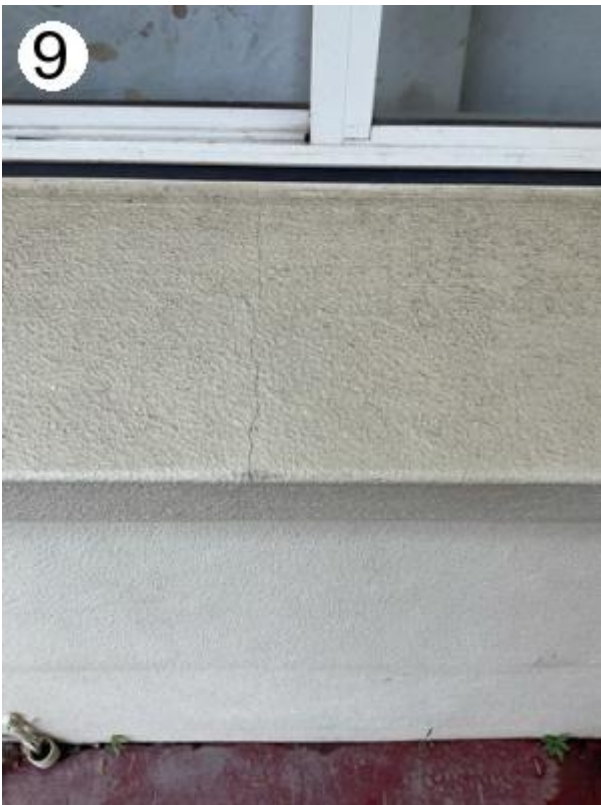
#9. Showing example of minor external wall cracks

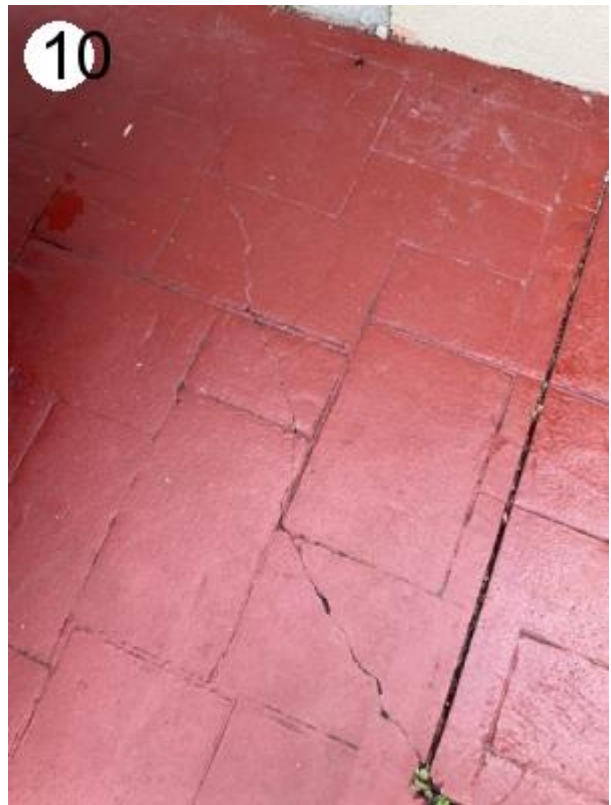
#10. Showing example of the concrete

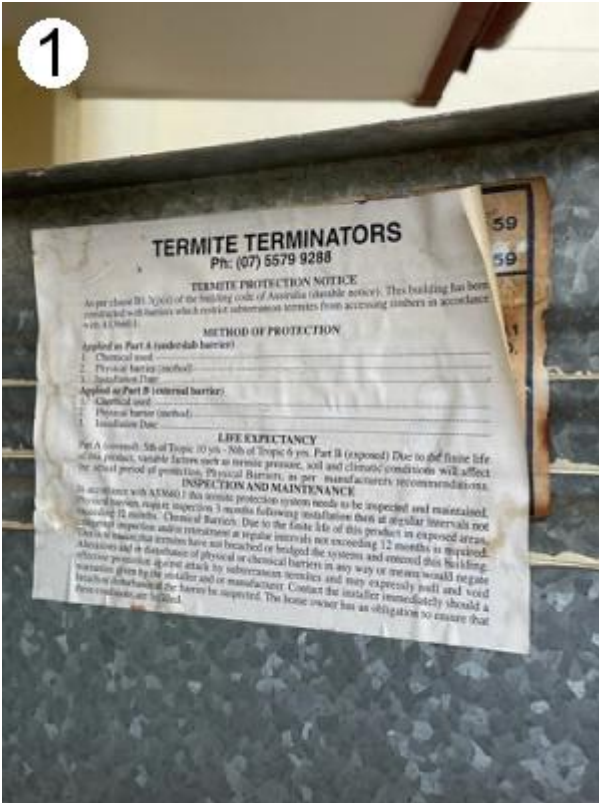
**Treatment sticker in meter box.
Evidence of a baiting system.**

#1. Showing the treatment sticker

Recommend contacting the body corporate to ascertain what termite management system is installed and if it is warranted. If it is not recommended installing a termite barrier system immediately.

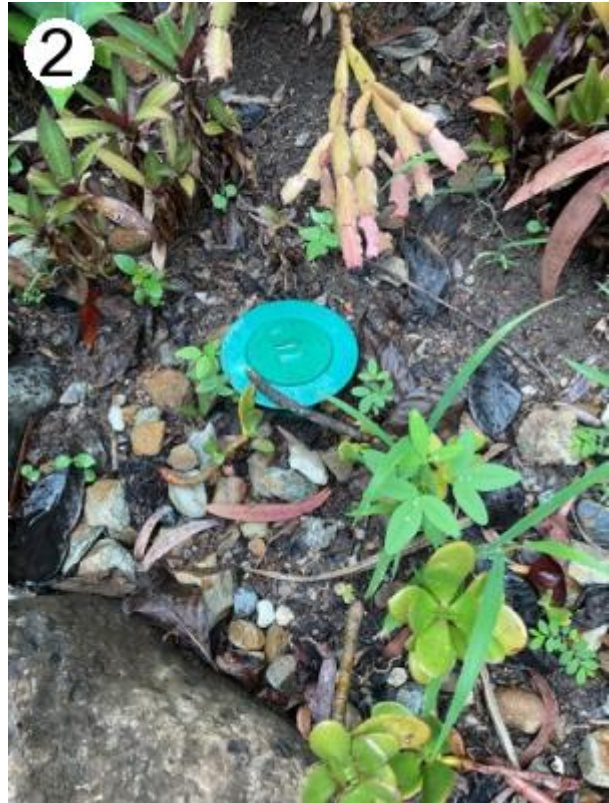
#2. Showing example of the baiting system

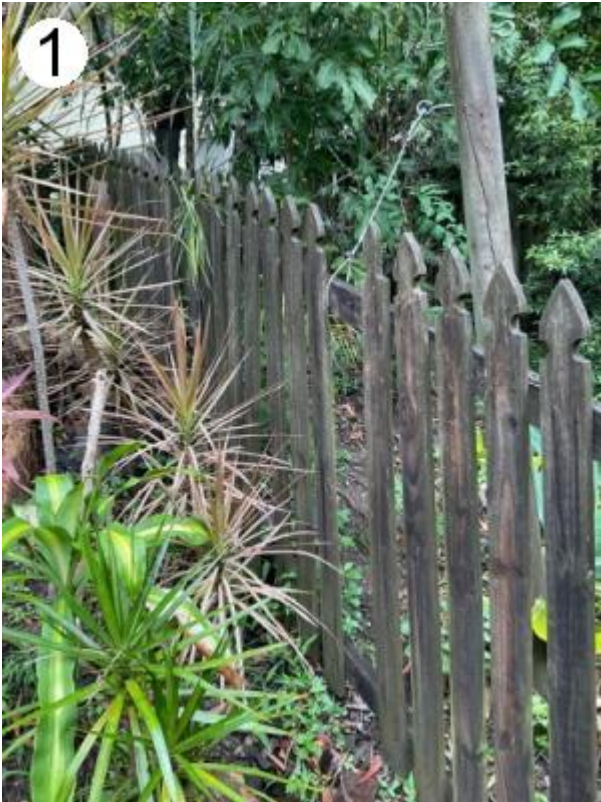
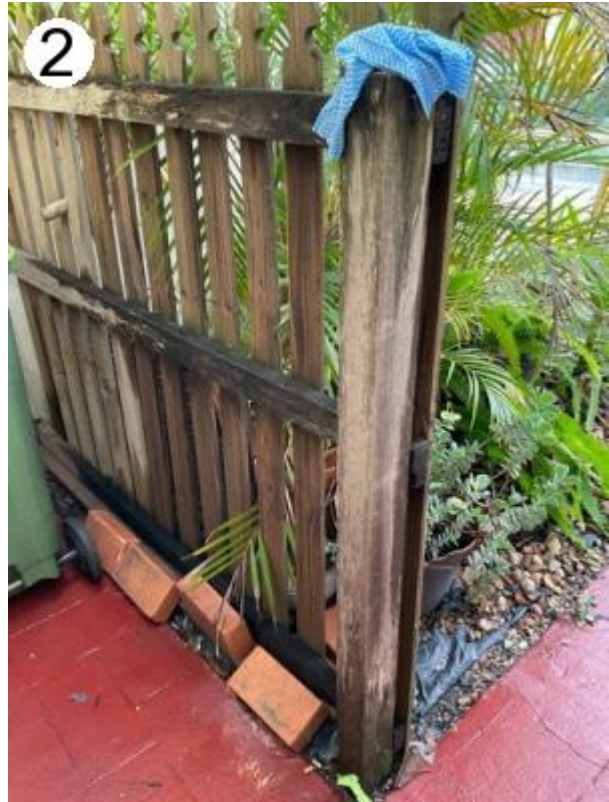
Wood rot to parts of the fences. Damage appears to be widespread. Recommend a carpenter remove the effected parts of timbers ensuring that no timbers are in contact with the ground and that any exposed timbers are painted to maximise the life of the

#1. Showing example of the rot

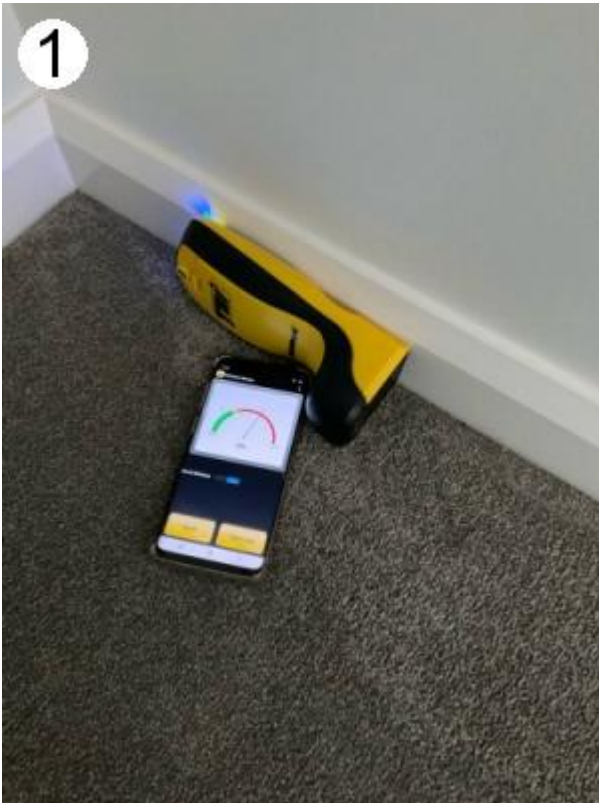
#1. Showing high moisture

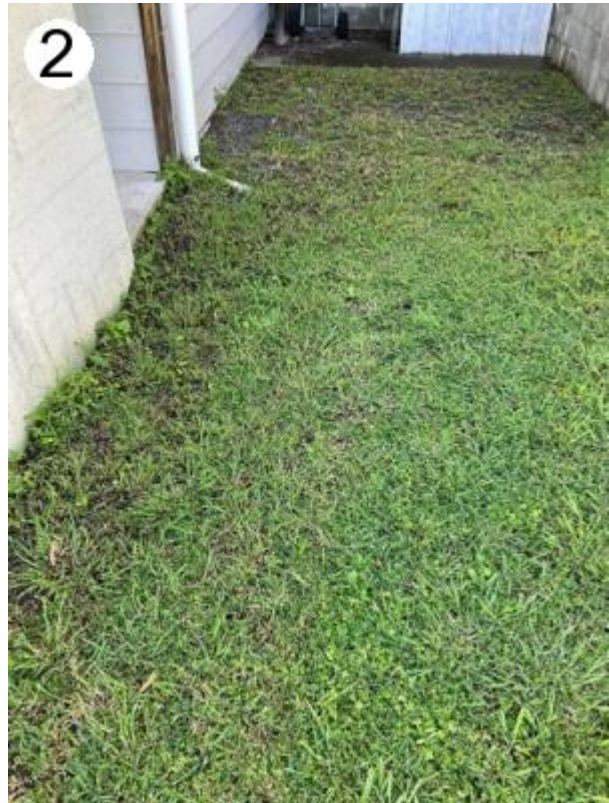
Poor surface drainage to various parts of the property. Recommend a plumber or landscaper rectify to reduce the risk of termite attack and other moisture related issues.

#2. Showing example of poor surface drainage

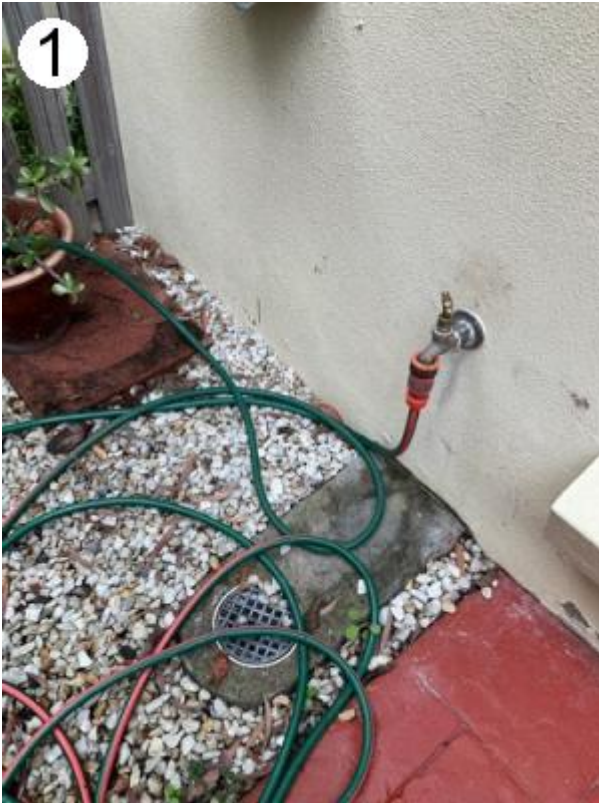
Brickwork in contact with the ground, concealed brickwork may provide an entry point for termites. Recommend installing a termite barrier system immediately if current system is not warranted.

#1. Showing example of the brickwork

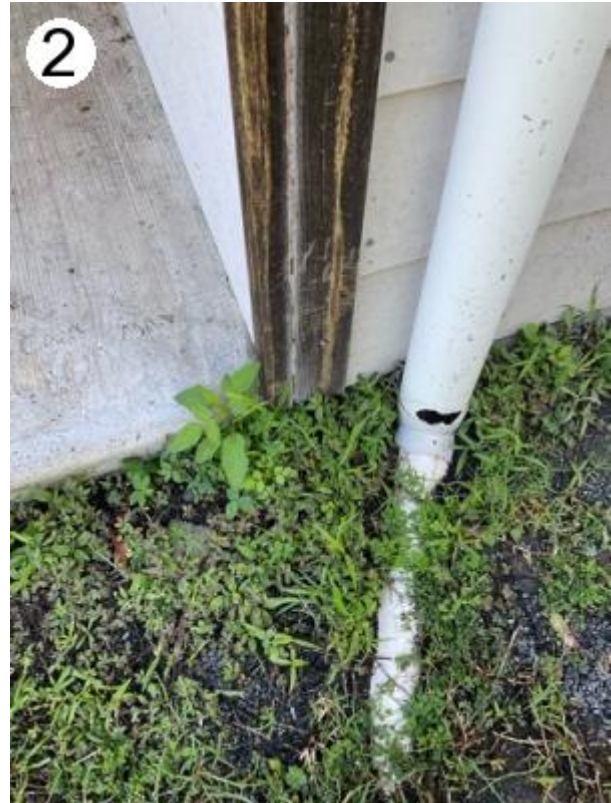
Timbers in contact with the ground, recommend exposing 75mm under to reduce the risk of termite attack and wood rot.

#2. Showing example of the timbers

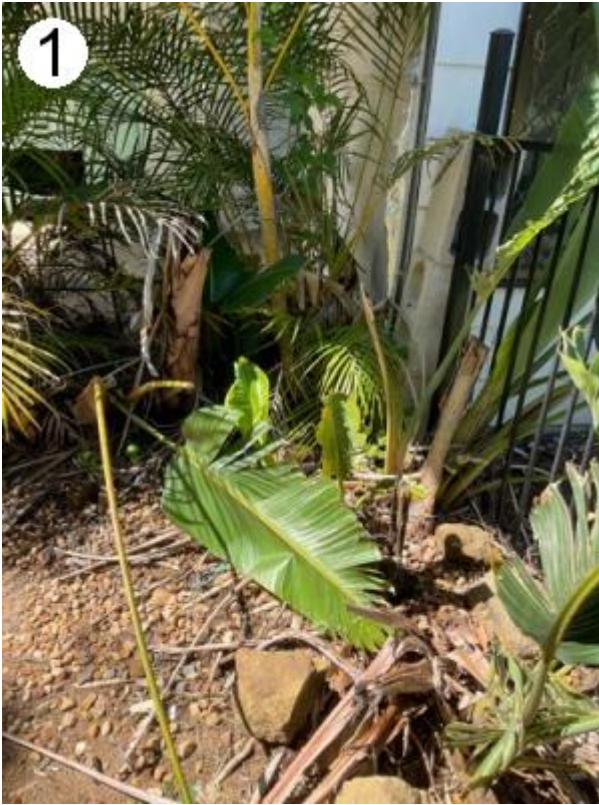
Vegetation against external walls, recommend removing to reduce the risk of termite attack.

#1. Showing example of the vegetation
