Serenity Home Inspections LLC

Property Inspection Report

1290 W Spring St, Smyrna GA 30080

Commercial Inspection

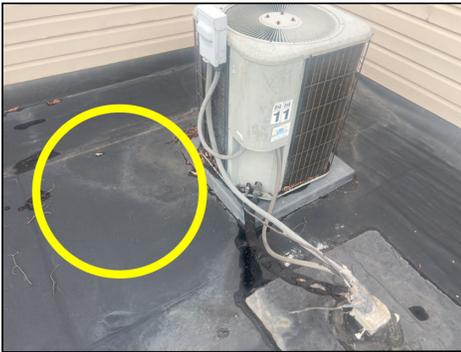
- Billowing observed on roof covering. Recommend contacting a licensed roofing contractor to review repair options. See photographs for locations and details.

Billowing observed on roof covering adjacent to AC compressor 11.

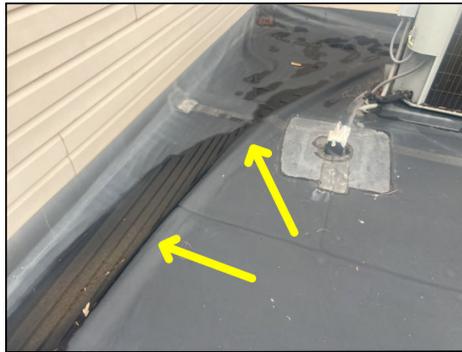
Billowing observed on roof covering. Recommend contacting a licensed roofing contractor to review repair options.

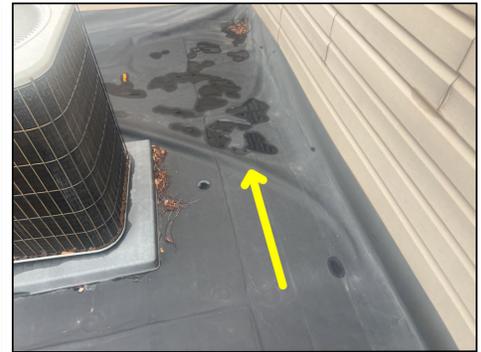
Billowing observed on roof covering. Recommend contacting a licensed roofing contractor to review repair options.

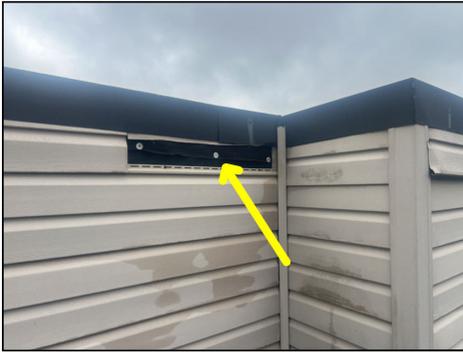
2.2. Missing section of aluminum siding, observed at rear side of parapet wall

Missing section of aluminum siding, observed at rear side of parapet wall

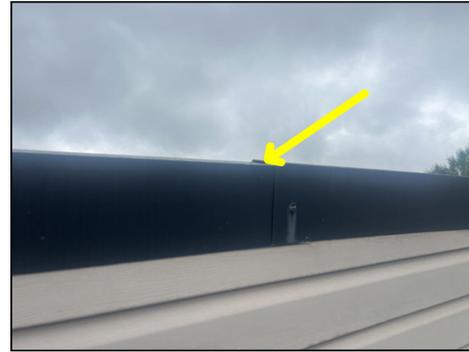
2.1. Gaps observed in coping, this is a potential water intrusion point. Recommend contacting a licensed roofing contractor to review repair options

Gaps observed in coping, this is a potential water intrusion point. Recommend contacting a licensed roofing contractor to review repair options

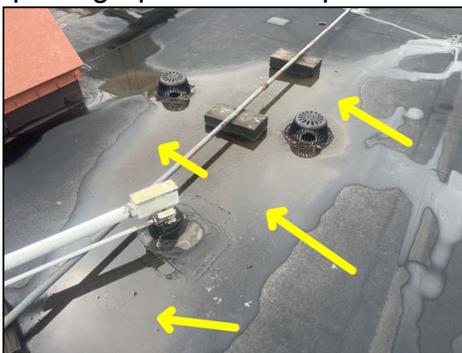
3.1. Active ponding observed on roof surface. Over time, ponding can lead to water intrusion to the interior space .Recommend contacting a licensed roofing contractor to review repair options. See photographs for examples.

Active ponding observed on roof surface.

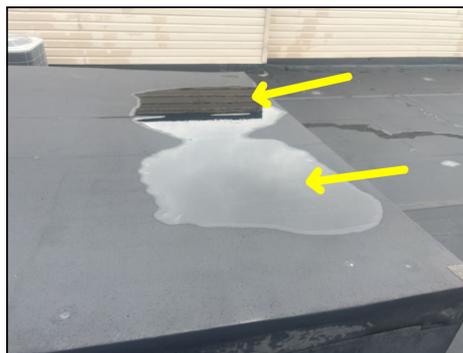
Active ponding observed on roof surface.

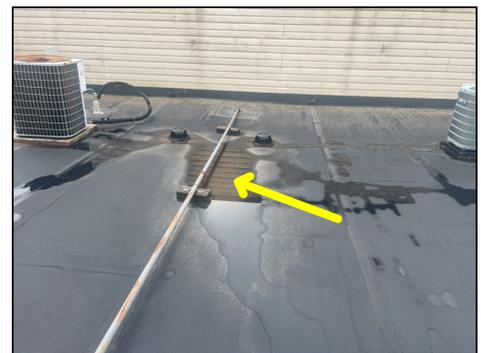
Active ponding observed on roof surface.

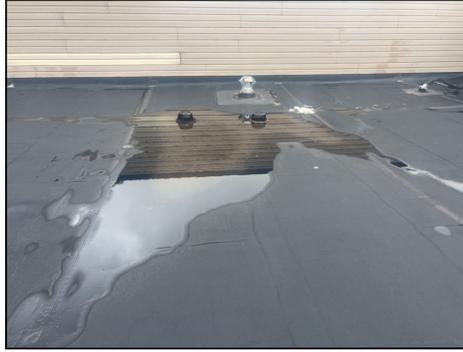
Active ponding observed on roof surface.

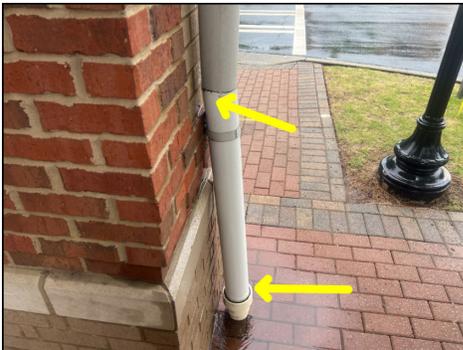
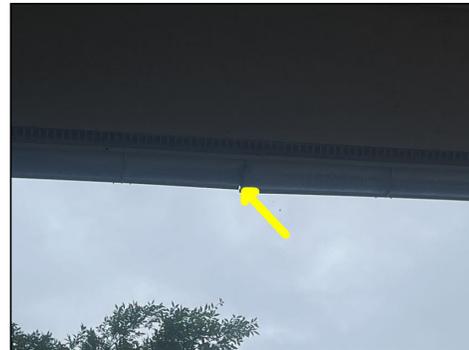
- 4.1. Some or all of the gutter downspouts are connected to underground drains. These are not visible and cannot be examined.
- 4.2. Clogged gutter downspout observed at exterior of Suite 130.
- 4.3. Damaged gutter observed at right side of building

Clogged gutter downspout observed at exterior of Suite 130. Damaged gutter observed at right side of building

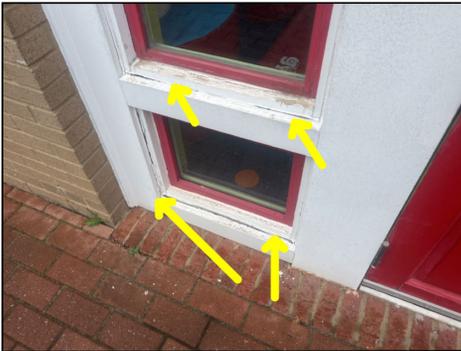
1.2. Water damaged wood trim observed at various areas on building exterior

Water damaged wood trim observed at suite 100

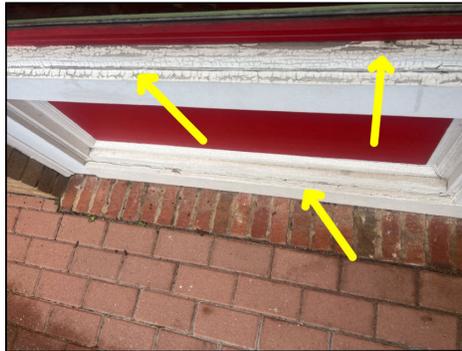
Water damaged wood trim observed at various areas on building exterior

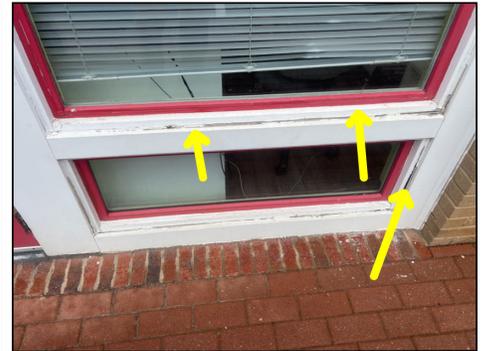
Water damaged wood trim observed at various areas on building exterior

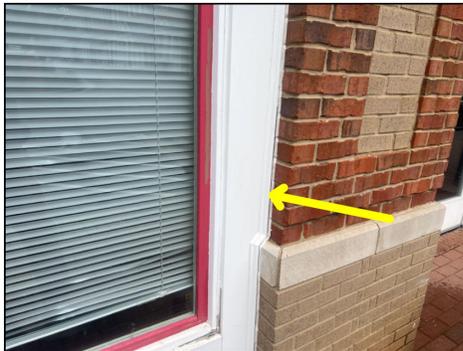
1.1. Deteriorated sealant observed at one or more areas of exterior flashing and trim. Recommend regular maintenance to ensure a proper seal is in place. See photographs for examples and locations.

Deteriorated sealant observed at one or more areas of exterior flashing and trim.

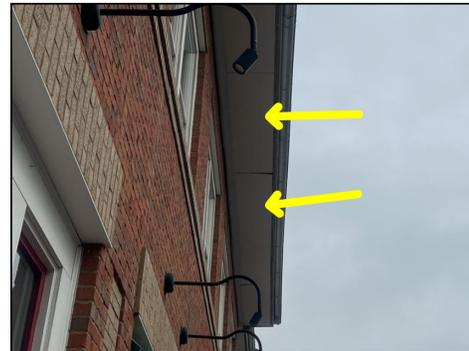
1.3. Loose soffit boards observed on rear side of building at right side

Loose soffit boards observed on rear side of building at right side

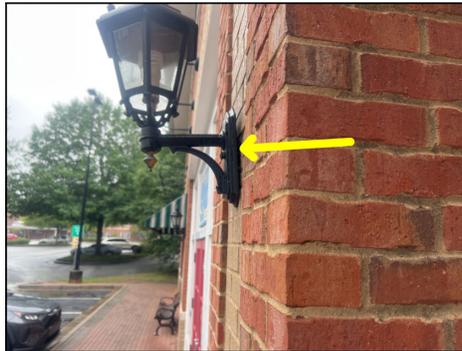
Loose fixture observed at left side of main entrance

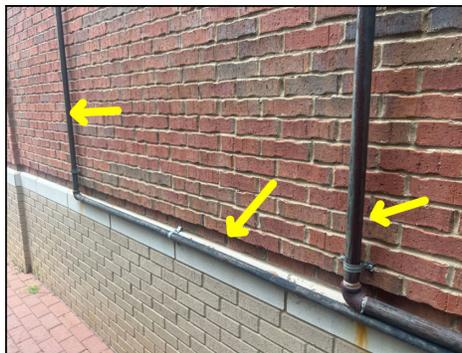
1.3. Rust observed on gas utility piping at one or more locations. Repair to prevent further deterioration. See photographs for locations.

Rust observed on gas utility piping at right side

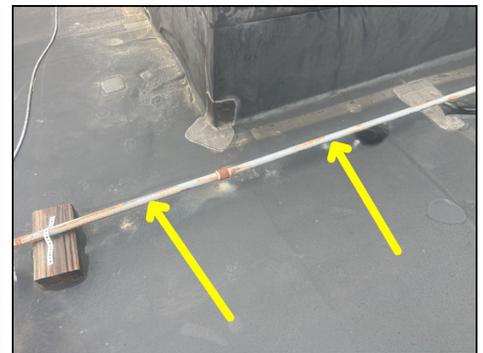
1.2. Exposed gas piping not marked for identification by a yellow label marked "Gas" in black letters occurring at intervals of 5 feet or less observed at one or more locations. See photographs for locations.

Exposed gas piping not marked for identification by a yellow label marked "Gas" in black letters occurring at intervals of 5 feet or less observed at one or more locations. See photographs for locations.

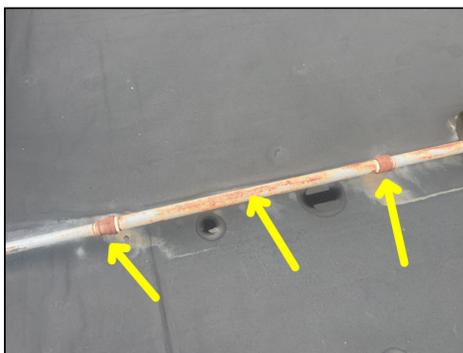
Rust observed on gas utility piping at roof

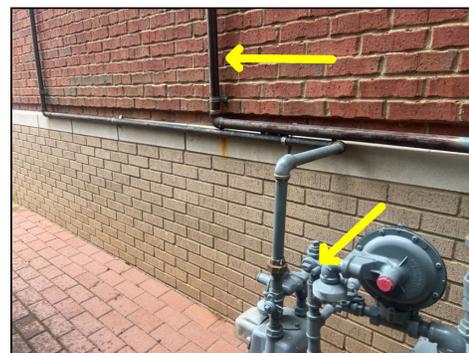
1.5. Gas meter for rooftop is not in use

Gas meter for rooftop is not in use

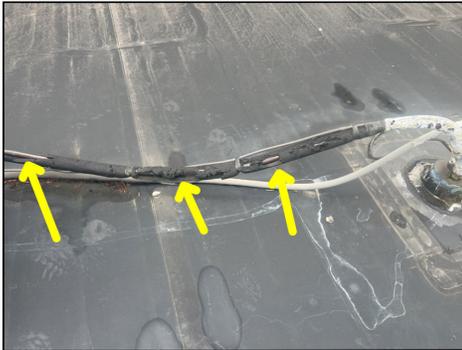
4.1. Refrigerant line insulation is damaged at one or more roof cooling compressors. Recommend repairs for improved performance.

Refrigerant line insulation is damaged at one or more roof cooling compressors. Recommend repairs for improved performance.

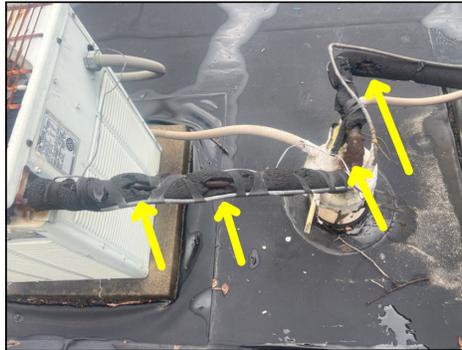
Refrigerant line insulation is damaged at one or more roof cooling compressors. Recommend repairs for improved performance.

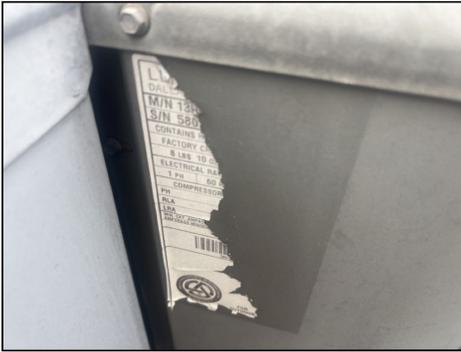
Exterior cooling unit compressor 11 data tag was damaged and not fully visible

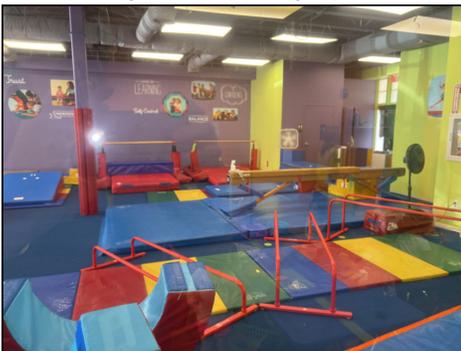
5.1. Air conditioning was not operating in Suite 100 rear area

Air conditioning was not operating in Suite 100 rear area

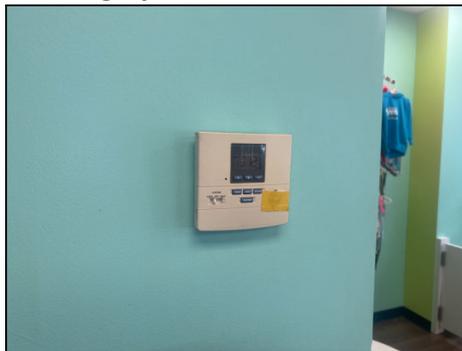
Air conditioning was not operating in Suite 100 rear area

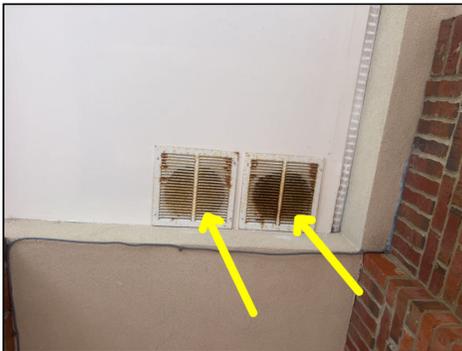
7.1. Rust observed on exterior ventilation duct covers

Rust observed on exterior ventilation duct covers

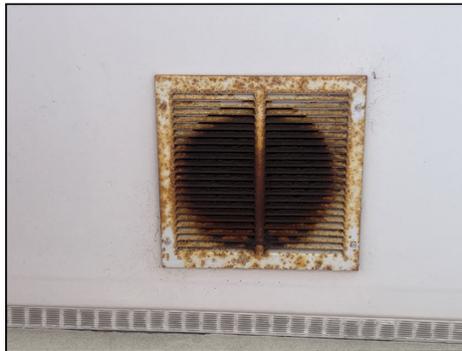
Rust observed on exterior ventilation duct covers

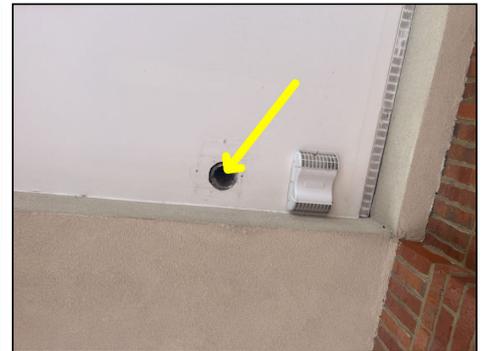
7.2. Missing exterior vent cover observed on exterior at Suite 130

Missing exterior vent cover observed on exterior at Suite 130

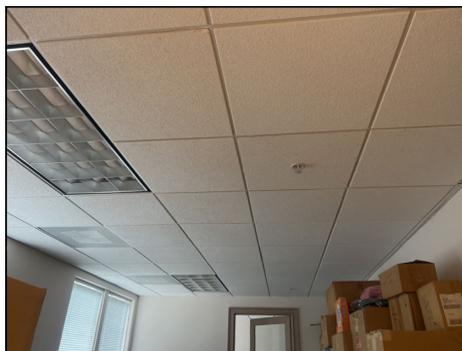
7.3. There were no visible HVAC vents in rear office portion of Suite 260.

There were no visible HVAC vents in rear office portion of Suite 260.

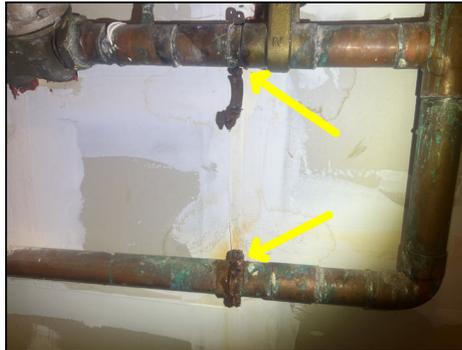
1.1. Corrosion and water, leakage, dripping from main water supply line observed

Corrosion and water, leakage, dripping from main water supply line observed

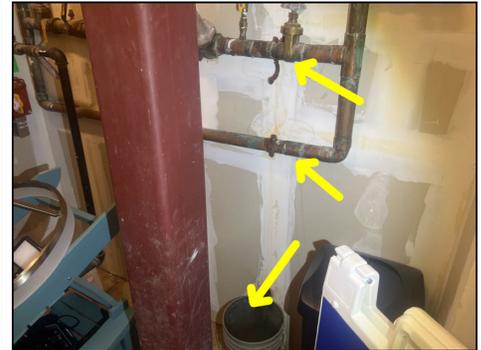
Corrosion and water, leakage, dripping from main water supply line observed

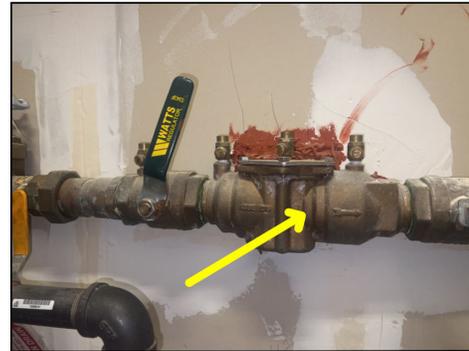
3.1. There was no visible inspection tag at the backflow preventer. Have inspected and tagged by licensed commercial plumber.

There was no visible inspection tag at the backflow preventer. Have inspected and tagged by licensed commercial plumber.

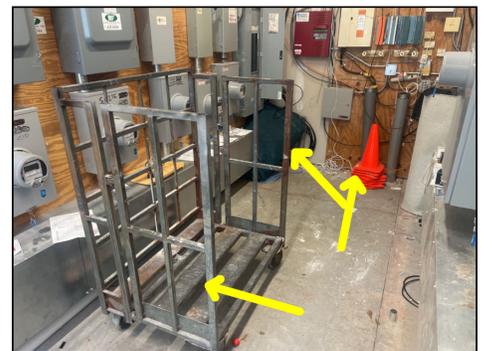
2.1. Storage observed in electrical room. Remove and keep room cleared of any storage to allow for access to equipment.

Improper storage in electrical room

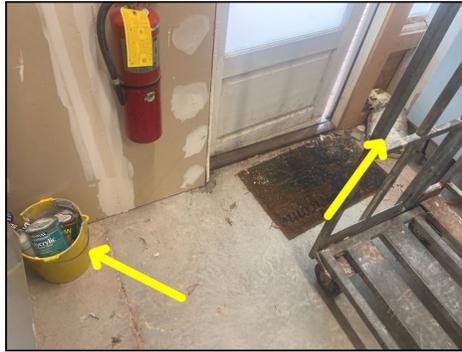
Improper storage in electrical room

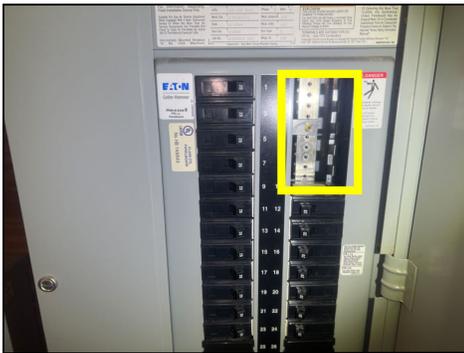
Open knockouts observed in main electrical room secondary service panel covers.

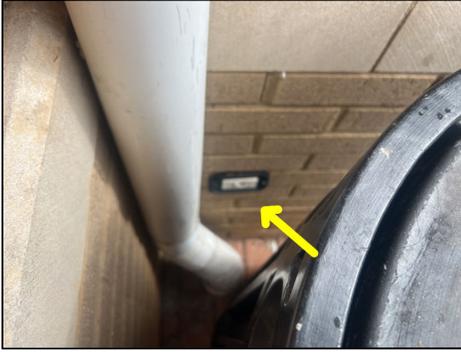
10.3. Missing/damaged weatherproof cover(s) noted at one or more outlets at the exterior of the home. Have the covers installed or repaired as needed. See photographs for specific locations.

Missing/damaged weatherproof cover at left side at rear main entrance

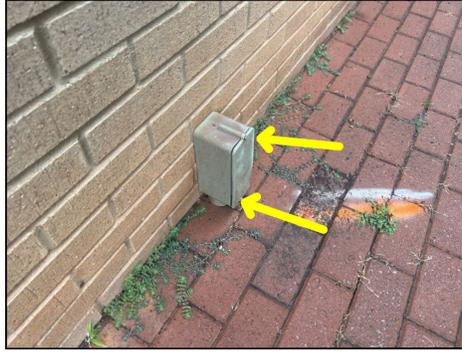
10.1. Loose screws observed that exterior electrical box at right side of building at front

Loose screws observed that exterior electrical box at right side of building at front

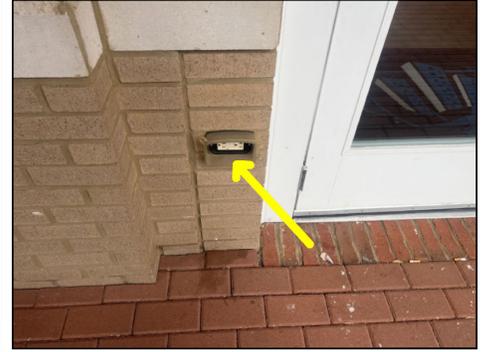
Missing, weatherproof, cover observed at left side of the front entrance

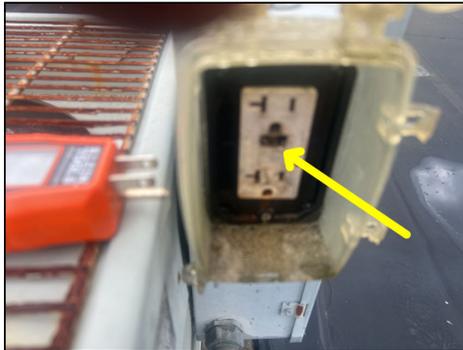
10.4. Rooftop convenience outlet was damaged. Convenience outlet are required to be **GFCI** and operational for repairs on rooftop equipment.

Rooftop convenience outlet was damaged. Convenience outlet are required to be GFCI and operational for repairs on rooftop equipment.

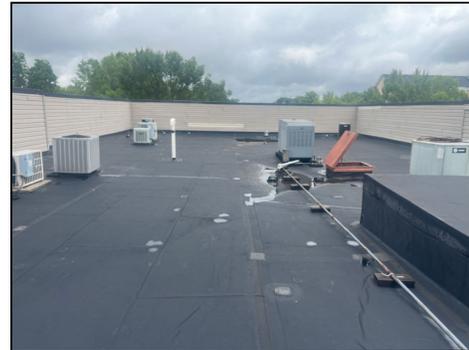
10.2. Lack of luminaire observed on rooftop. Convenience luminaire is required for maintenance on rooftop equipment.

Lack of luminaire observed on rooftop. Convenience luminaire is required for maintenance on rooftop equipment.

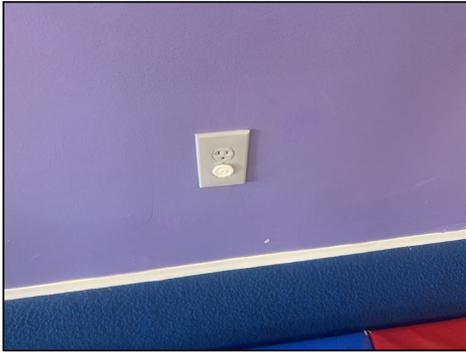
11.2. Nonoperational outlets observed on right wall of Suite 100

Nonoperational outlets observed on right wall of Suite 100

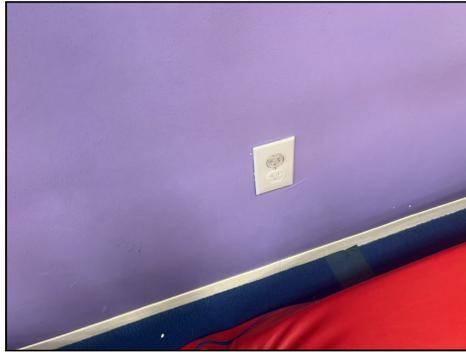
Nonoperational outlets observed on right wall of Suite 100

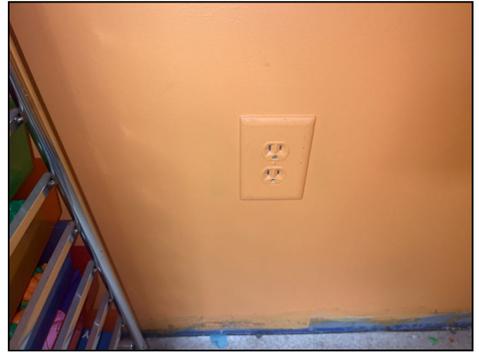
Painted outlet observed in closet in Suite 100

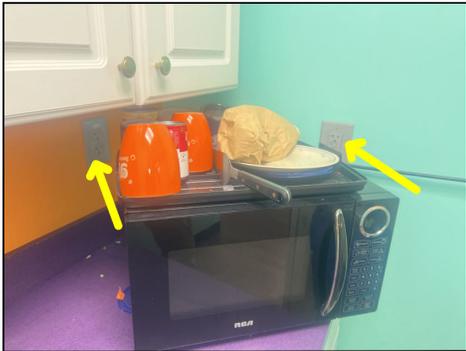
Non energized receptacles at break room area suite 100

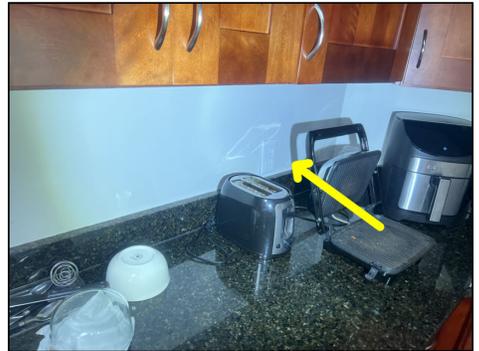
11.3. Non-GFCI outlets observed in second-floor main suite break room. GFCI's are recommended for kitchen areas.

Non-GFCI outlets observed in second-floor main suite break room. GFCI's are recommended for kitchen areas.

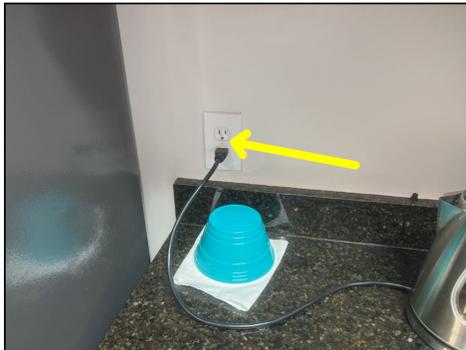
Non-GFCI outlets observed in second-floor main suite break room. GFCI's are recommended for kitchen areas.

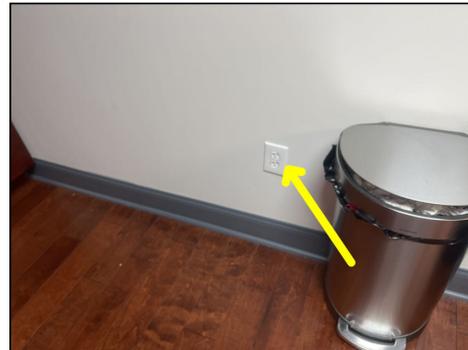
Non-GFCI outlets observed in second-floor main suite break room. GFCI's are recommended for kitchen areas.

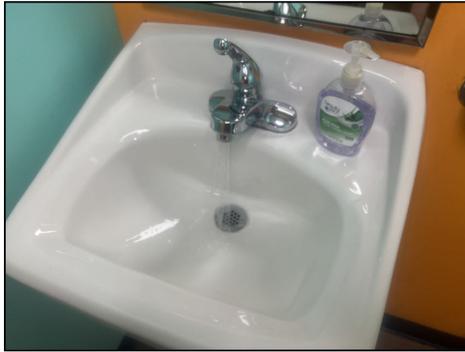
There was no hot water in front Suite 100 bathroom

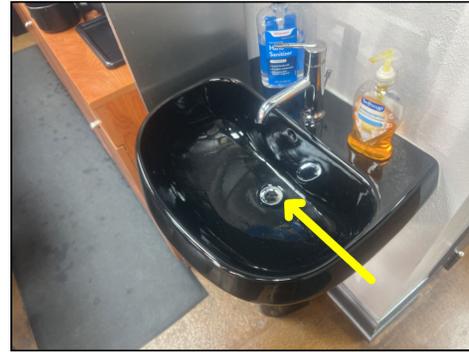
Missing drain stopper observed in hand wash sink in Suite 120

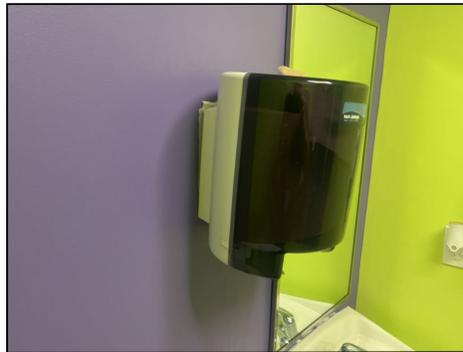
2.1. Loose towel dispensers observed. See photographs for locations.

Loose towel dispenser in suite 100

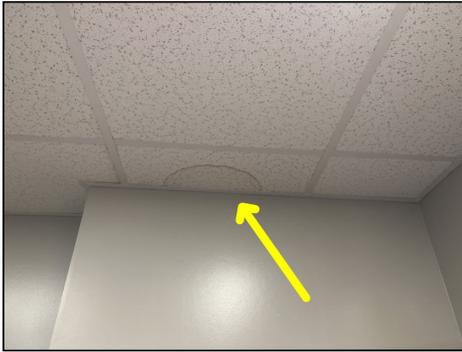
- 3.1. Moisture stains observed at one or more areas on interior ceiling. The areas were dry at the time of inspection and no leaking was noted. See photographs for locations and details.
- 3.2. Ceiling stain observed in rear right exam room in Suite 130. Area above ceiling is not accessible.
- 3.3. Ceiling stain observed in entry hallway in Suite 227. Area above ceiling is not accessible.
- 3.4. Ceiling stains observed in main office area in Suite 260. Area above ceiling is not accessible.
- 3.5. Ceiling stains observed in hallway in Suite 260. Area above ceiling is not accessible.
- 3.6. Ceiling stains observed in right office in Suite 230. Area above ceiling is not accessible.
- 3.7. Ceiling stain observed in reception area of second floor main suite. Area above ceiling is not accessible.

Ceiling stain observed in rear right exam room in Suite 130. Area above ceiling is not accessible.

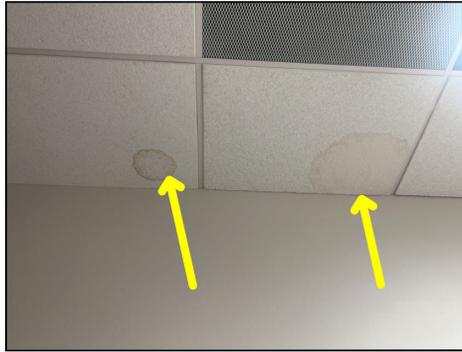
Ceiling stain observed in entry hallway in Suite 227. Area above ceiling is not accessible.

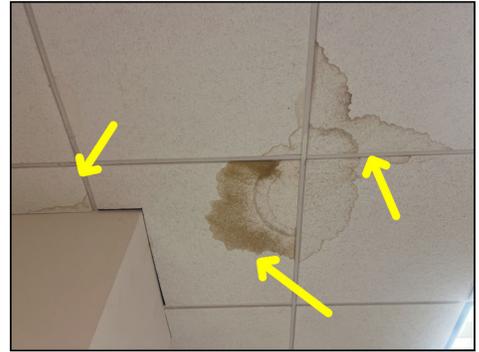
Ceiling stains observed in main office area in Suite 260. Area above ceiling is not accessible.

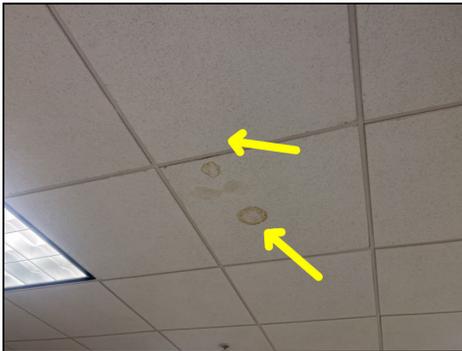
Ceiling stains observed in main office area in Suite 260. Area above ceiling is not accessible.

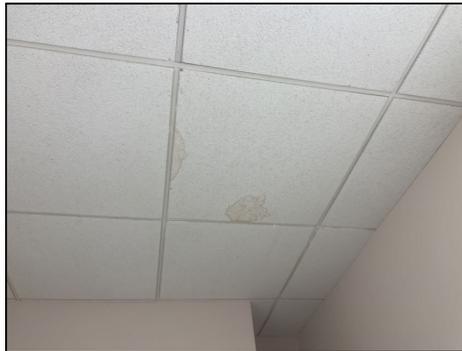
Ceiling stains observed in hallway in Suite 260. Area above ceiling is not accessible.

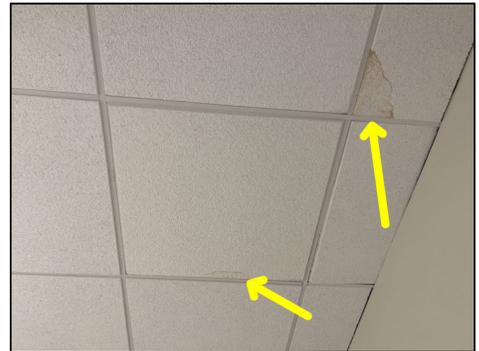
Ceiling stains observed in right office in Suite 230. Area above ceiling is not accessible.

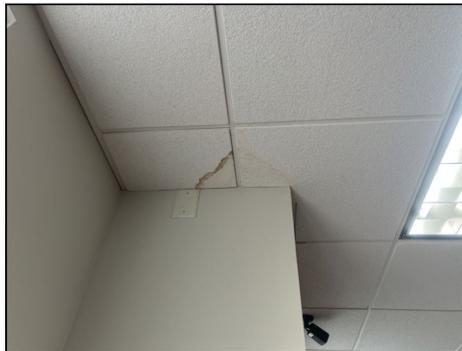
Ceiling stain observed in reception area of second floor main suite. Area above ceiling is not accessible.

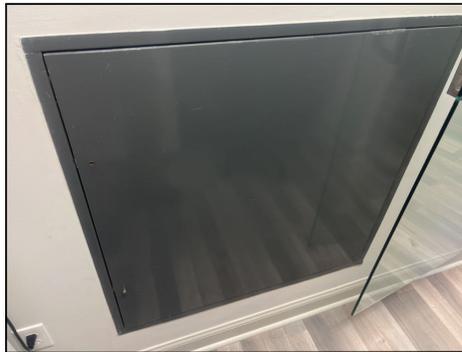
5.1. Access panel observed in Suite 230 receptionist area. Panel did not open. Not inspected.

Access panel observed in Suite 230 receptionist area. Panel did not open. Not inspected.
