Serenity Home Inspections LLC

Property Inspection Report

123 Your New Home Lane, Atlanta GA 30360

Date of Inspection: 1/20/2016

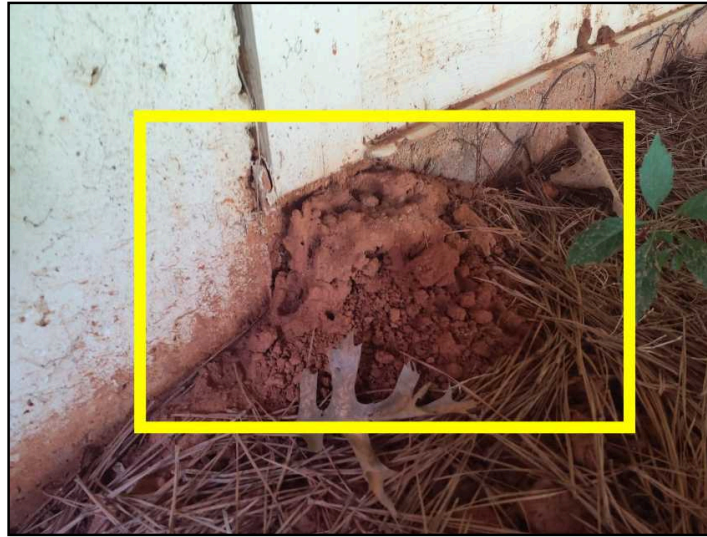
3.2. Insect mound built up to base of exterior siding and trim below back deck. recommend further evaluation by qualified pest control company for type and correction needed

Insect mound built up to base of exterior siding and trim below back deck. recommend further evaluation by qualified pest control company for type and correction needed

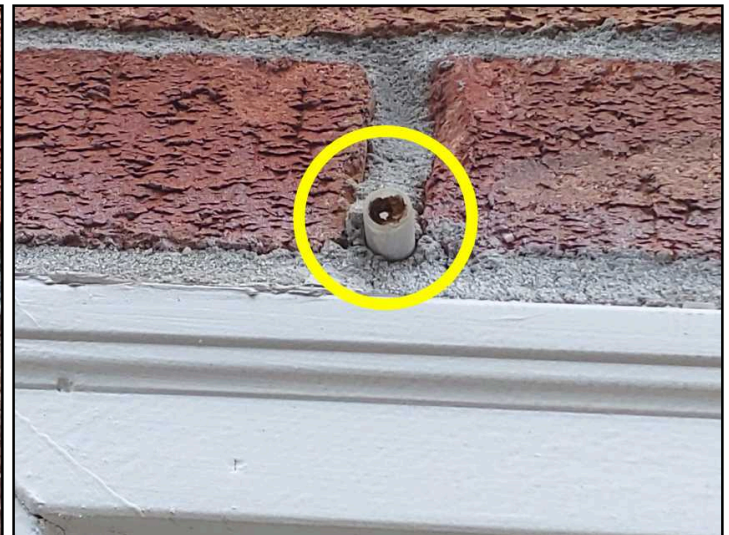
Drainage weep channels in exterior brick are clogged or missingsporadic around home. Have qualified contractor correct for proper drainage and to prevent brick from cracking.

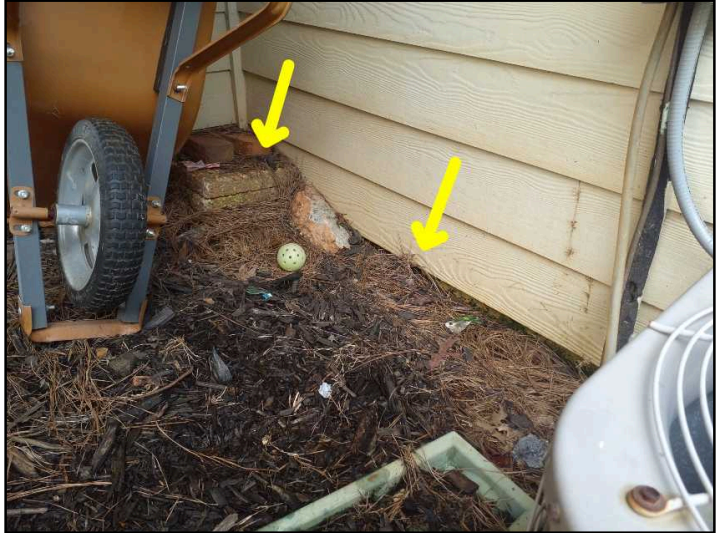
Portions of the exterior siding and trim are in direct contact with the soil. This will cause accelerated water damage and increased potential for insect activity including wood destroying insects. This condition will also dramatically increase the potential for water intrusion into the home. There should generally be a 4-6 inch gap between the siding/trim and ground level. Recommend further evaluation and correction by a qualified contractor.

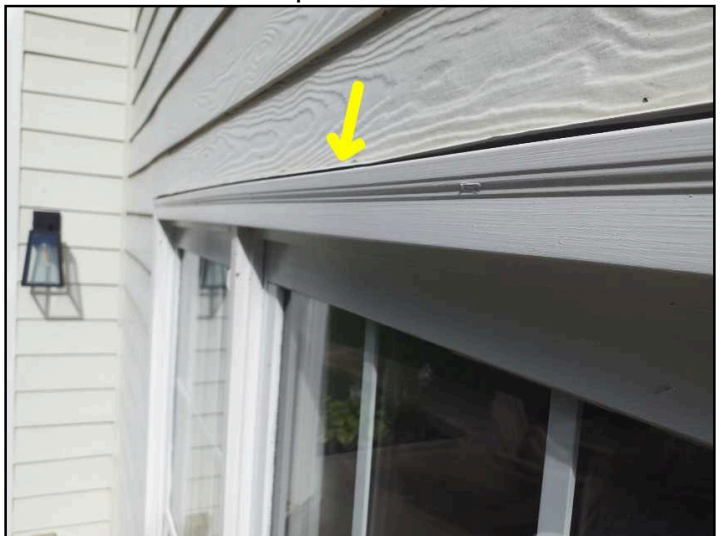
Flashing issues sporadic around exterior of home where trim of all penetrations protrudes beyond edge of flashing above which may allow rain intrusion into wall cavities. further evaluation needed for correction

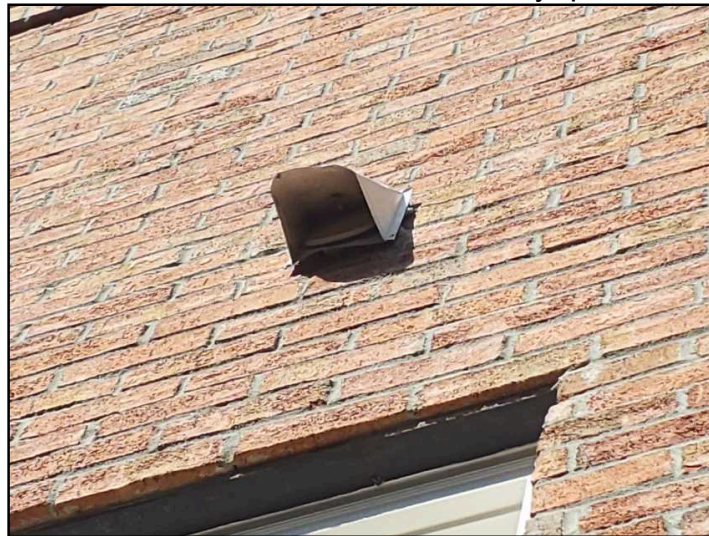
High efficiency furnace exhaust intake on right side of home should not be in close proximity to dryer exhaust vent. recommend further evaluation by qualified HVAC technician

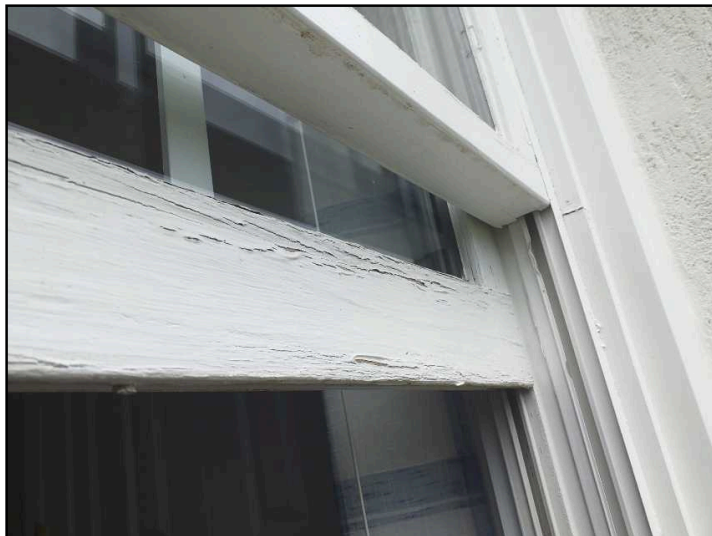
5.5. Multiple windows are stuck shut sporadic in home. Break seal and ensure operation. Stuck windows in a bedroom can prevent emergency egress in case of fire.

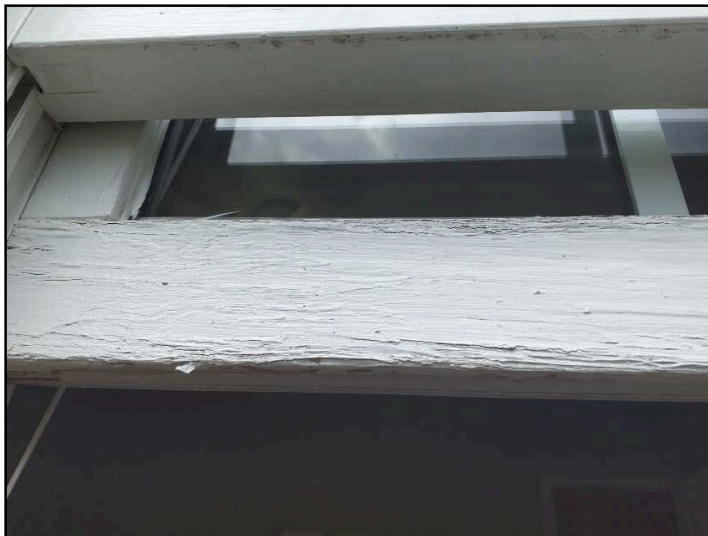
Some deterioration visible at exterior portion of windows. Recommend repair as needed to prevent deterioration

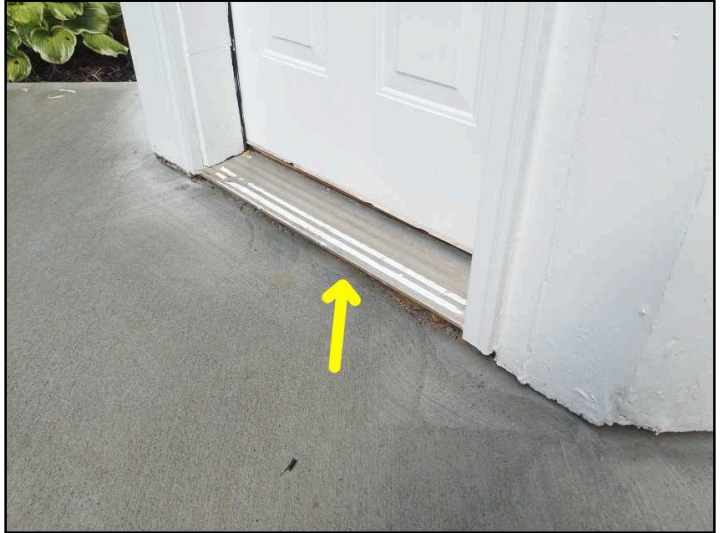
Back deck exterior door is misaligned making operation more difficult. Recommend correction

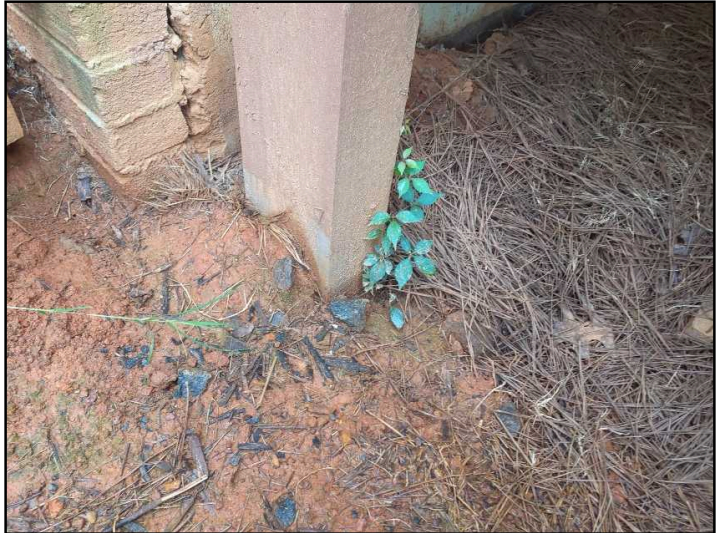
1.4. Back deck structure is visibly sagging towards outer corner with vertical posts slightly leaning below. recommend further evaluation by qualified contractor for cause and correction

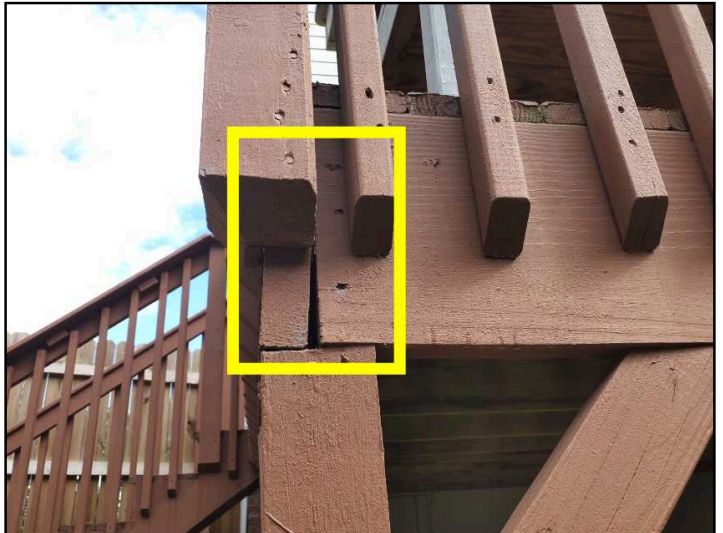
It is recommended to install metal plates and fasteners to secure connections of the deck framing and the wood posts to the deck framing.

It is recommended to install metal plates and fasteners to secure connections of the deck framing and the wood posts to the deck framing.

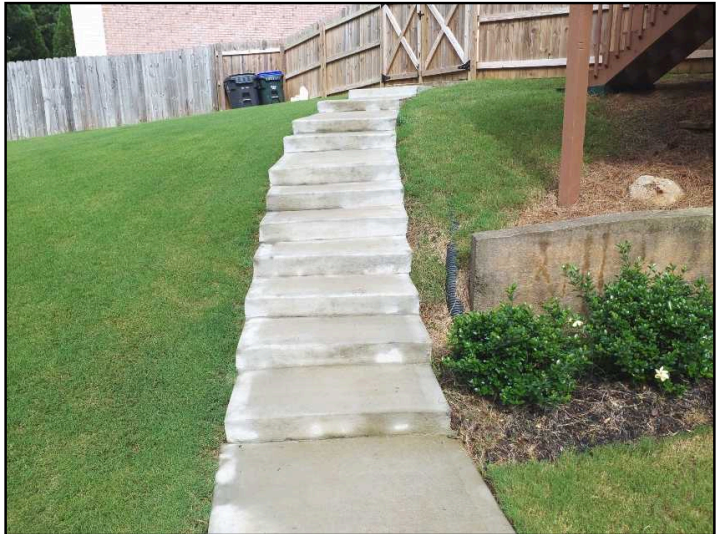
The handrail is not graspable. Deck stairs require a graspable, continuous and smooth handrail for safety. A 2x4 or 2x6 board is not an acceptable hand rail.

Handrail suggested at exterior steps

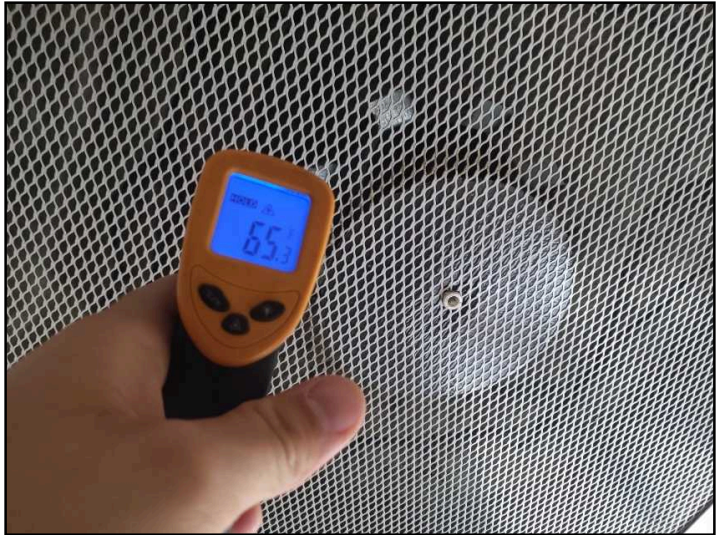
The basement level AC unit did not appear to adequately cool when tested. Less than a 12 degree temperature difference was noted, between the supply and return, with 14-22 degrees being the expected operating range. It is suggested to have the unit reviewed and serviced as needed by a licensed HVAC contractor to ensure proper operation.

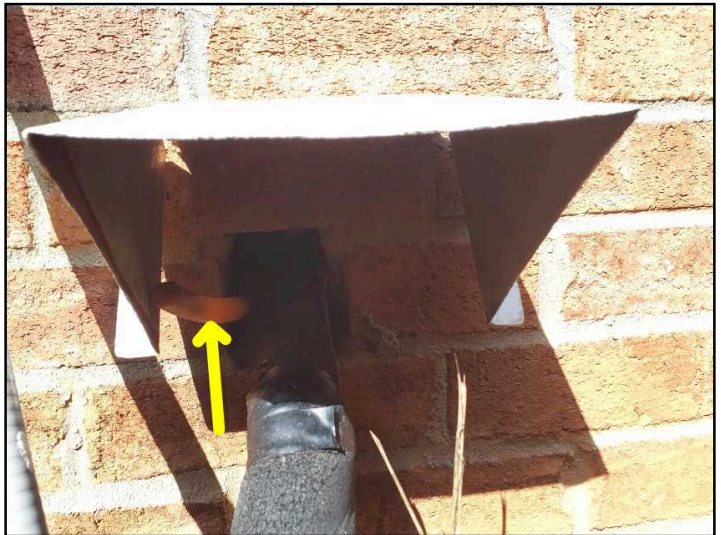
The condensate drain lines should discharge at least five feet from foundation walls to prevent water from collecting near or against the foundation walls as required by industry standards. Have a licensed HVAC or qualified contractor correct.

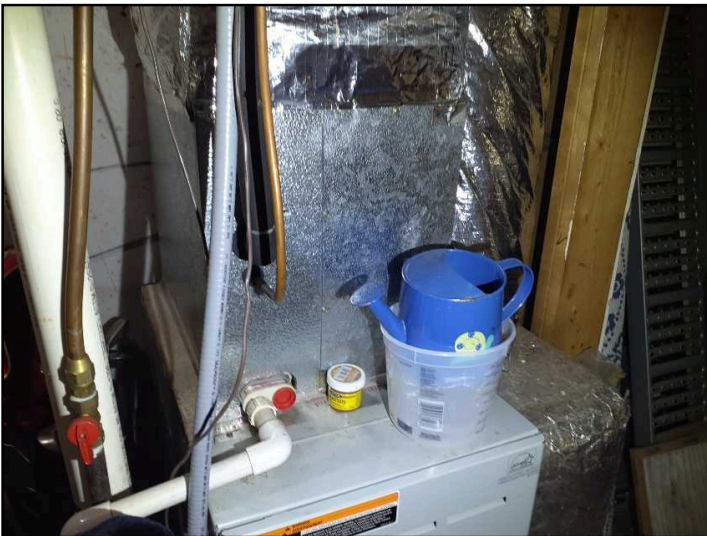
The evaporator coil portion of the HVAC system in the basement unit is beyond its normal life expectancy at 1999

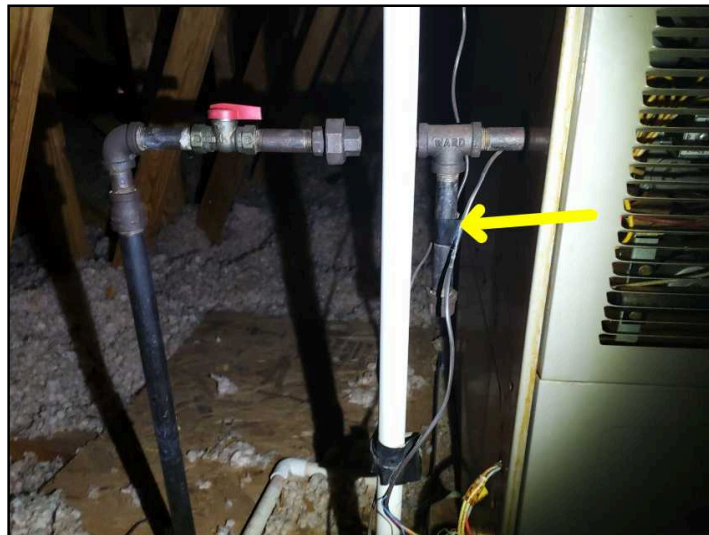
The sediment trap is incorrectly installed on the gas line at the side of the furnace in the attic. The trap should be installed where the pipe changes direction. Have a HVAC contractor examine and repair.

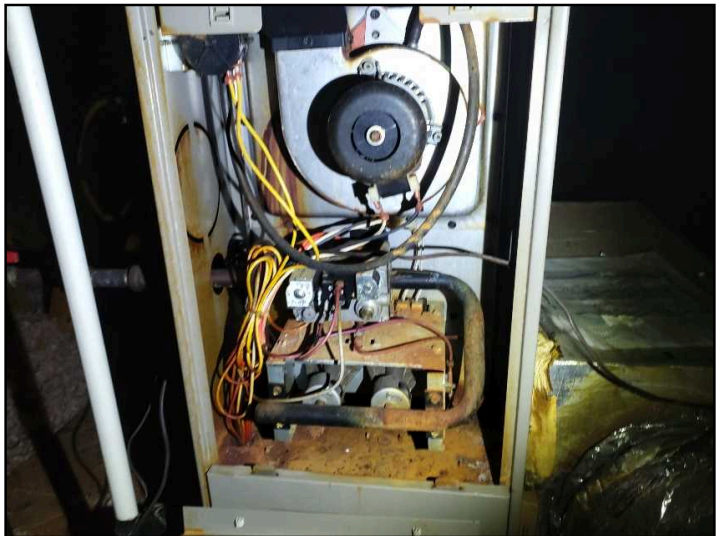
Rust noted on burners in furnace

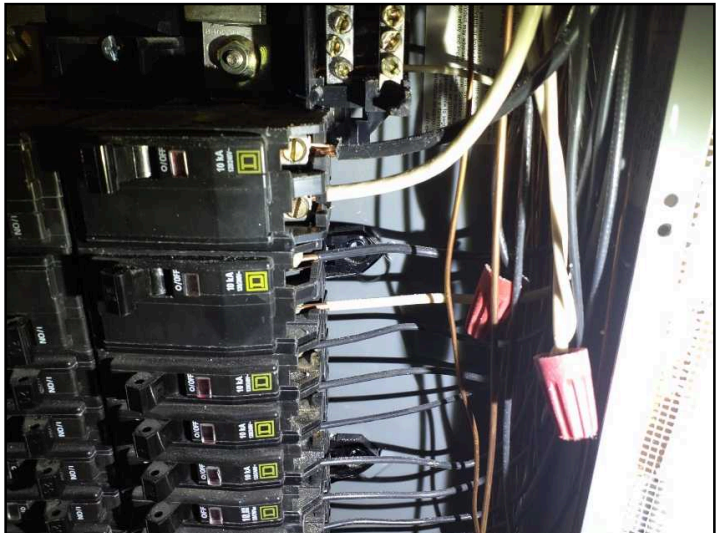
240 live white wires noted at main panel

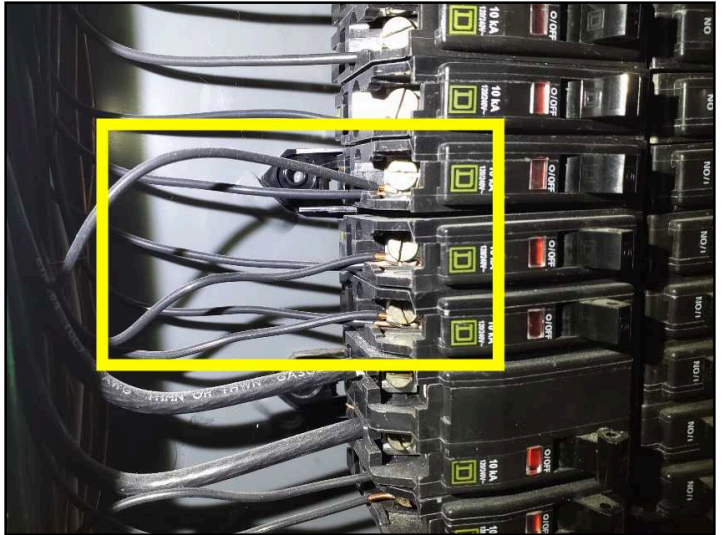
Page 41 Item: 3	Main Panel Comments	<p>3.5. Double tapping observed at the breakers at the left side of the main panel box. This is where more than one wire is installed at a breaker point meant only for one wire. Have an electrician examine and repair.</p> <p>3.6. There is a black and white wire connected to a 2 pole breaker to feed a 240 volt circuit in the panel. In this case the white wire is usually not a neutral wire and should be coded black to avoid confusion. This is usually done at the panel with electrical tape or marker.</p>
Page 43 Item: 4	Sub Panel Comments	<p>4.3. Ground and neutral wiring in sub electrical panel should be isolated on a separate buss.</p> <p>4.4. Multiple deficiencies uncovered at sub-electric panel in basement with improper wire gauges, improper wire installation and other deficiencies. recommend a full evaluation by qualified electrical contractor for extend of correction needed</p>

Double tapped breakers

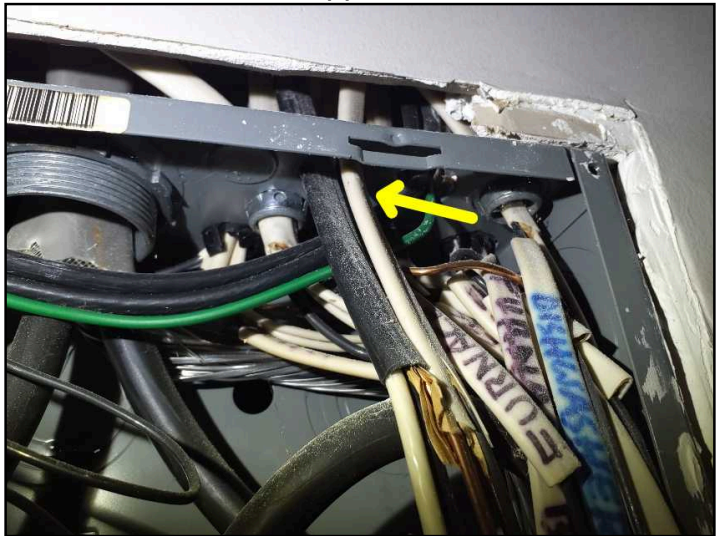
Wire passing through open knockouts were observed at the top and/or bottom of the main panel. Have wire plugs installed to prevent damage to the wires.

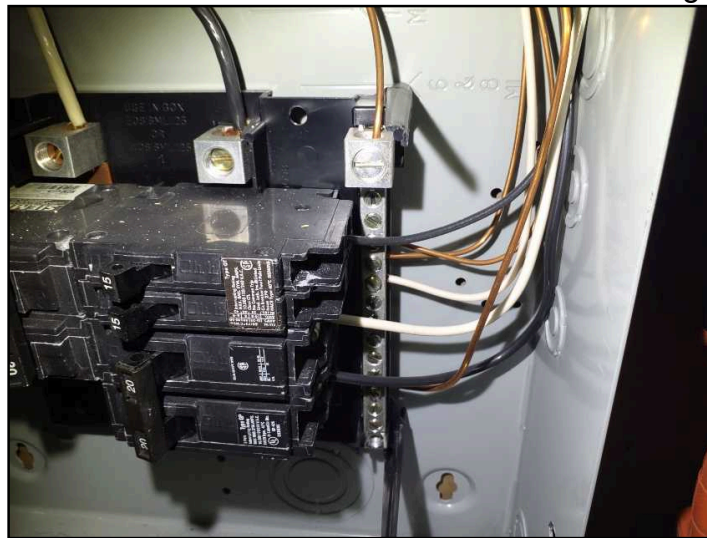
Ground and neutral wiring in sub electrical panel should be isolated on a separate buss.

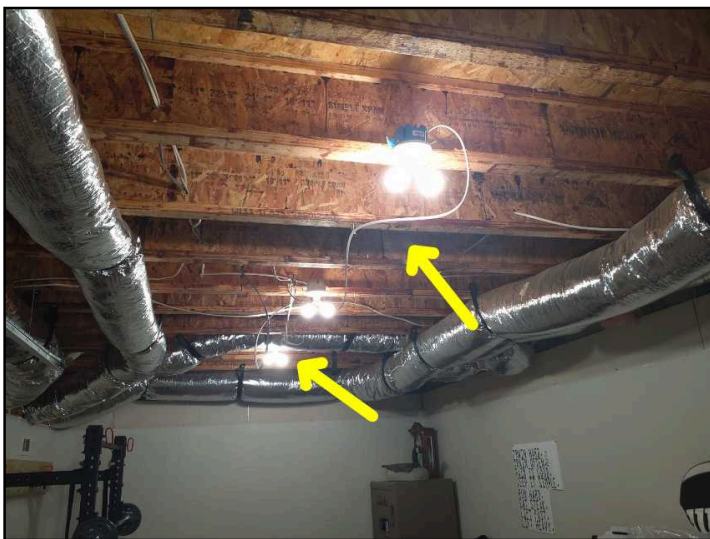
Much of the wiring appears to not be a professional installation in the basement with sagging wires and floating electrical splices.

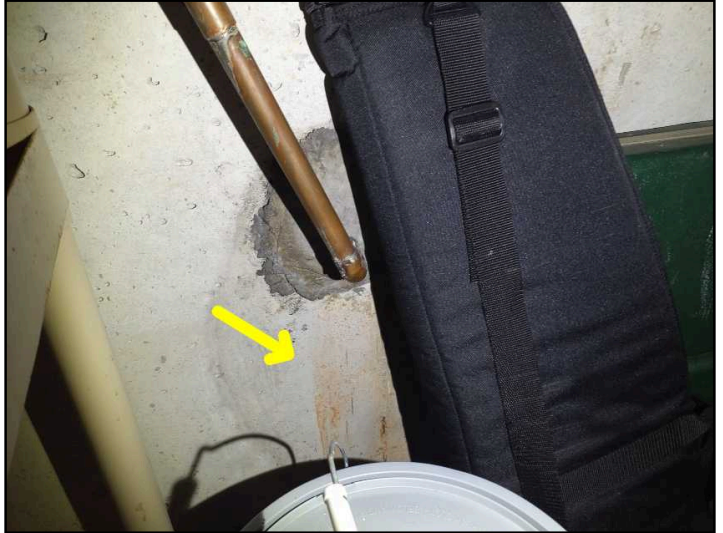
Evidence of past water intrusion noted at the wall below the main water line penetration. The area appears to have been patched/sealed, and no moisture was noted at the time of inspection. Suggested monitoring and if further issues arise, have repaired as needed.

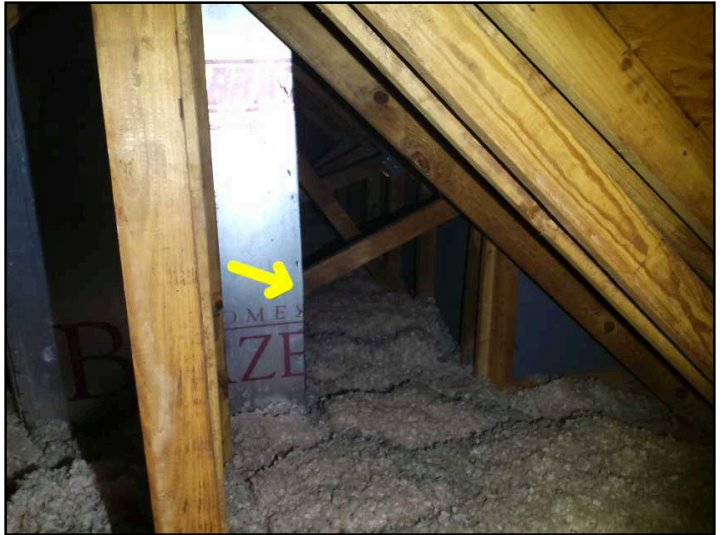
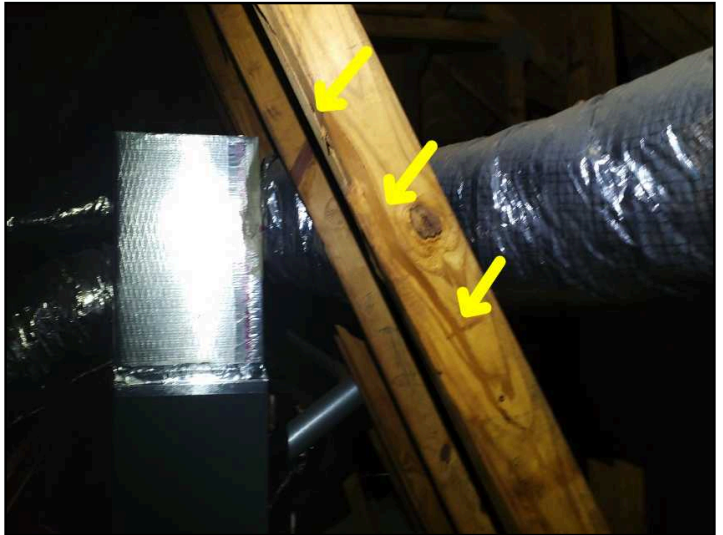
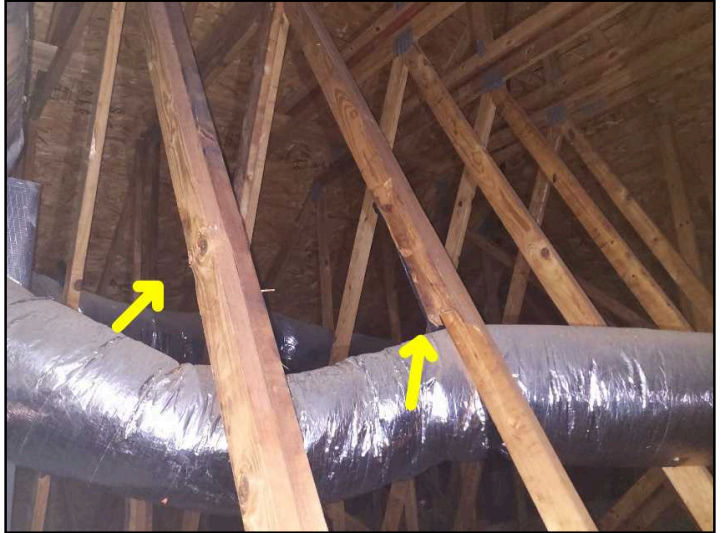
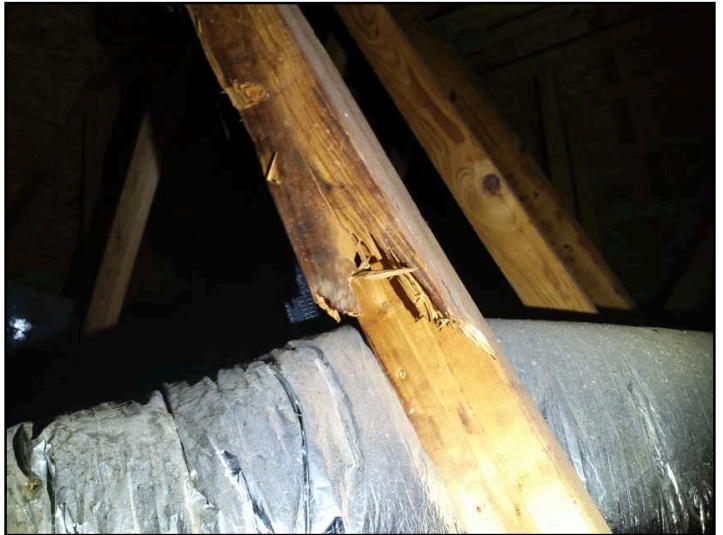
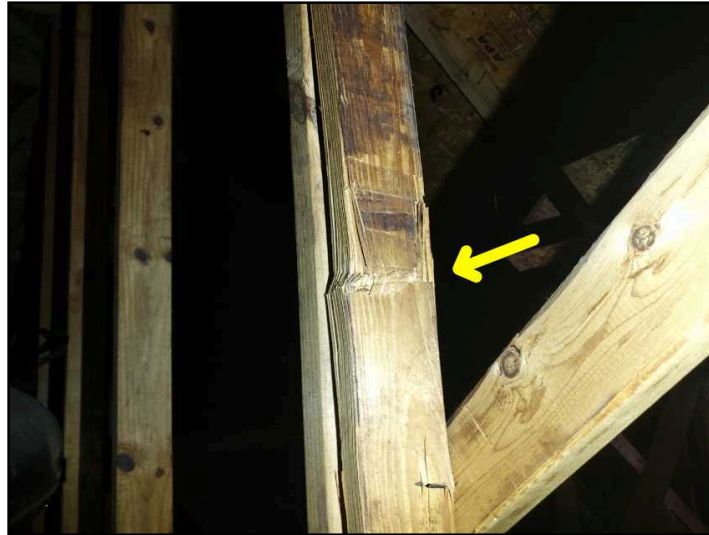
Page 51 Item: 2	Attic Framing	2.1. A portion of the roof truss framing system appears to have been cut or altered running through the chimney and multiple surrounding truss framing members have cracked and separated with some previous repairs beginning to separate. recommend further evaluation for cause and correction by qualified contractor or engineer
-----------------	---------------	---

A portion of the roof truss framing system appears to have been cut or altered running through the chimney and multiple surrounding truss framing members have cracked and separated with some previous repairs beginning to separate. recommend further evaluation for cause and correction by qualified contractor or engineer

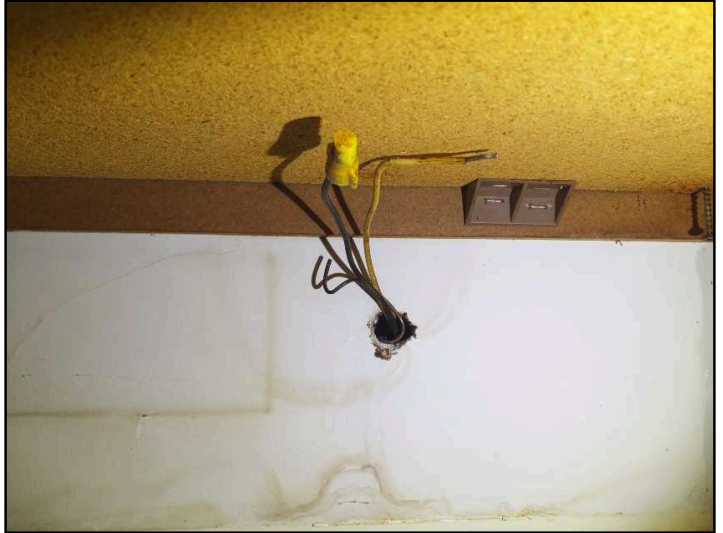
Exposed electrical wire in basement kitchen where exhaust fan should be installed

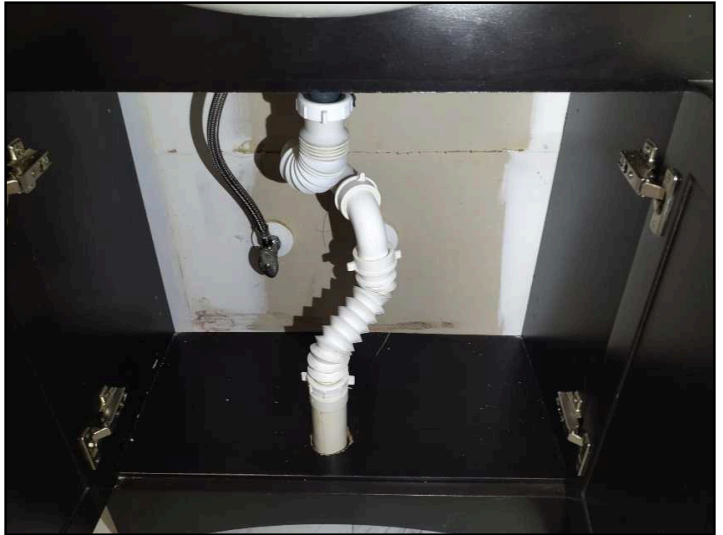
corrugated drain line with missing P-trap was noted at basement bathroom sink. These are subject to frequent clogging and should be replaced with a smooth wall pipe.

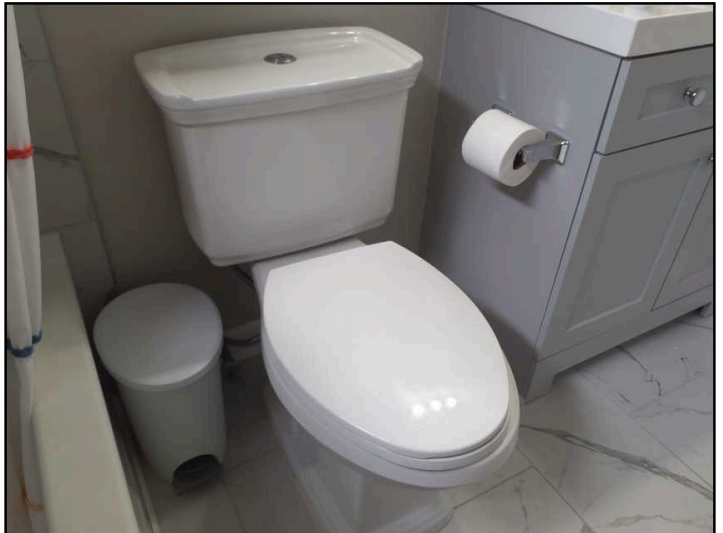
Loose toilet at second floor hall bath

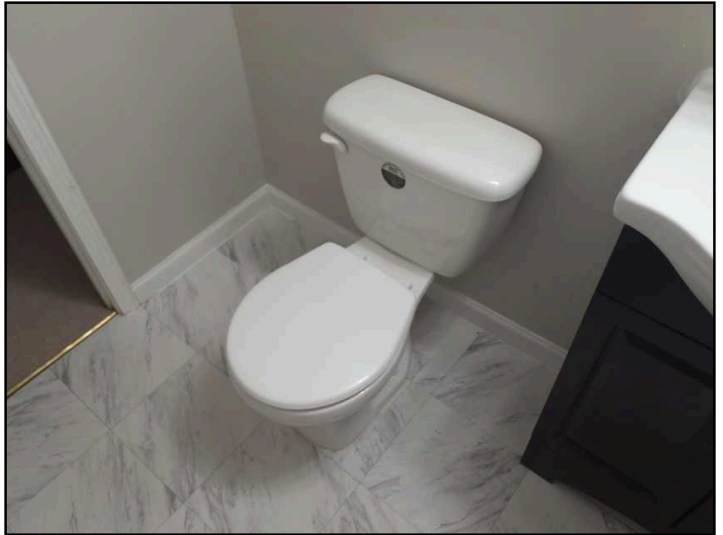
Loose toilet at basement level bath

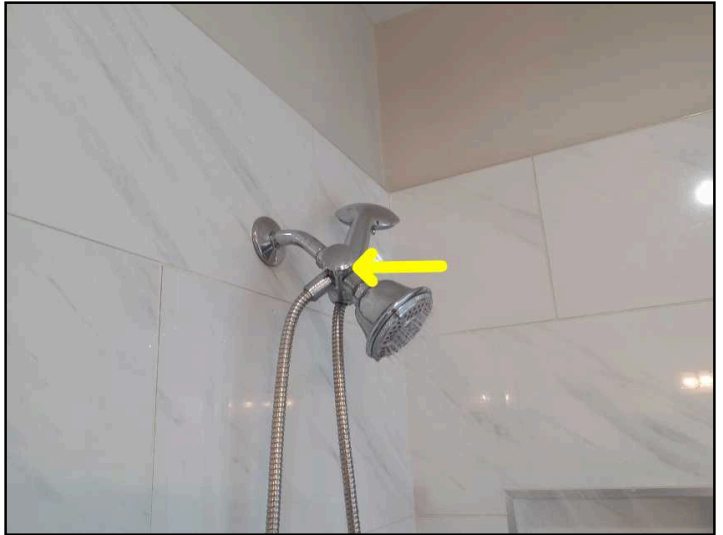
Leaking noted at hand held shower head. Suggested to repair or replace as needed.

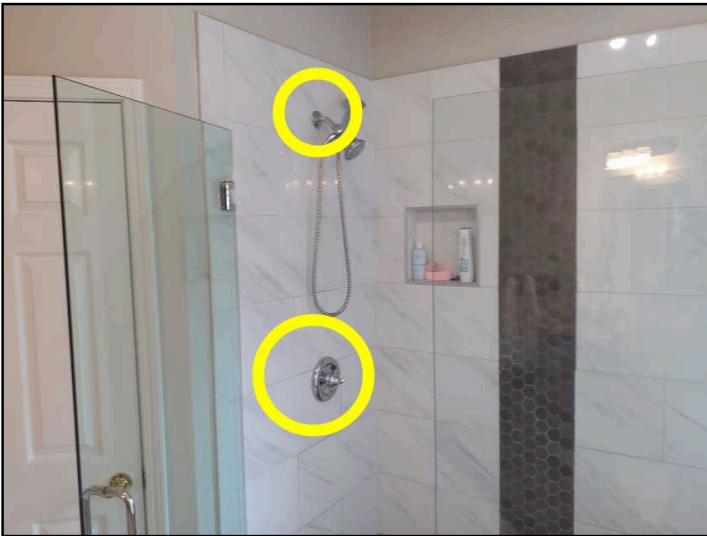
The plumbing components at the master shower stall wall are not properly secured or sealed which may allow damage to piping or water intrusion into wall cavity

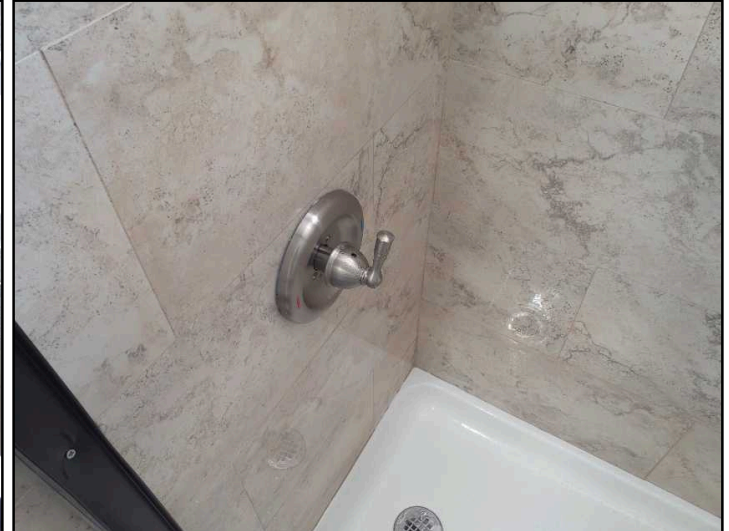
The hot and cold water lines are reversed at the shower in the main level bath room.

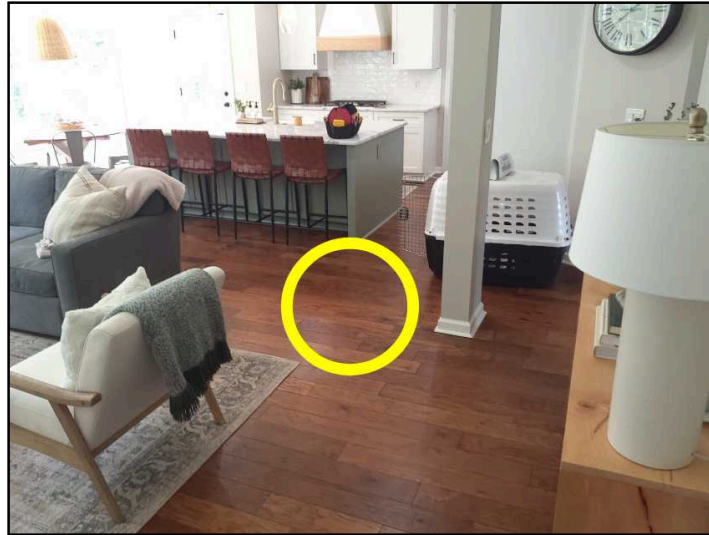
Small area of flooring next to support post between living room and kitchen is slightly loose and shifting when stepped on. recommend further evaluation for cause and correction by qualified contractor

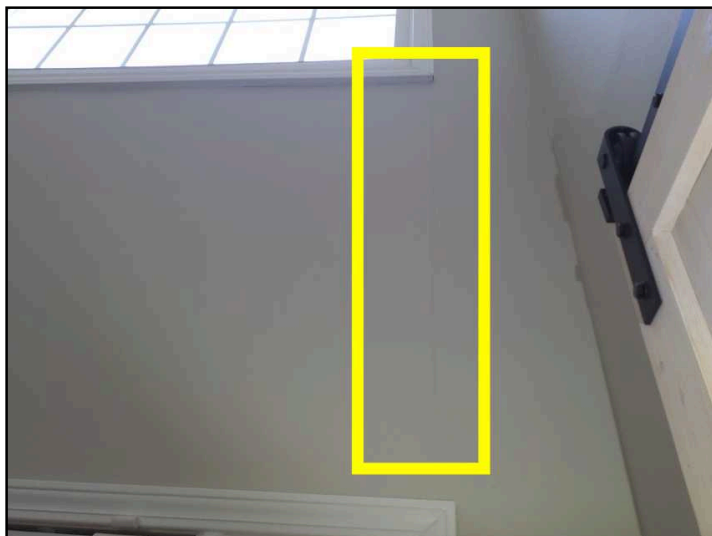
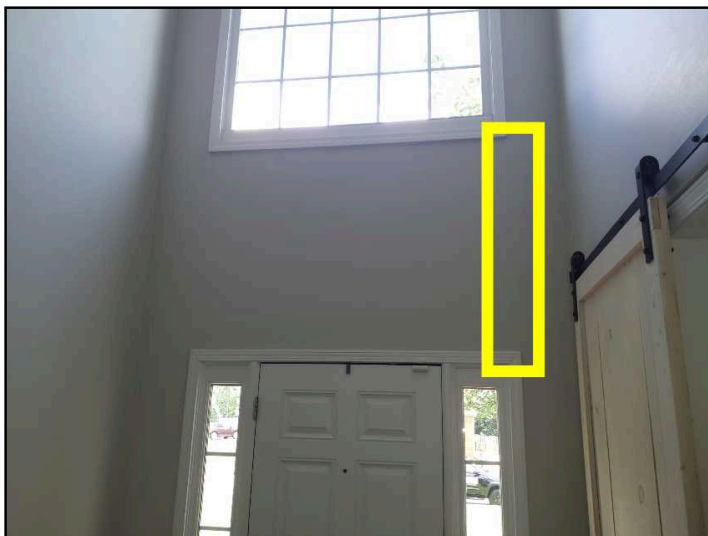
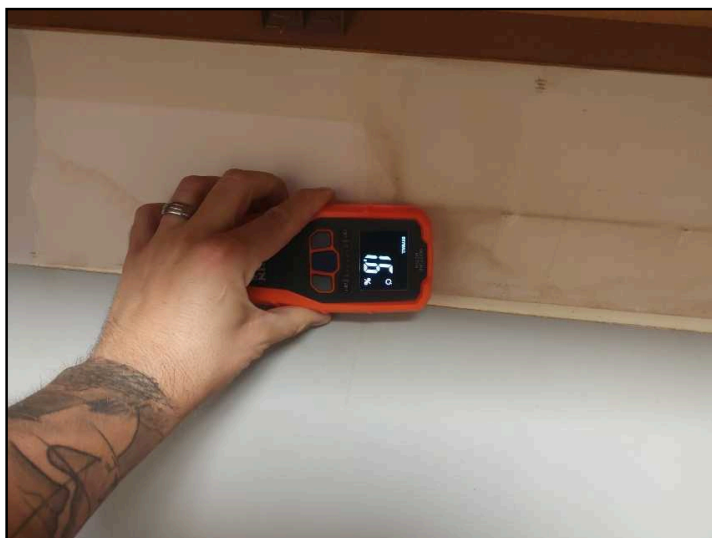
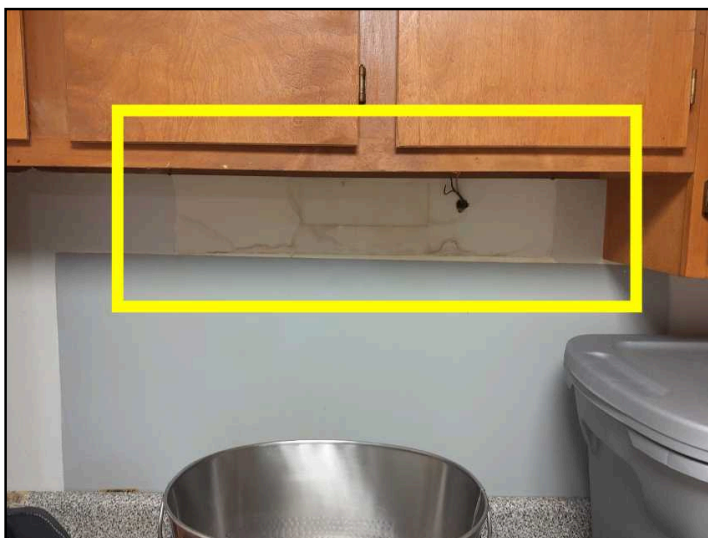
Water-like staining down wall below foyer window inside home indicates some rain intrusion at window frame. recommend further evaluation for cause and correction

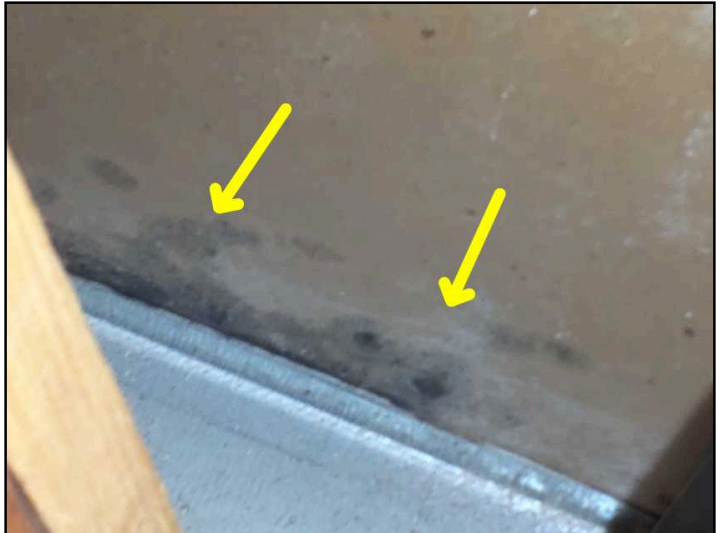
Possible mold growth and pace of drywall across from water heater in basement. recommend further testing to determine type and correction needed

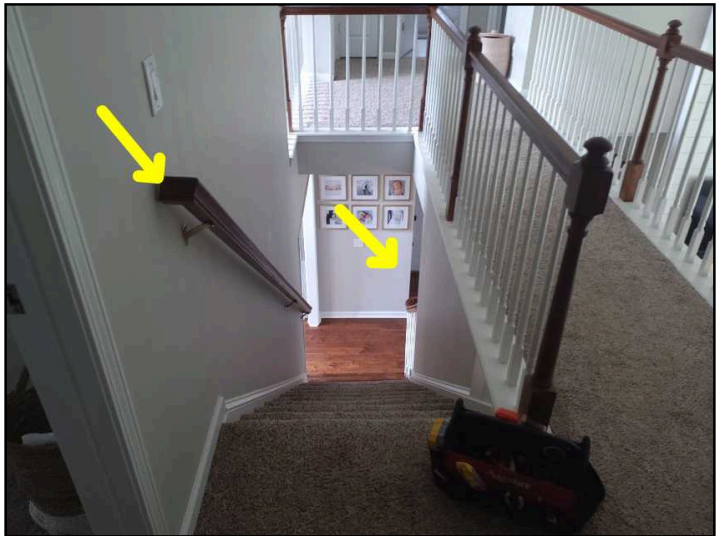
Secure the loose hand rail at the second floor staircase.

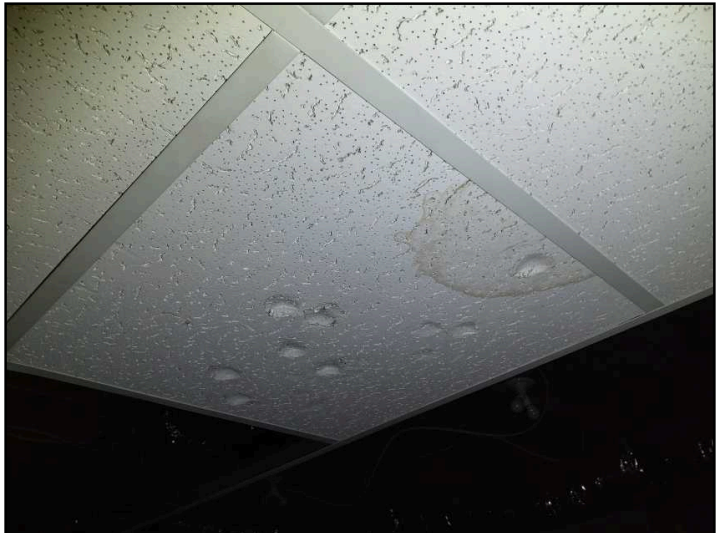
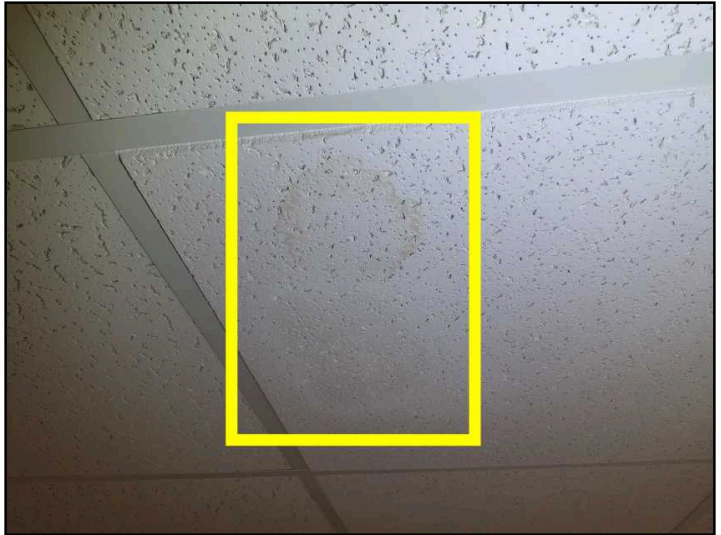
Page 73 Item: 7	Basement Comments	7.5. Evidence of past water event in basement around bedroom closet and bathroom. staining and discoloration is visible on multiple ceiling tiles although no current saturation was detected during inspection. organic like growth was uncovered at multiple locations in this area. further testing will be needed to determine type of growth and correction or treatment needed. recommend further evaluation for cause and correction by qualified contractor

Water staining on ceiling tiles sporadic throughout basement. No current saturation was detected during inspection. replaced tiles and monitor

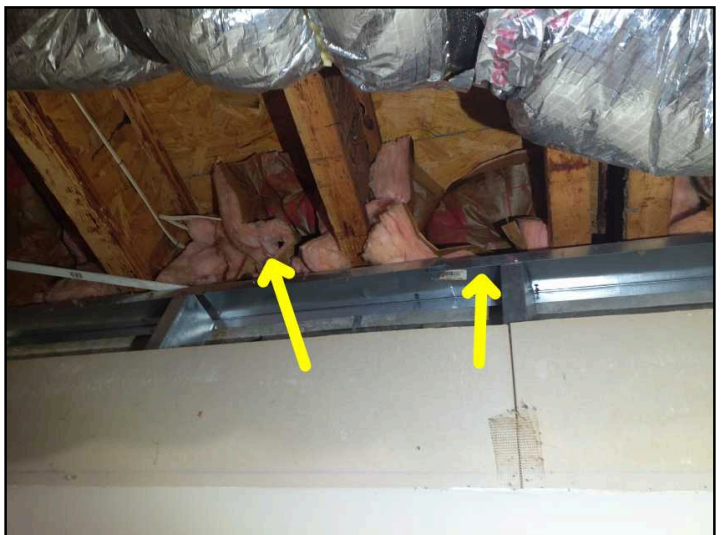
The insulation at the ceiling or walls of the basement has been installed backwards. The paper facing should be installed towards the conditioned side of the home. The paper portion is flammable and should not be left exposed.

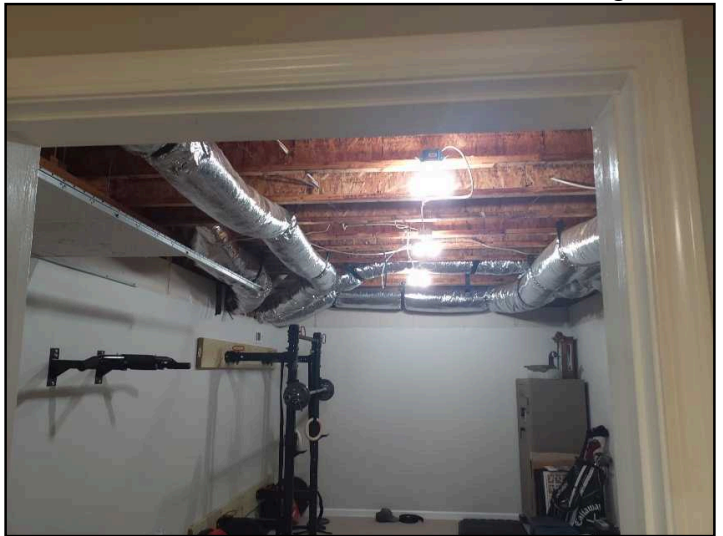
Large portion of drop ceiling is missing in area outside basement kitchen
