# First Choice Inspection Services

## PROPERTY INSPECTION REPORT

**Concerning:** 1234 Any Street Sample  
Corpus Christi TX 78401  
(Address or Other Identification of Inspected Property)

**By:** Salvatore M Iacono TREC #7465.  
(Name and License Number of Inspector:) (Date)

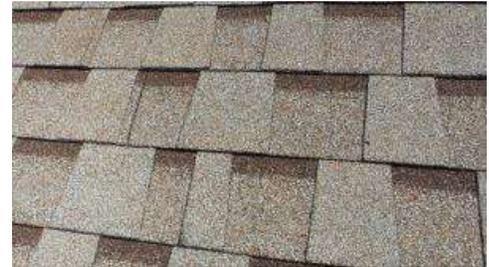
ROOF COVERING OBSERVATIONS- Roof covering observed showing normal wear for age.

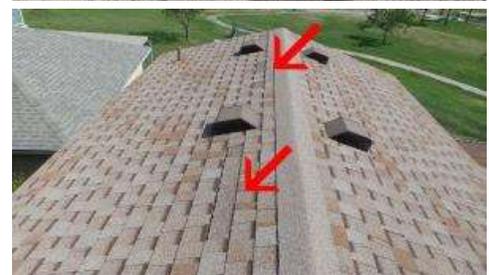
ROOF COVERING OBSERVATIONS- **A number of damaged or missing tabs was noted at the rear of the structure above the upstairs bedroom. This may be storm related.**

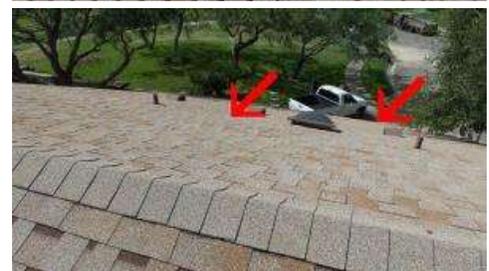
ROOF COVERING OBSERVATIONS- Minor roof deflections at the front of the structure maybe an indication that a slight structural movement has occurred.

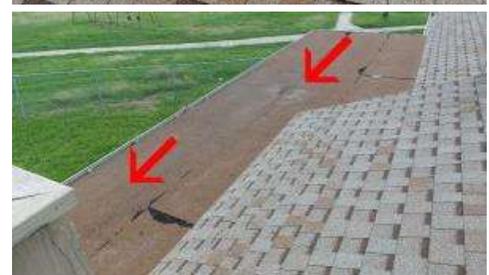
ROOF COVERING OBSERVATIONS- Roof covering observed showing normal wear for age. **Signs of water ponding or puddling noted over the rear flat roof covering.** A licensed roofing contractor should be consulted to make further evaluation.

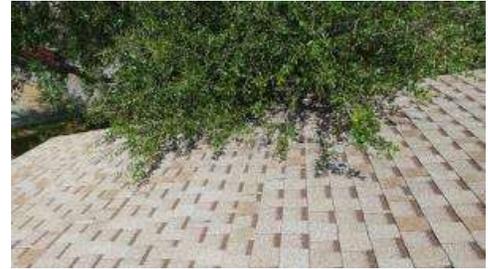
ROOF COVERING OBSERVATIONS- Tree limb(s) observed in contact and rubbing surface of roof. Trim to avoid excessive wear.

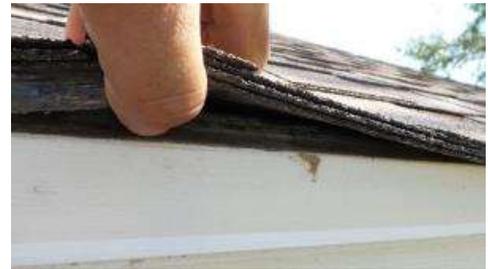
ROOF JACKS, FLASHING, & COUNTER FLASHING OBSERVATIONS- Tar paper does not lay over drip edge flashing at eave edges of roof. This allows water behind the drip edge flashing and on to the decking, fascia and soffit.

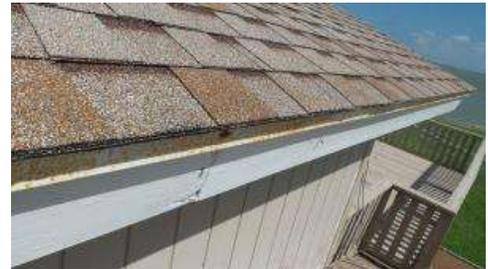
ROOF JACKS, FLASHING, & COUNTER FLASHING OBSERVATIONS- Surface rust was present at exposed drip edge flashing which is typical for coastal environments. GUTTERING OBSERVATIONS- No problems noted at this time. Downspouts terminate near the foundation. All gutter downspouts should have splash blocks or diverters to control erosion.

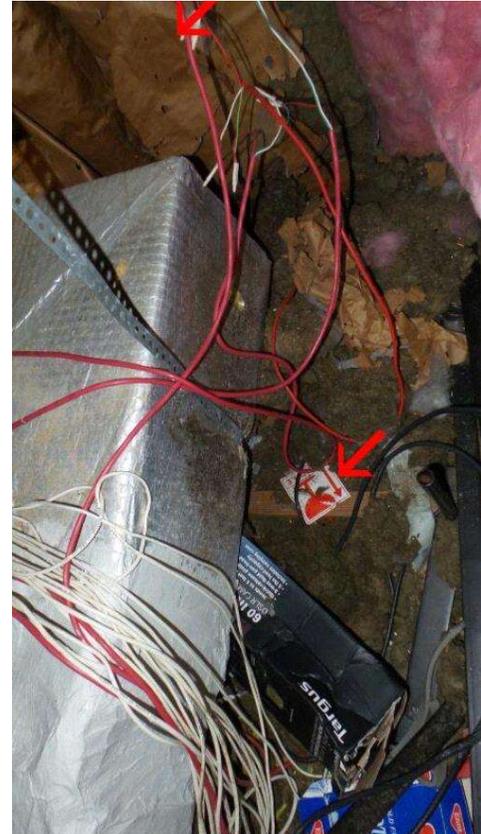
*Approximate Average Depth of Insulation: 5 - 9 inches, combination of batt type and blown in present. Insulation has been disturbed and good coverage is no longer present, with bald spots noted here and there.*

**insulation is generally poor**

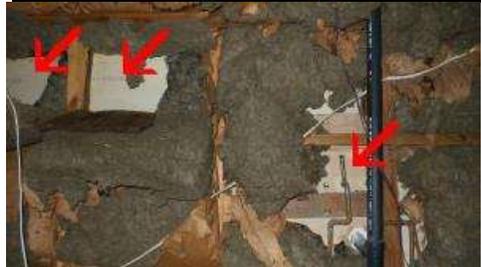
Some of the vertical insulation is failing and repairs are needed.

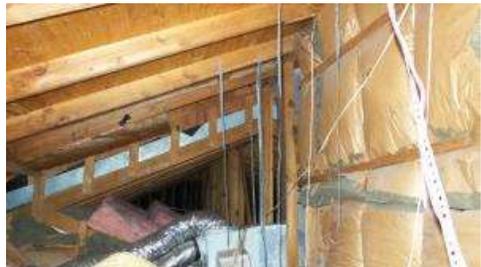
ATTIC OBSERVATIONS- Conventional framing, Lack of fire separation noted at attic door in garage. The door does not appear to be fire rated. This is normal building installation as this is not required or enforced locally. ROOF STRUCTURE OBSERVATIONS-Framing is typical for a home built in this time period. The system appears functional. Debris prevents full inspection. ATTIC VENTILATION IS PROVIDED BY: Turbo vents, soffit vents.

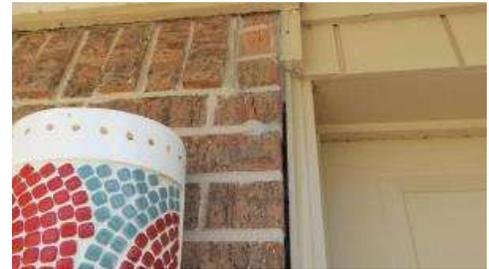
Previous repair open gap between trim and brick work noted at left side of garage maybe an indication that a structural movement has occurred. All opened gaps & seams to be sealed as a part of regular maintenance.

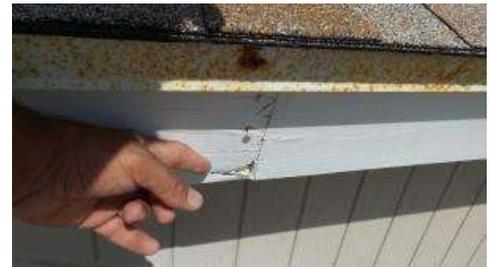
**Wood rot noted to fascia board at rear along roof line.**

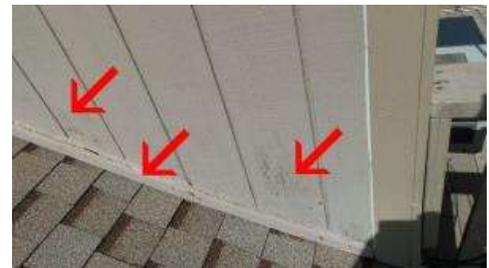
**Wood rot noted to lower sections of siding and trim at rear along roof line.**

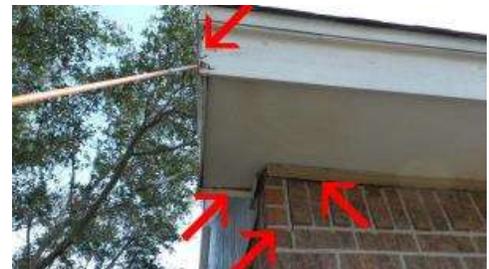
**Loose bricks, brick fractures, loose trim, loose soffit and wood rot noted to corner fascia board at front left of structure.**

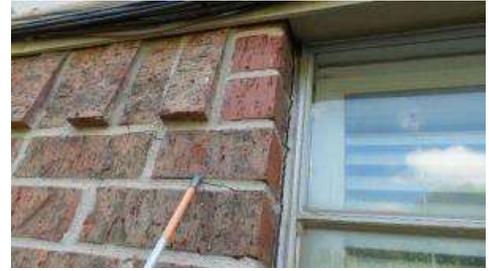
Multiple brick fractures including separation were noted at the left side of the structure. This may be an indication that structural movement has occurred or is occurring. Evaluation is recommended.

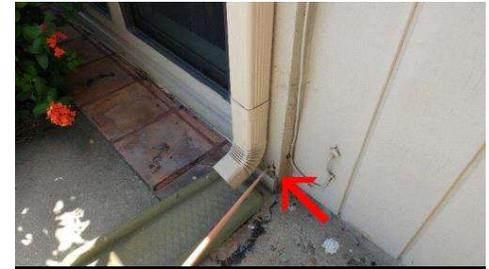
**Wood rot noted to lower sections of wood trim at both left and right of rear converted patio. Inquire with sellers for details. Previous repairs are noted. This may be an area of previous water entry.**

**at both sides**

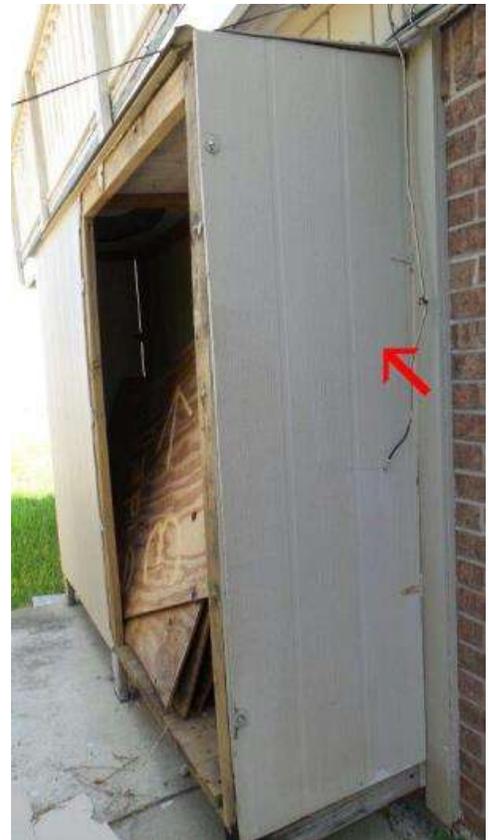
**Damage was present at the lean against closet at the left side of the structure. Inspector recommends that it be removed.**

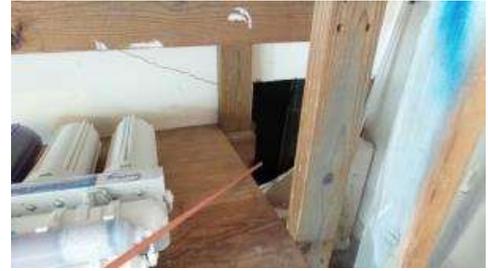
Large diagonal fractures and missing wallboard noted at garage wall surfaces maybe an indication that a structural movement has occurred. It appears that an air conditioning repair maybe present in this area. Inquire with sellers for details.

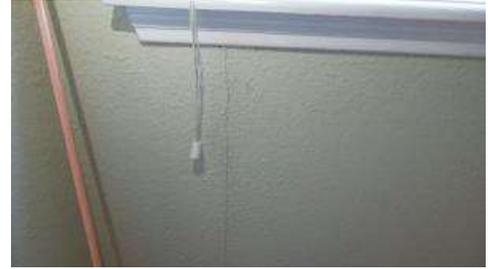
Interior wall fracture noted at downstairs left side bedroom maybe an indication that is structural movement has occurred.

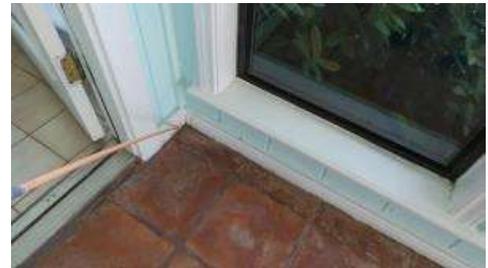
**Water stains around floorboards in rear converted patio maybe an indication that surface water enters this area. Inquire with sellers for details. Previous repairs were also noted.**

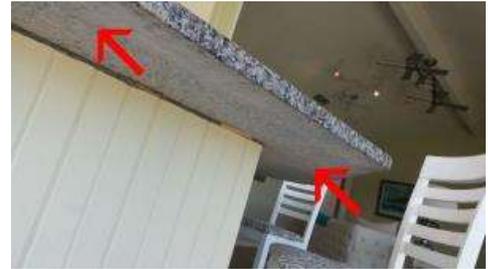
No supports are present at the granite overhang at the breakfast bar area. Injury risks maybe present. Supports a recommended when more than a 9 inch overhang is present.

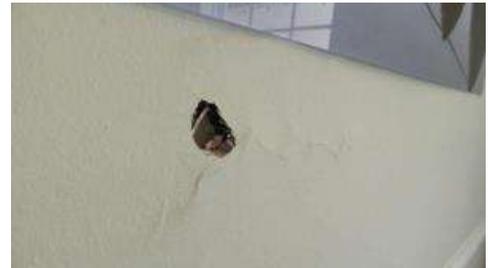
Impact damage and wall damage noted at dining.

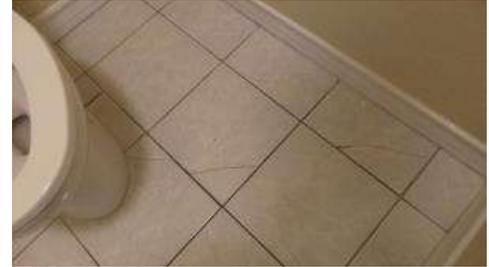
**Tile fractures noted at master toilet.**

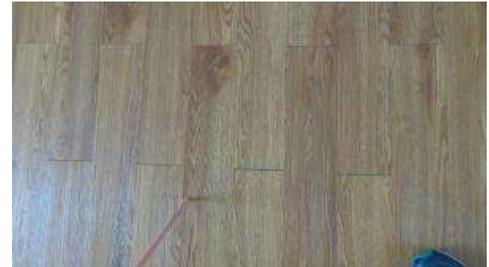
Minor separation is noted between the vinyl floor boards at the upstairs den.

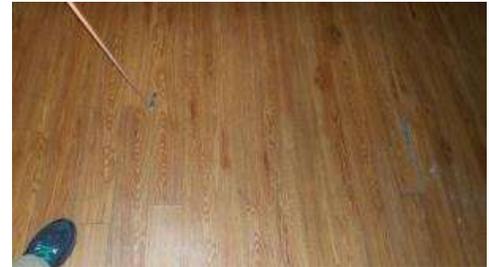
**loose and damaged vinyl flooring was noted at downstairs bedrooms. Inquire with sellers for details.**

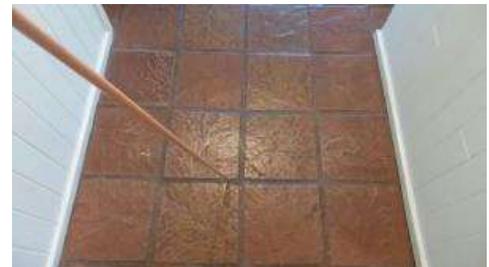
Most of the red tiles were loose when tapped on. This may be an indication that a slight structural movement has occurred. These tile should be monitored for fractures in the future.

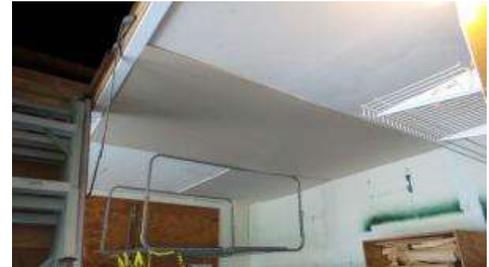
Previous repairs, fractures and water stains noted at garage ceiling surfaces maybe an indication of prior roof leaks and structural movement. Inquire with sellers for details.

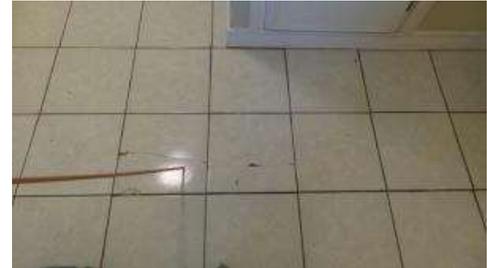
Fractured loose tiles and poor grout were noted at master bath. These maybe an indication that a structural movement has occurred.

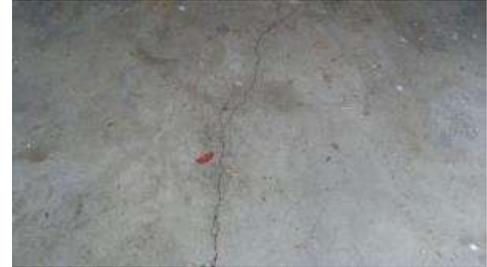
Stress fractures noted at garage concrete floor maybe an indication that a structural movement has occurred.

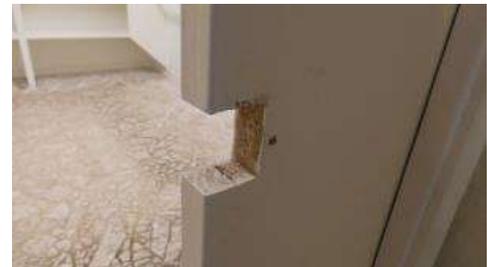
Pocket door hardware was missing at master closet.

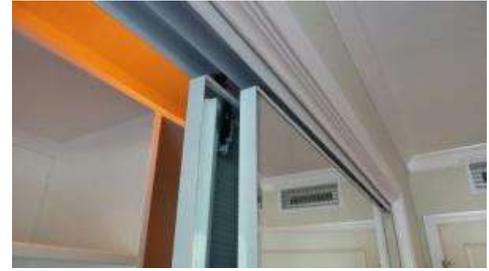
Mirror closet doors are off track and difficult to operate at downstairs left front bedroom closet.

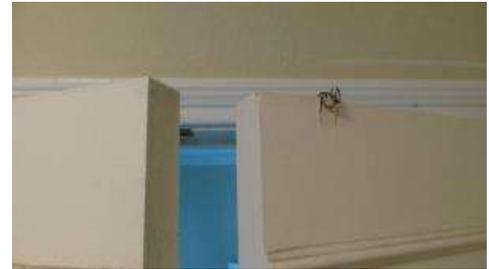
Latching Hardware is damaged at master bath.

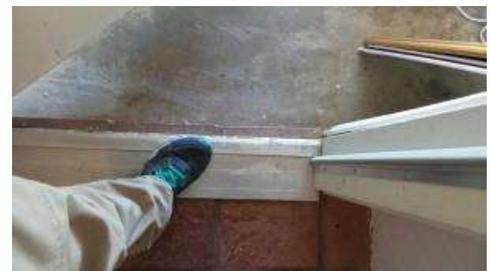
Threshold and trim are loose at garage entry door.

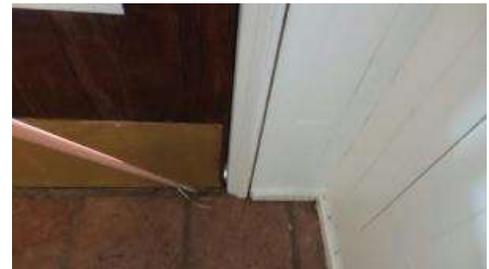
Light and air leak noted at entry. Weather strip/door is in need of repair.

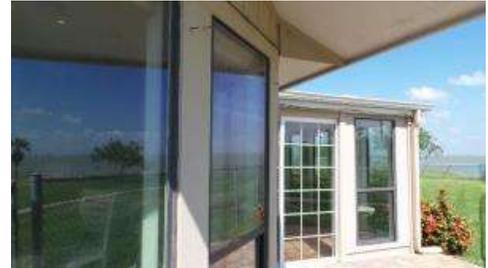
Possible window fogging or failed thermal seals were noted at the rear facing windows. A reputable window company should be contacted for further evaluation and repair recommendations. Window springs failed and some windows were difficult to open.

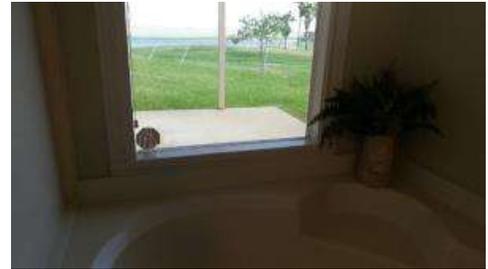
No safety or tempered glass was noted at the window by the spa tub. This was not required when this home is built.

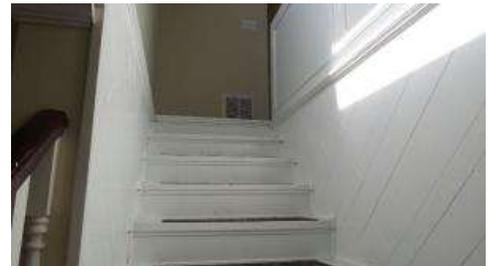
**No handrail is present at the upper course of stairs. Fall risks may be present.**

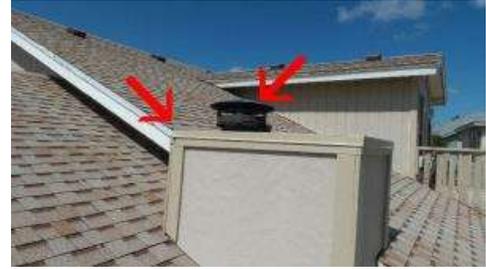
**Chimney does not have proper clearance from the roof/structure. (this may be from the addition). Evaluation is needed.**

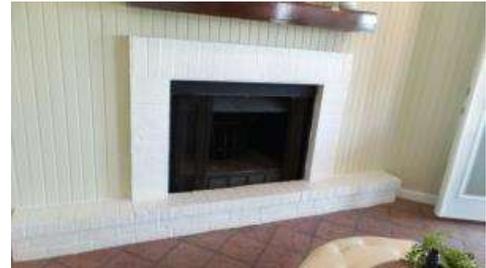
FIRE PLACE LOCATION- First Floor, Living Room.  
 FIREPLACE TYPE- Prefabricated metal, FIRE PLACE OBSERVATIONS- Damper is present.(functional). Rust was present at flu. Service is recommended prior to use.

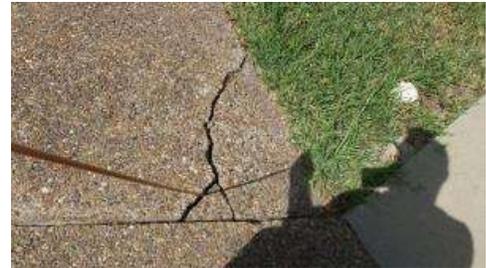
Stress fractures with differential movement noted at areas of the concrete driveway.

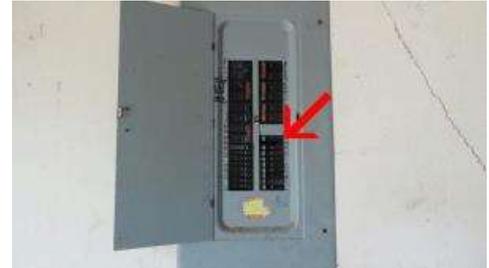
Breakers are not labeled and breaker cover is missing at right side. Cover screws are missing.

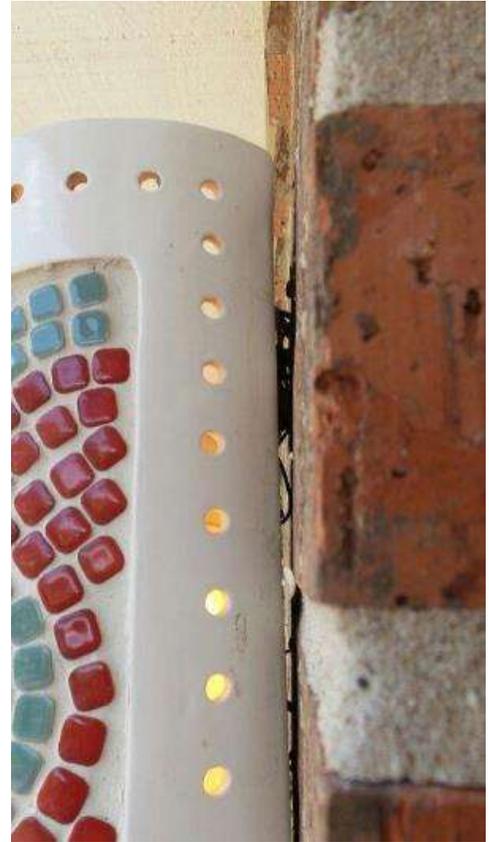
LIGHTING & CEILING FAN DEFICIENCIES-  
Fixtures are loose or wiring is visible behind garage exterior light fixtures.

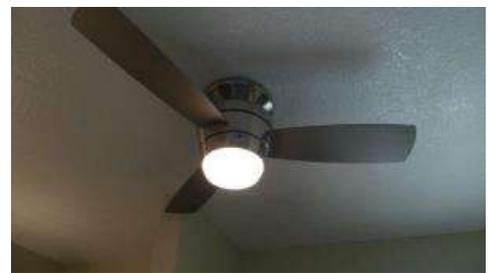
Ceiling fan did not function at master bath. (remotes may be missing at several fans)

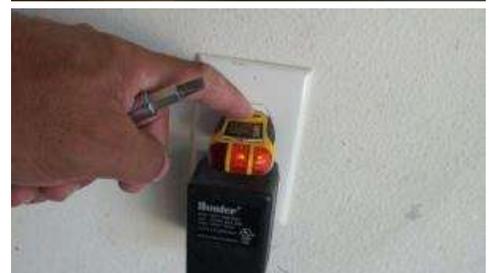
RECEPTACLE DEFICIENCIES- **Ground Fault circuit Interrupter(s) were not present, not install properly, and/or do not operate as shown by use of a separate testing device in the Garage, exterior bathrooms and kitchen.**

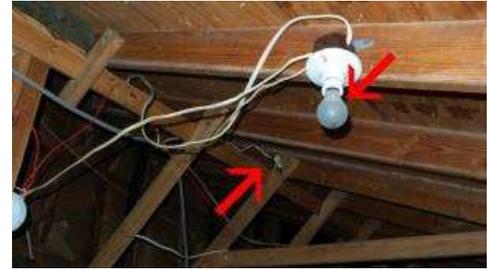
Globes or covers are needed at all closet and attic light locations. A receptacle is improperly wired with no junction box present. Conductors are not properly secured to structure in attic over garage. Evaluation is needed by licensed electrician.

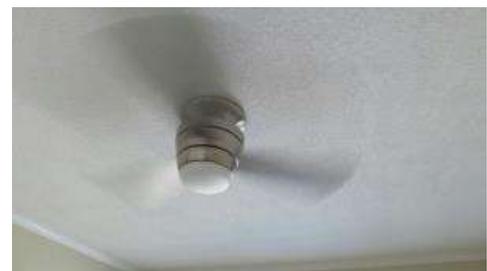
Light fixture failed to operate at upstairs rear room.

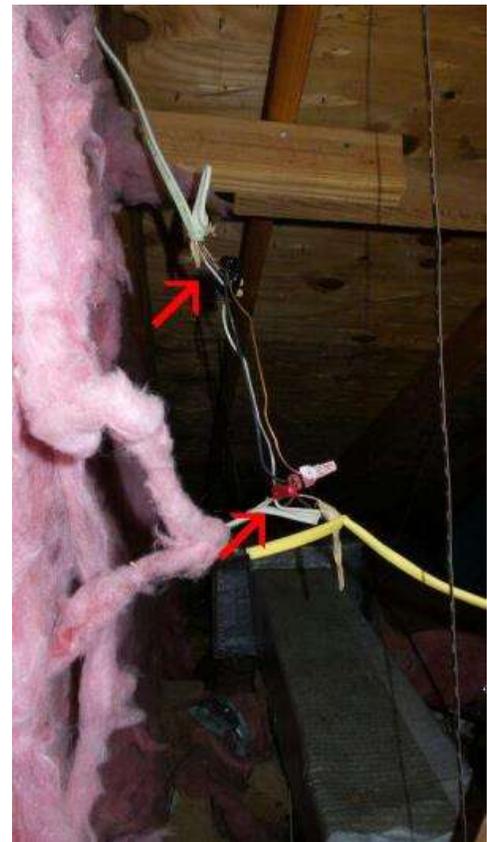
Handyman wiring is a very unsafe condition which is noted at both attic spaces. Evaluation and repair recommendations are needed by licensed electrician. The presence of handyman wiring is an undesirable condition which should be corrected by a licensed electrician. Wiring and connections are often installed in a haphazard manner, with an increased potential for shock, safety and fire hazards. The installer may be familiar with particular precautions which he/she has grown accustomed to taking when operating equipment powered with such wiring, but as a purchaser, you or your family may not be. One of the most common problems is the use of inappropriate wire in exterior or damp locations. Doubling up of wires on circuit breakers and incorrect routing and attachment of wires, along with incorrect wiring of fans are other often seen occurrences. Costs for correcting wiring of this type can accumulate rapidly, as correction of one deficiency sometimes uncovers the existence of another. Every instance of handyman wiring present may not be detailed in this report.

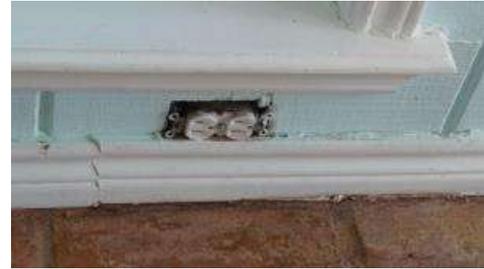
RECEPTACLE DEFICIENCIES- Receptacle is loose and cover is missing at converted patio.

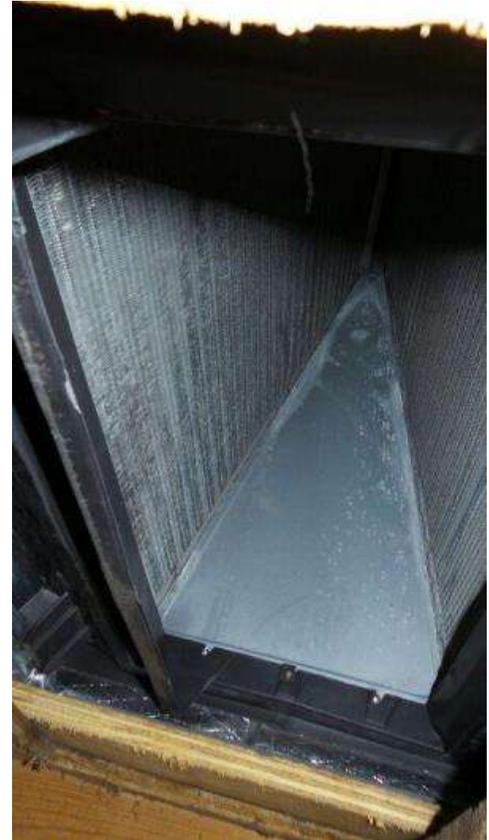
Inside coils were slightly dirty but appear to be serviceable.

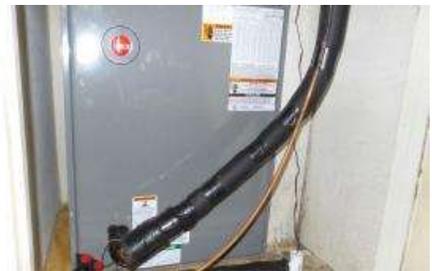
Electric, - Central, - Split System. AIR TEMPERATURE DIFFERENTIAL- Air Temperature Deficiencies- **Temperature drop/differential observed was less than 15 degrees. (12 degrees)** EVAPORATOR OBSERVATIONS- No problem observed during this inspection period. **Tip: add a cup of distilled vinegar to the cleanout at the primary drain when changing filters to avoid drainage problems,** THERMOSTAT OBSERVATIONS- No problems observed during this inspection period. The air conditioning system should be further evaluated by a licensed HVAC Technician. NOTE: Average life span of a A/C system in this area is between 10 - 12 years under normal conditions. (slightly shorter for heat pumps) The purchase of a mechanical warranty package should be considered at this time. Check with your Realtor for additional information.

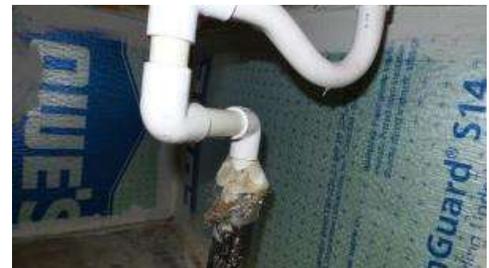
**Improper drain connection noted under unit. Repairs needed.**

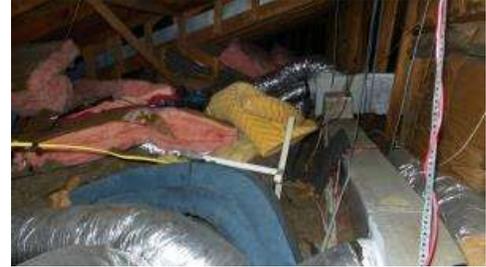
DUCTWORK TYPE- Fiberglass duct board and/or flexible type ducts were primarily used for distribution/return system throughout. Insulation-Ductwork, Air Chase and/or Plenum Observations- **Openings observed at ducts and/or at blower unit allowing air to escape from the system. Duct work is routed improperly in area(s) Straps are missing or damaged at some flexible duct lines. Strapping is needed to prevent animal intrusion. Flexible duct lines should be kept off of the insulated surface.**

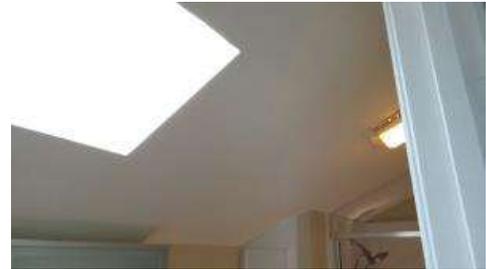
No air conditioning vent is present at the upstairs bathroom. The skylight in this room produces a large amount of heat. It is noted that the door is Louvered. Inspector felt noticeably warmer temperatures in this area.

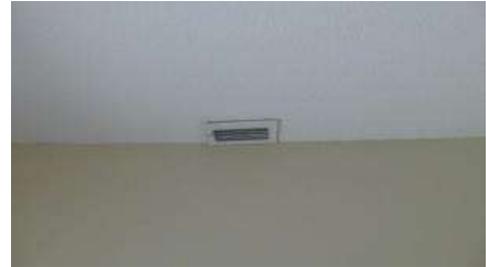
Register is loose at master bath.

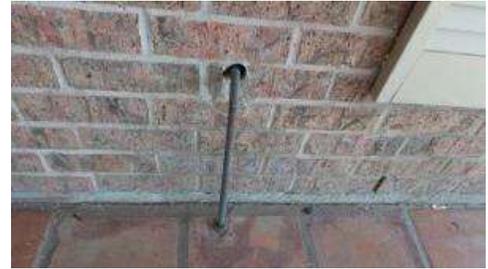
Municipal service is primary water source. SUPPLY PIPING TYPE- Combination of materials, Copper, Plastic, POTABLE WATER LINE  
 OBSERVATIONS- Appears serviceable, EXTERIOR PLUMBING- No anti-siphon protection observed on exterior hose bibs/faucets. This is a basic safety attachment to the end of faucets that will protect from a cross connection or back-flow of water into the house. The exposed water line at the front porch is not protected from impact nor insulated.

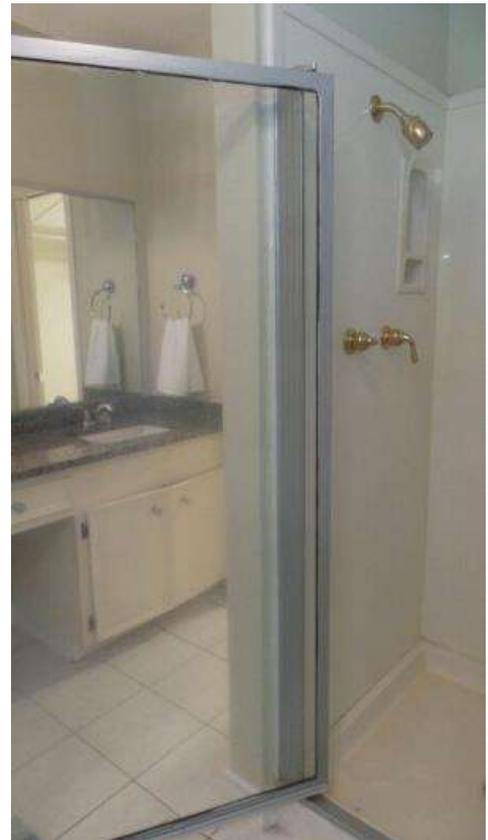
**Master shower handles spend 360 degrees. The shower door has been recently painted with aluminum paint. The bottom threshold or rubber seal is missing from the bottom of the shower door.**

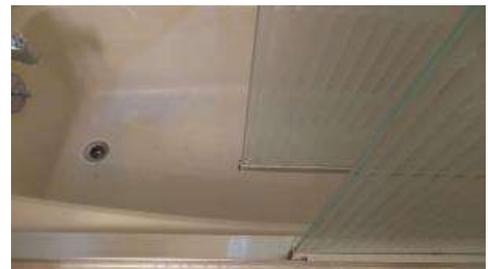
**Door is loose it downstairs bath.**

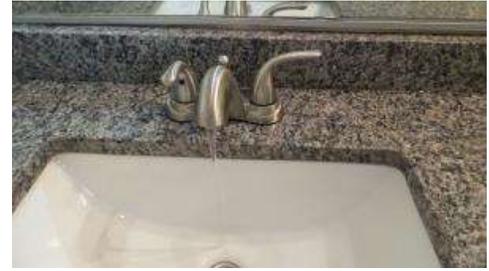
Hot water flow was low at left side master sink. There was a whole around the countertop at the faucet and the faucet was slightly loose.

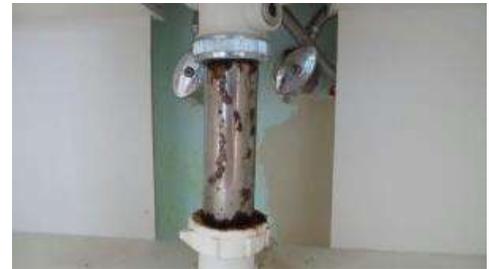
Signs of previous leaks noted at upstairs bathroom sink. The sink and or the cabinet do not appear to be properly attached to the structure.

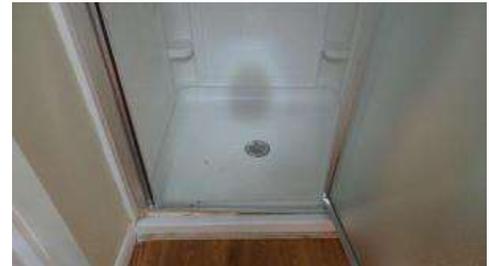
It appears that a small amount of water stands after operation at the upstairs shower. This may be an indication that the shower is installed unevenly. Evaluation is recommended by licensed plumber.

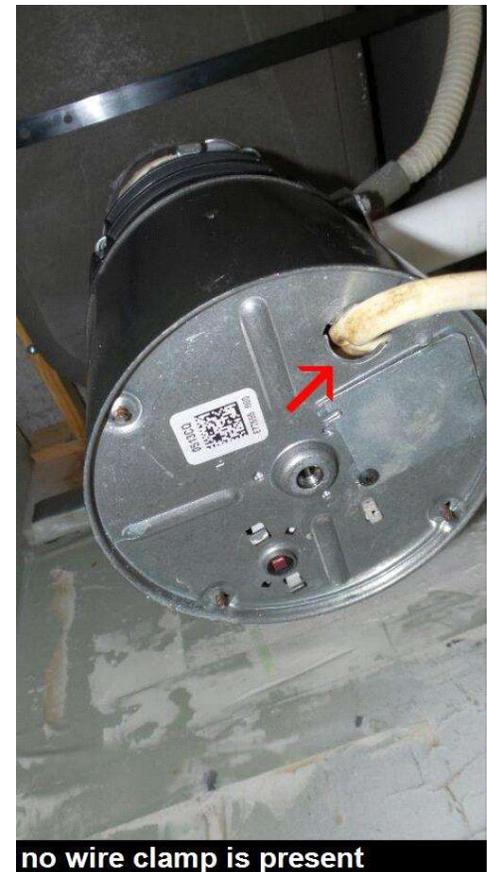
**The following deficiencies were noted: Incorrect material and/or installed was present in disposer wiring.**

**no wire clamp is present**

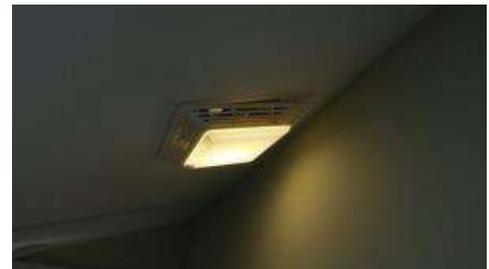
Combination heat & vent unit present. **Vibration was noted.** Vent unit present. Vent pipe(s) do not terminate outside out the structure. Unit cover is loose at upstairs.

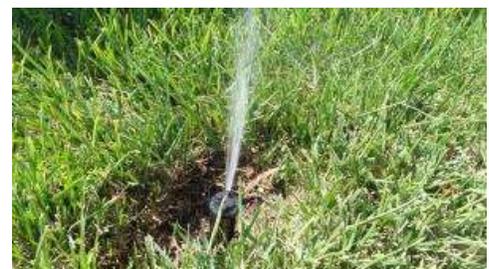
PUMP/MOTOR OBSERVATIONS- No problems noted during the inspection. Number of zones - 6  
 VALVE TYPE- Electric, VALVE  
 OBSERVATIONS- NOTE: Sprinklers were checked in manual mode only. TIMER AND SUBPANEL  
 OBSERVATIONS- No problems noted at the time of inspection. SPRINKLER HEAD OBSERVATIONS- Full coverage is not assured, DEFICIENCY  
 OBSERVATIONS- No rain or free sensor was noted and the backflow preventer ur is not a part of this inspection.
