**Structural Integrity Reserve Study**  
**(Project #22-016)**  
**for**  
**Orchid Springs Village, No. 200, Inc.**  
**200 El Camino Drive**  
**Winter Haven, FL 33884**

**Date: March 21, 2024**

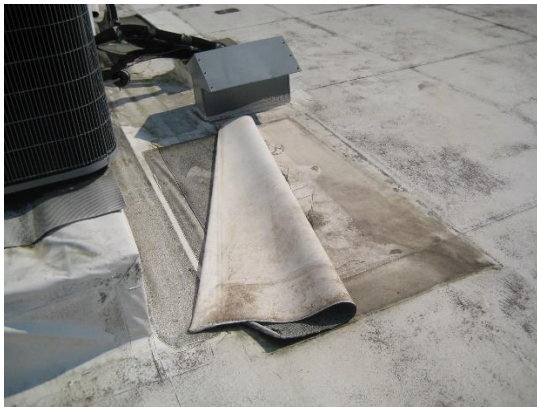
A visual inspection, it was noted that the top layer of the roofing system was separating from the main layer at numerous areas on the roof. It appeared numerous areas of the top layer of the roofing system was peeling away or missing. Additionally, many of the mats for foot-traffic have separated from the roofing system and are no longer attached to the roofing system. All the metal hatches appeared to be in good condition. As such, it appears that the roofing system has reached the end of the useful life cycle.

Roof mat separated from the roof system.

It is recommended that reserve funds be obtained to replace the roof in 2027 and replace the roof again in 2047.

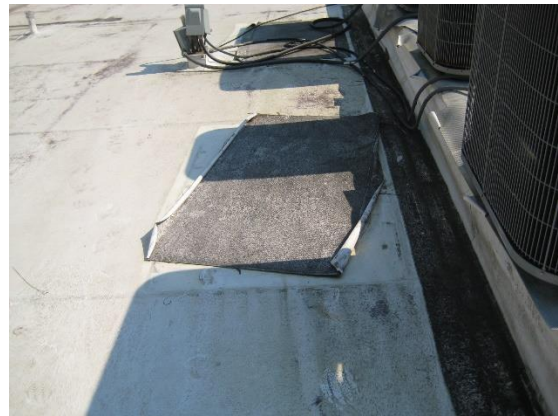
Roof mat separated from the roof system.

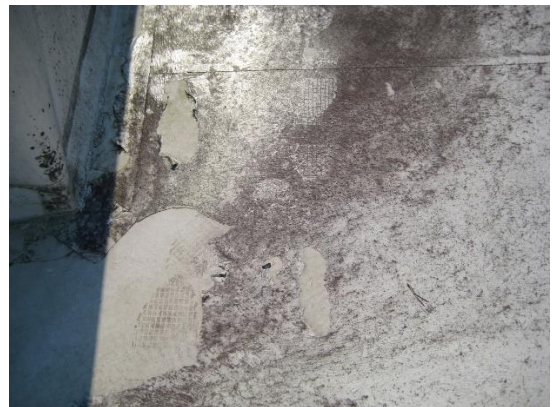
Coating separating from the roofing system.

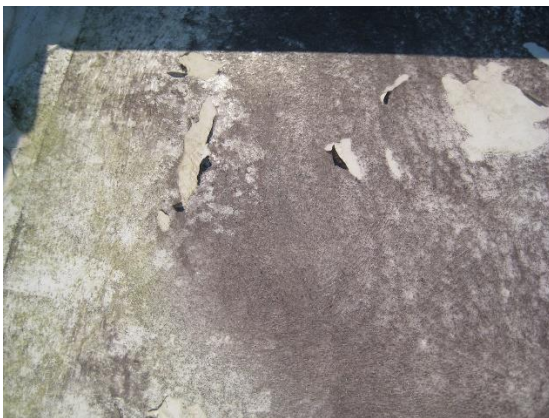
Coating separating from the roofing system.

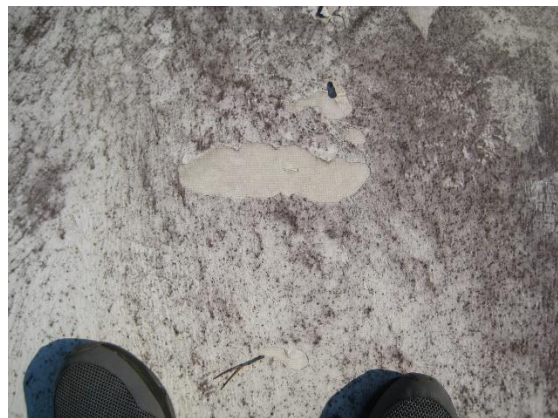
Coating separating from the roofing system.

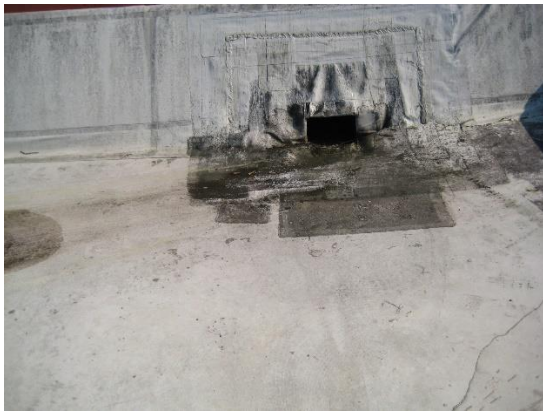
The roof's drainage system includes downspouts that convey the stormwater to the adjacent wetland. It appears the original downspouts have been replaced by large PVC pipes. These pipes are not properly supported and not properly connected to the roofing system. As such, some stormwater is bypassing the PCV pipes. Further, the drainage inlets on the roof do not have vertical screens to ensure debris does not block the follow of water.

Drain to gutter; no screen.

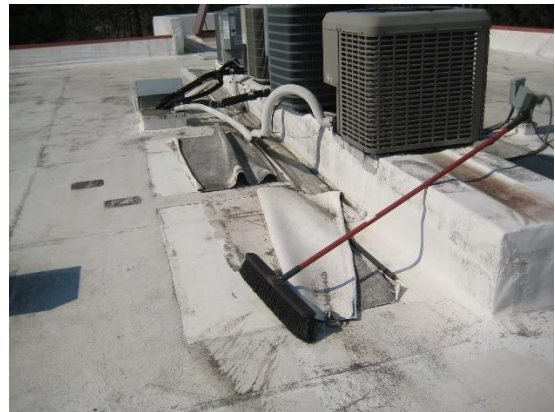
A/C system. Mat separating from the roofing system.

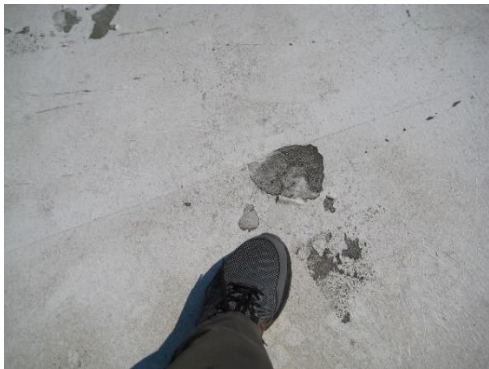
Coating separating from the roofing system.

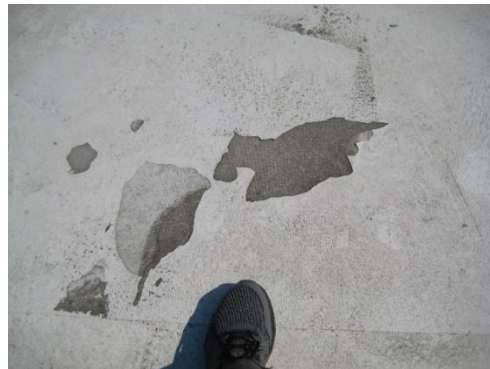
Coating separating from the roofing system.

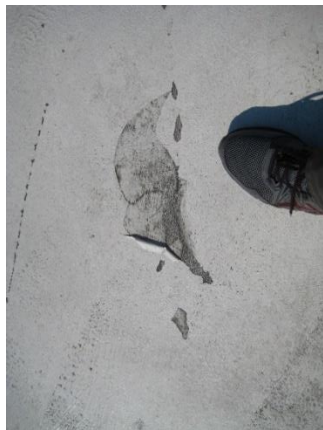
Coating separating from the roofing system.

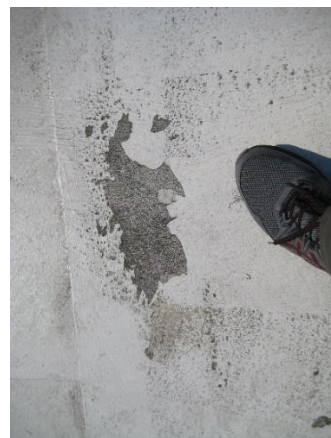
Coating separating from the roofing system.

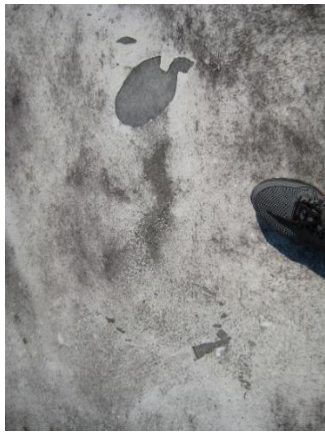
Coating separating from the roofing system.

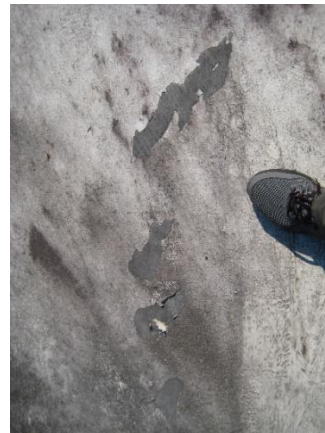
Coating separating from the roofing system.

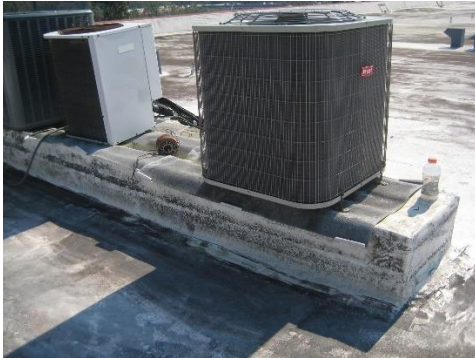
A/C system and debris.

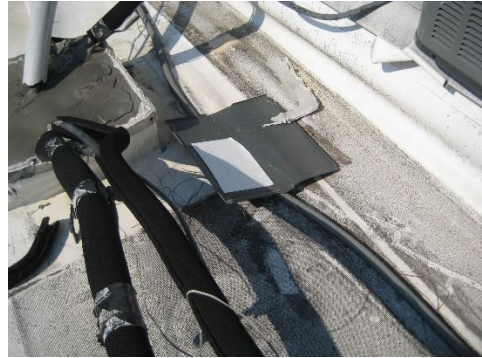
A/C pipig and debris.

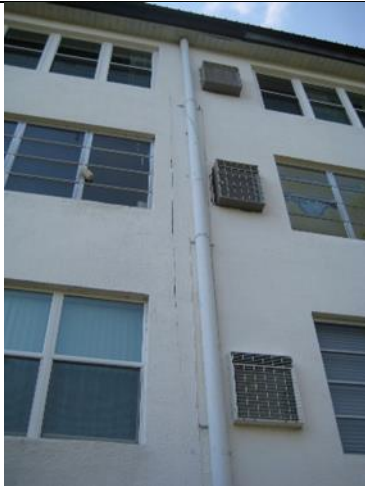
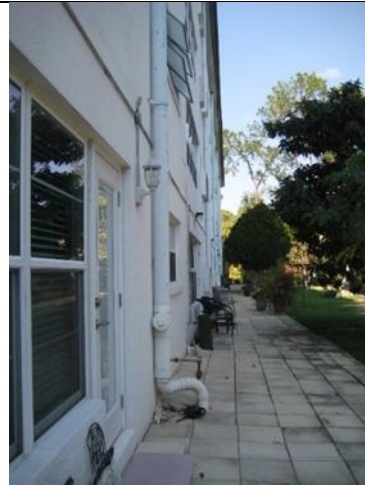
PVC Downspouts

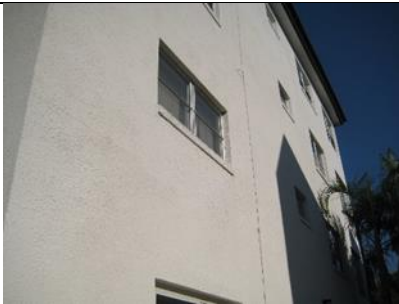
Typical exterior with cracks.

It is recommended that reserve funds be collected to repair, grout, caulk, and paint the exterior of the building in 2026 and again about 12 years thereafter.

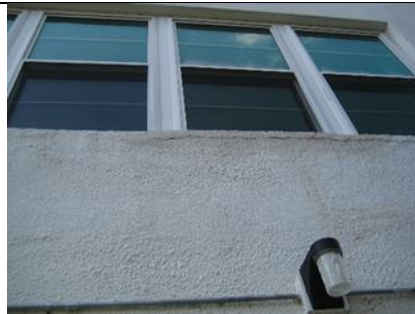
Typical exterior with cracks.

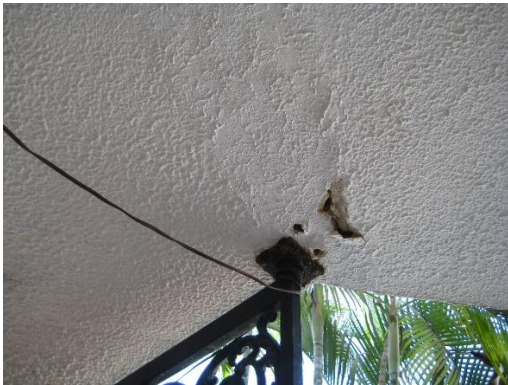
Rebar in breezeway ceiling.

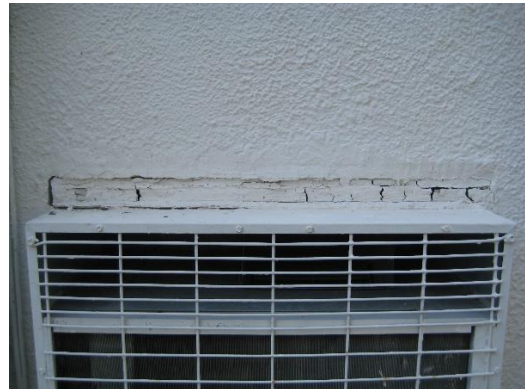
Most concerning, there are many openings in the exterior surfaces of the building that allow water to flow into the walls of the building. Such openings are adjacent to gas lines, internet cables, potable water lines, and the perimeter of the air conditioning units. Additionally, the exterior walls including exterior windowsills have notable cracks. When water enters the walls of the building, stucco mesh, rebar, and other materials deteriorate and weaken the structure. As such, all openings should be repaired, grouted, and caulked as soon as possible. Thereafter, the exterior of the building should be painted. The project should include exterior metal stairs wells which are corroding.

Openings around an air conditioner unit.

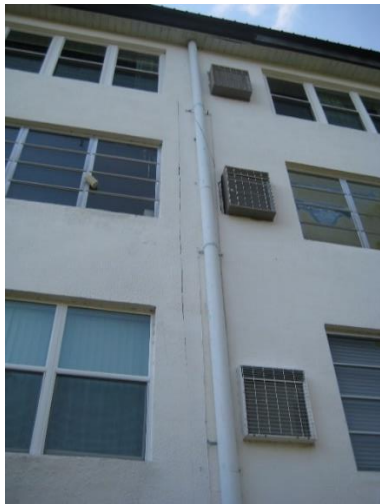
Openings around air conditioners.

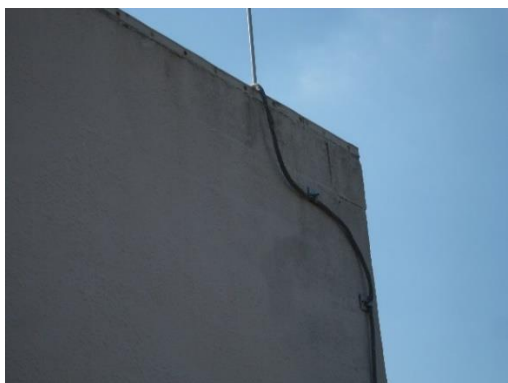
Cracks around corner block.

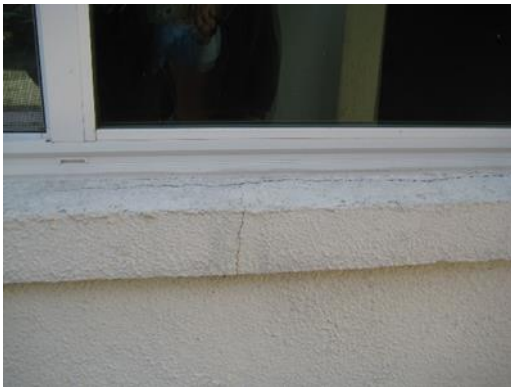
Minor cracks on windowsill.

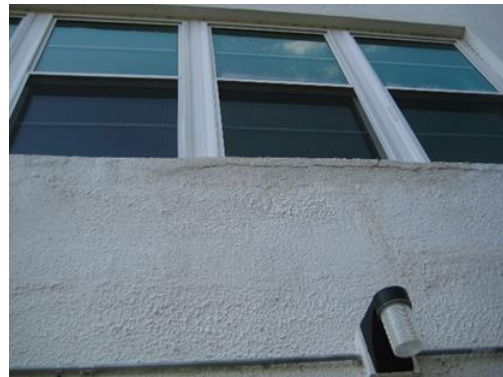
Cracks on windowsill.
