Sea Conquest
Marine Surveys & Consultancy

Sail Boat [REDACTED] Survey Report

SAIL BOAT	[REDACTED]
HIN	[REDACTED]
DATE	[REDACTED]
REPORT NO.	[REDACTED]

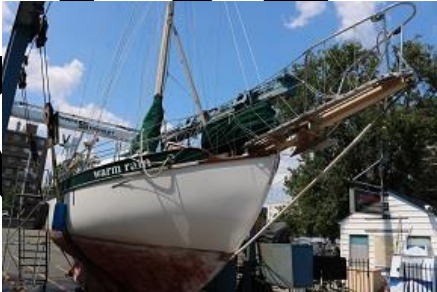
1.1	General Hull Condition	Yes √	No	NA	NS
<p>Hull in good shape, however observed minor blisters in bottom parts of the hull. Moisture meter showed low moisture readings on outer hull.</p>					
1.2	Bow / Stem / Bowsprit	Yes √	No	NA	NS
<p>Bow and stem are in good condition, no any signs of cracks or damages. Bowsprit solid in place, no any signs of cracks or damages.</p>

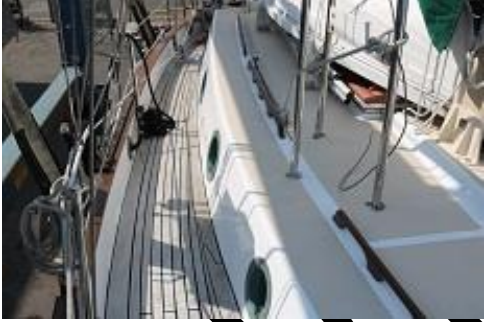
1.5	Deck / Flooring	Yes	No	NA	NS
	Boat's deck teak wood in good shape, no any bends or cracks observed.	√

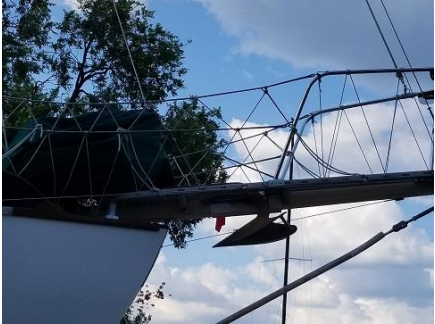
1.8	Rails / Pulpit	Yes	No	NA	NS
	Stainless steel rails apply around the boat, are in very good condition, no any signs of damages or corrosion. Stainless steel pulpit in good condition, no any signs of damages.	√

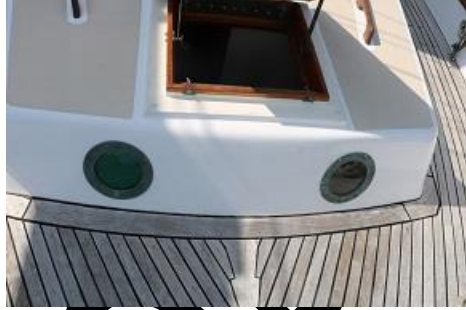
1.11	Port Holes	Yes ✓	No	NA	NS
<p>5 port holes located on each side port and starboard, 2 port holes located forward and 2 aft of accommodation space. All port holes are in good condition and well securing from inside.</p>

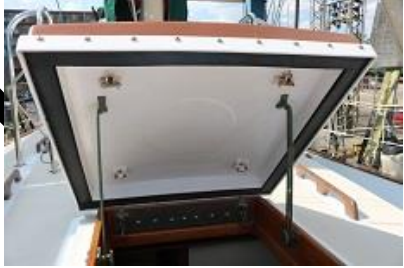
1.12	Hatches & Water Tight Integrity	Yes ✓	No	NA	NS
<p>1 hatch located forward of accommodation space, watertight, good seals and inner locks.</p>

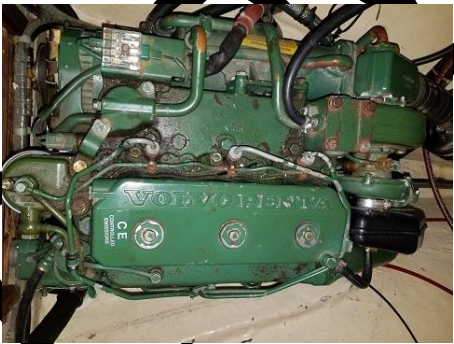
2.1	General Engine Condition	Yes	No	NA	NS
<p>Inboard Volvo Penta 2003T, turbo charged 3 cylinder, 4 stroke, Engine was not started or tested, but all fittings, and gear are in place.</p>

Note: During the survey aux engine was not started or loaded, and it is recommended and understood that Volvo Penta diesel engine to be surveyed by a qualified diesel engine mechanic to determine the comprehensive condition of the engine, gears, pumps, heat exchanger, etc.

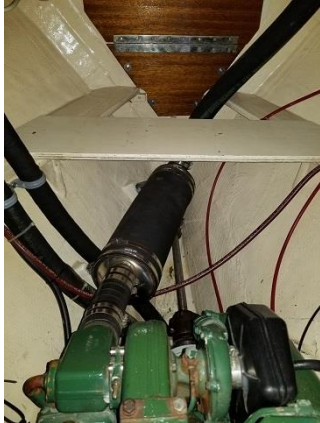
2.2	Engine Exhaust / Exhaust Pipe / Clamps	Yes	No	NA	NS
<p>Exhaust muffler and pipes were checked. Hoses are in good condition, with 2 stainless steel clamps well fitted on each end.</p>

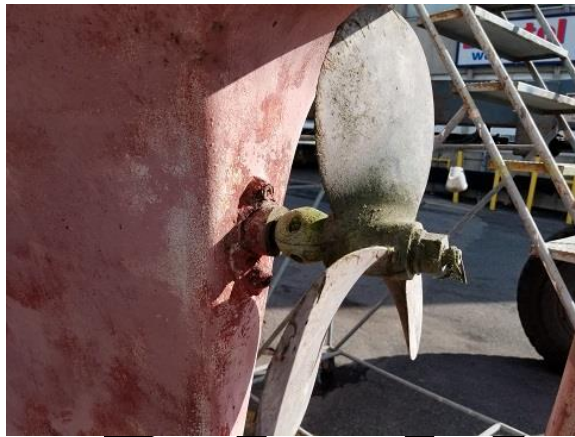
3 blades right hand propeller, in good condition, no any signs of bends or scratches in blades.

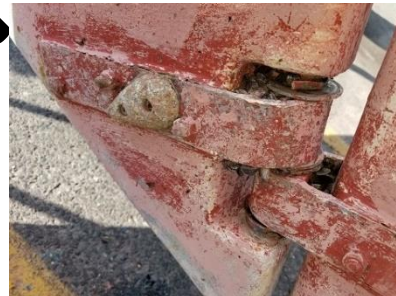
Anticorrosion anode on propeller in 60% condition.
3 anticorrosion plates on rubber need to be replaced.

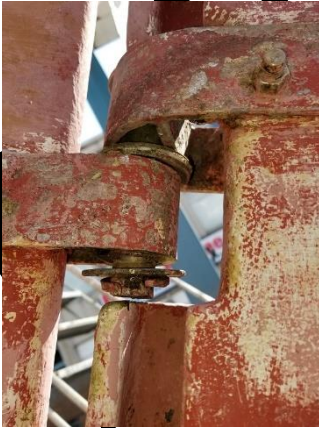
2.15	Rudder Mount	Yes	No √	NA	NS
The rudder subject to 3 mounting pivot pins, the middle pivot pin is loose and not secured in position.

S.	Non Conformances & Remarks	Category	Recommendations
1	The rudder subject to 3 mounting pivot pins, the middle pivot pin is loose and not secured in position.	High	Middle mounting pivot bolts to be secured and to be tightened.
2	Anodes on rudder mounting plates need to be changed.	Low	To replace 3 anodes on rudder mounting plates.
3	Mast Navigation Light lantern is not available. However deck Nav. lights are in place.		To install Mast light lantern on top of the mast. As per ABYC A-3, Transport Canada Requirements, and Colreg.
4	Minor small blisters found on hull's bottom parts.	Low	Proper maintenance to remove small blisters while next hull maintenance.
5	Warning Labels are missing: Shore Power Connection. Stove.	Low	Warning Labels to be applied as per ABYC E-11. ABYC A-3.
6	Engine compartment is missing natural ventilation as compartment includes batteries as well.	High	To install natural ventilation in engine compartment as per ABYC H-32 and E-10.

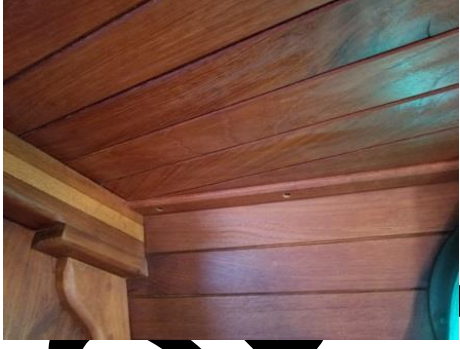
3.1	Interior	Yes ✓	No	NA	NS
<p>Tradition all teak interior in good condition, Inside cabin the teak is very well maintained, no any signs of damages or molds. Closets, lockers table. Seats, ladder, ceiling are in good condition.</p>

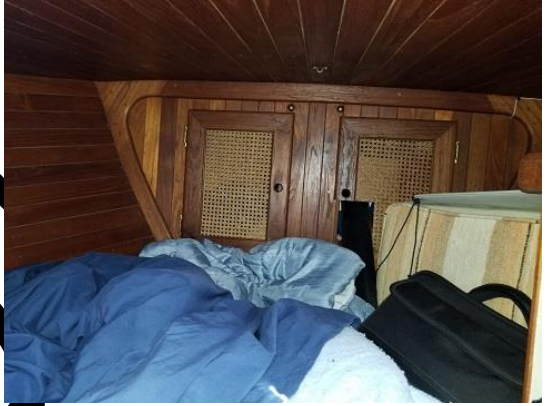
3.2	Berths / Bunks	Yes ✓	No	NA	NS
<p>6 berths in good condition.</p>

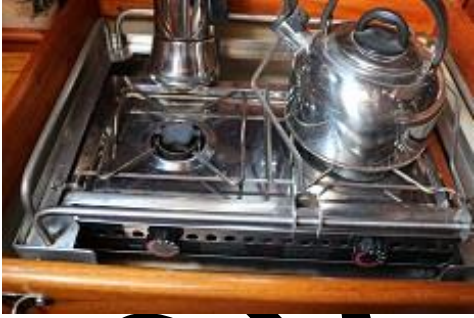
4.1	Stove / Barriers	Yes √	No	NA	NS
<p>Origo 3000 Free standing non pressurized 2 burners alcohol stove, with barriers. Manufacture warning applies on it, <u>However ABYC labels are not available.</u></p>

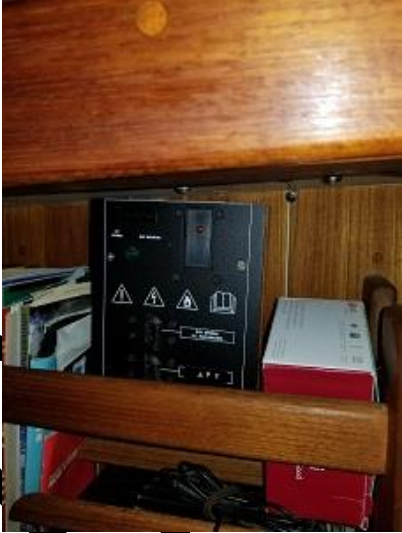
6.1	AC Power System	Yes ✓	No	NA	NS
<p>Shore power connection to 110V AC panel located in aft cabin. 2 x 30Amp breakers applies. <u>No AC voltmeter available however the vessel is manufactured and likely complied with existing standard at that time. Recommended as required by ABYC E-11.</u> 110 wiring is properly connected</p>

15	Sewage system does not include holding tanks.	High	To install a holding tank system and no direct overboard discharge as per ABYC TH-29, transport Canada Shipping act, and Marpol.
16	Pyrotechnics, flares are expired.	Medium	To apply new flares as per transport Canada requirements.
17	No any exterior deck lights or search light available.	Recommend	To place external light and search light on deck.
18	No AC voltmeter available on AC panel.	Low	To be installed as per ABYC E-11.

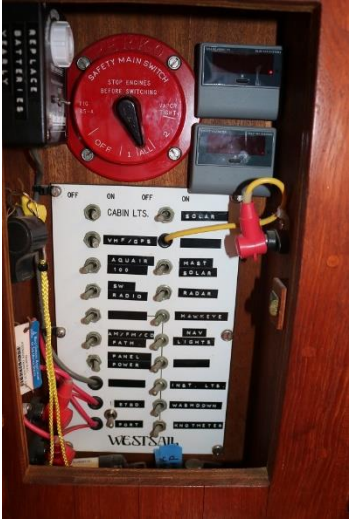
6.2	DC Power System	Yes ✓	No	NA	NS
<p>2 batteries connected in parallel, via DC electrical panel with safety main switch. 12 V equipment connected. With electronic voltmeter and DC Ammeter on panel. All wiring are connected properly and wire color coding applies as per ABYC standard.</p>

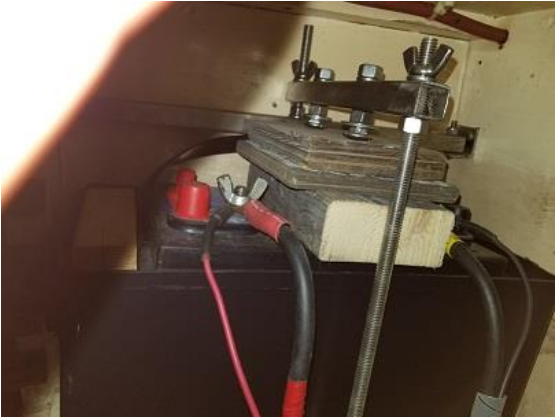
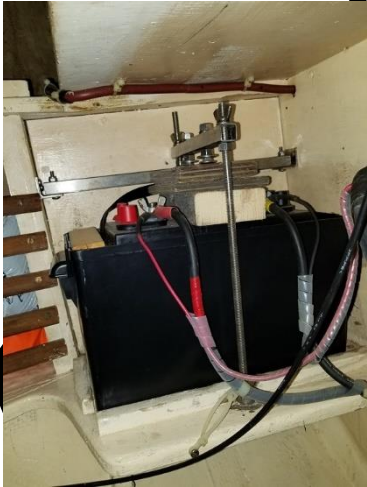
6.3	Batteries Storage / Stowage / Securing / Ventilation / Terminal Protection	Yes	No ✓	NA	NS
<p>2 marine grade wet batteries located port and starboard sides inside engine compartment. Batteries are well secured and located in acid proof battery boxes.</p> <p><u>No safety caps available on positive terminals.</u></p> <p><u>No proper ventilation available in compartment as per requirements.</u></p> <p><u>Batteries are located below fuel tanks, which batteries shall not placed below fuel tanks.</u></p> <p><u>SEE DIFICIENCIES NOTES</u></p> <div style="display: flex; justify-content: space-around;">

7	AC Electrical outlets are missing ground fault circuit interrupter GFCI.	High	To replace electrical outlets by proper outlets with GFCI as per ABYC E-11.
8	Batteries are missing safety caps on positive terminal.	Medium	To install safety caps on batteries positive terminals as per ABYC E-10.
9	Batteries are installed below fuel tanks at starboard and port sides. Batteries shall not be installed directly above or below a fuel tanks.	Medium	To relocate batteries from position below fuel tank as per ABYC E-10.
10	No lightning protection system available onboard.	Medium	Lightning protection system to be installed as per ABYC TE-4.
11	Fire and smoke detectors are not available onboard.	High	To install fire and smoke detectors. All vessels 26 FT and more in length with accommodation spaces intended for sleeping shall be equipped with single station smoke alarm as per NFPA 302-44.12.3.
12	CO detection system is not available.	Medium	To install CO detector.

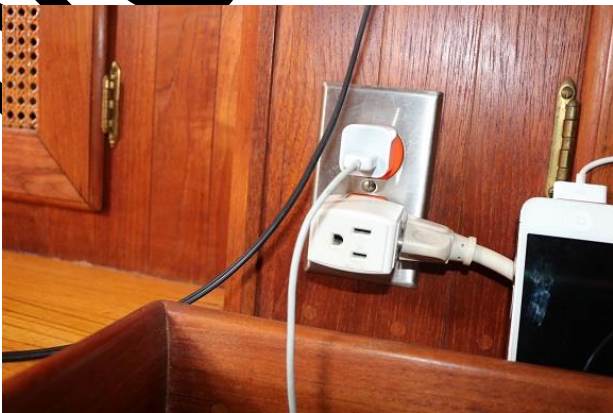
6.5	Electrical outlets / Ground Fault Circuit Interrupter (GFCIs)	Yes	No ✓	NA	NS
<p>As 3 AC electrical outlets on board. No GFCIs available on AC electrical outlets.</p> <div style="display: flex;"> <div style="font-size: 4em; font-weight: bold; opacity: 0.5; transform: rotate(-15deg); margin-right: 20px;">DO NOT</div>

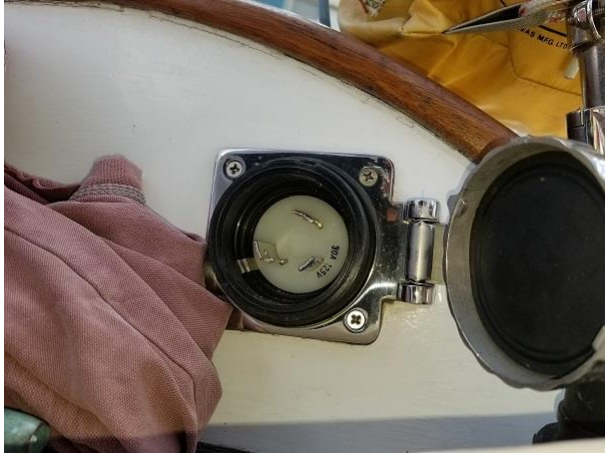
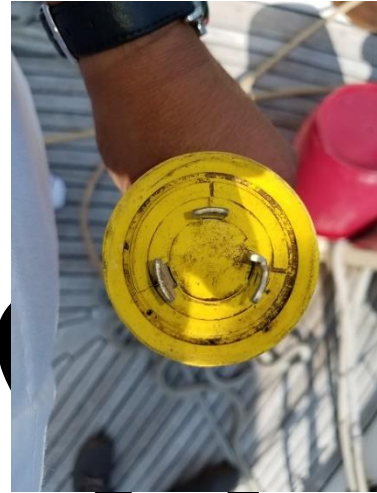
Shore power connection located starboard quarter, in good condition and well sealed with cap.
 Shore power cable 30 AMP, 125V in good condition, no any signs of damages or burns.
Shore power connection is missing required warning and labels.

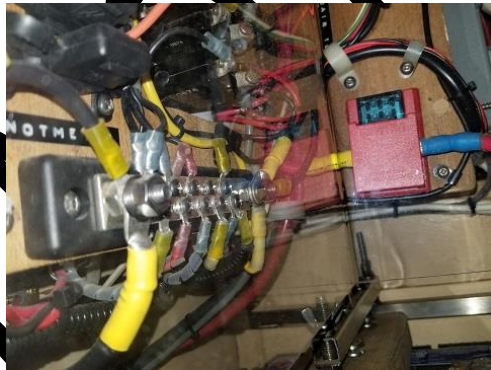
Common ground point available and all equipment grounding cables are properly connected to.

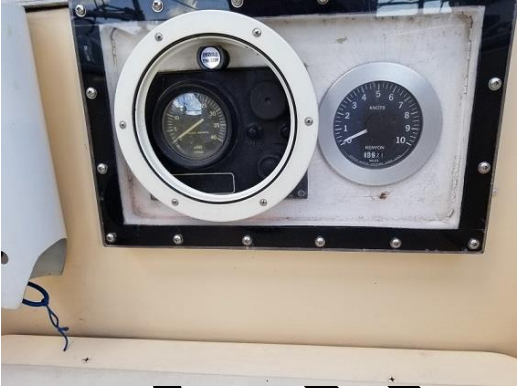
7.1	Dashboard & Gauges	Yes	No	NA	NS ✓
<p>Engine RPM, and Speed Knot meter gauges. Not tested.</p>

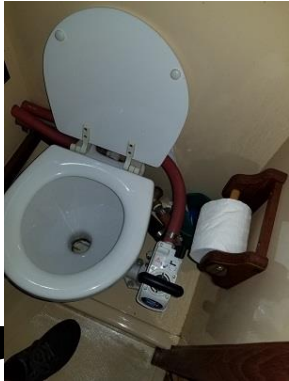
9.1	Toilet	Yes ✓	No	NA	NS
<p>Jabasco marine toilet. All hoses and fittings are in good condition, no any signs of leaks or damages.</p>

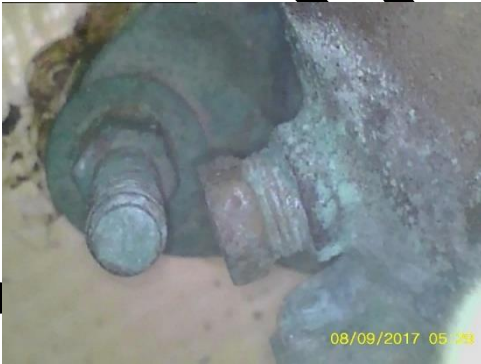
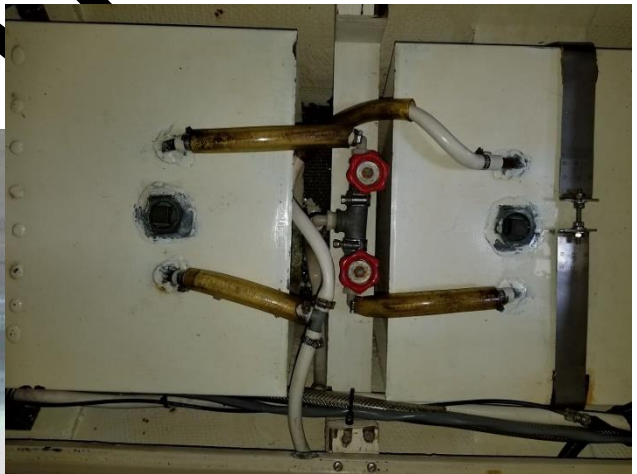
10.2	FW Tanks	Yes	No ✓	NA	NS
<p>2 FW tanks 35 G each. Located below cabin flooring near aft center. Tanks are located together in for and aft position. Tanks are well secured. No any sign of corrosion or rust. Hoses and fittings found in good order.</p> <div style="display: flex;">

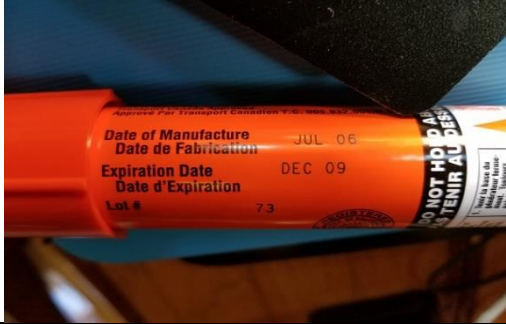
11.1	Life Jackets	Yes	No	NA	NS
	6 Life jackets, Transport Canada approved.	✓			
11.2	Pyrotechnics / 6 Torches / Exp. Date	Yes	No	NA	NS
	Flares were expired.		✓

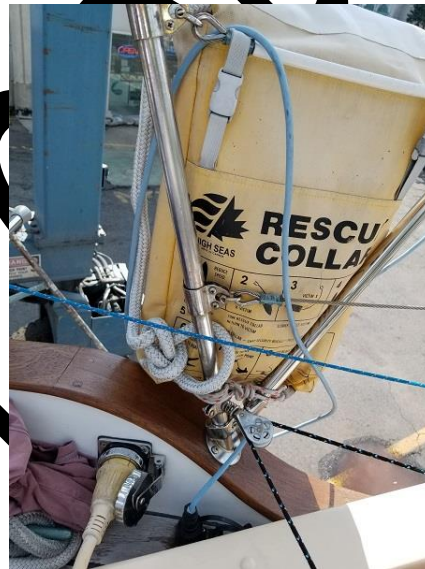
11.10	Rescue Collar	Yes	No	NA	NS
	High Seas rescue collar, in good packing condition, located on deck starboard side	✓

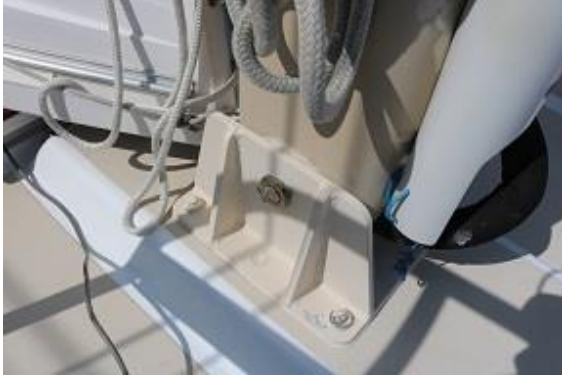
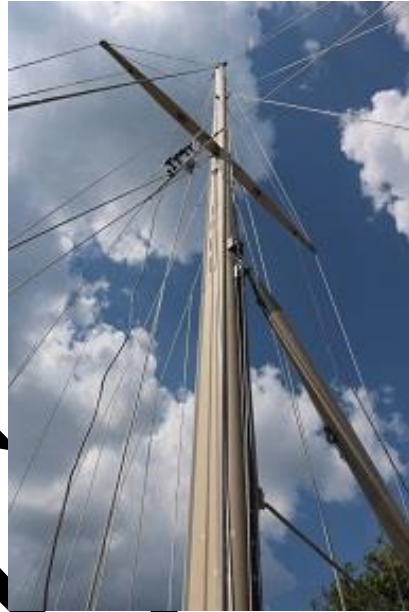
Mast in good condition, solid, no any flexes or loose motions, base is very clean, no any signs of rust or corrosion, and well secured.
Mast was visually checked from deck level.

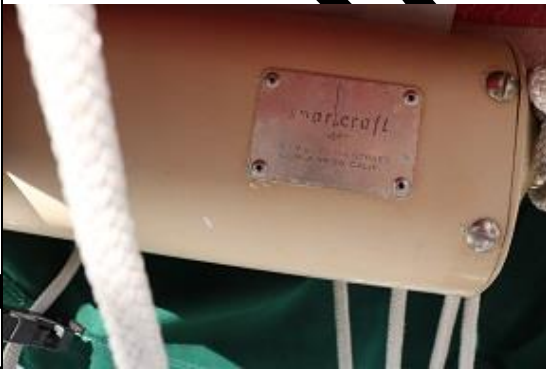
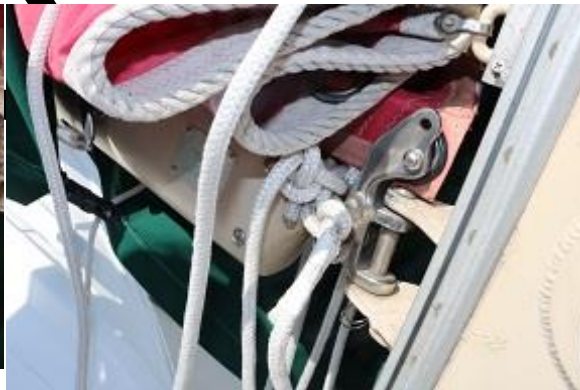
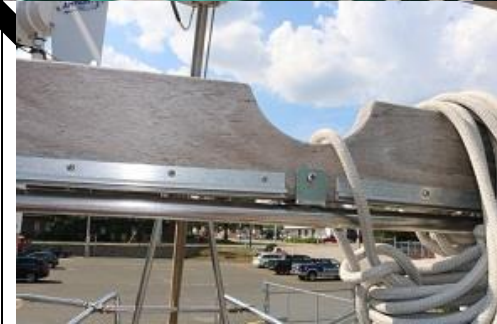
Boom is well secured in location, choseneck is in clean condition, no any signs of corrosion.
Teak boom crutch in a very good condition, no any signs of stress or cracks.

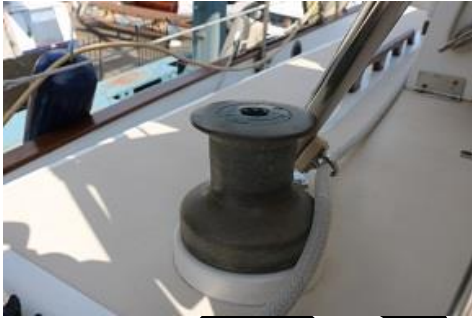
12.7	Winches	Yes	No	NA	NS
	All winches onboard were tested and found to be in good order.	✓

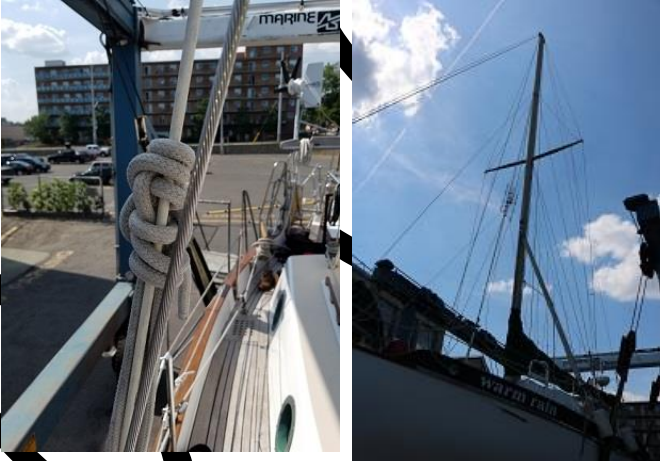
12.8	Sheaves / Forestays / Aftstays	Yes	No	NA	NS
	Sheaves, forestays and aftstays wires checked found in very good condition, no any signs of corrosion or damages inside strands.	✓
